# *Origins and Dynamics of Wide Gage Derailments*

**Gary Wolf**

**Wolf Railway Consulting**

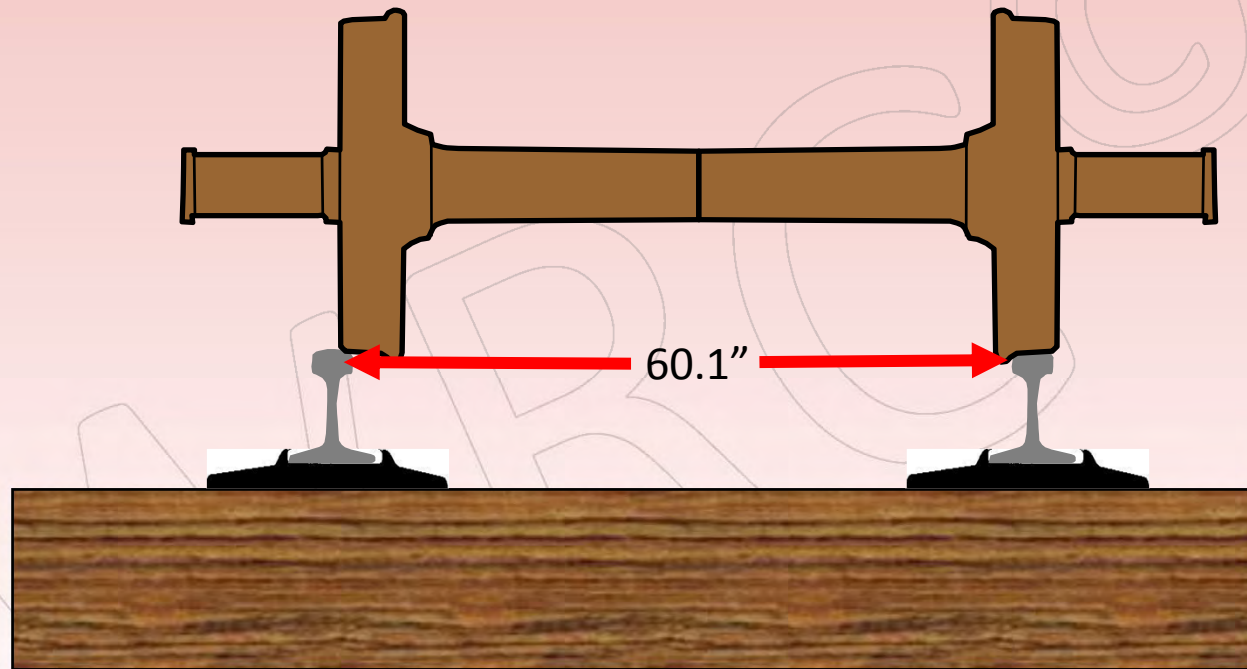
Point of incipient wheel drop  
Due to widening of gage

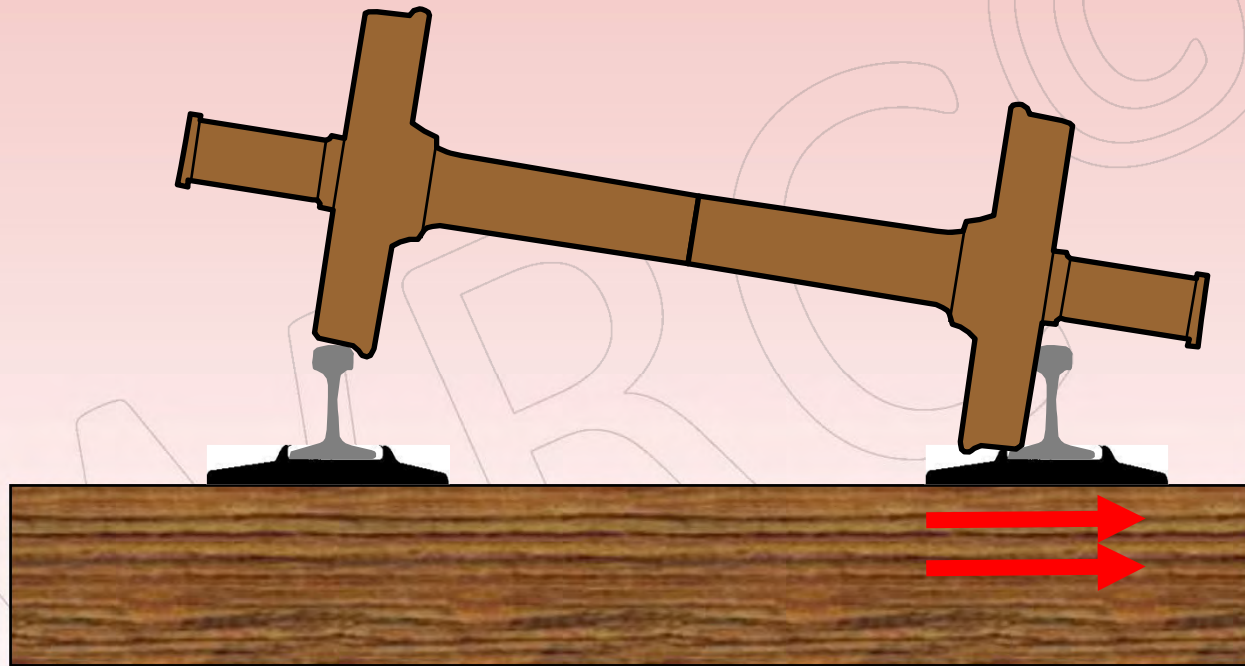
Wide Gage due to lateral  
Translation of rail

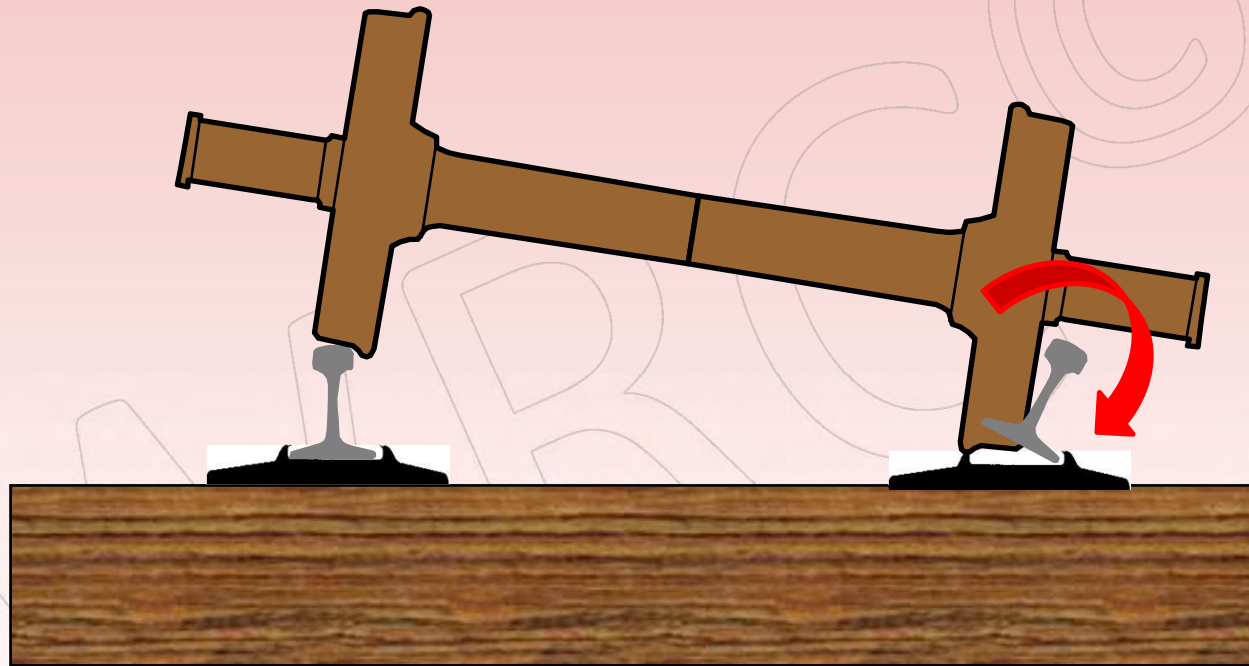
Wide Gage due to rail  
Rolling outward

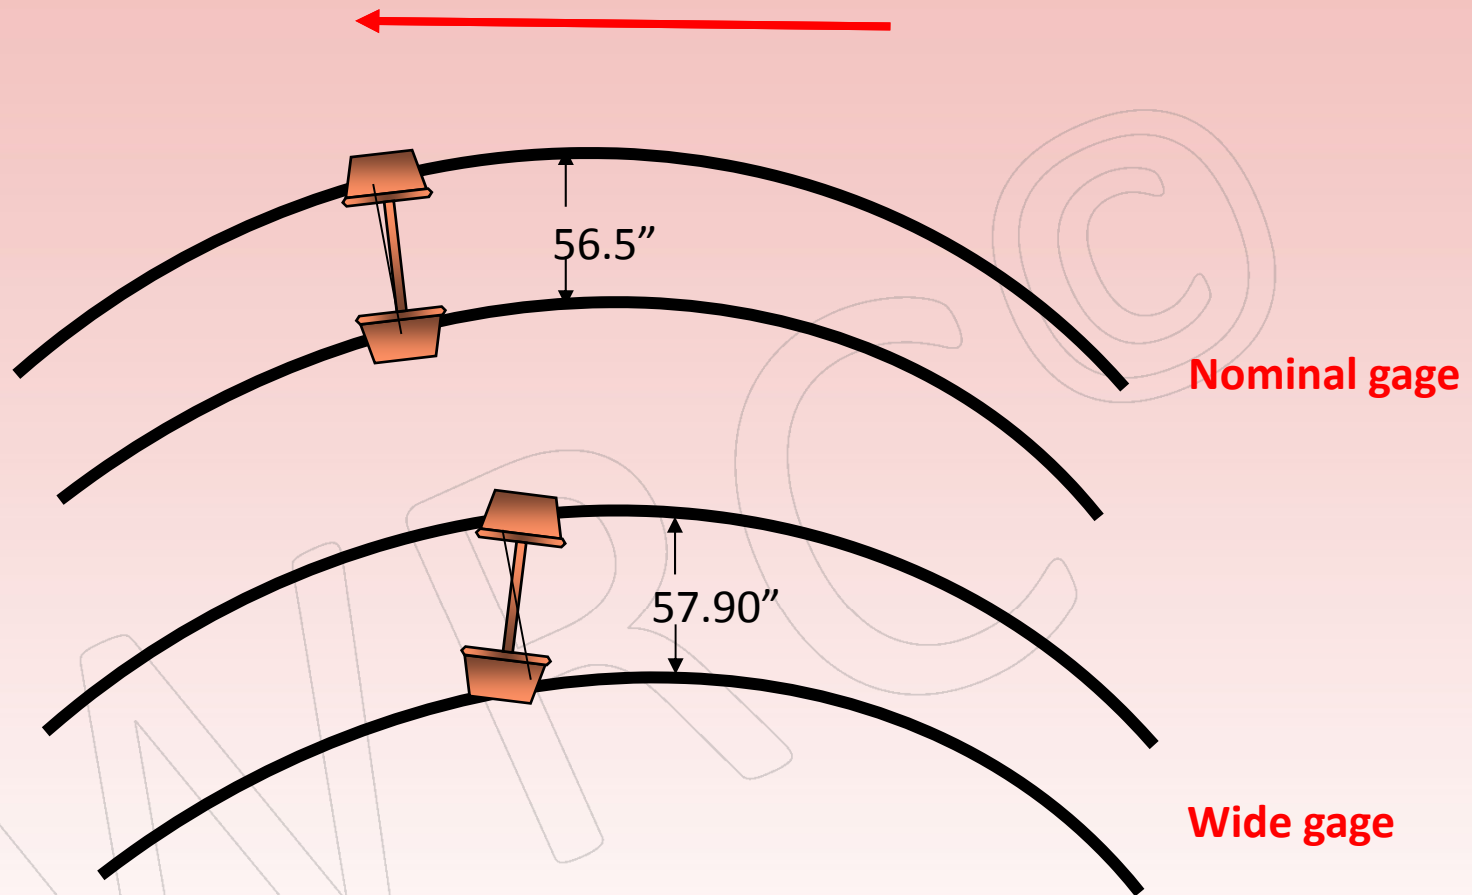
**Pre-existing Wide Gage can allow greater wheelset angles of attack;  
Greater angles of attack can cause greater lateral creep forces.  
Wide gage also can lead to poor wheelset steering and adverse contact geometry**

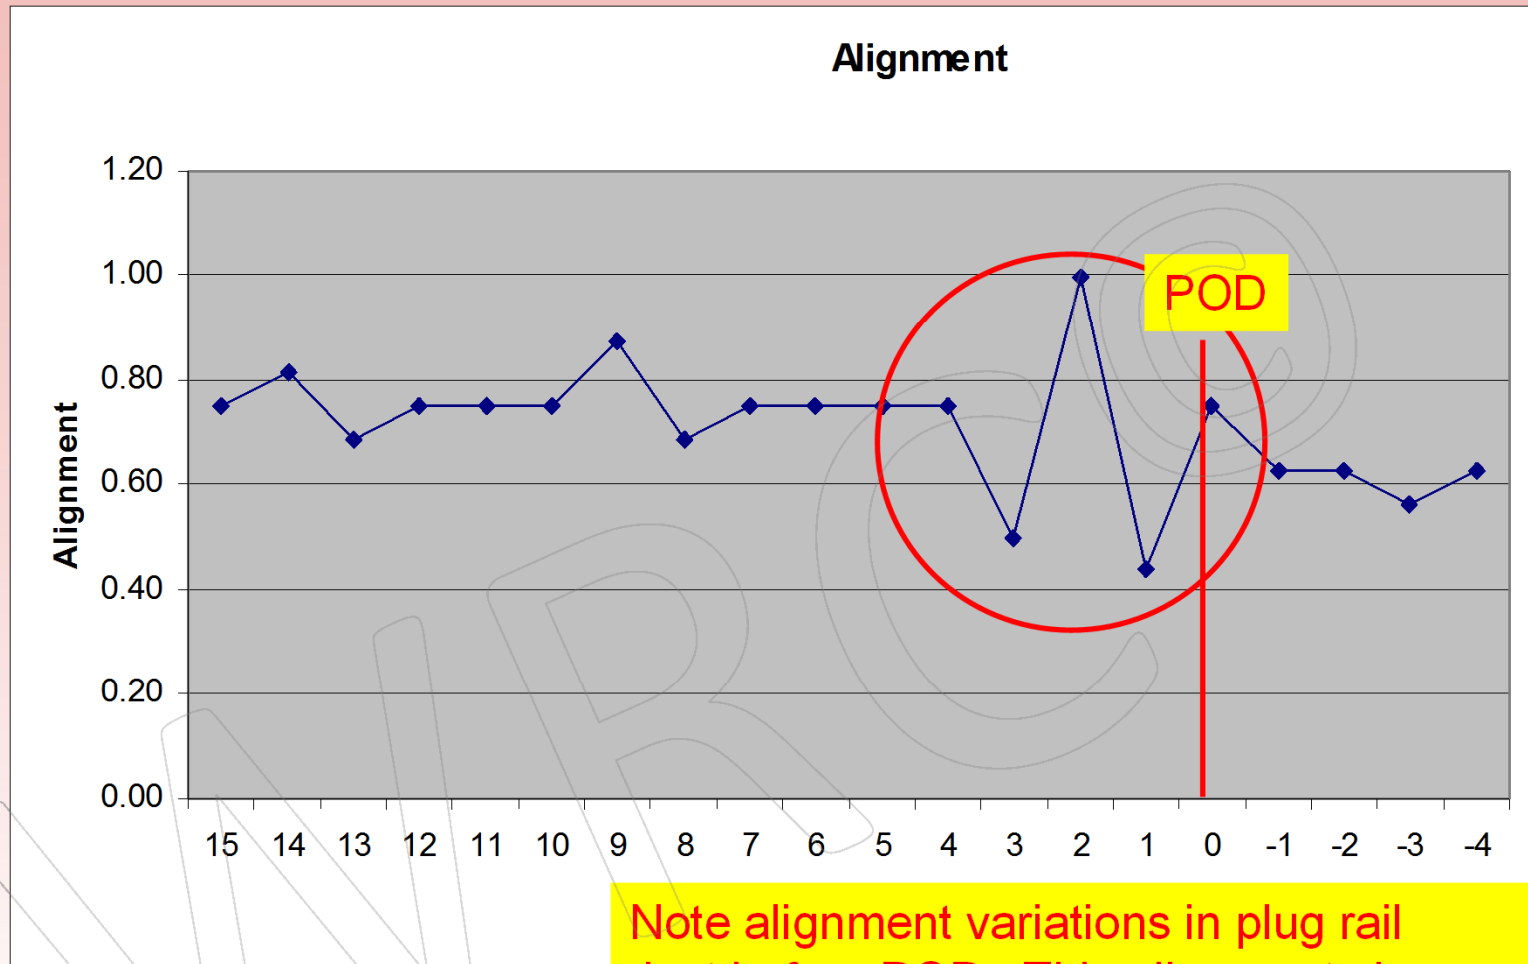
Note alignment variations in plug rail just before POD. This alignment change is evident in photos in report.

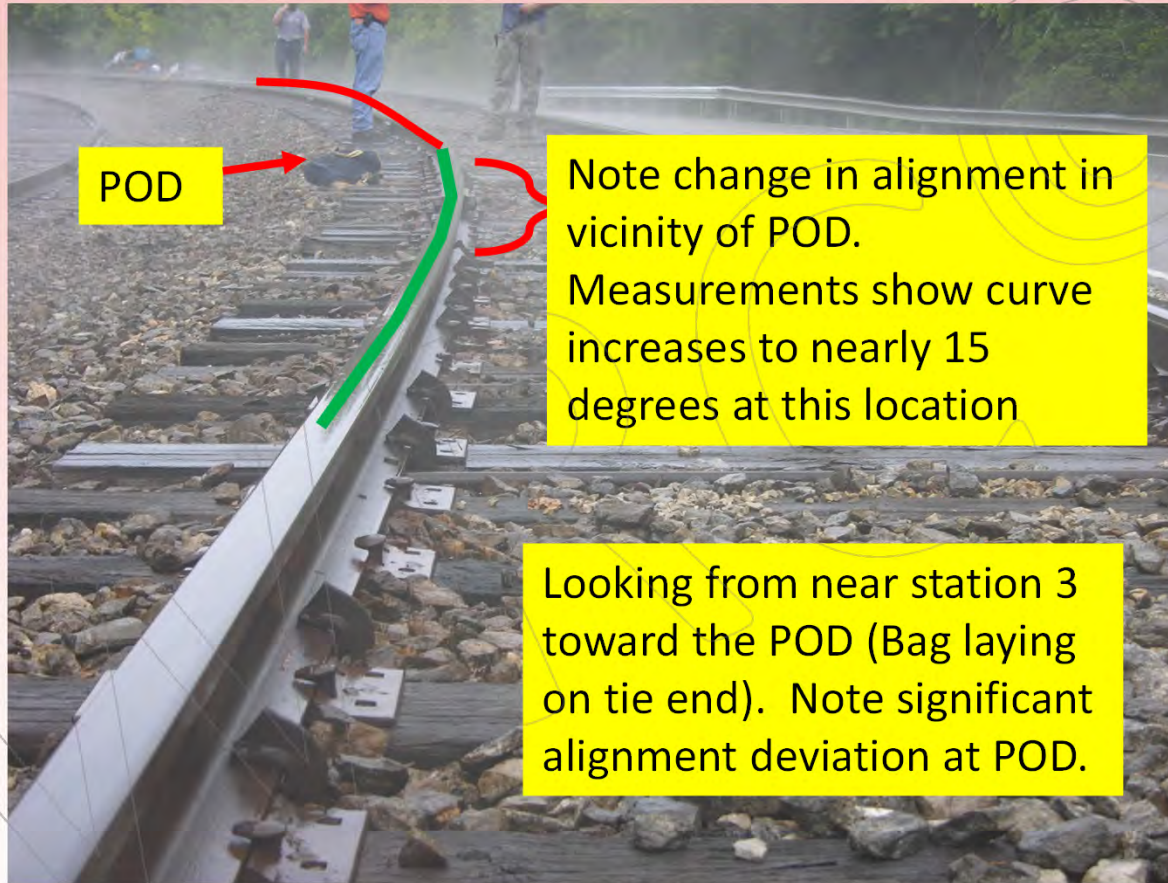
Note change in alignment in vicinity of POD. Measurements show curve increases to nearly 15 degrees at this location

Looking from near station 3 toward the POD (Bag laying on tie end). Note significant alignment deviation at POD.

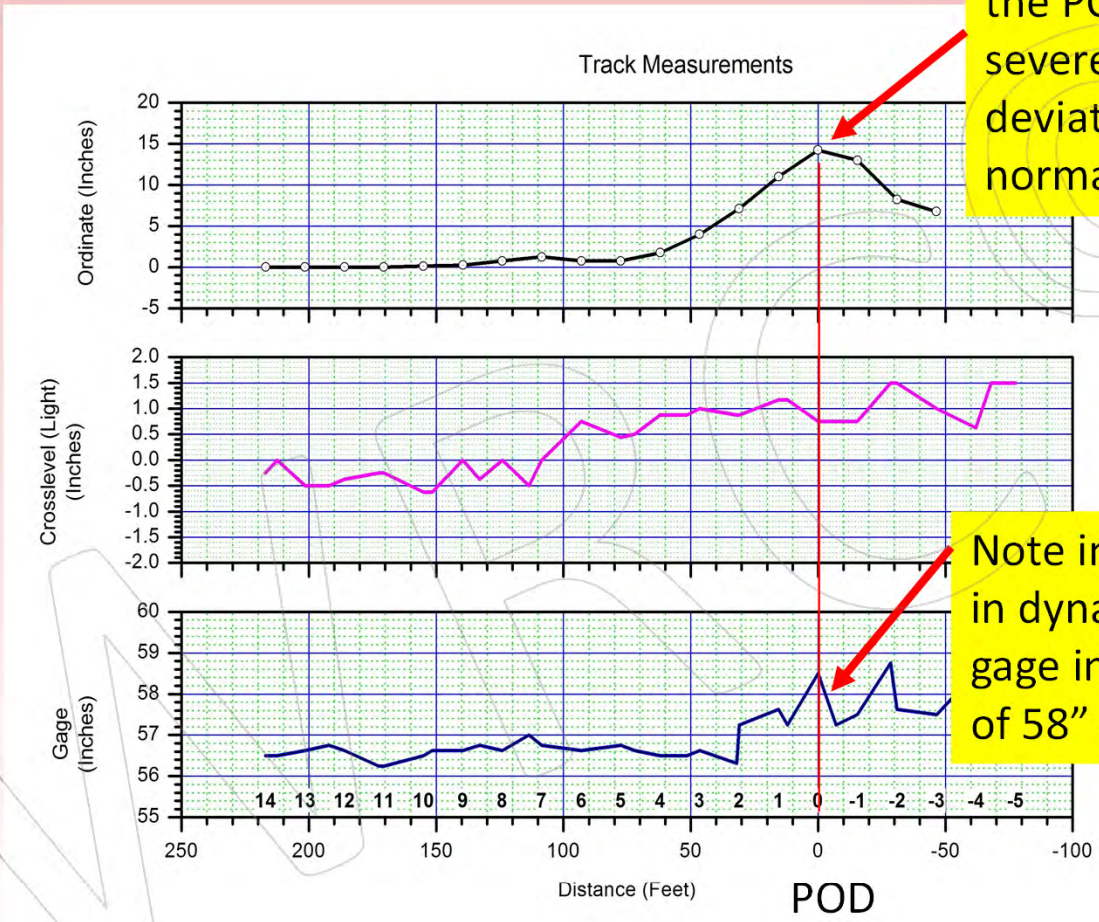
Note sharp increase in degree of curve at the POD due to severe alignment deviation from normal.

Note increase in dynamic gage in excess of 58" at POD

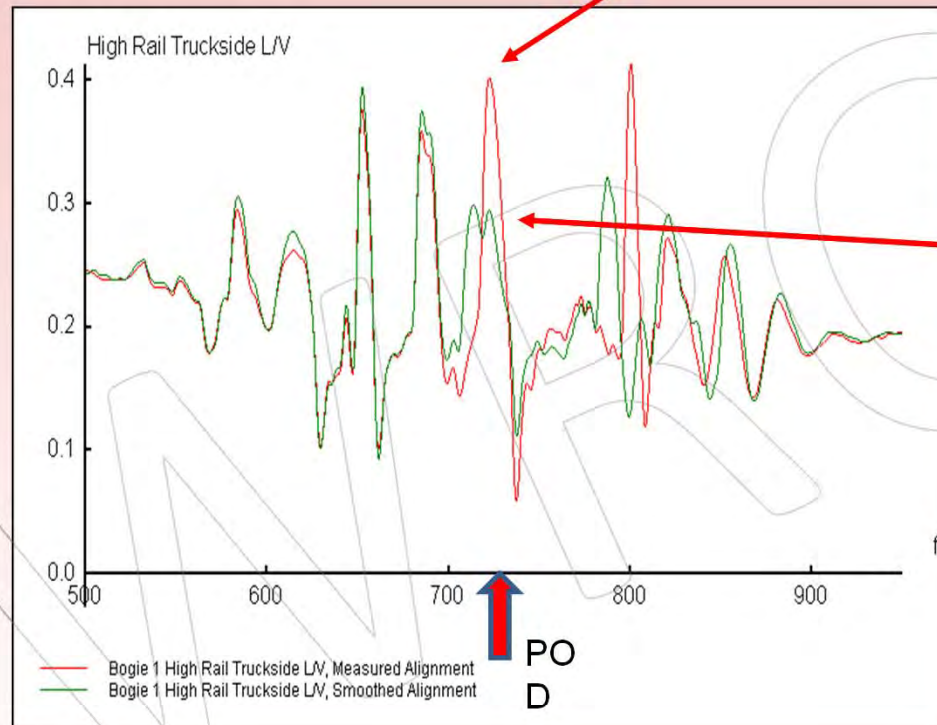
Note, peak L/V Ratios at the POD

Truck Side L/V at POD:

Measured  
Alignment = 0.40

Smoothed  
Alignment = 0.29

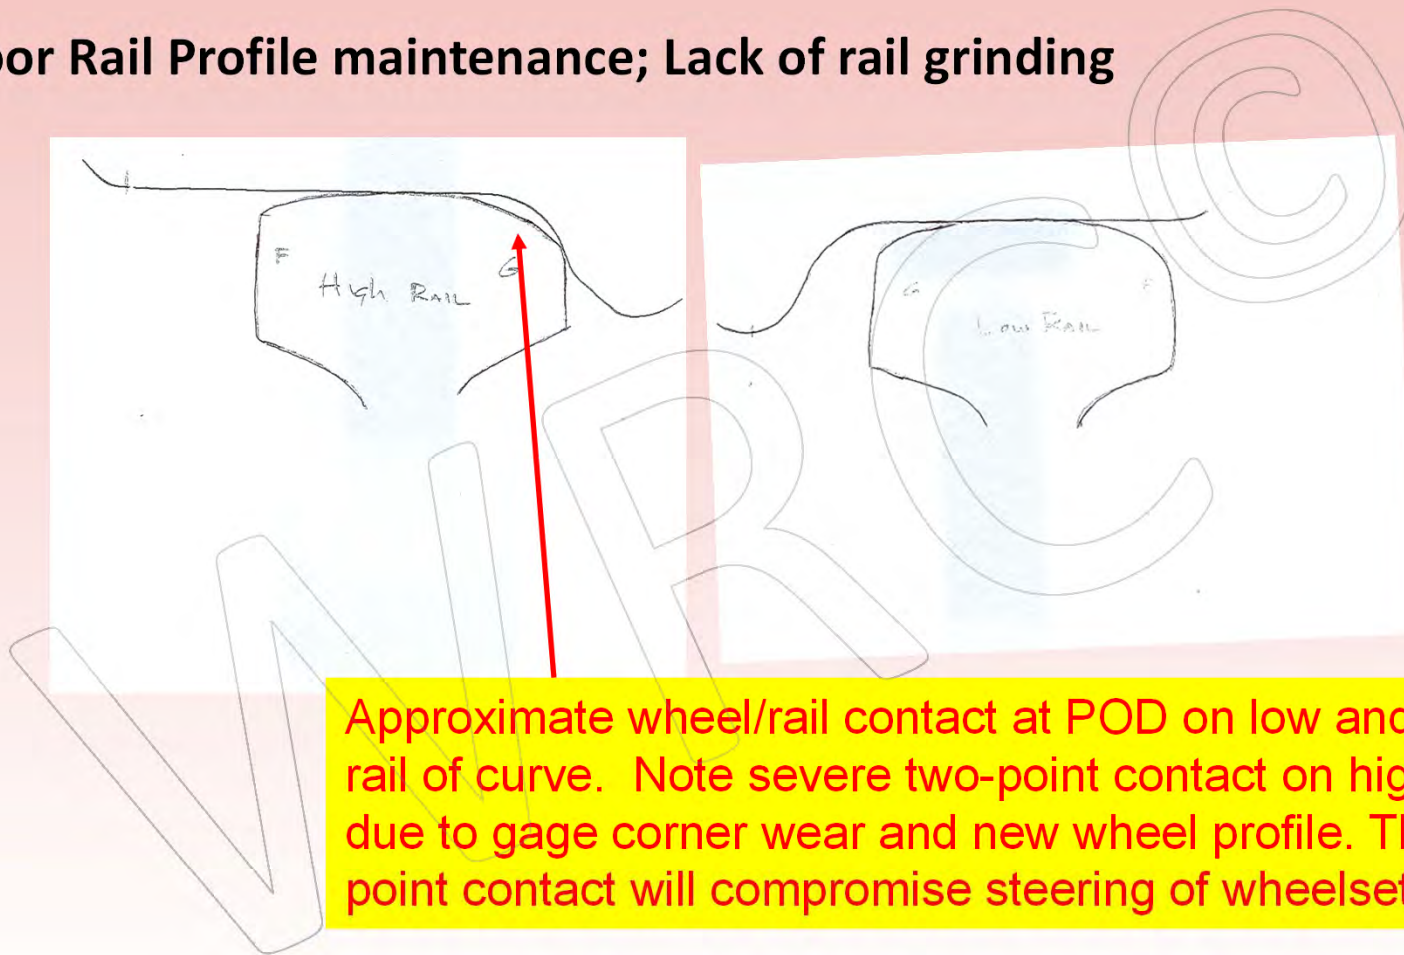
Approximate wheel/rail contact at POD on low and high rail of curve. Note severe two-point contact on high rail due to gage corner wear and new wheel profile. This two point contact will compromise steering of wheelset.

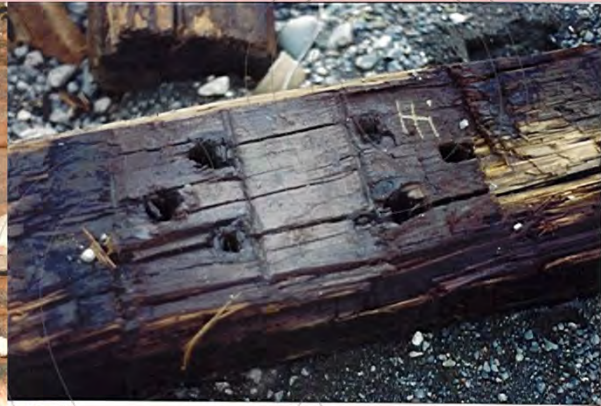
**Elongated Field side  
Spike hole and showing  
Loose spike in hole**

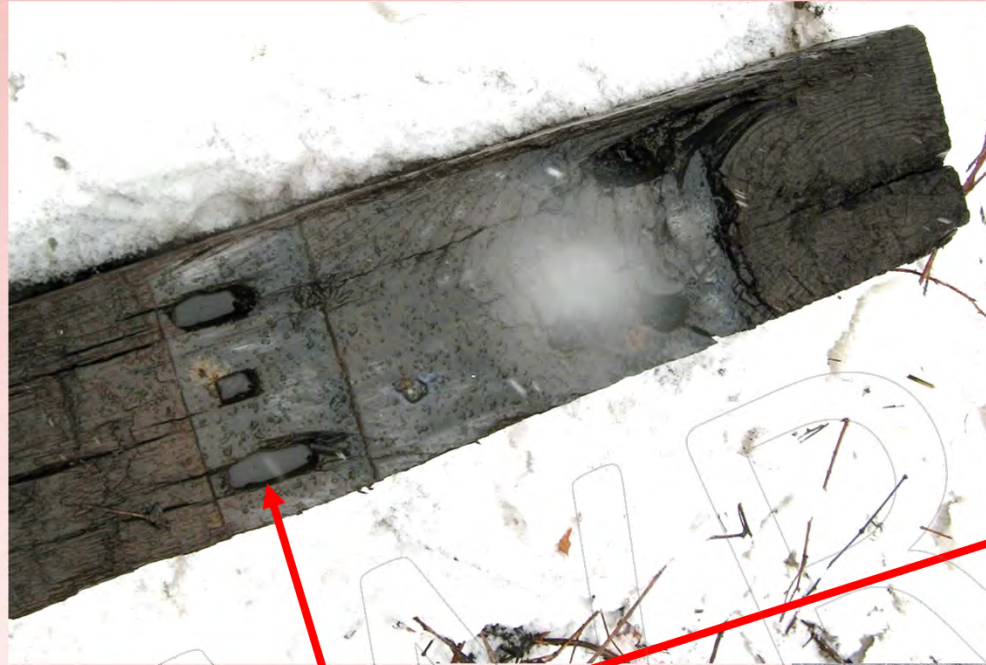
**Elongated  
Spike holes**

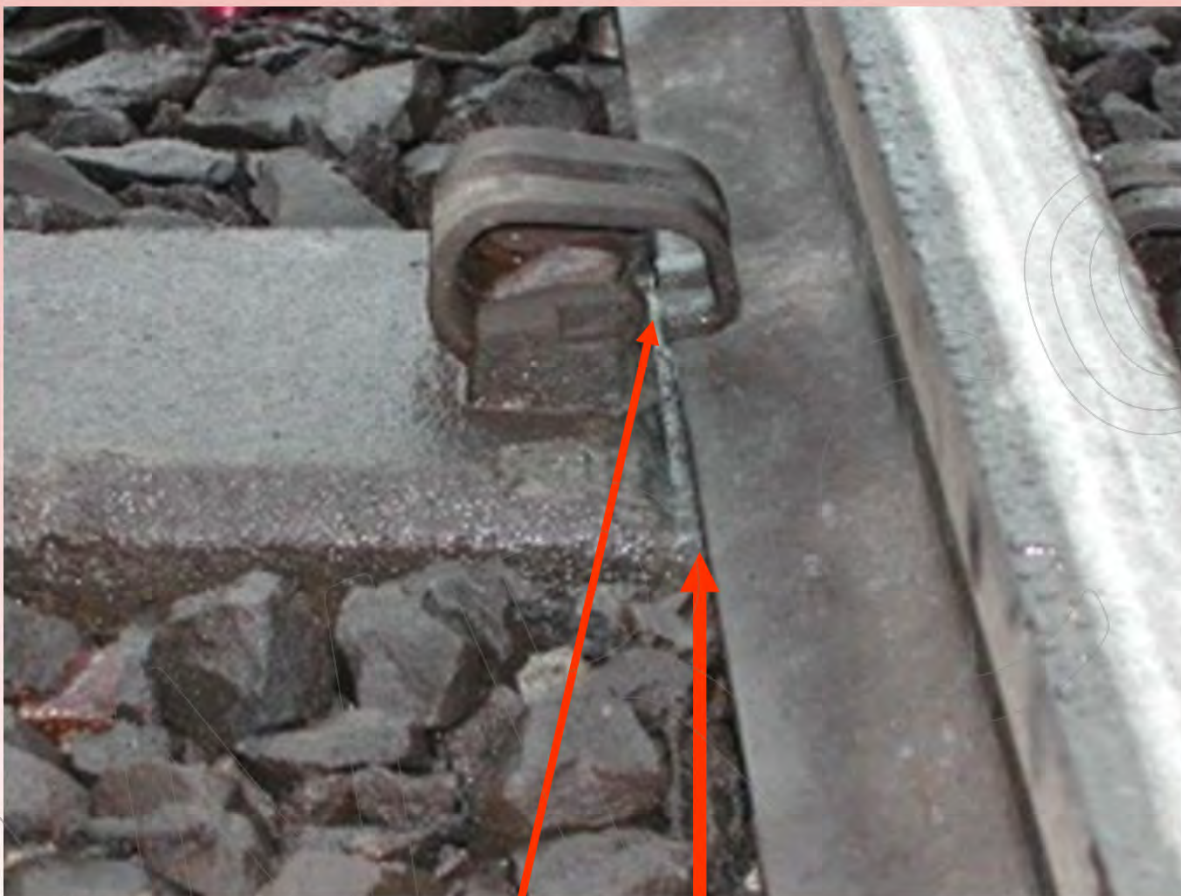
**Watch for Tie Seat Abrasion under Rail**

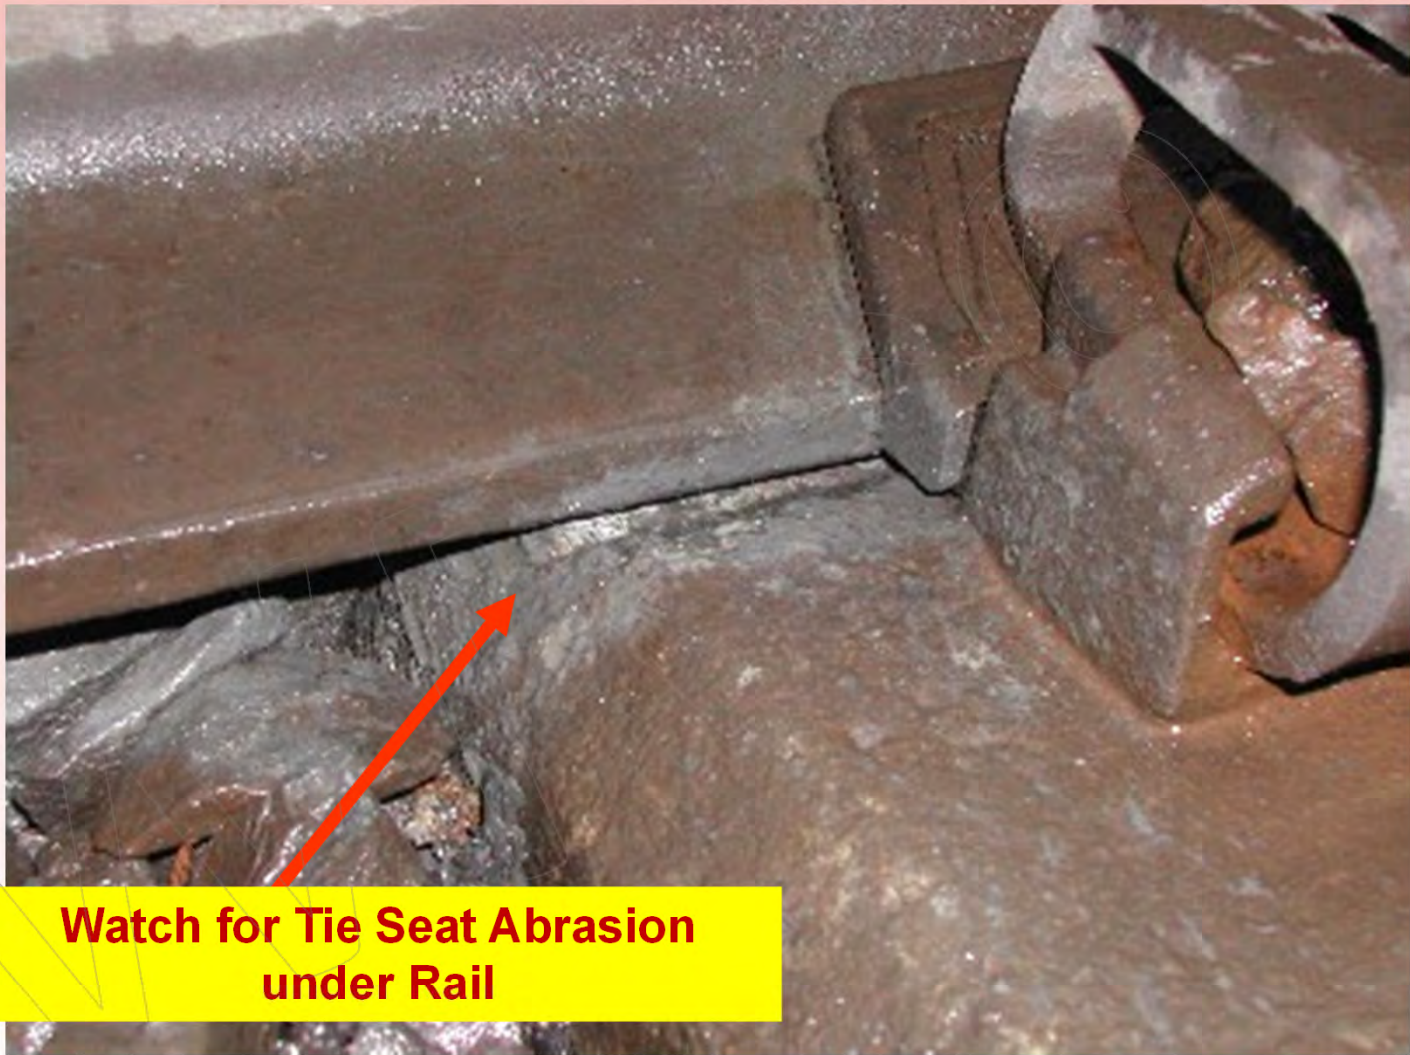
**Watch for Tie Seat Abrasion  
under Rail**

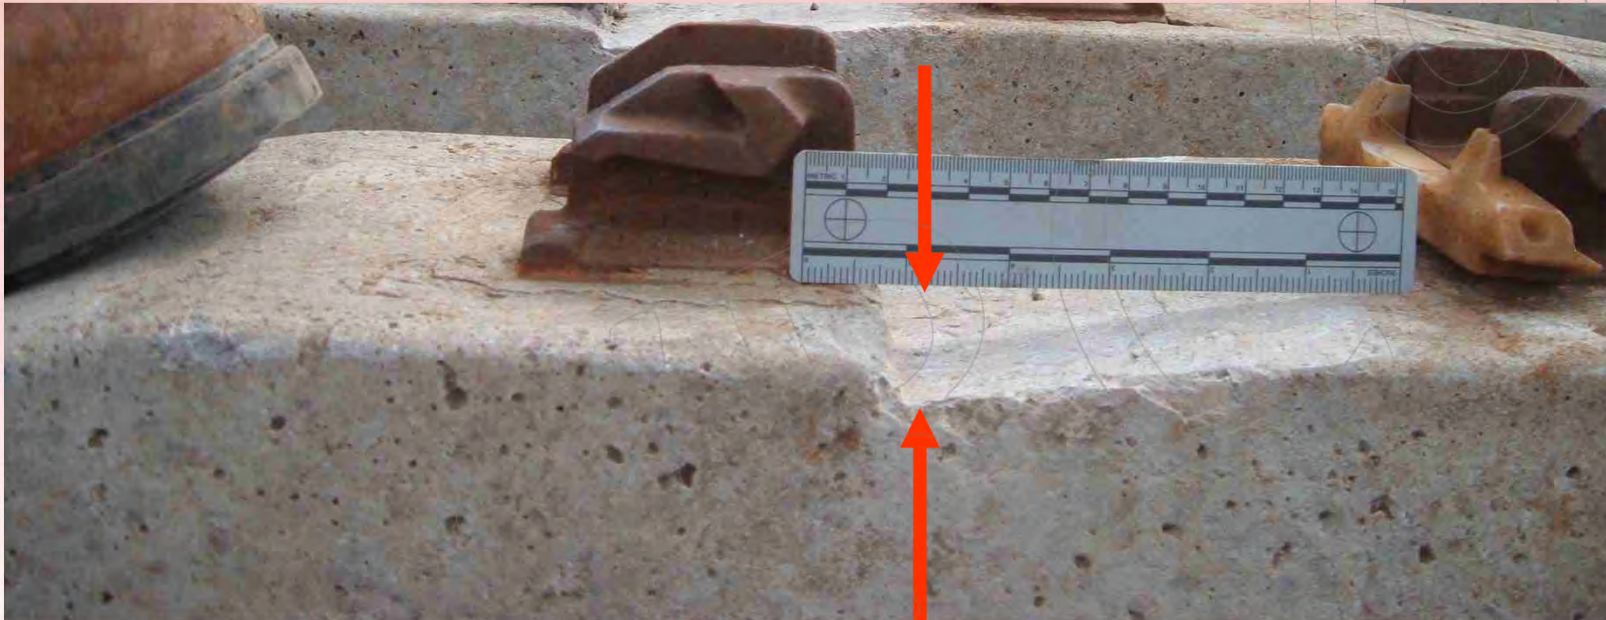
**Tie Seat Abrasion under Rail and Pad**

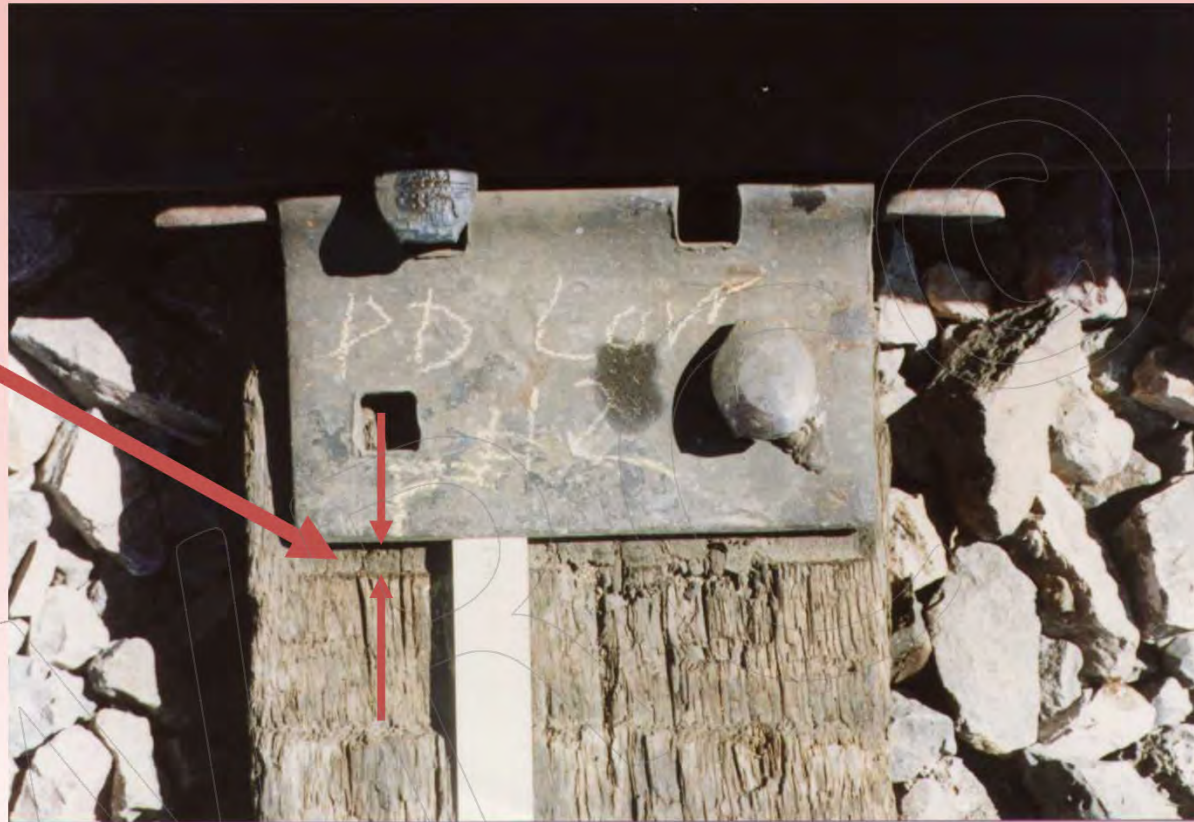
**Dynamic  
Gage  
Widening**

**No more than 1/2" lateral movement per FRA**

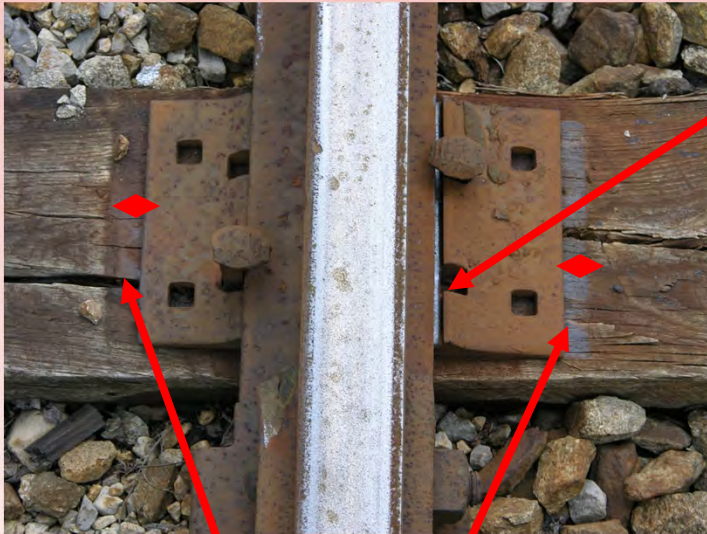
Note wear in shoulders of tie plate allowing additional rail movement under dynamic load.

Note significant dynamic gage widening under load.

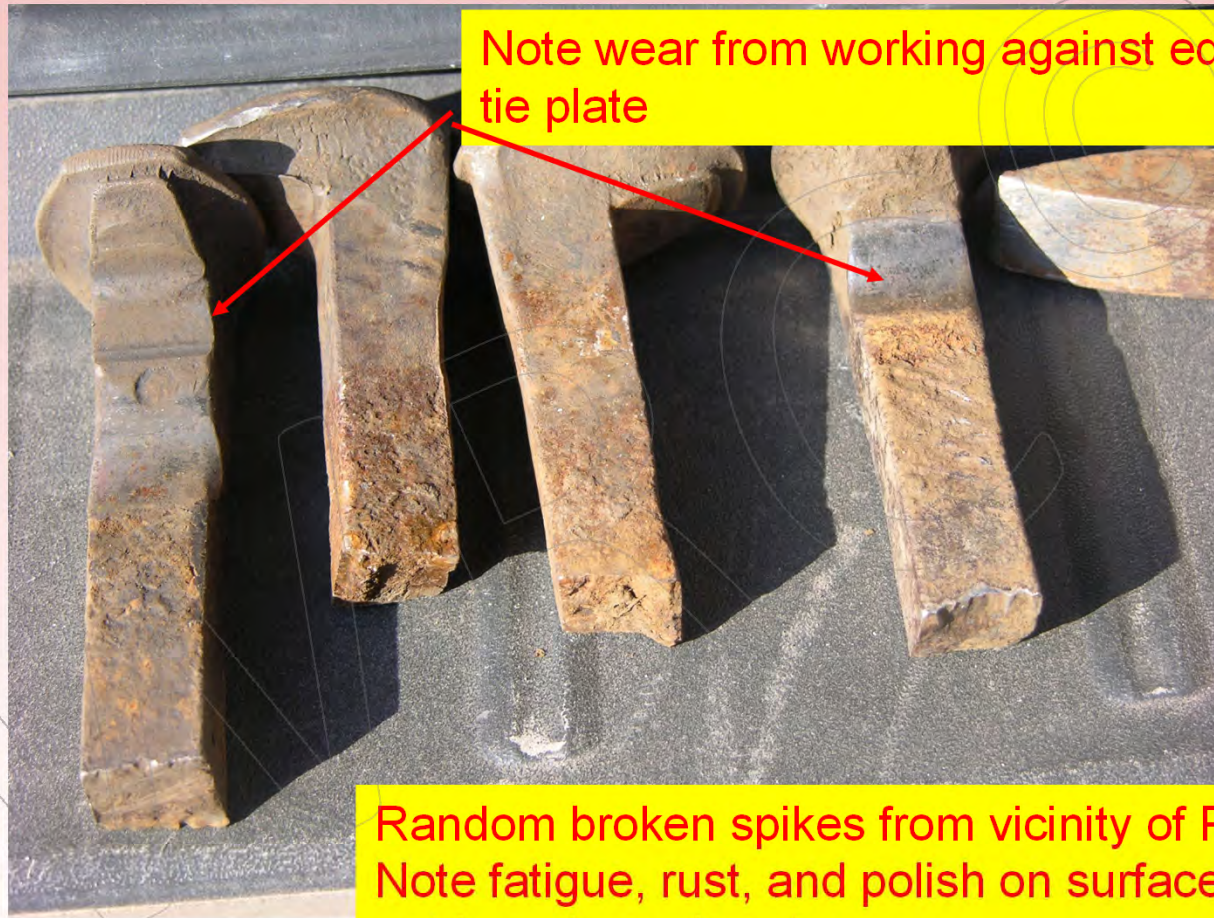
Note wear from working against edge of tie plate

Random broken spikes from vicinity of POD. Note fatigue, rust, and polish on surface indicating not brand new break.

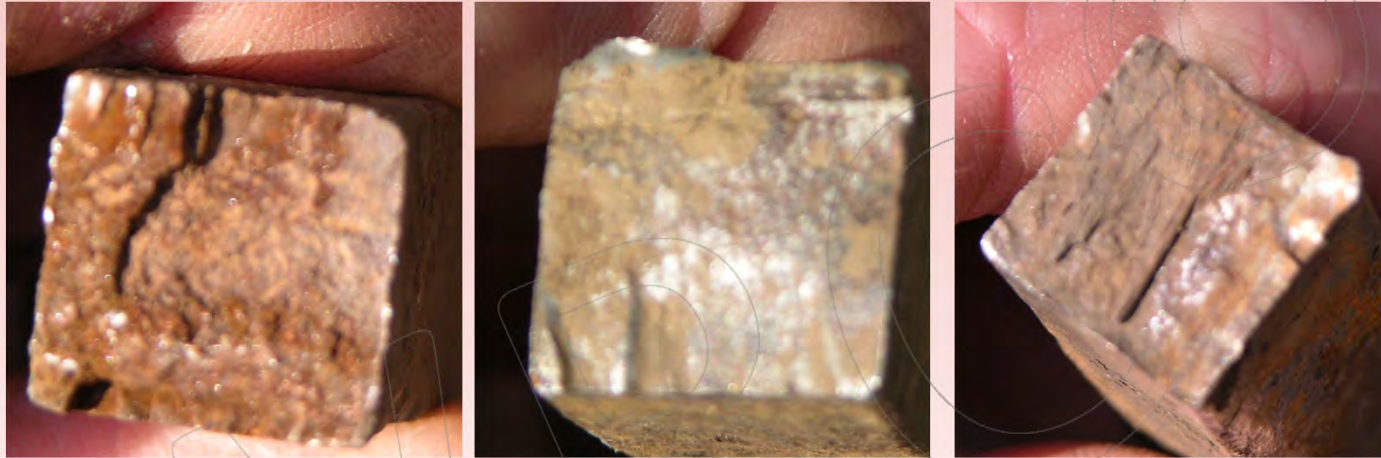
Fracture surfaces on three random broken spikes in Vicinity of POD. Note breaks appear to be “old”.

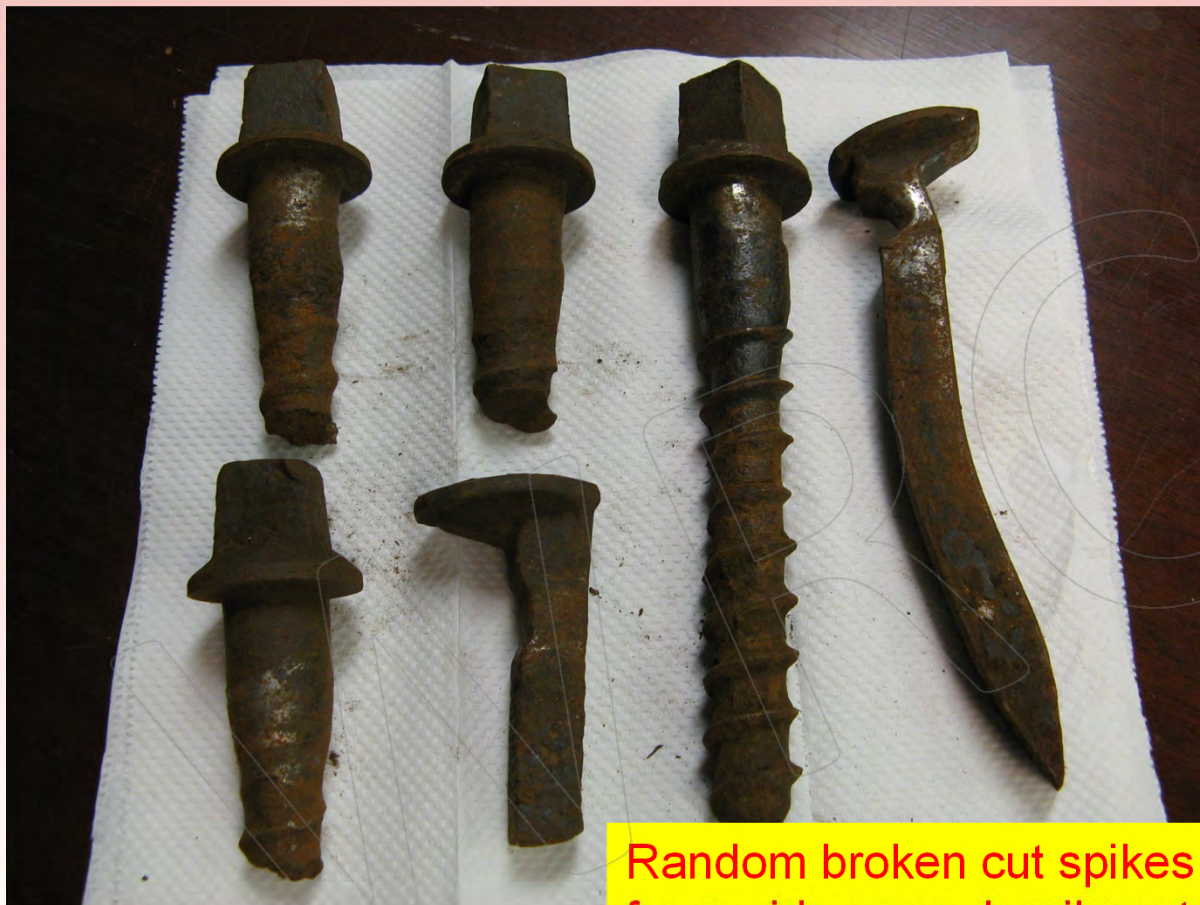
Random broken cut spikes and screw spikes from wide gage derailment. Note fatigue, rust, and polish on surface indicating not a brand new break.

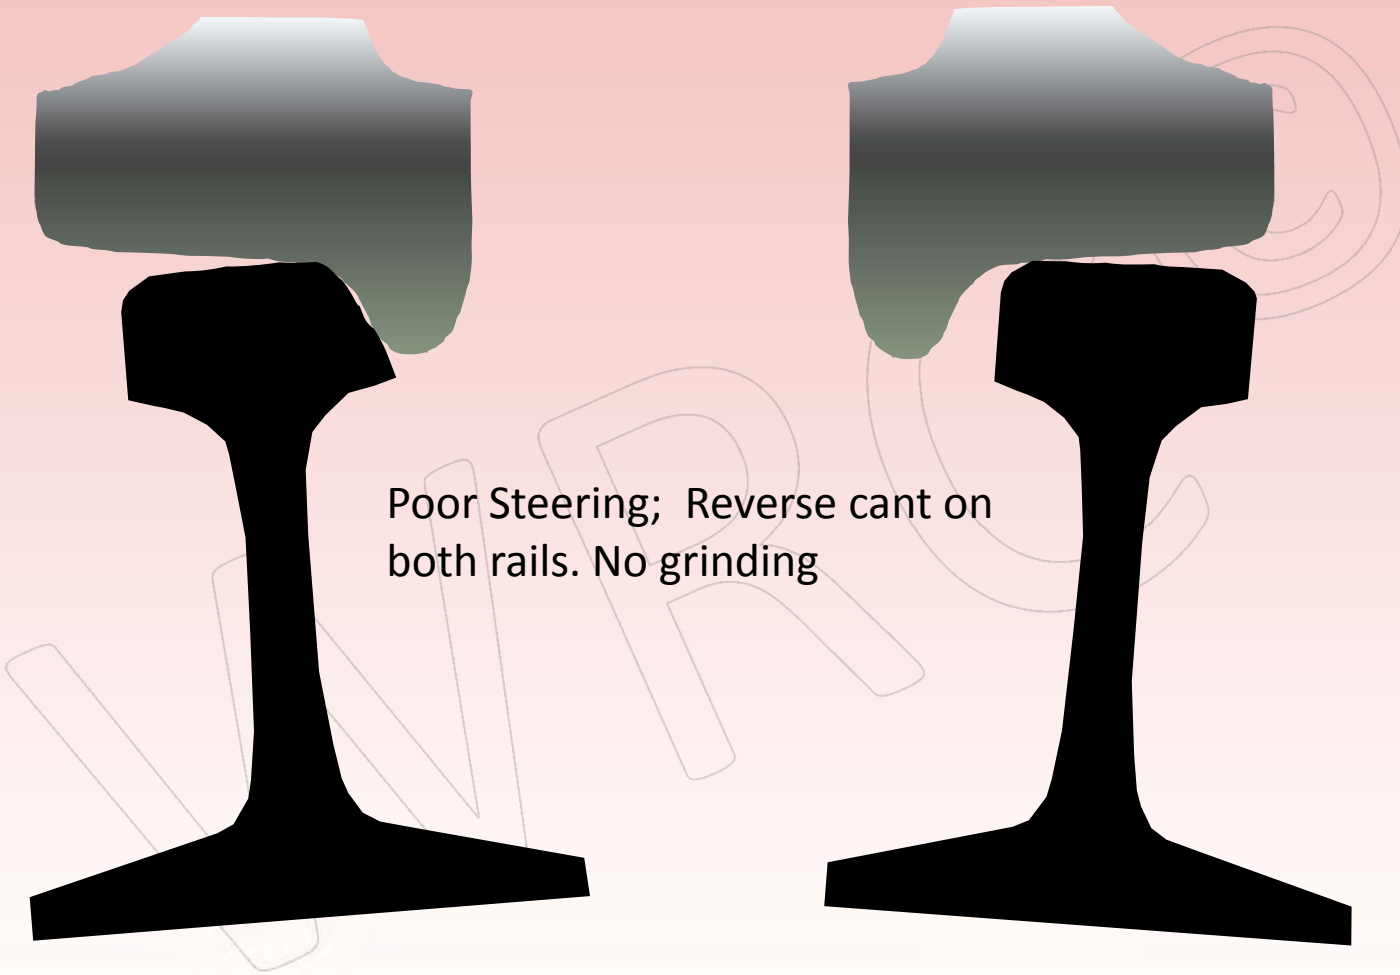
Poor Steering; Reverse cant on both rails. No grinding

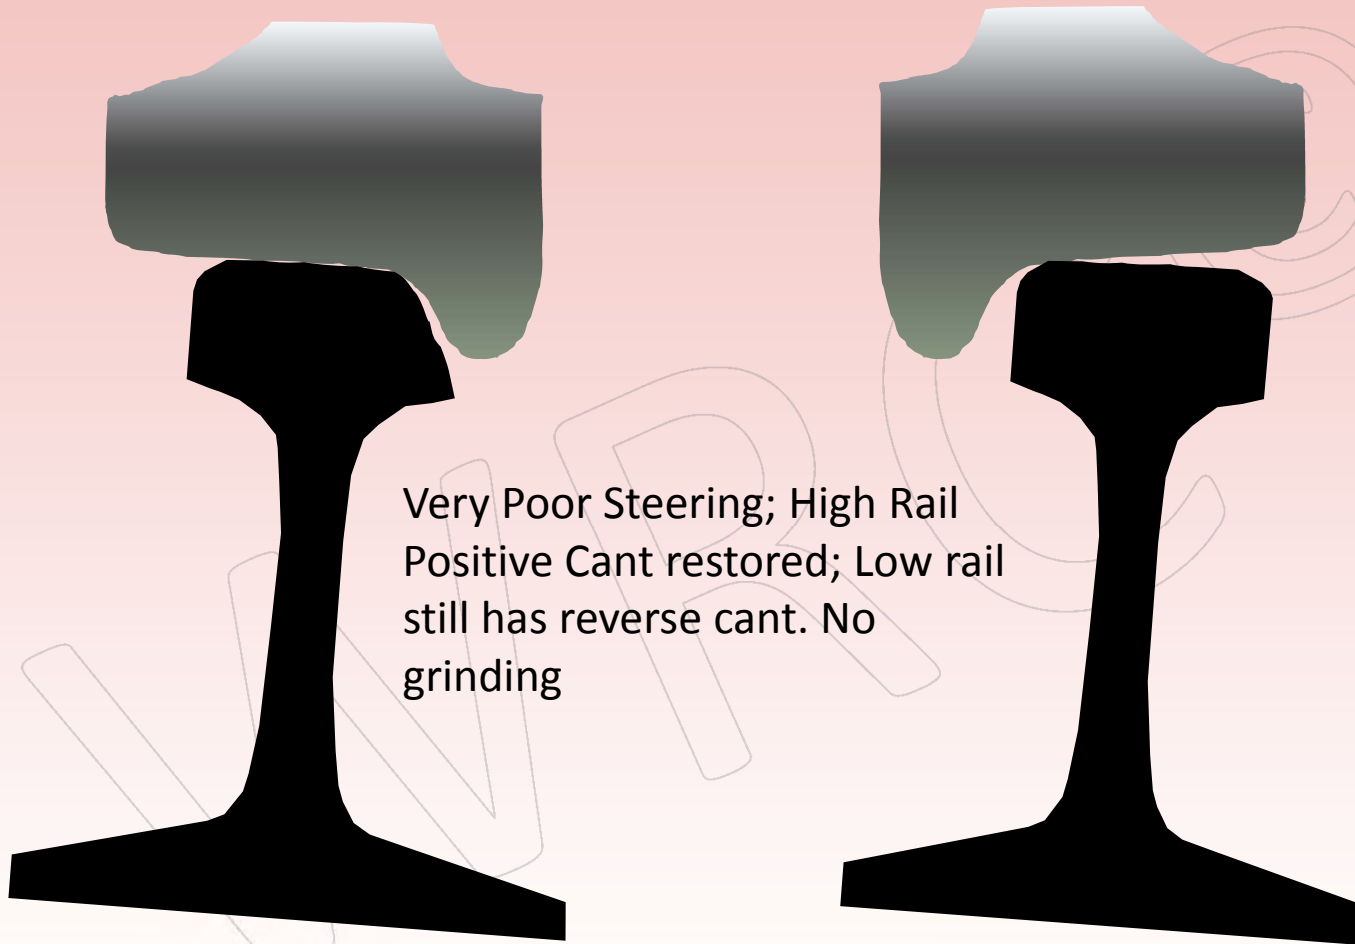
Very Poor Steering; High Rail  
Positive Cant restored; Low rail  
still has reverse cant. No  
grinding
