Challenges Handling Multilevels and Other Long/Cushion Equipped Cars

*Walter Rosenberger
Norfolk Southern
- Research & Tests*

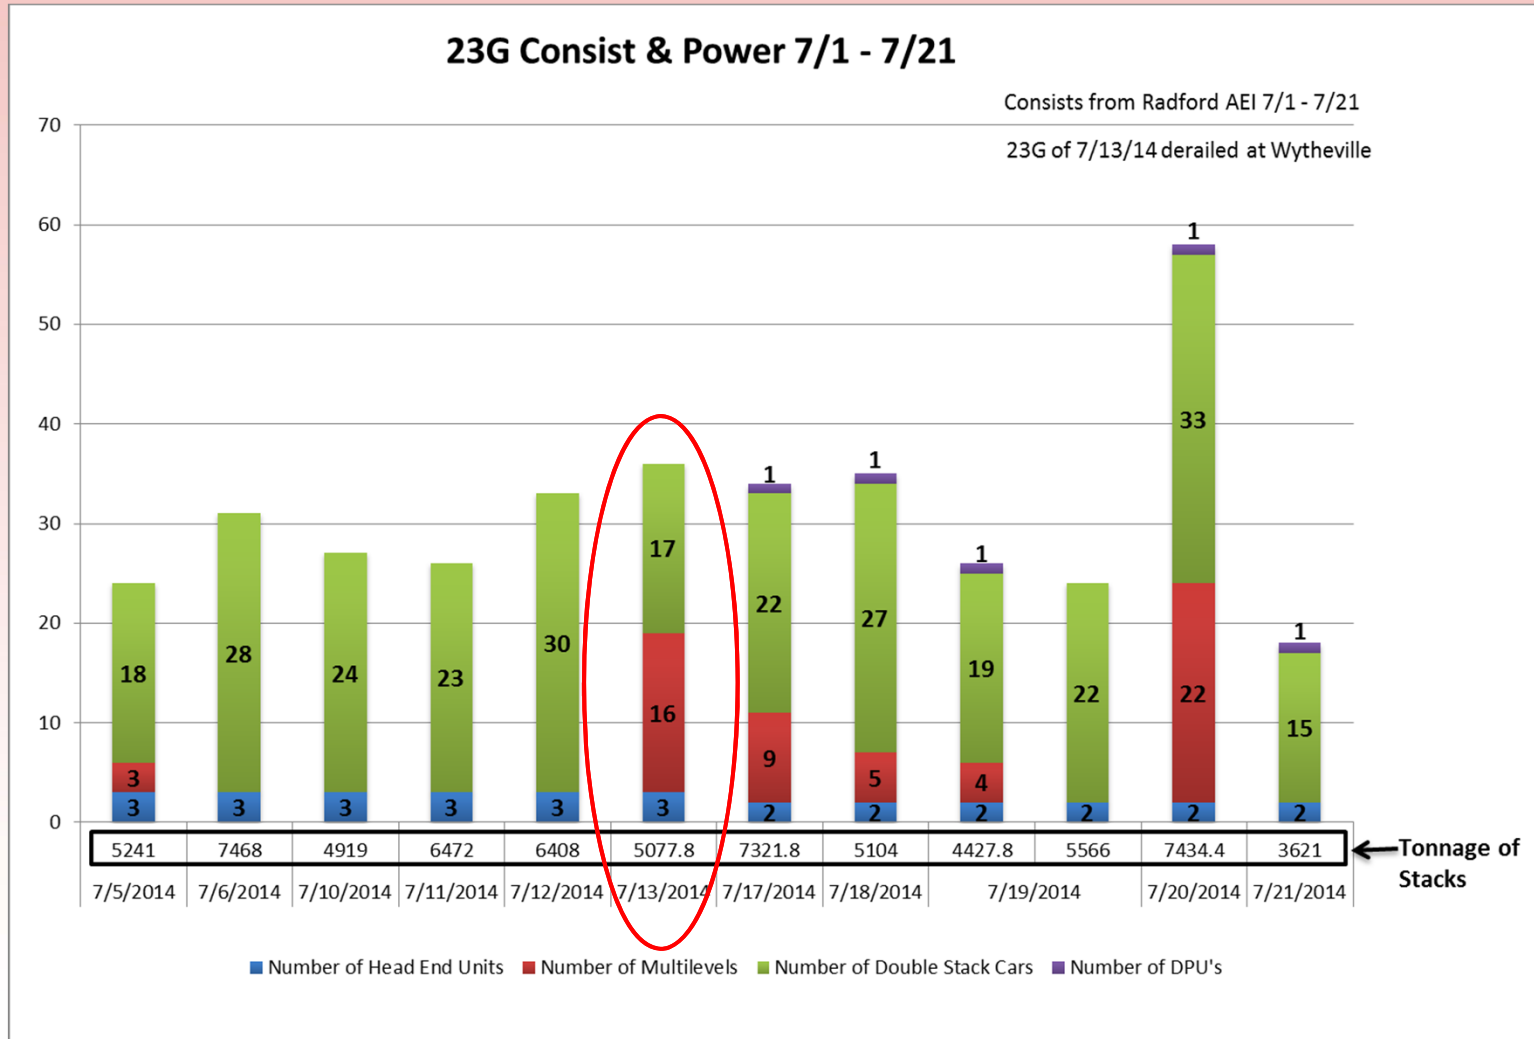
Wytheville 23G: consist history

- “Trail end 3rd head car/head end 4th head car (both 89 ft multilevels) jackknifed in entry spiral of 4.1° curve account aggressive dynamic braking of a train incorrectly built without DP to mitigate in-train forces of doublestacks trailing multilevels.”
- FRA Cause Code: **H519 Dynamic brake, too rapid adjustment**

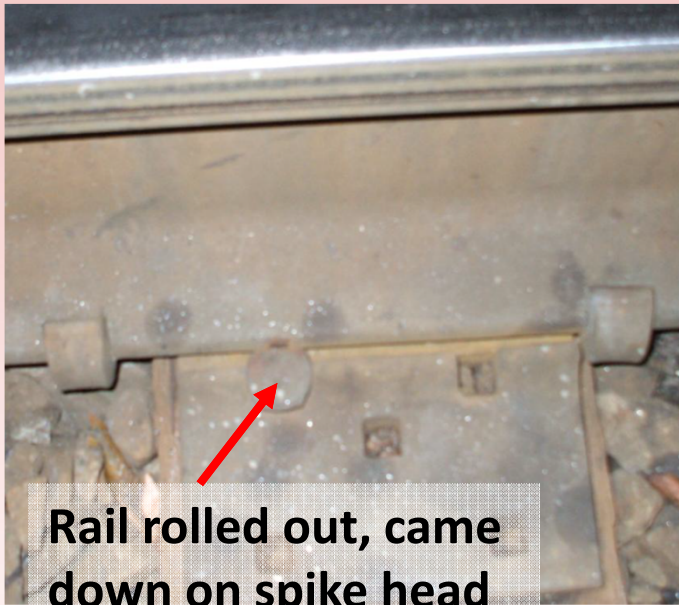
Roanoke 23G: track evidence

- 3x0 (one DB isolated), 36 loaded M/L's, 30 loaded doublestacks (8665 tons); 11,376 tons; 10,706 ft
- Derailed the lead truck of 20th head car, loaded 89' multilevel
- 13 mph with 920 amps of dynamic brake
- POD: point of switch, #10 turnout
- Rail began rolling out 2-1/2 stations ahead of switch
- Near bottom of a 2-mile 0.82% descending grade

- “Lead wheels, lead truck of 20th head car (loaded multilevel CN 710905) partially rolled north rail and passed behind switch point account resultant lateral forces associated with improper train makeup.”
- FRA Cause Code: **H501 Improper train make-up at initial terminal**

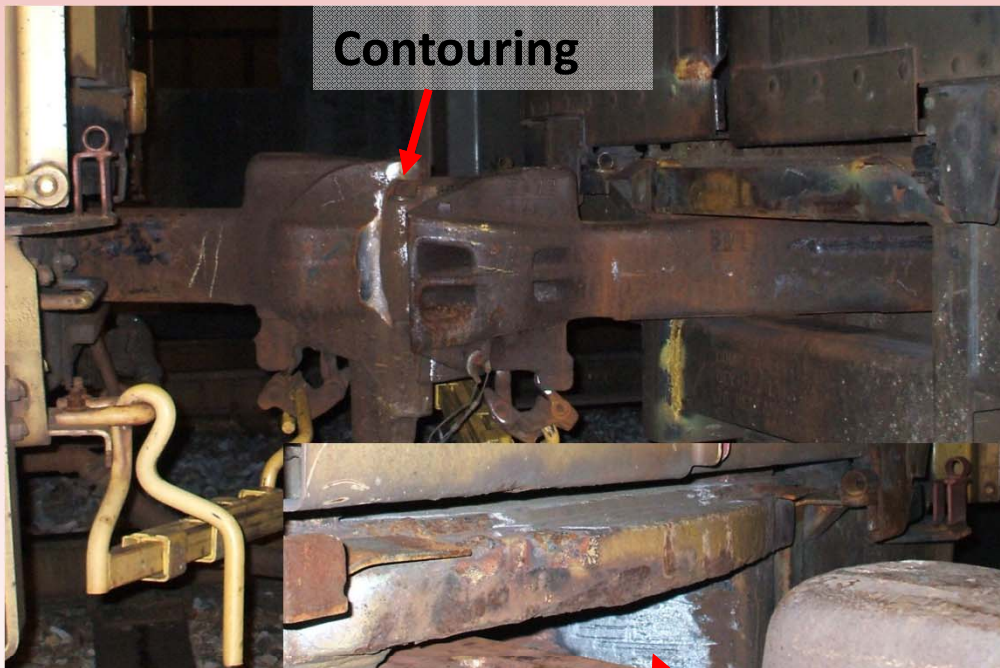
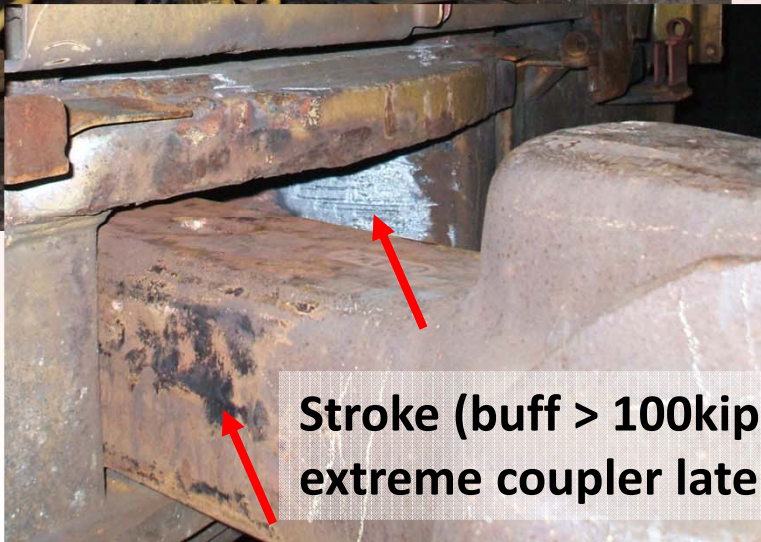
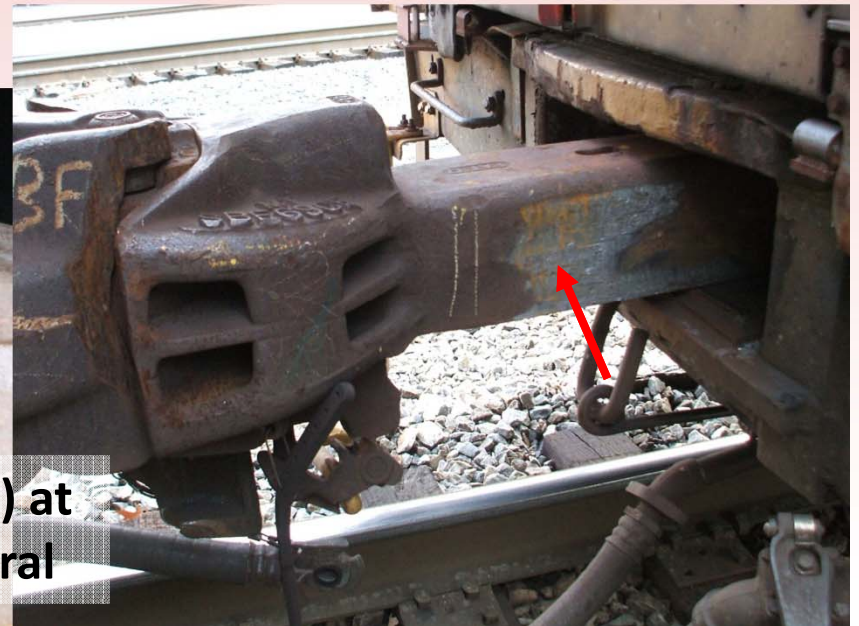
Roanoke 23G: coupler evidence

- Long car
- Long coupler overhang
- Long shank couplers
- High degree of coupler angularity

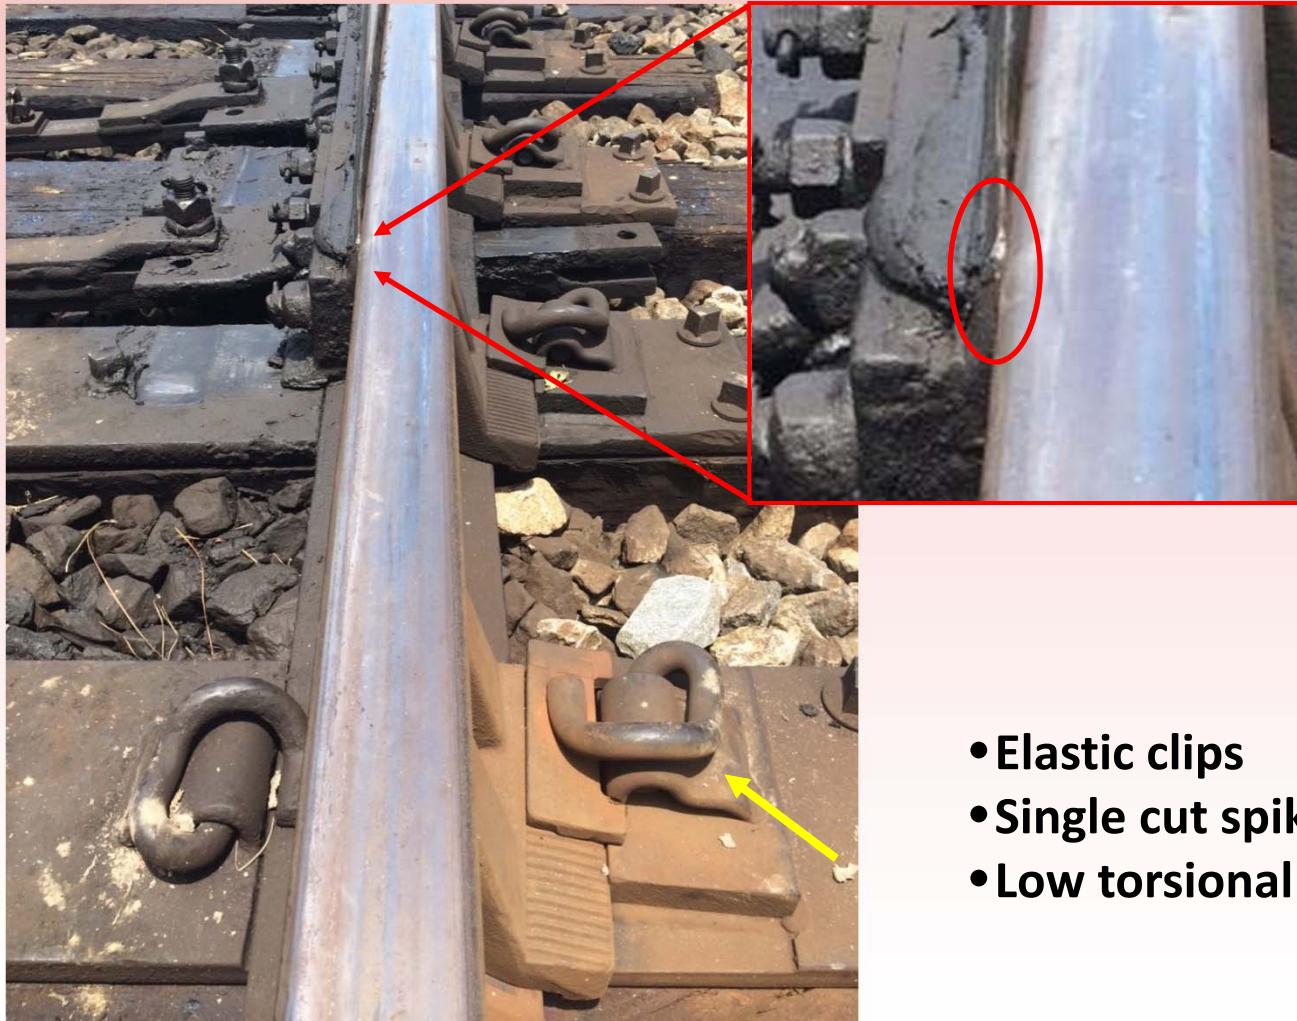
Lumberton 314: track evidence

- Elastic clips
- Single cut spikes
- Low torsional restraint

- “Trail truck of 17th head car, in a block of 21 autoracks trailed by 6323 tons, picked the switch point at 15 mph in full dynamic braking, account lateral force due to long car coupler angle sufficient to deflect stock rail.”
- FRA Cause Code: **H506 Lateral drawbar force on curve excessive, train make-up**

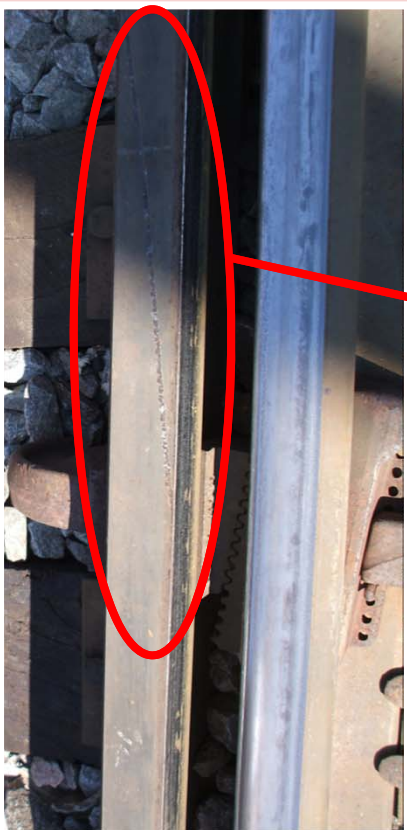
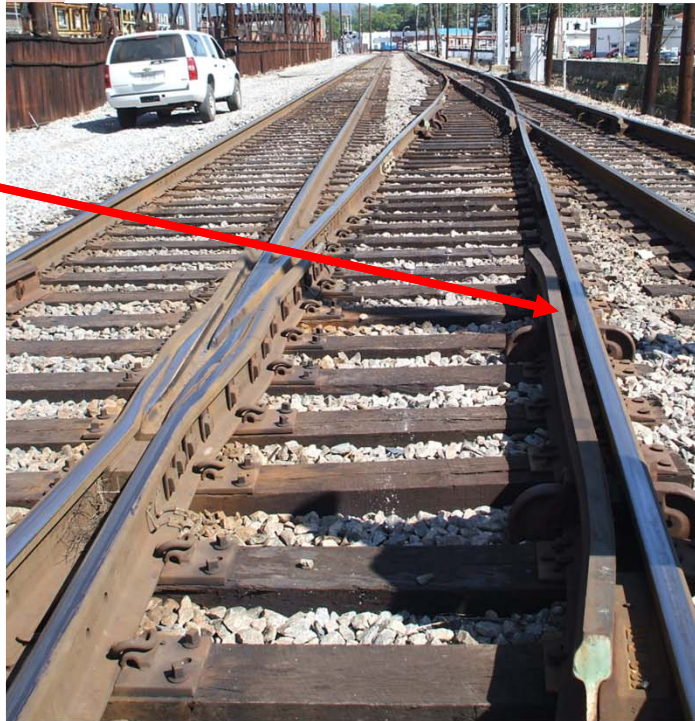
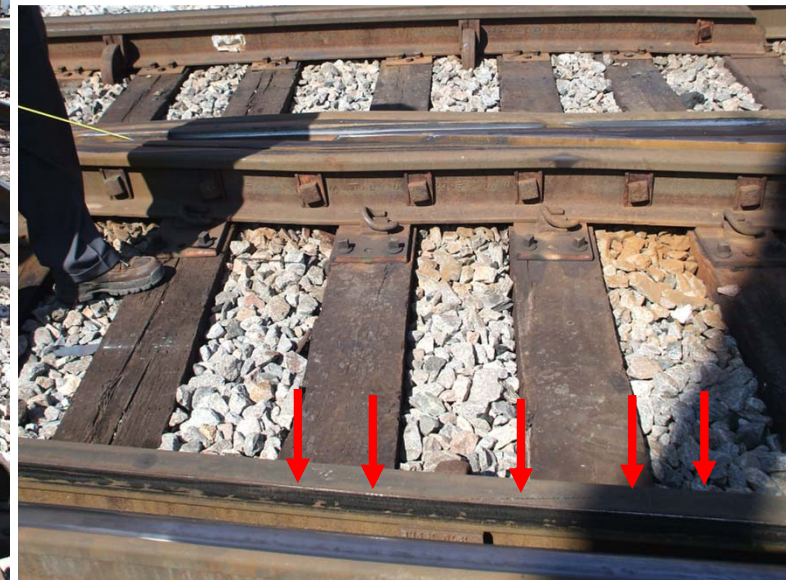
Roanoke 192: track evidence

- 3x0 (1 isolated), 12,653 tons, 9120 ft
- 9 mph in DB-8, 670 Amps
- Derailed trail truck of 39th H/C, empty 89' flat
- Car ahead was an empty 73' bulkhead flat, car behind was another empty 89' flat; ahead of 83% of train's tonnage
- Climbed guard rail of #10 frog in crossover
- Near bottom of a 2-mile 0.82% descending grade

This situation can become critical where there is less than one car length of track in between the lead curves of the switches in a crossover. It becomes more severe for the sharper turnouts (#10 and less). The problem is caused by the long overhang on these long cars. Consideration should be given in yards for this train make-up by limiting the routes traversed to areas where the above mentioned problem is minimized.

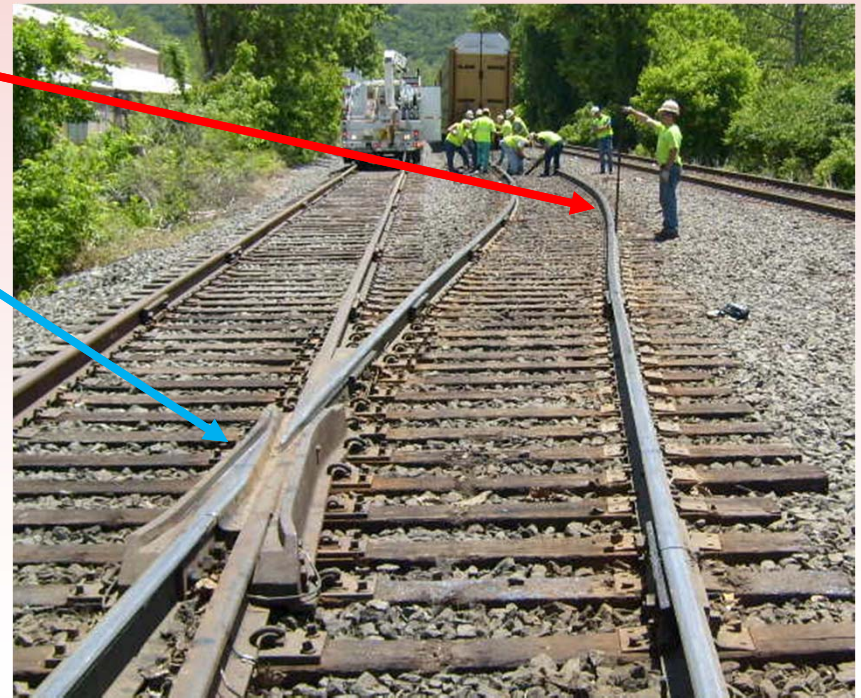
Allentown – May 2014

- Shoving 4626 tons with 18 powered axles at 7 mph, 271 kips buff
- Derailed empty 89' Multilevel, 7th from locomotive
- Rolled high rail of 11.5°
Return Curve, not at frog,
account *Self-Guarded Frog*

- **Reduce buff forces**
- **Optimize placement of long EOCC cars with respect to tonnage**
- **Reduce curvature**
- **Limit population of EOCC-equipped cars**
