Using Wheel Rail Interface Analysis to Evaluate Rail Transit Maintenance Priorities:

A Case Study on Los Angeles Metro BLUE Line

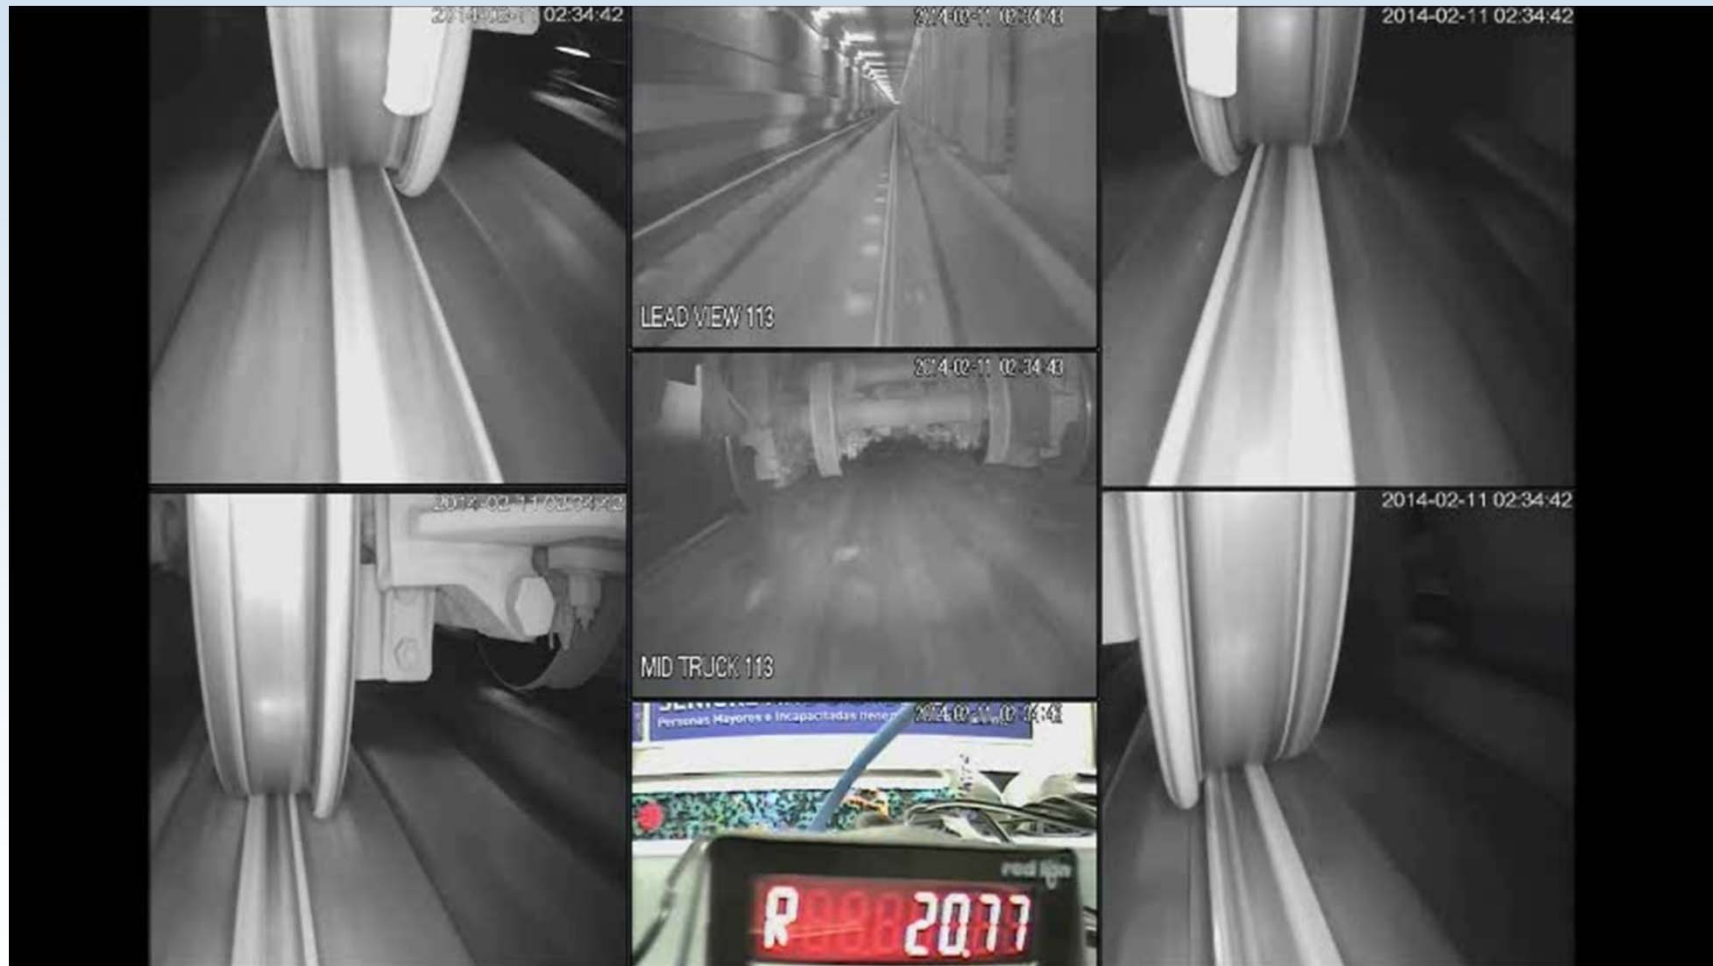
P-865 Tracking Bias

- Both the P-865 and P-2000 were found to have an offset or Tracking Bias. The wheels on one side of each test car ran closer to the rail in tangent track than the wheels on the opposite side
- The P-2000 was found to experience hunting onset at 45 mph and sustained hunting at 50 mph and up

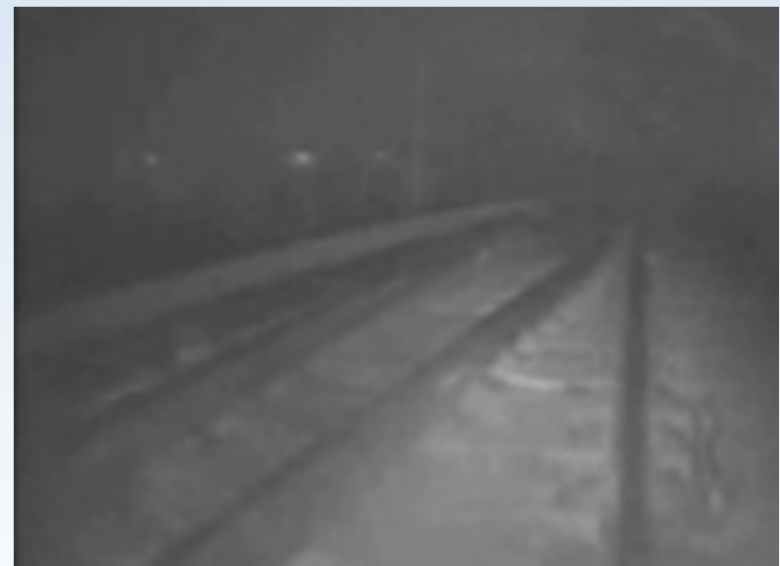
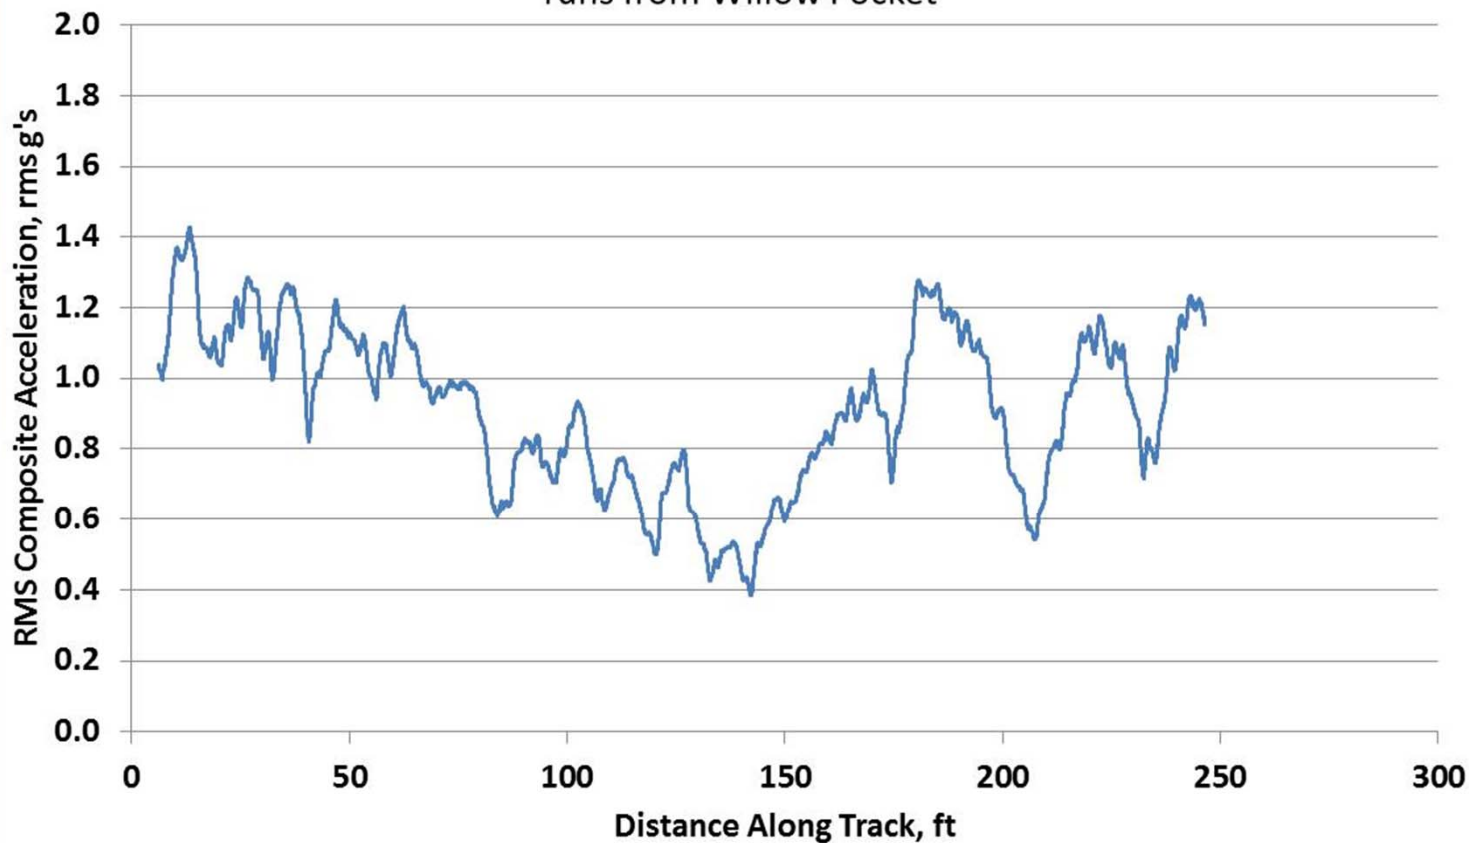
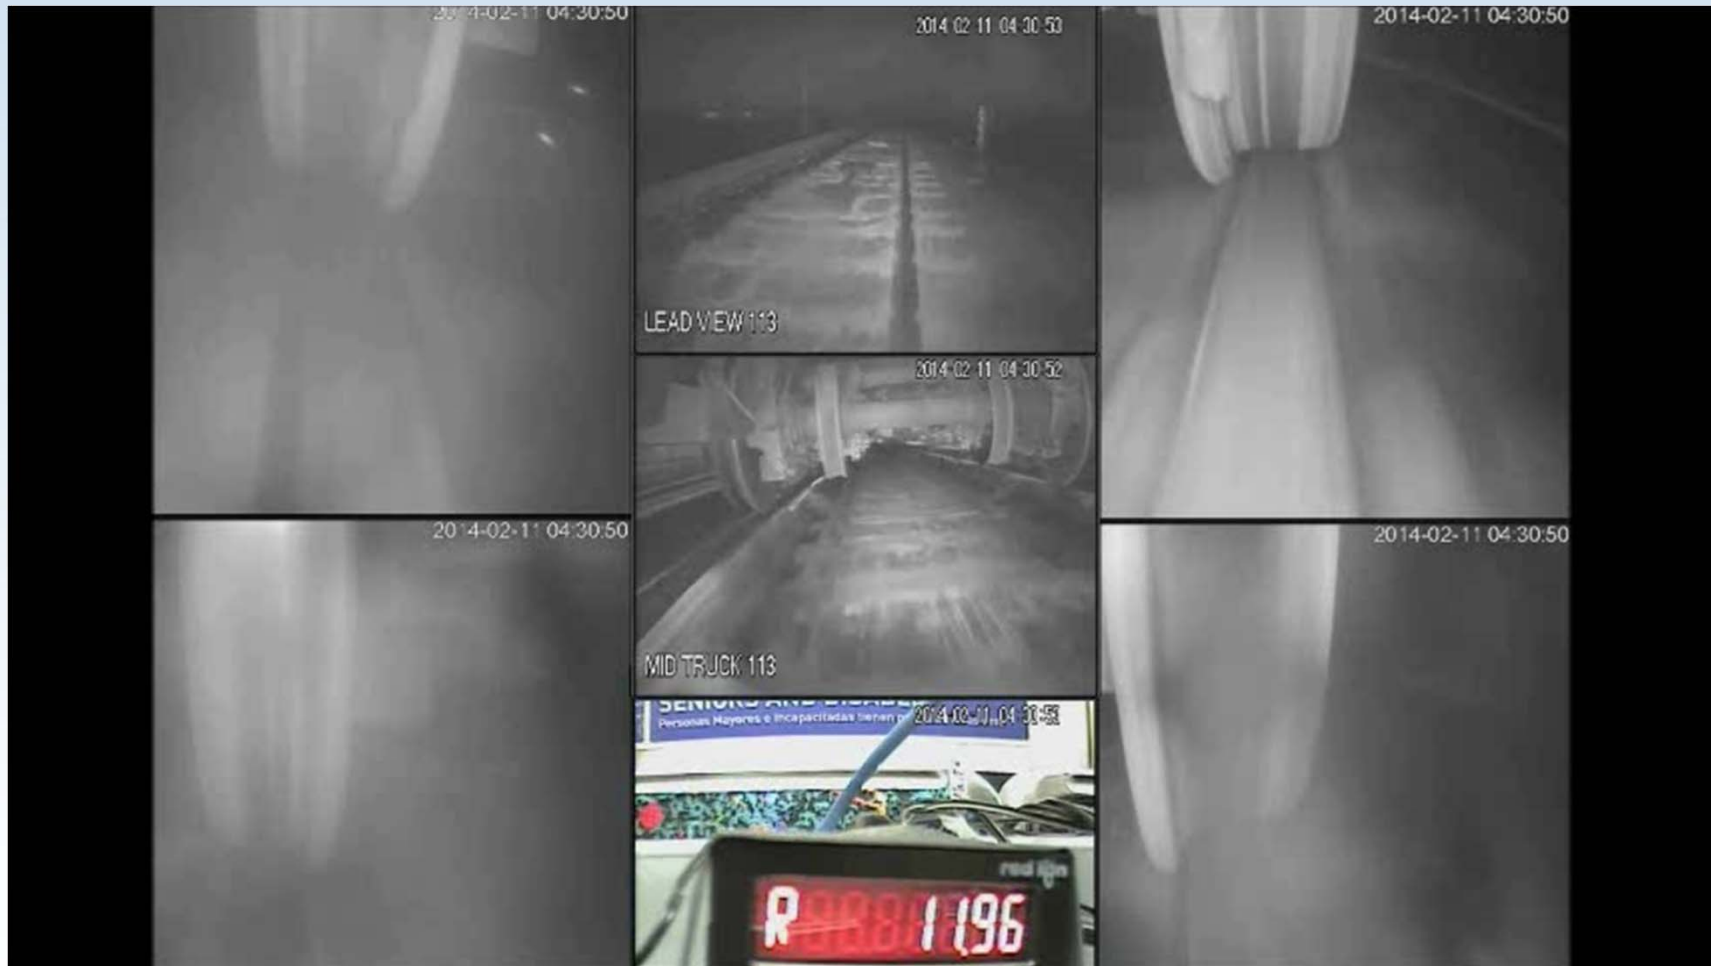
Metro Site 7

- The #10 Crossovers & Turnout North-Bound into Division 11 Yard from Trk #1 to Trk #2 and into the Yard from LA River Bridge into the Yard on our end of test runs from Willow Pocket
- Severity Index of **18.96** (P-865)
- This area was noted by LA Metro as having rotten ties and in the process of tie replacement

The #10 Crossovers North-Bound into Division 11 Yard from Trk #1 to Trk #2 and into the Yard from LA River Bridge into the Yard on our end of test runs from Willow Pocket

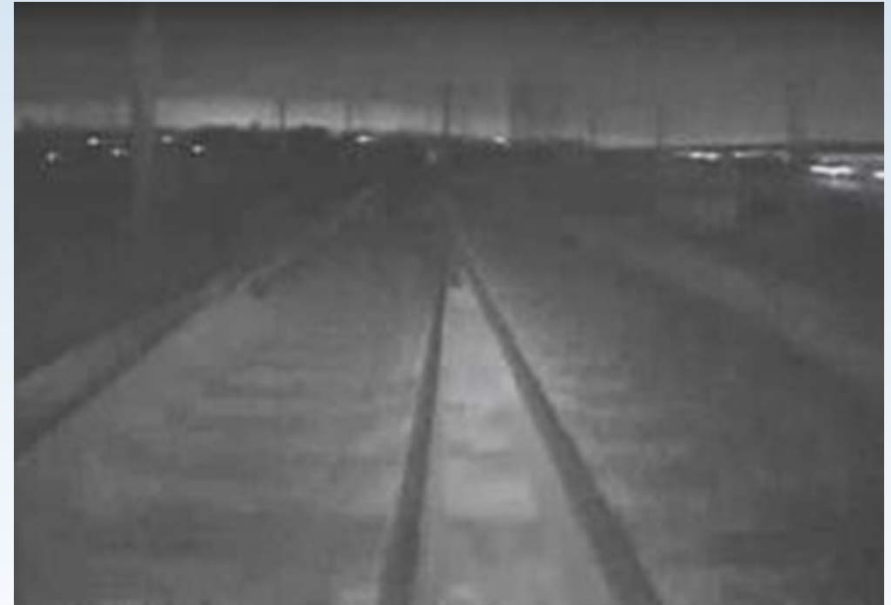
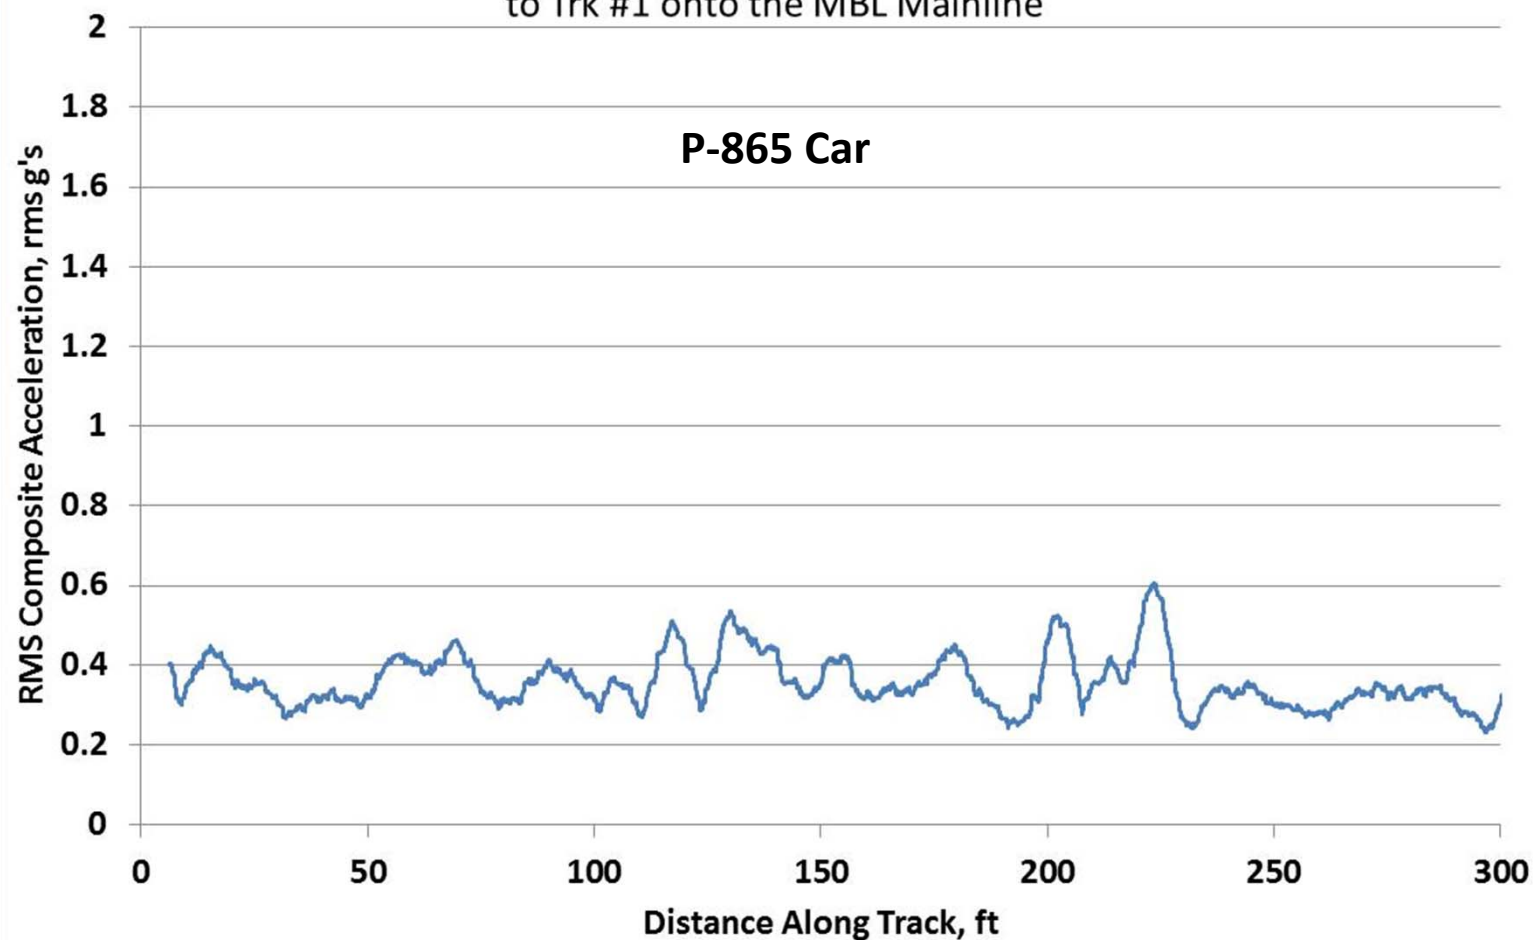
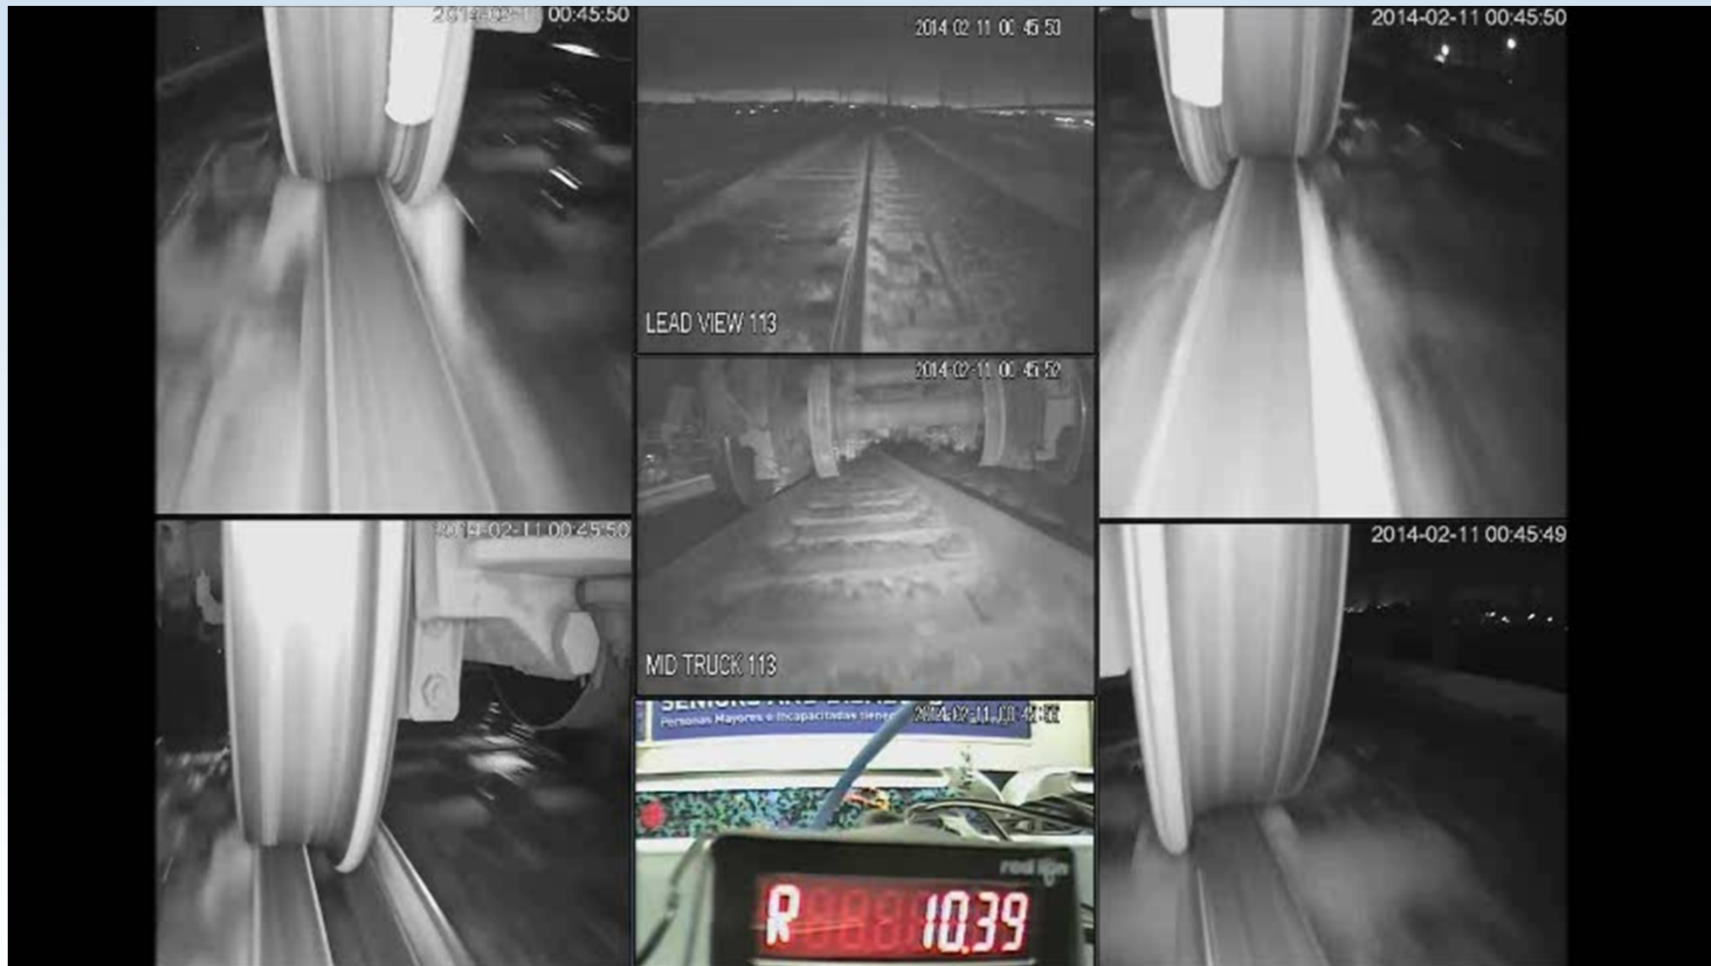
Metro Site 4

- The #10 Turnout & Crossovers North-Bound out of the Division 11 Yard from Yard to Trk #2 to Trk #1 onto the MBL Mainline
- Severity Index of **7.43** (P-865)
- Site of wood tie/ballast construction with poor drainage

The #10 Crossovers North-Bound out of the Division 11 Yard from Trk #2 to Trk #1 onto the MBL Mainline

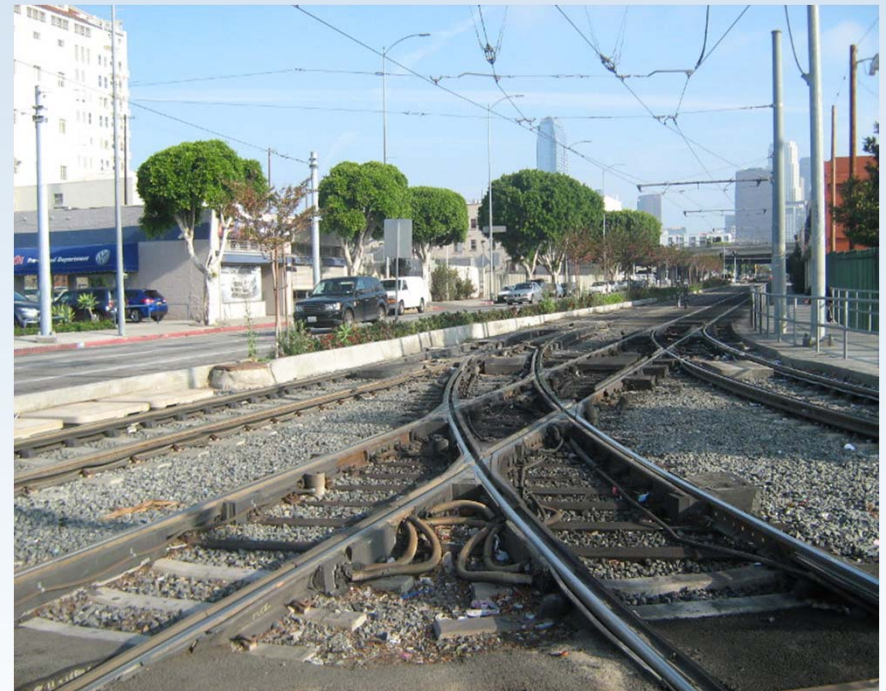
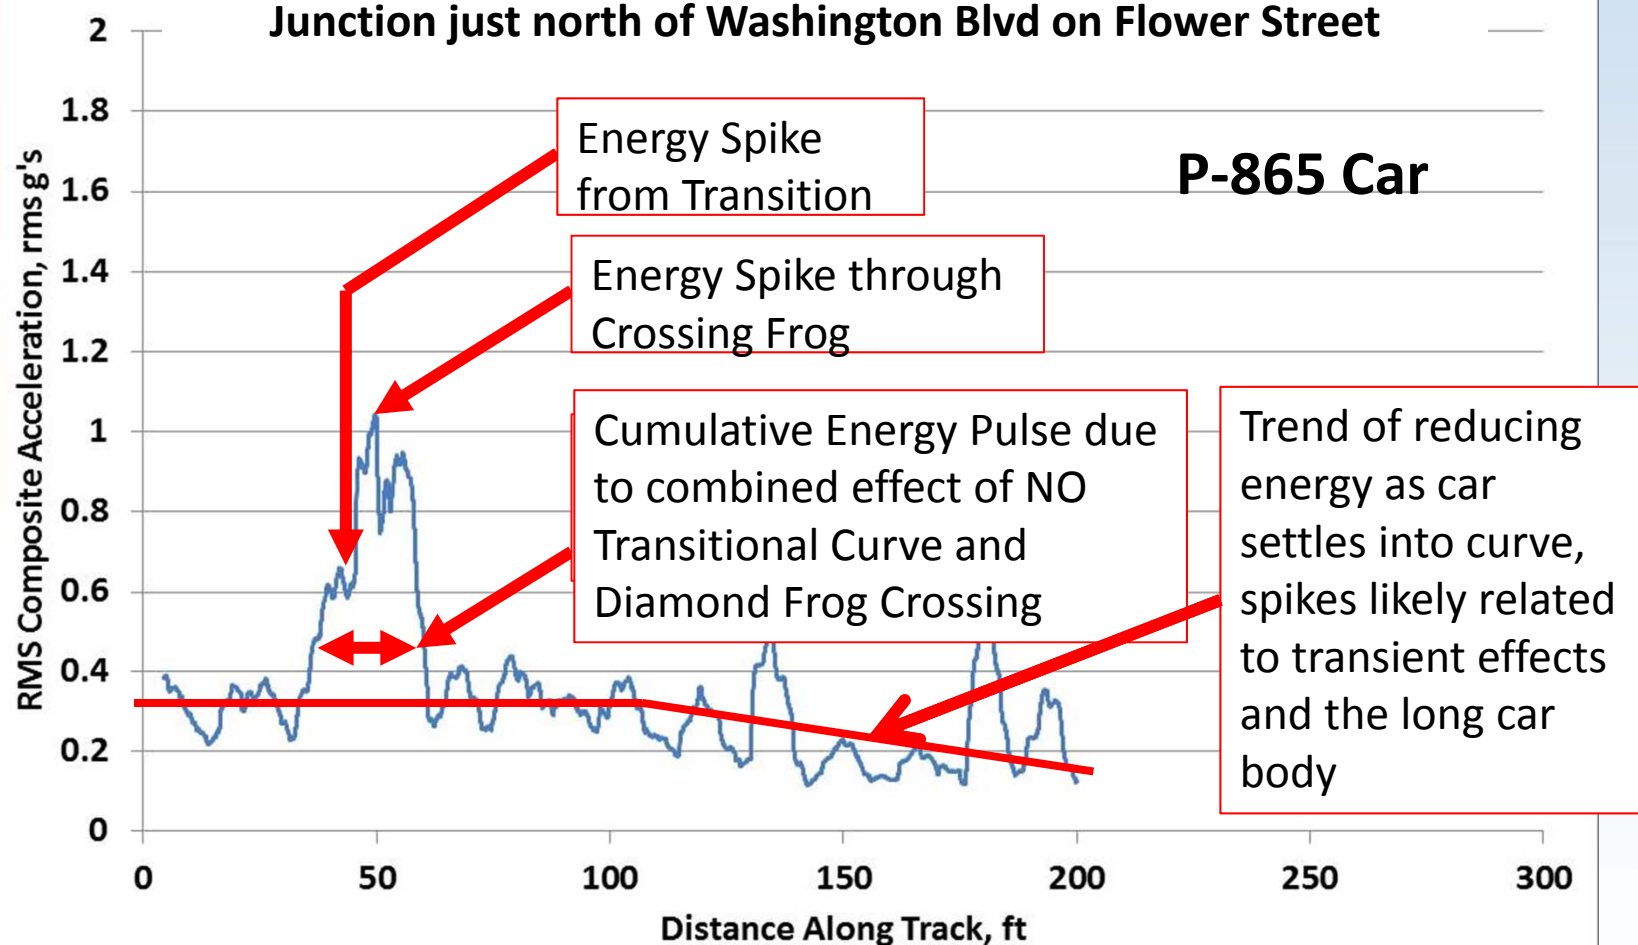
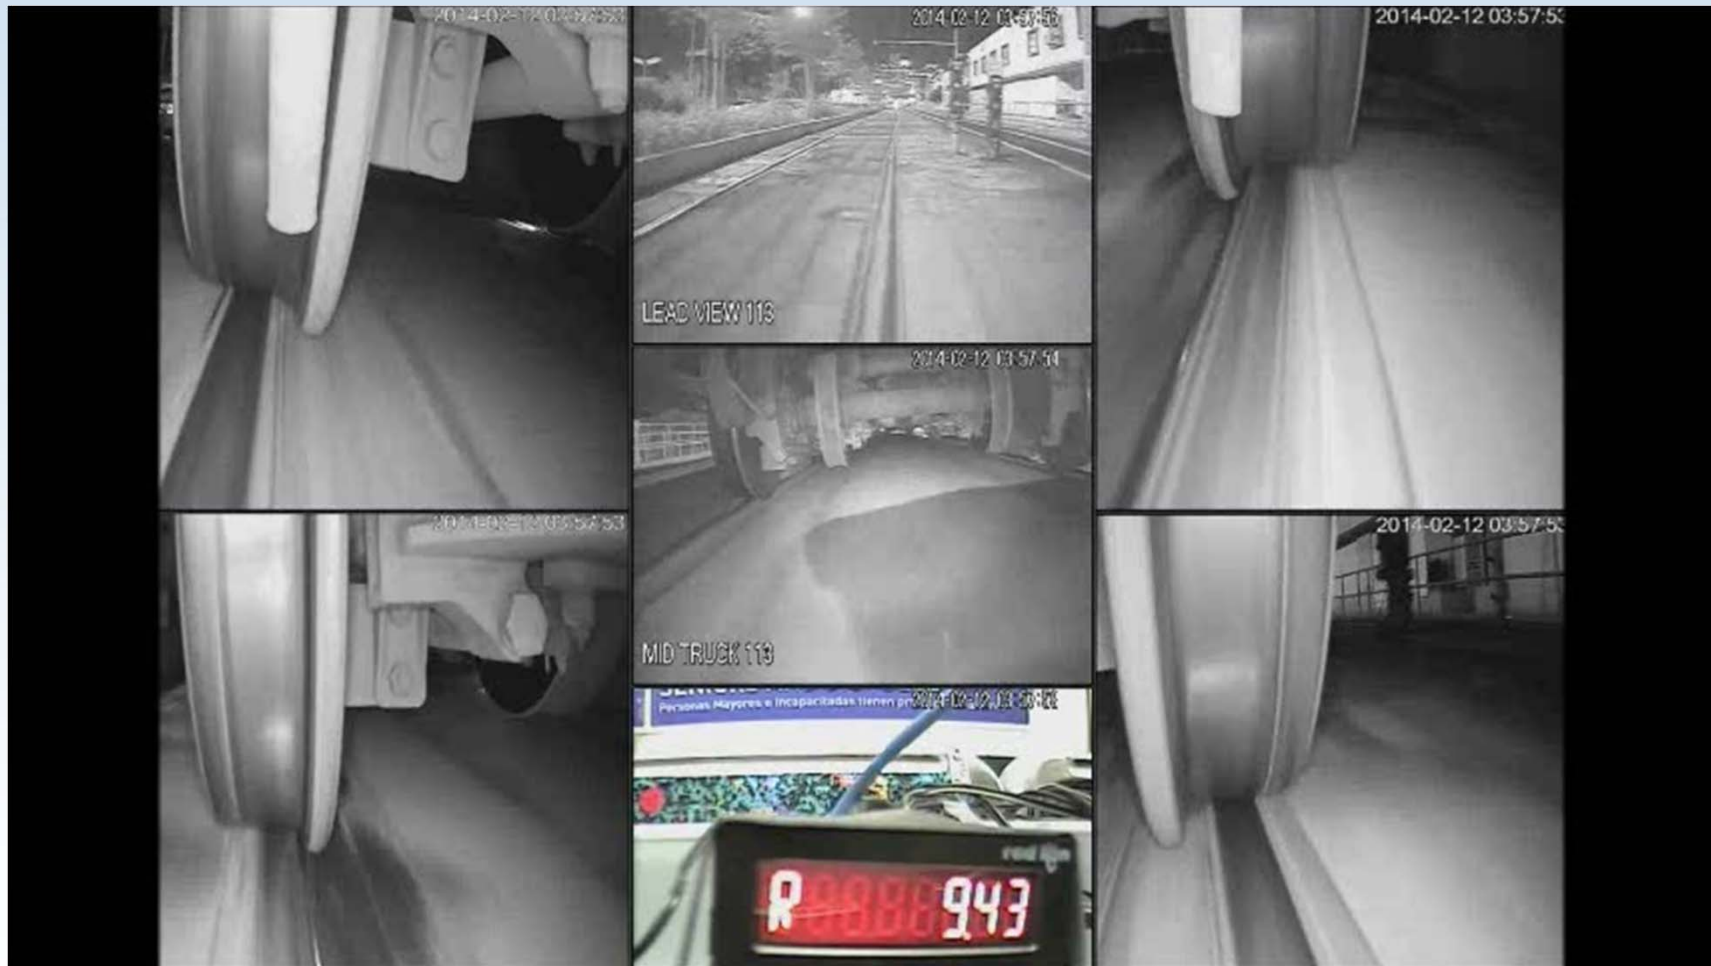
Metro Site 5

- The 190' R Turnout and 160' R Diamond at the Expo / MBL Junction just north Washington Blvd on Flower Street
- Severity Index of **6.84** (P-865) & **3.89** (P-2000)
- Construction of wood tie/ballast with alignment design issues and crossing frog modification

The 190' R Turnout and 160' R Diamond at the Expo/MBL Junction just north of Washington Blvd on Flower Street
