When Wheels and Rails don't Interact in a Good Way

Transportation
Safety Board
of Canada

**MAIN-TRACK DERAILMENT
CANADIAN NATIONAL
FREIGHT TRAIN G84042-09
MILE 73.6, FORT FRANCES SUBDIVISION
NICKEL LAKE, ONTARIO
10 NOVEMBER 2013**

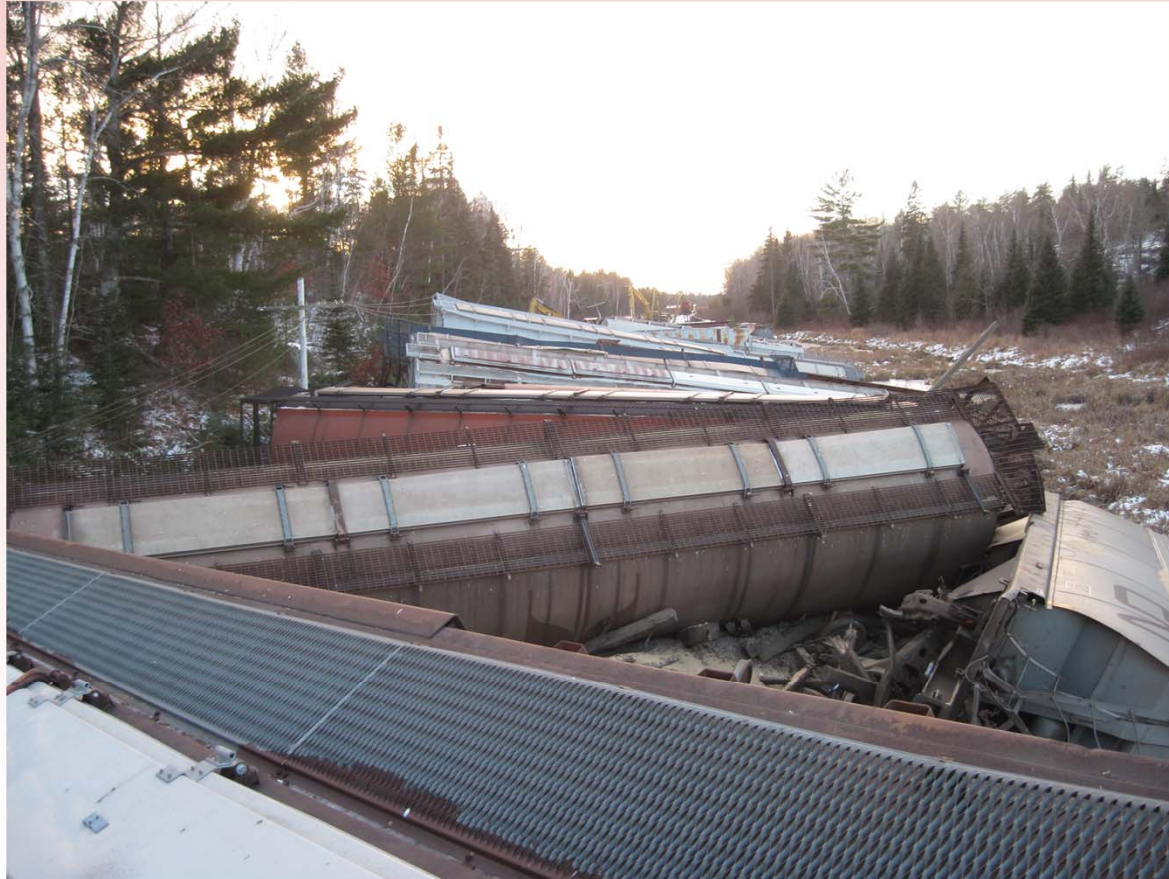
Point of Derailment

- Mile 73.68, between reversing 4.05° LH and a 4.92° RH curves 182' apart
- Cars 22 and 23 separated
- 40 cars derailed in two main groups

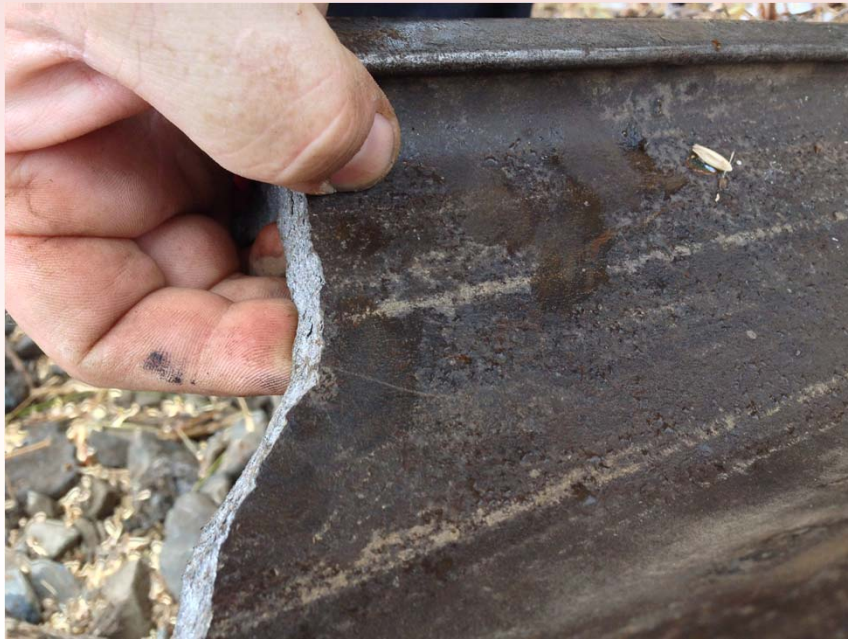
High Rail

- high rail was 1989/1991 115-pound CWR with 14 mm of head wear and 6 mm of flange wear
- low rail was 1994 115-pound CWR with 13 mm of head wear and no flange wear
- wheel flange marks on the web of the high rail
- wheel marks on the head of the low rail

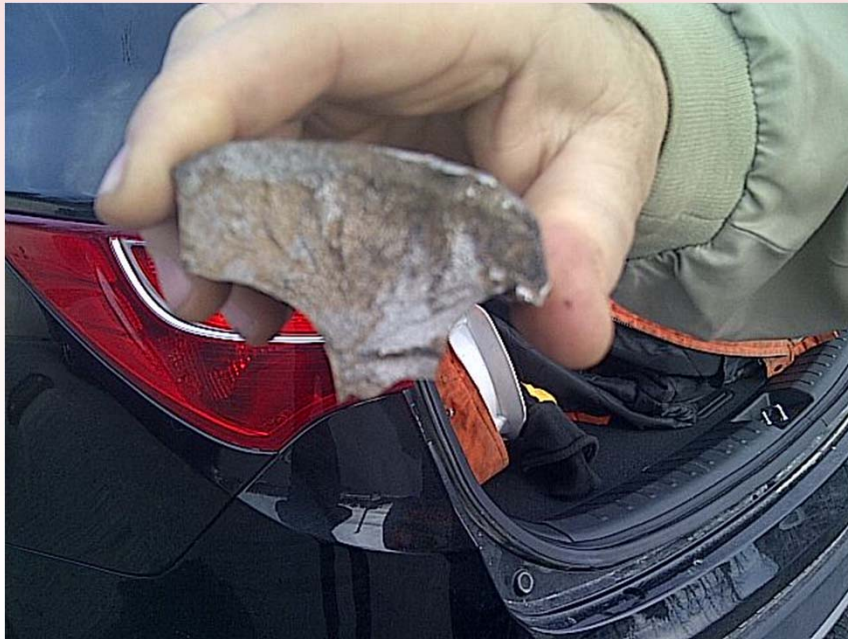
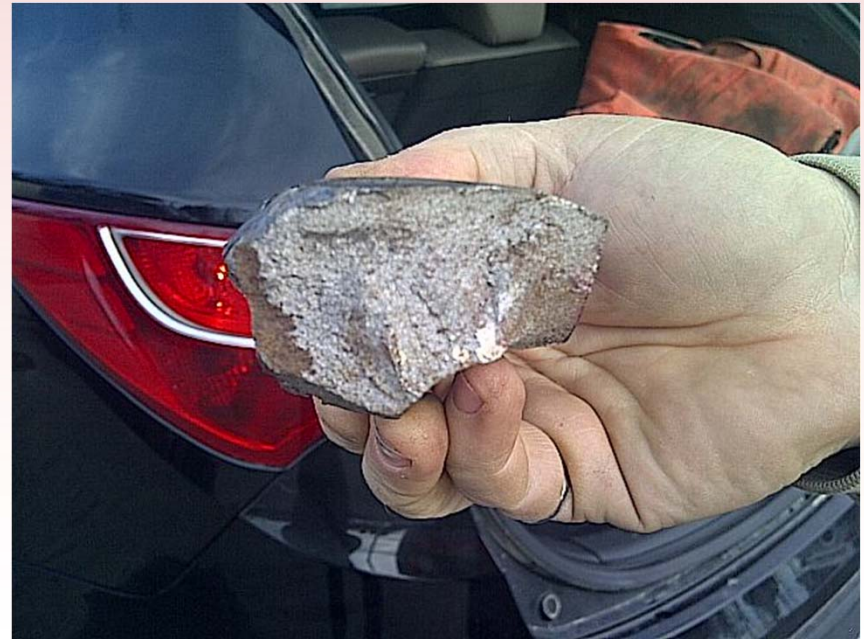
High Rail

- With the high rail close to its wear limits, wheel/rail contact was closer to the field side of the high rail, resulting in a lower lateral-to-vertical derailment threshold
- High rail likely rolled or canted out sufficiently to allow low rail wheels to drop in

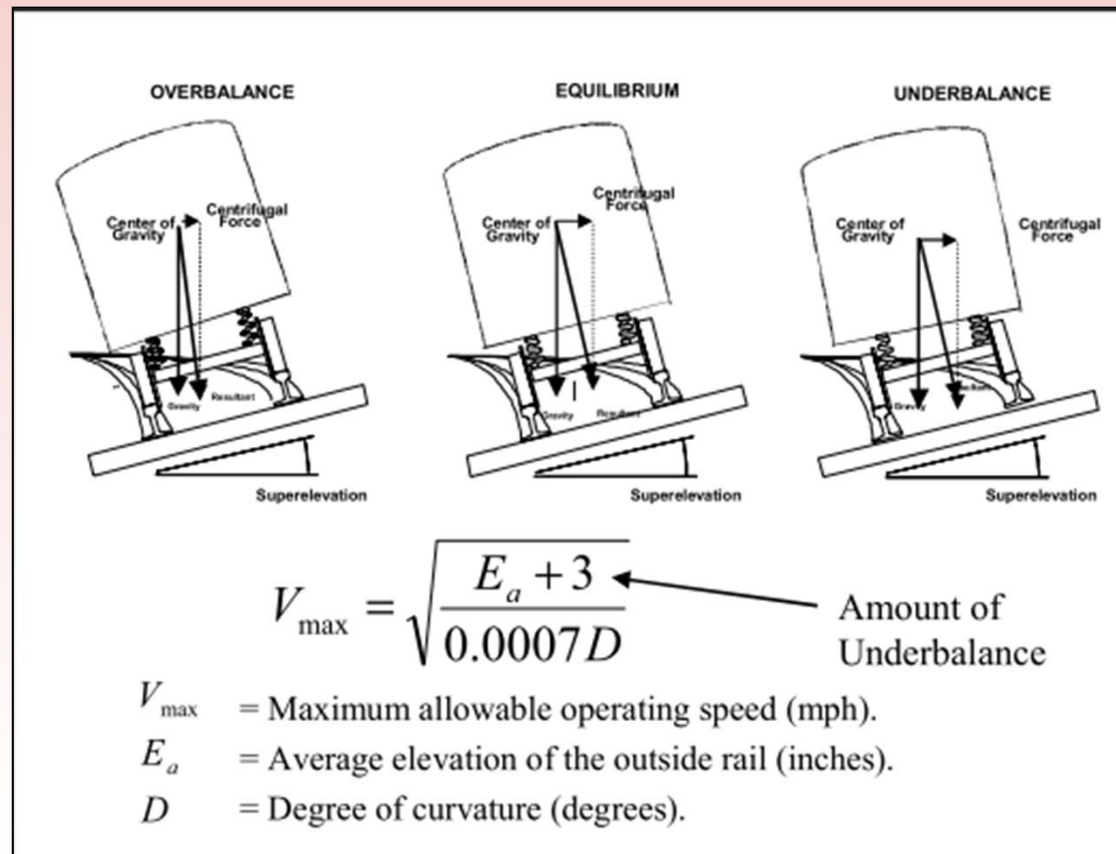
- With 0.35-inch actual SE and 2 inches imbalance, the design speed was 28.8 mph
- For actual speed of 37 mph, the balanced SE for a 4.05° curve is 3.9 inches → curve was 3.55 inches under elevated
- With 2" imbalance, minimum SE is 1.9 inches

The curve was under-elevated for 37 MPH, resulting in increased lateral forces being exerted on the high rail, promoting dynamic wide gauge

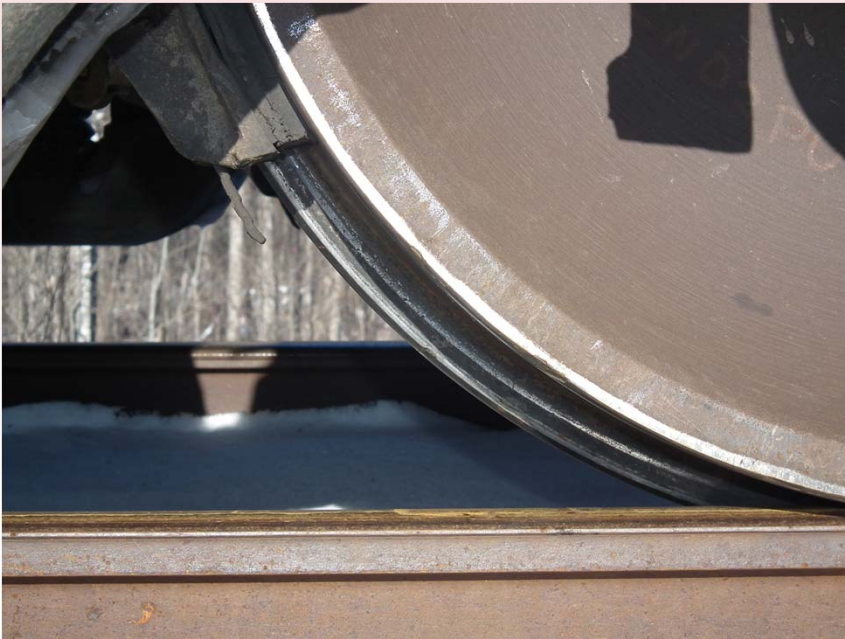
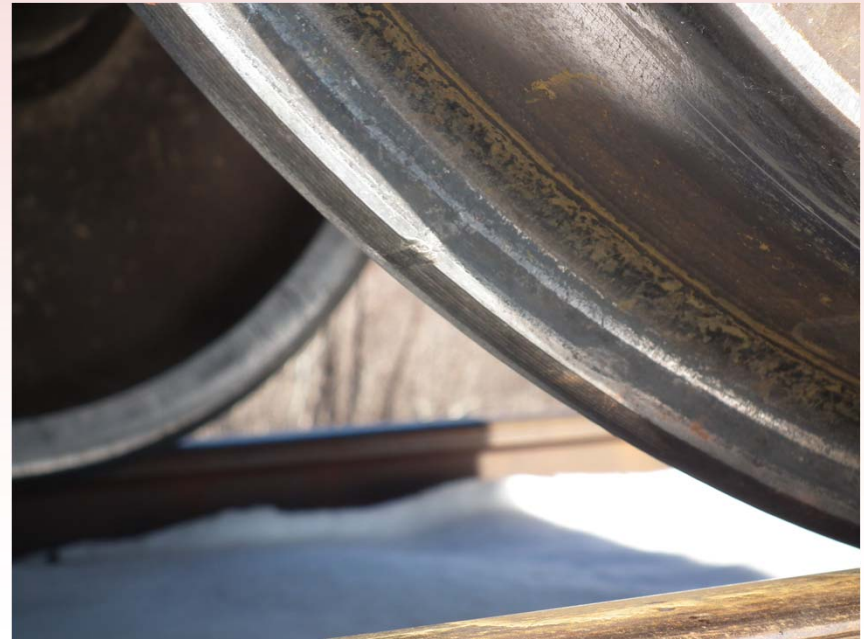
L-4 Wheel

- L4 wheel on trailing truck on 22nd car derailed first but then re-railed itself
- abrasion marks throughout the L4 wheel rim face circumference and flange

The derailment likely initiated when the high rail of the 4.05° left-hand curve rolled out, allowing the trailing L-4 wheel of the 22nd car to drop down and ride on the web and base of the high rail, spreading the high rail behind it as it proceeded
