A Derailment Investigation and Broken Spikes

*Brad Kerchof
Research & Tests*

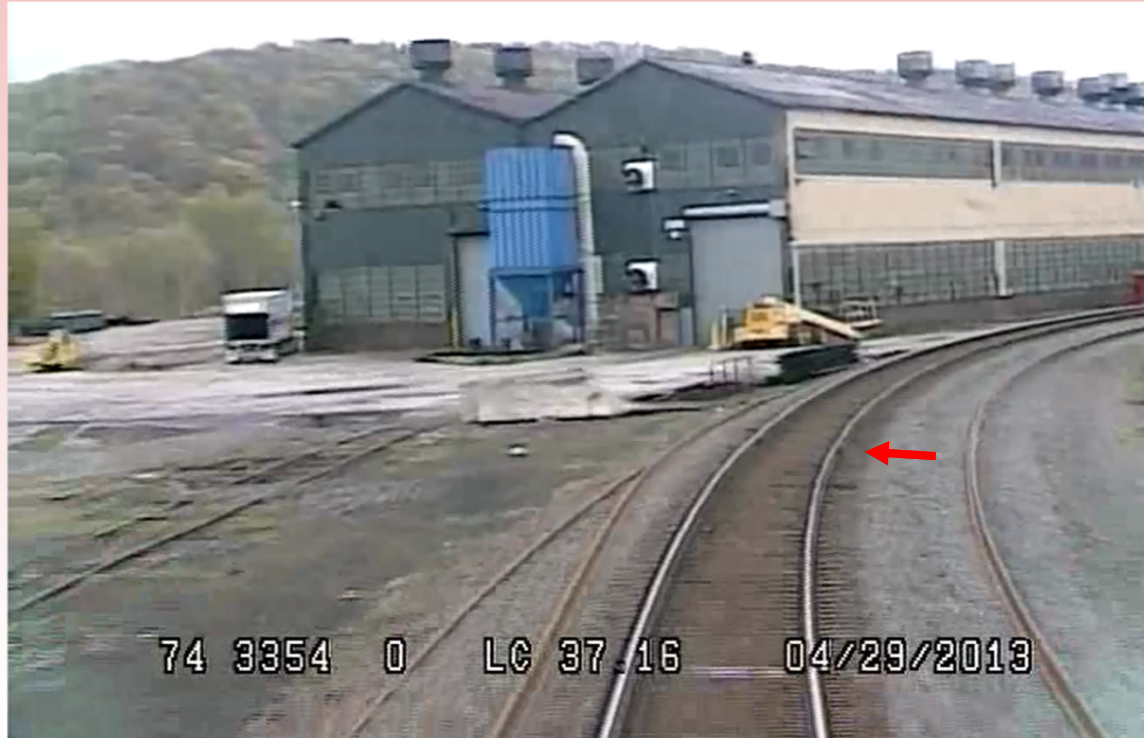
- looking east at the entrance spiral to the 8.3° curve and at the former steel plant
- signal cut section with insulated joints is at the point of spiral to curve (red arrow)
- track damage began at the insulated joints

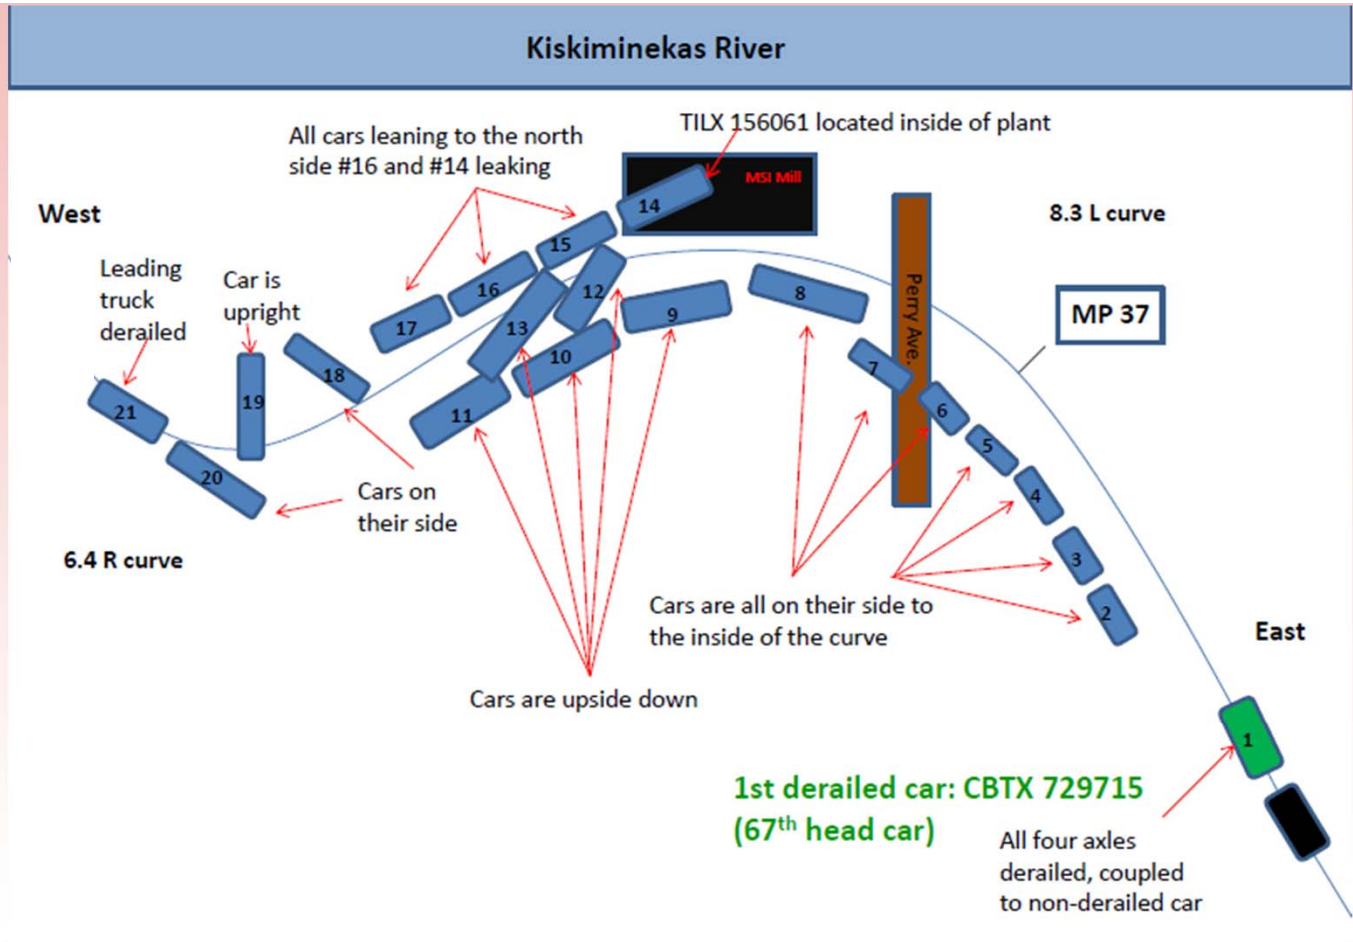
The 14th derailed car ended up inside the building

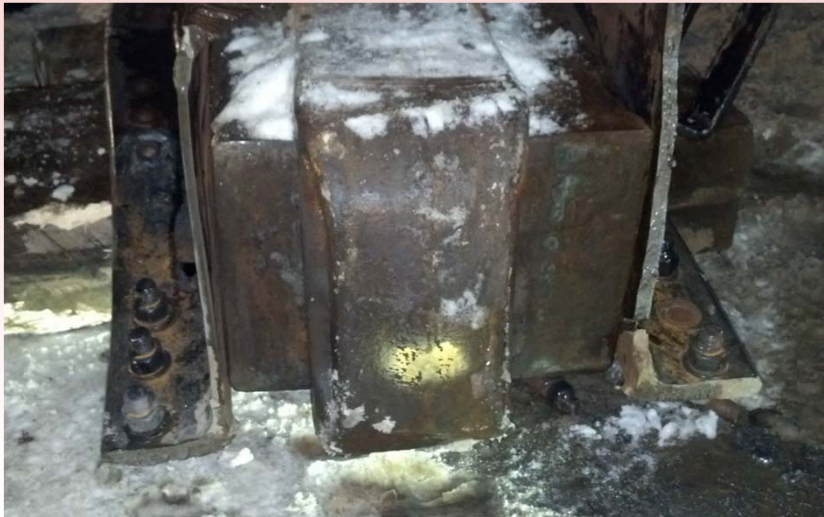
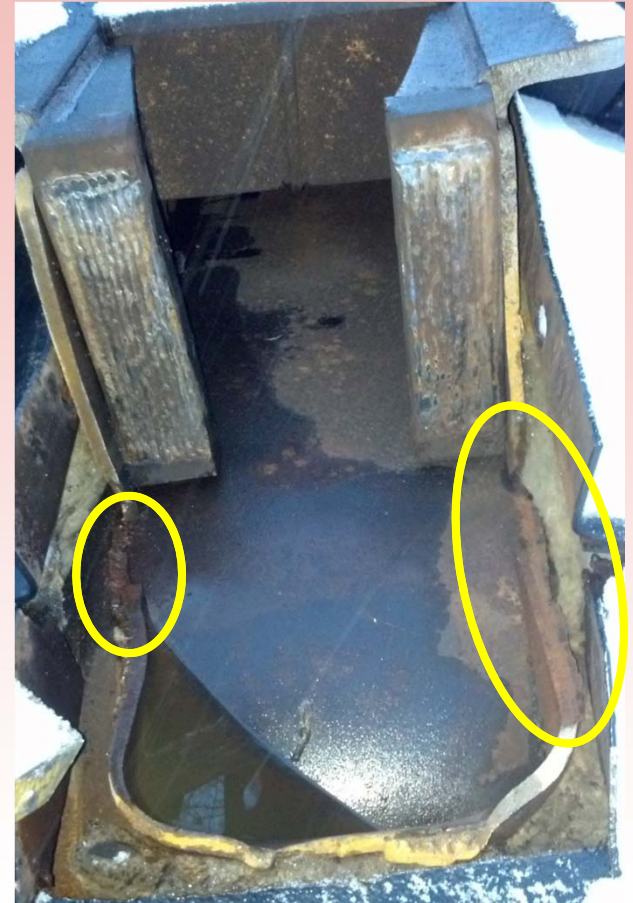
Proposed cause: broken stub sill on 11th head derailed car

The fracture surfaces showed a number of old weld cracks, old fatigue cracks, and large areas of extremely poor weld penetration. But.....

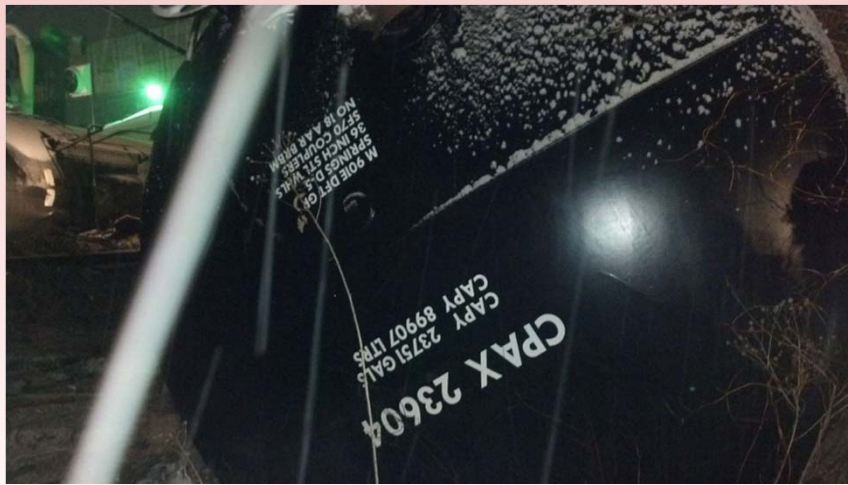
Based on the fracture pattern, we concluded that the stub draft sill failed due to a high rotational force consistent with coupled cars trying to roll over. Based on the orientation, CAPX 23604 was rolling to its right side (toward the inside of the curve) while the car behind was resisting.

This stub sill separated from the trailing end of the 11th derailed car. The coupler and stub sill were carried by the 12th car and had no marks to indicate that they had struck the track structure.

Conclusion: The failure of the stub sill was a result of the derailment and not the cause.

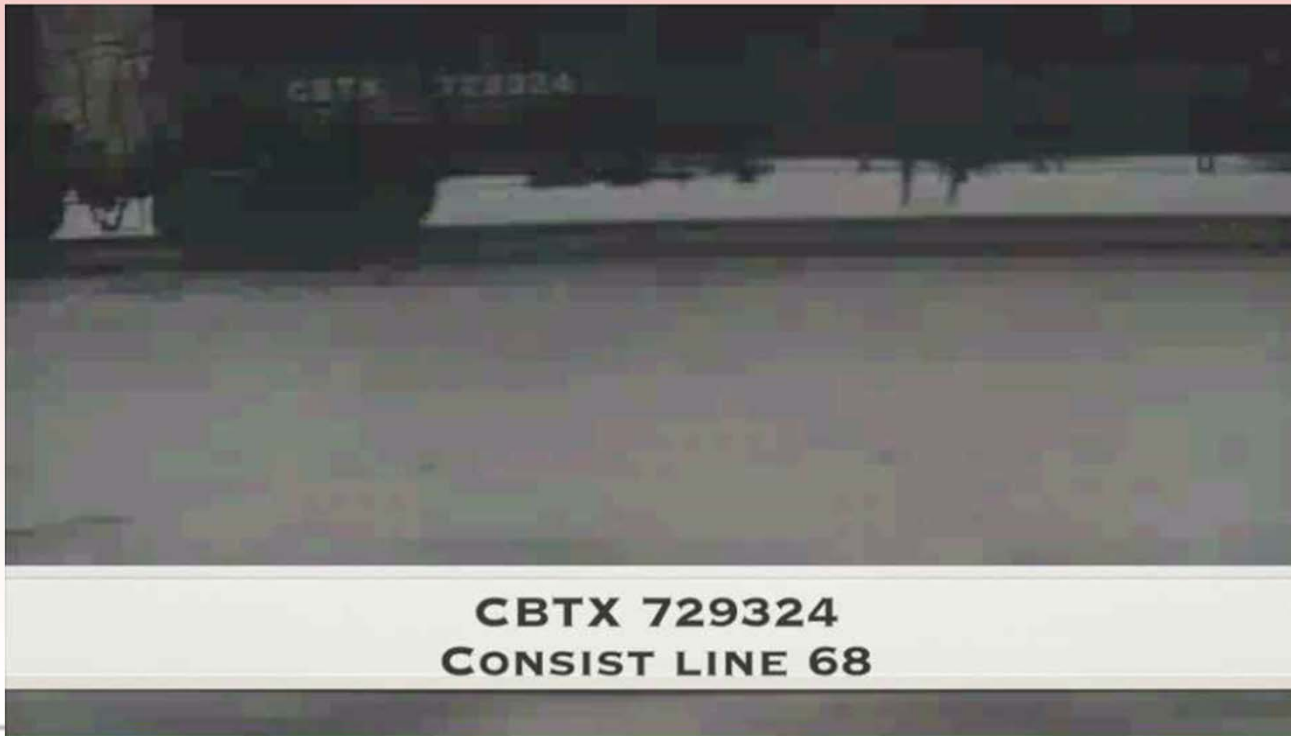
Another screen shot from the security camera video: We were able to read the reporting marks on the car that was two positions ahead of the first car to derail.

This car was consist line 68, or the 65th head car (the consist included 3 locomotives).

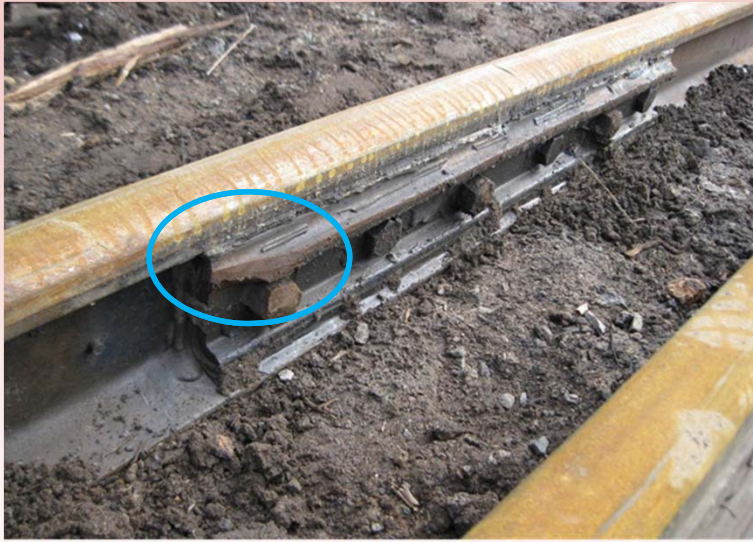
High-side IJ shows receiving end batter

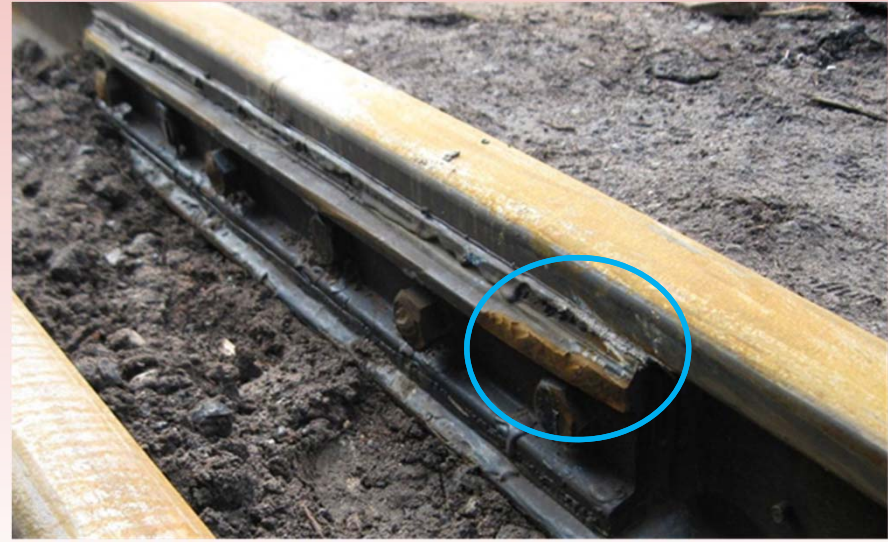
Low-side IJ also shows receiving end batter

Conclusion: Wheels had dropped in before these joints (on both rails).

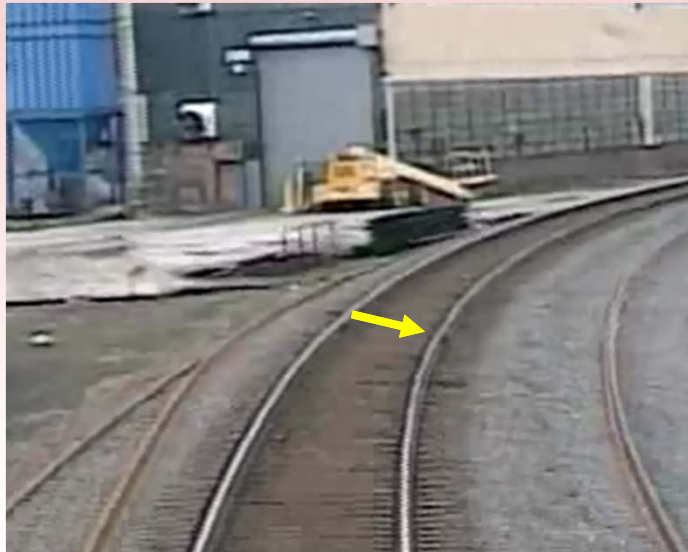
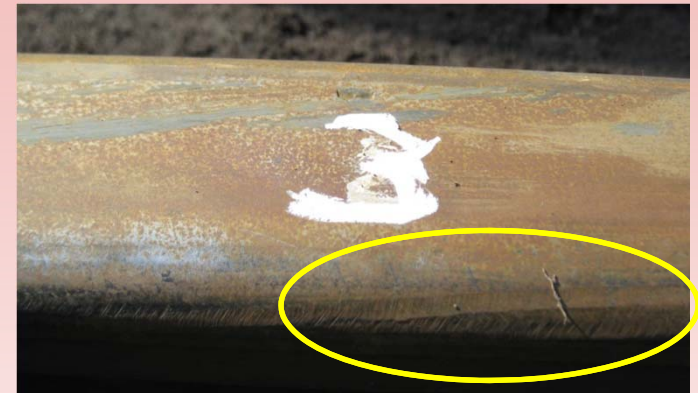
The low rail / gage corner showed four wheel rim drop-in marks, located 3 to 6 feet before the insulated joint.

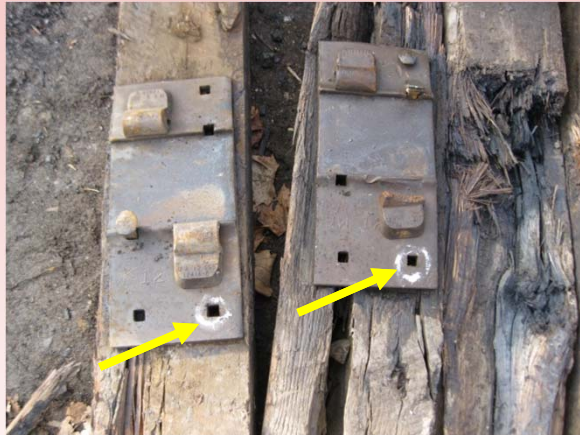
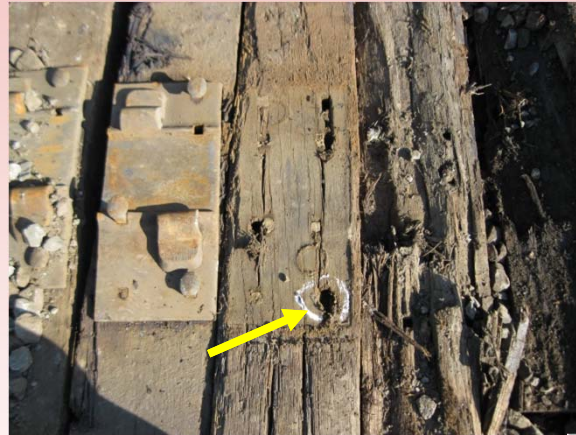
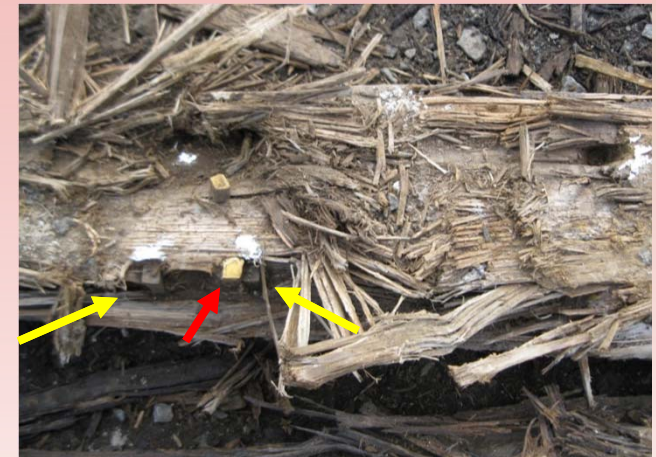
Liquid spike hole filler (red arrow)

- No evidence of plate movement (too much tie damage)
- Broken spikes were found (yellow arrows)

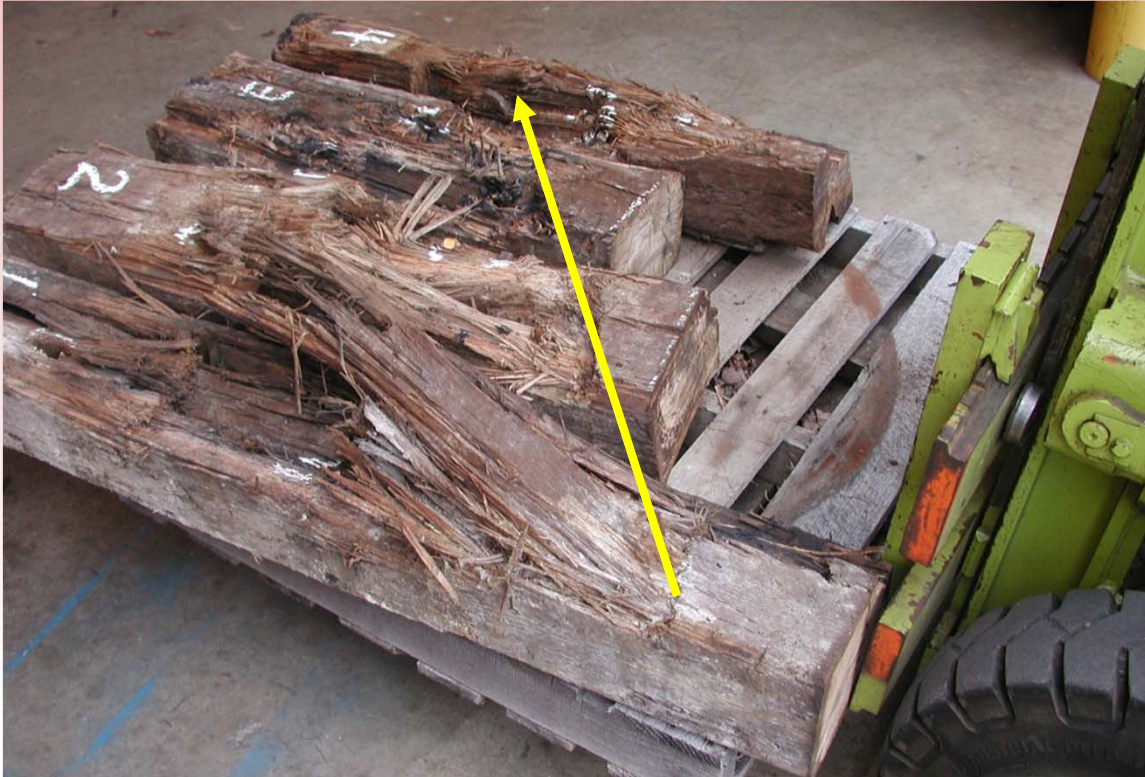
- These tie sections were all from the high side, based on condition of the tie plate seat.
- Wheel mark indicates that these were likely adjacent ties
- We believe that these ties were positioned under the high-side II, immediately east of the tie with the staple.

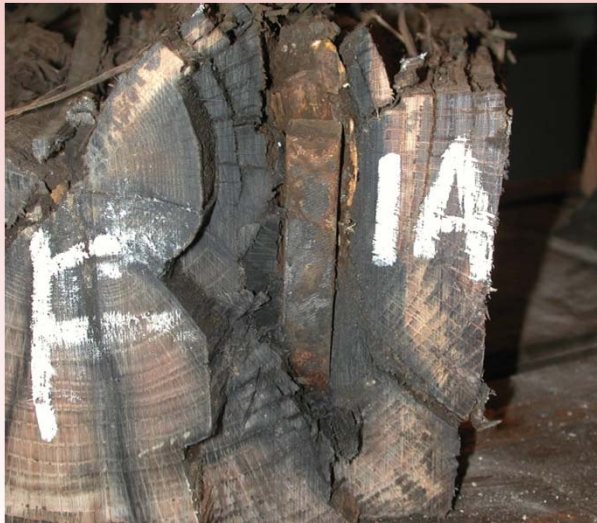
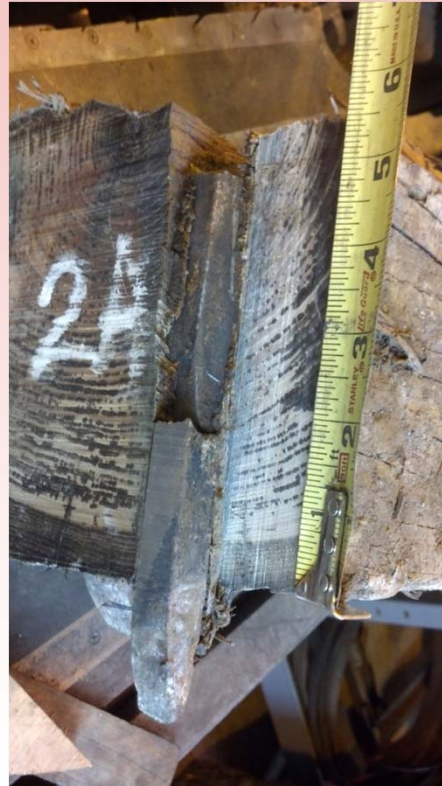
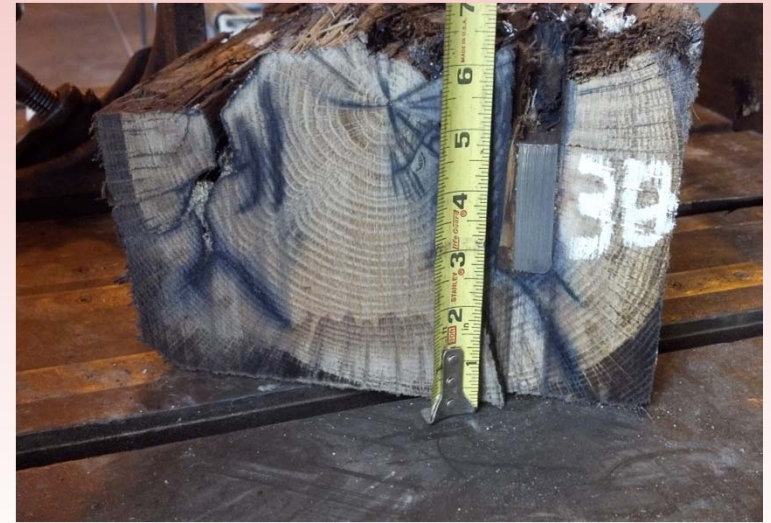
Cross-sectioning of ties revealed broken spikes

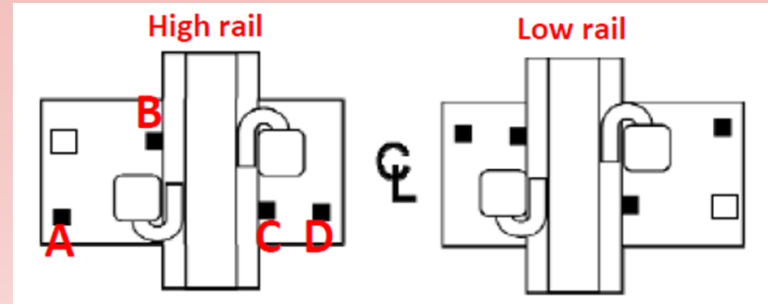
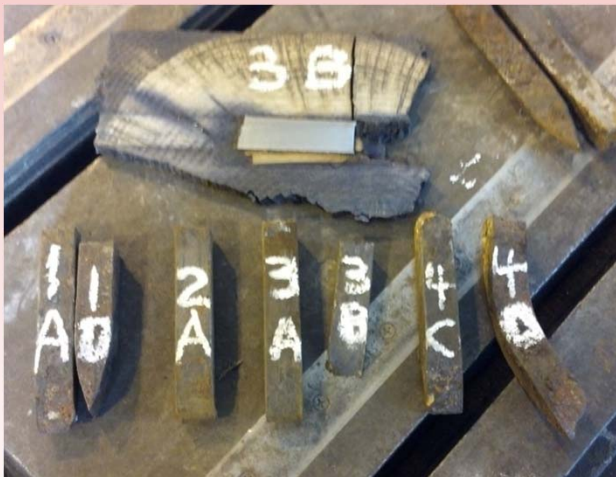
7 broken spikes were found in the 4 tie ends

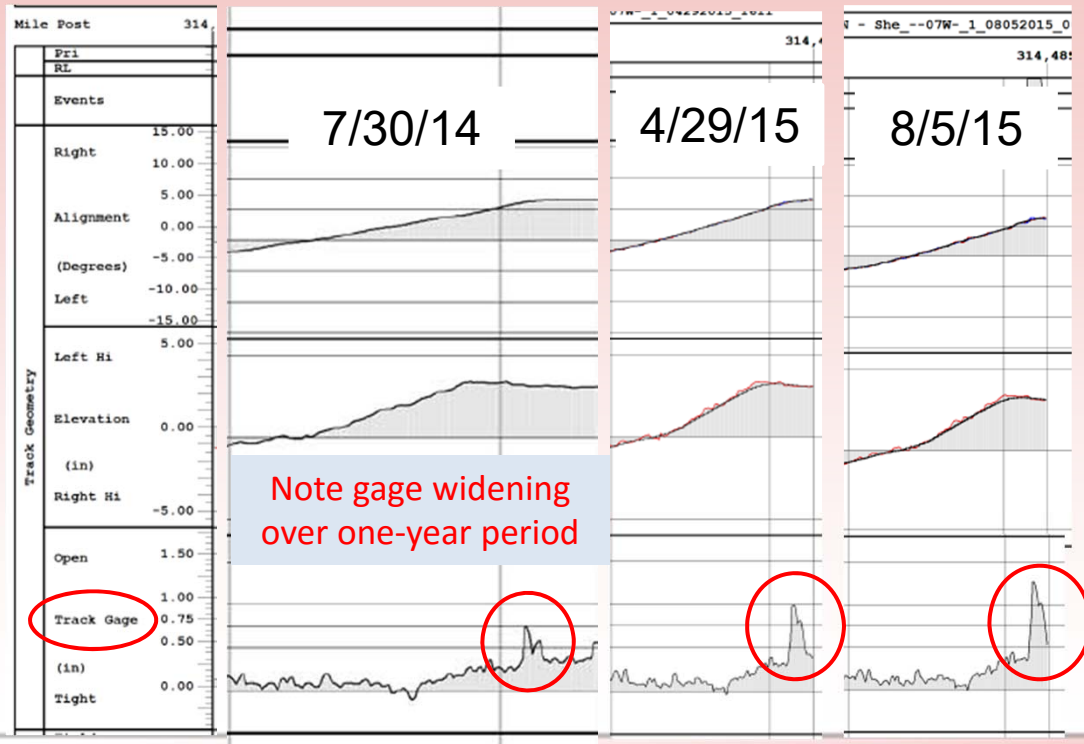
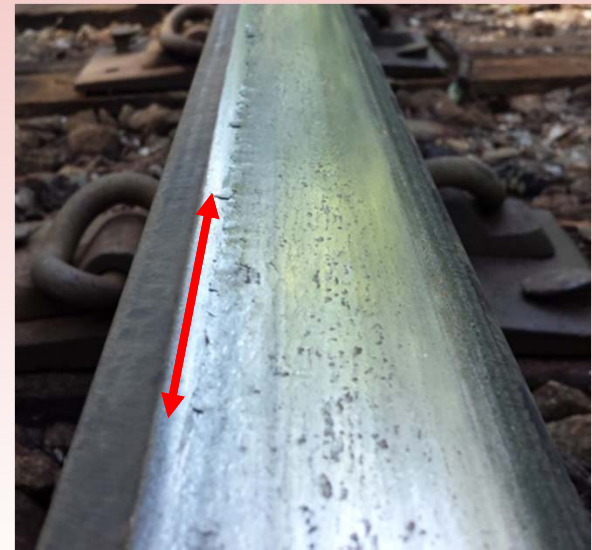
Over one year, gage widened from 57-1/4" to 57-3/4"; broken spikes were found to be the reason

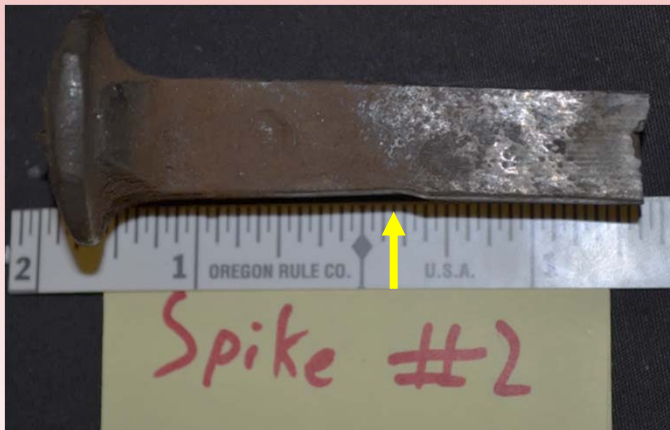
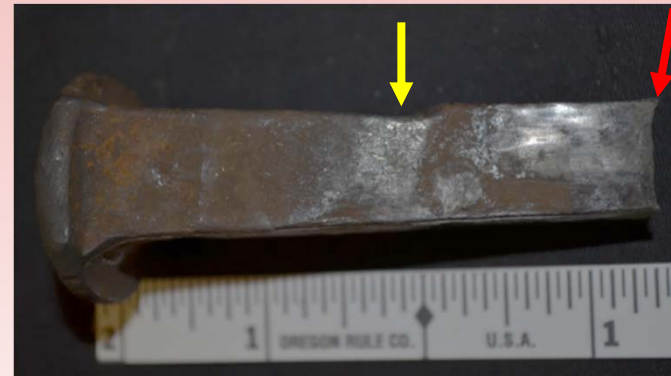
- Yellow arrows - note deep groove on uphill side of shaft, caused by longitudinal (downhill) force applied by the tie plate.
- Red - fatigue fracture originated in uphill back corner.

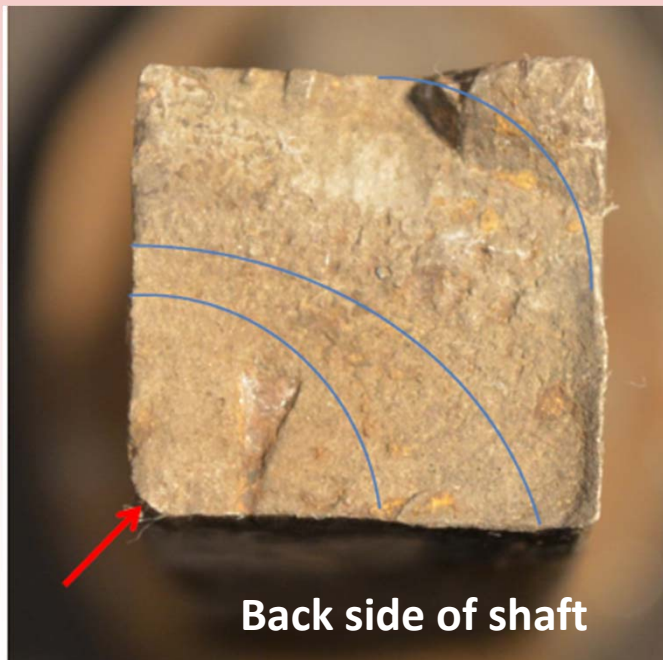
- The fatigue fracture originated in the corner marked with the red arrow, and propagated along a pattern indicated by the blue lines.
- The primary load was due to lateral forces, however, significant longitudinal force is also indicated.

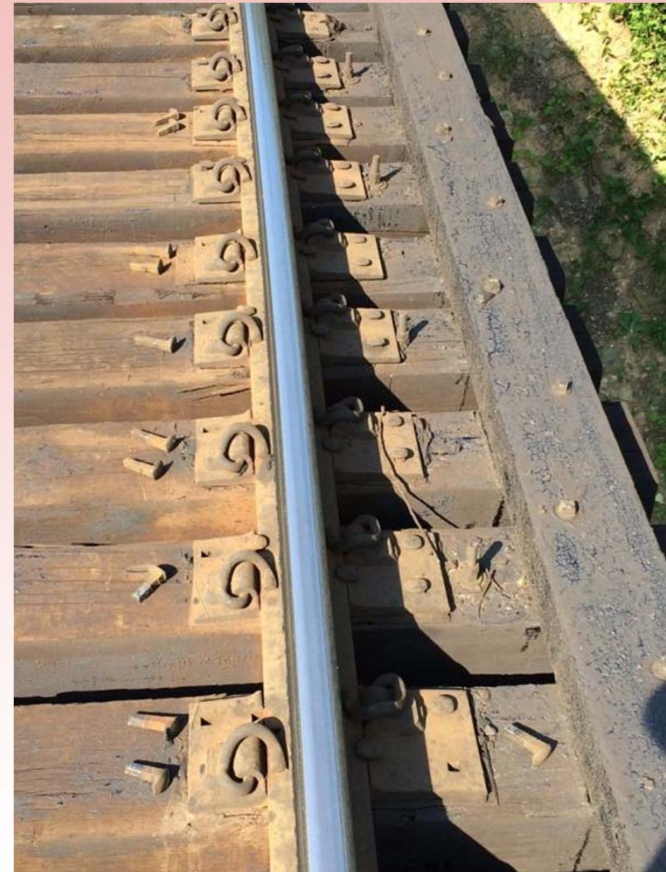
5 consecutive ties have 13 broken spikes in 20 spike positions, yet no tie plate movement!
