# Hunting at Vale EFC

**Case study of bogie hunting at Vale EFC between 2009 to 2017, and the inter-relationship between track and rollingstock**

**Paul Bladon, Denis D'Aoust, Pedro Freire**

HEAVY HAUL SEMINAR \* JUNE 7-8, 2017

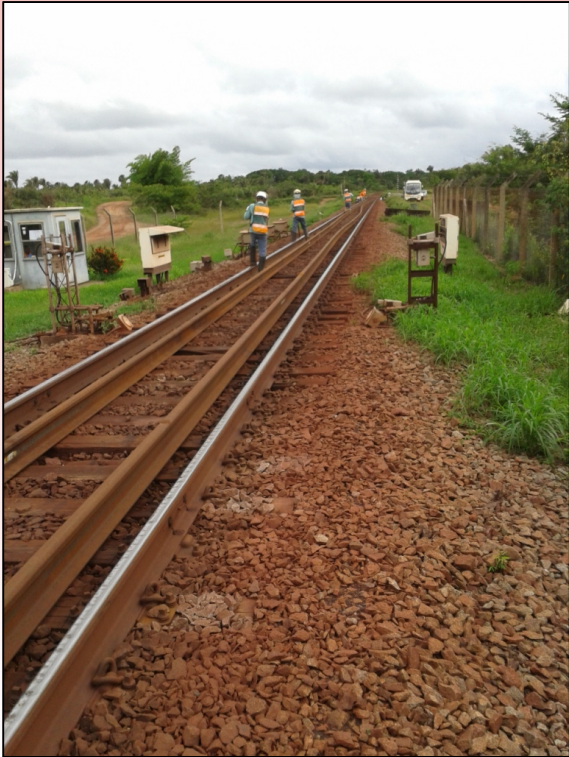
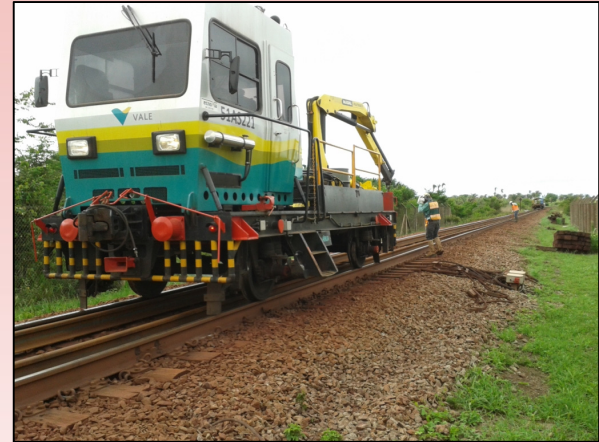
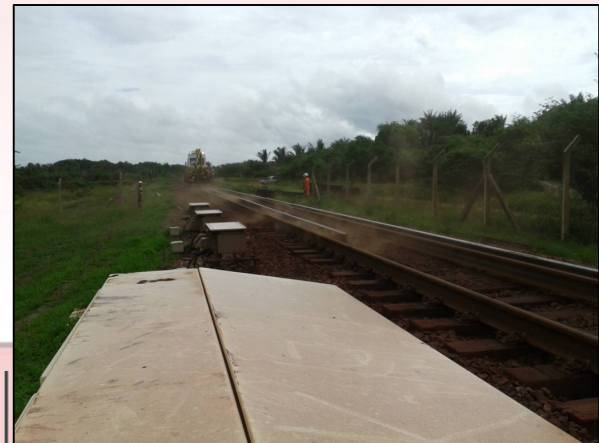
## 2<sup>nd</sup> Intervention Rail Replacement

Replaced previous rail (25m sections) with better quality rail (250m sections)

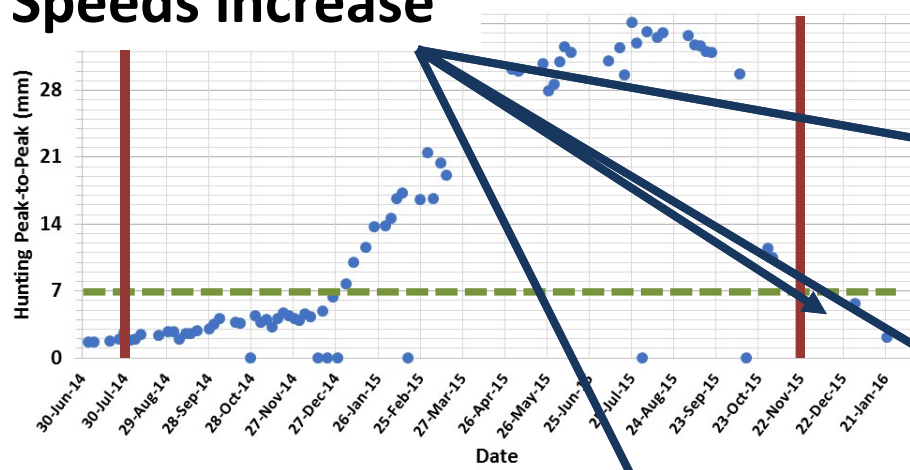
JT Bogie 20, Loaded Direction

# Speeds increase

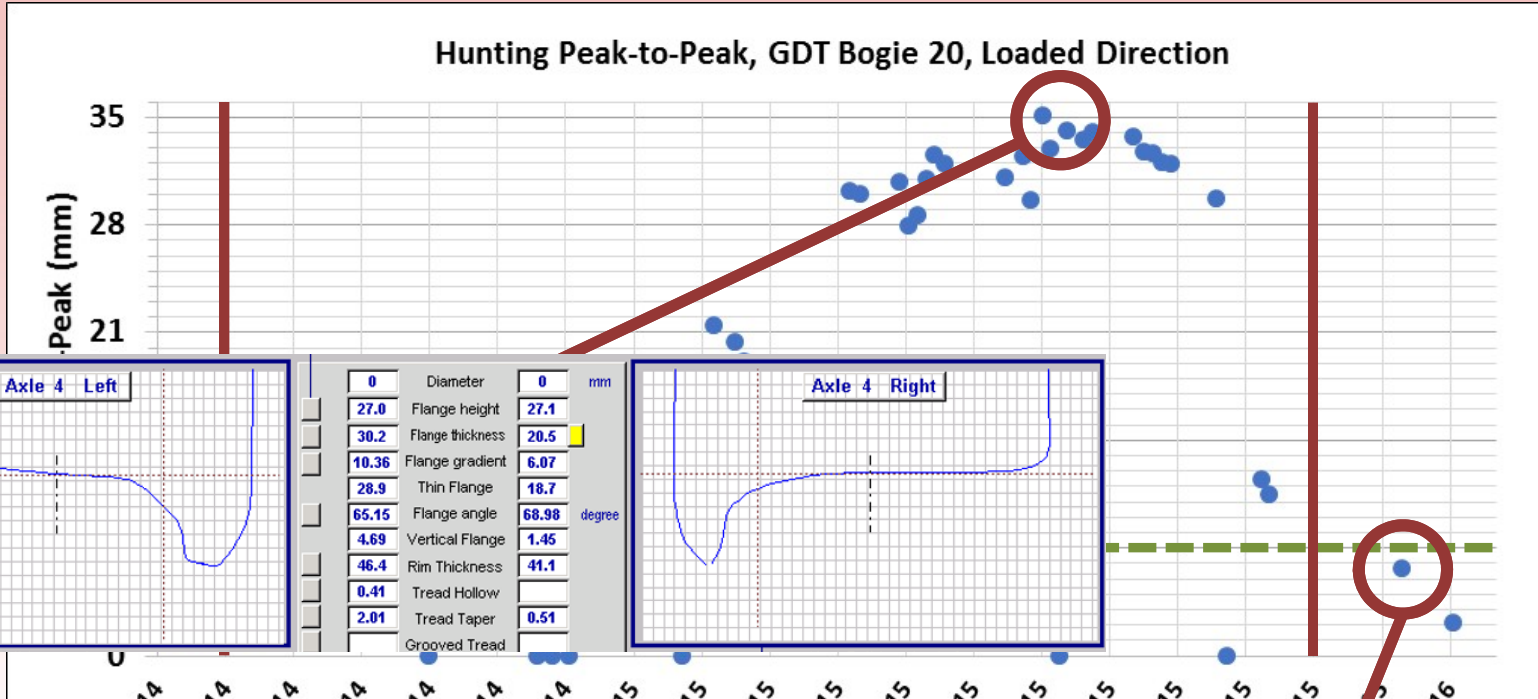
### Hunting Peak-to-Peak, GDT Bogie 20, Loaded Direction

0	Diameter	0	mm
27.0	Flange height	27.1	
30.2	Flange thickness	20.5	
10.36	Flange gradient	6.07	
28.9	Thin Flange	18.7	
65.15	Flange angle	68.98	degree
4.69	Vertical Flange	1.45	
46.4	Rim Thickness	41.1	
0.41	Tread Hollow		
2.01	Tread Taper	0.51	
	Grooved Tread

0	Diameter	0	mm
25.8	Flange height	27.2	
32.3	Flange thickness	30.7	
11.96	Flange gradient	8.94	
30.6	Thin Flange	29.1	
51.40	Flange angle	64.27	degree
4.60	Vertical Flange	5.44	
58.7	Rim Thickness	60.7	
	Tread Hollow		
1.93	Tread Taper	1.92	
	Grooved Tread

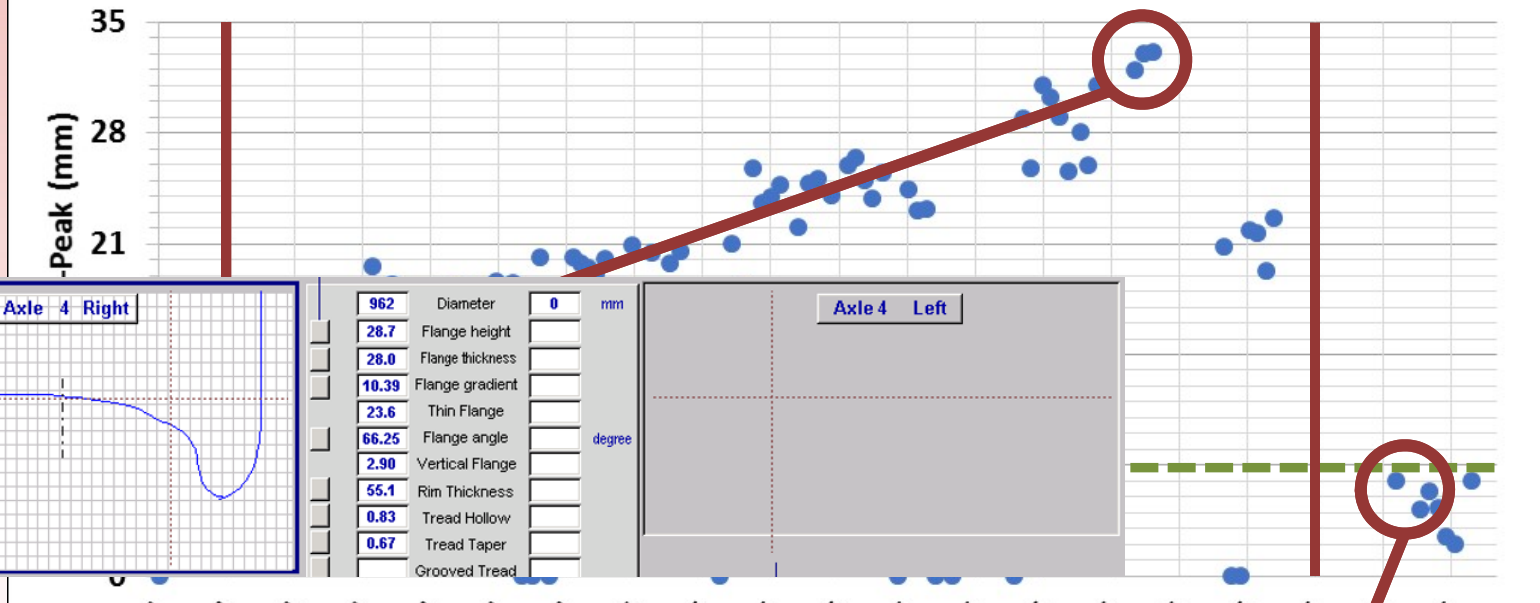
### Hunting Peak-to-Peak, GDT Bogie 26, Loaded Direction

962	Diameter	0	mm
28.7	Flange height		
28.0	Flange thickness		
10.39	Flange gradient		
23.6	Thin Flange		
66.25	Flange angle		degree
2.90	Vertical Flange		
55.1	Rim Thickness		
0.83	Tread Hollow		
0.67	Tread Taper		
	Grooved Tread

0	Diameter	0	mm
27.6	Flange height	27.3	
29.7	Flange thickness	30.4	
10.19	Flange gradient	10.06	
27.5	Thin Flange	28.6	
61.27	Flange angle	60.92	degree
4.63	Vertical Flange	5.47	
54.0	Rim Thickness	55.7	
	Tread Hollow		
2.21	Tread Taper	2.32	
	Grooved Tread
