How Wayside Detector Data Can Drive Forensic Analysis of Derailments

G Walter Rosenberger
Norfolk Southern –
Research & Tests

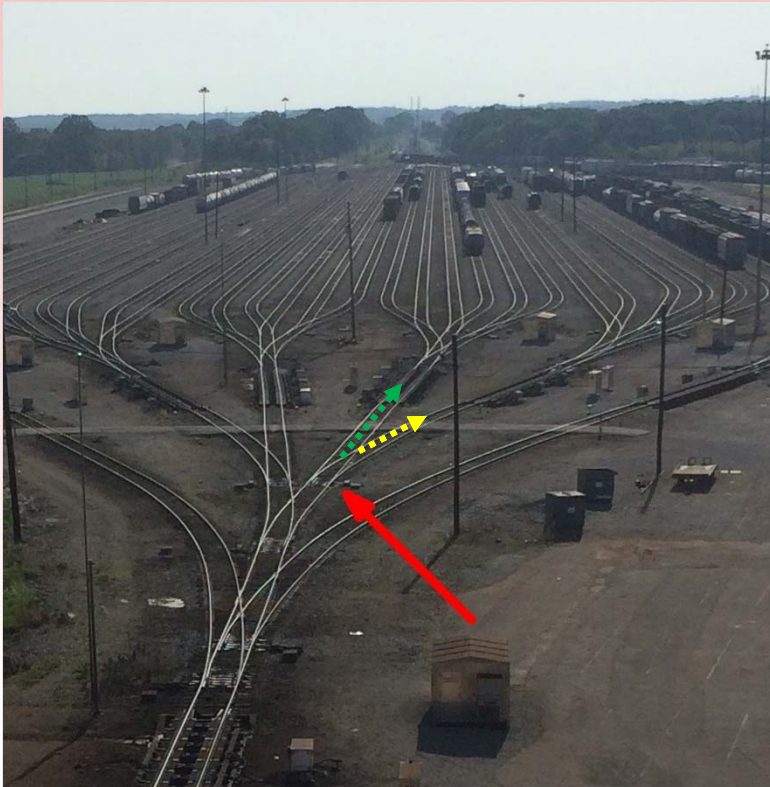
- Switch 26 (red arrow) was lined for Track 21 (green arrow).
- Lead truck R4/R3 blunted/picked switch, but took intended route.
- Wheel behind the point rail forced switch to reverse position.
- Trail truck took diverging route (yellow arrow) and derailed.

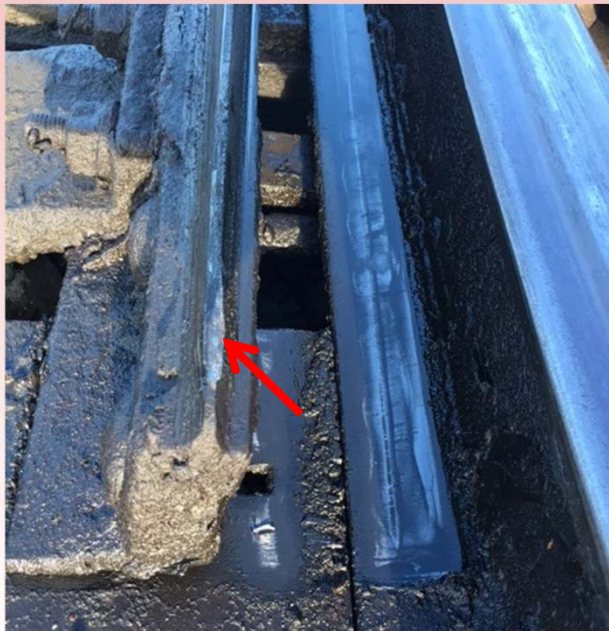
Switch 26, RH straight point, blunted

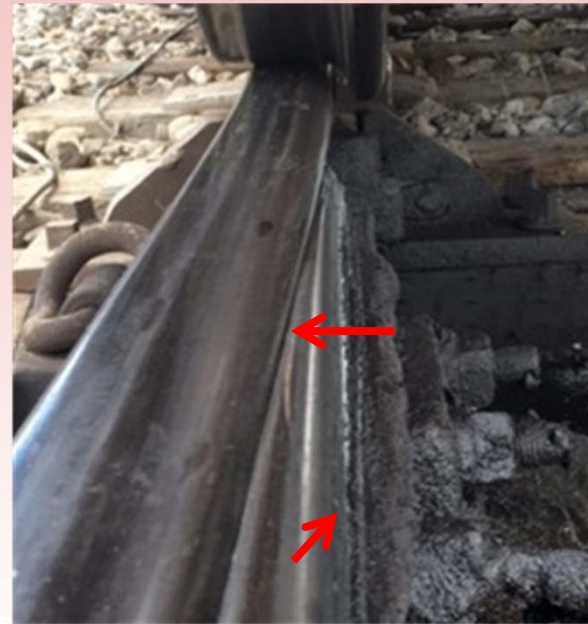
Flange mark on top of RH straight point

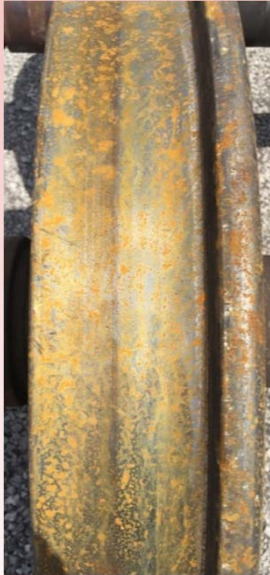
L3: fuller flange and normal tapered tread

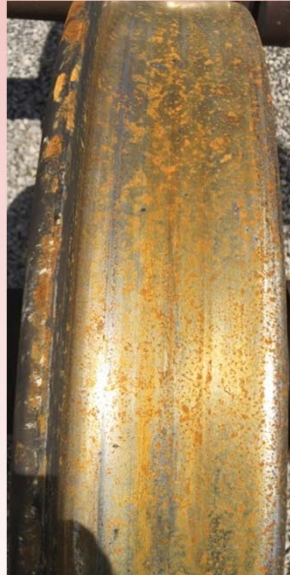
R3: thinner flange and 2mm hollow tread – **picked switch point**

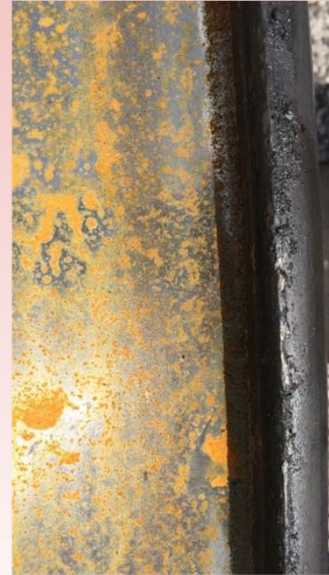
L4: thinner flange and 2mm hollow tread

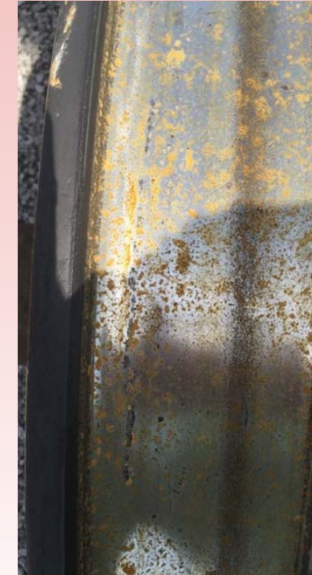
R4: fuller flange and normal tapered tread – **may have blunted point**

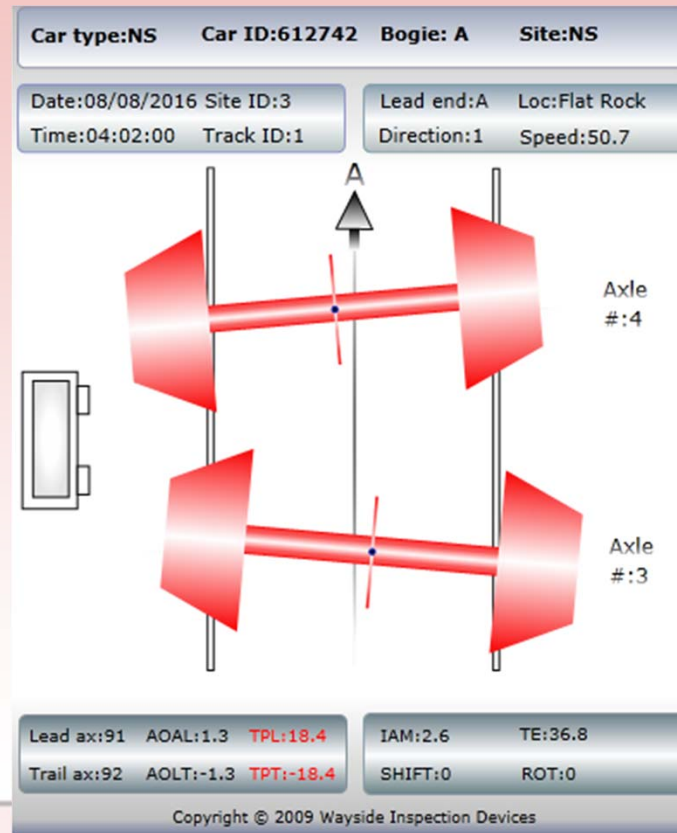
L4: thinner flange and 2mm hollow tread

L3: fuller flange and normal tapered tread

R4: fuller flange and normal tapered tread – **may have blunted point**

R3: thinner flange and 2mm hollow tread – **picked switch point**

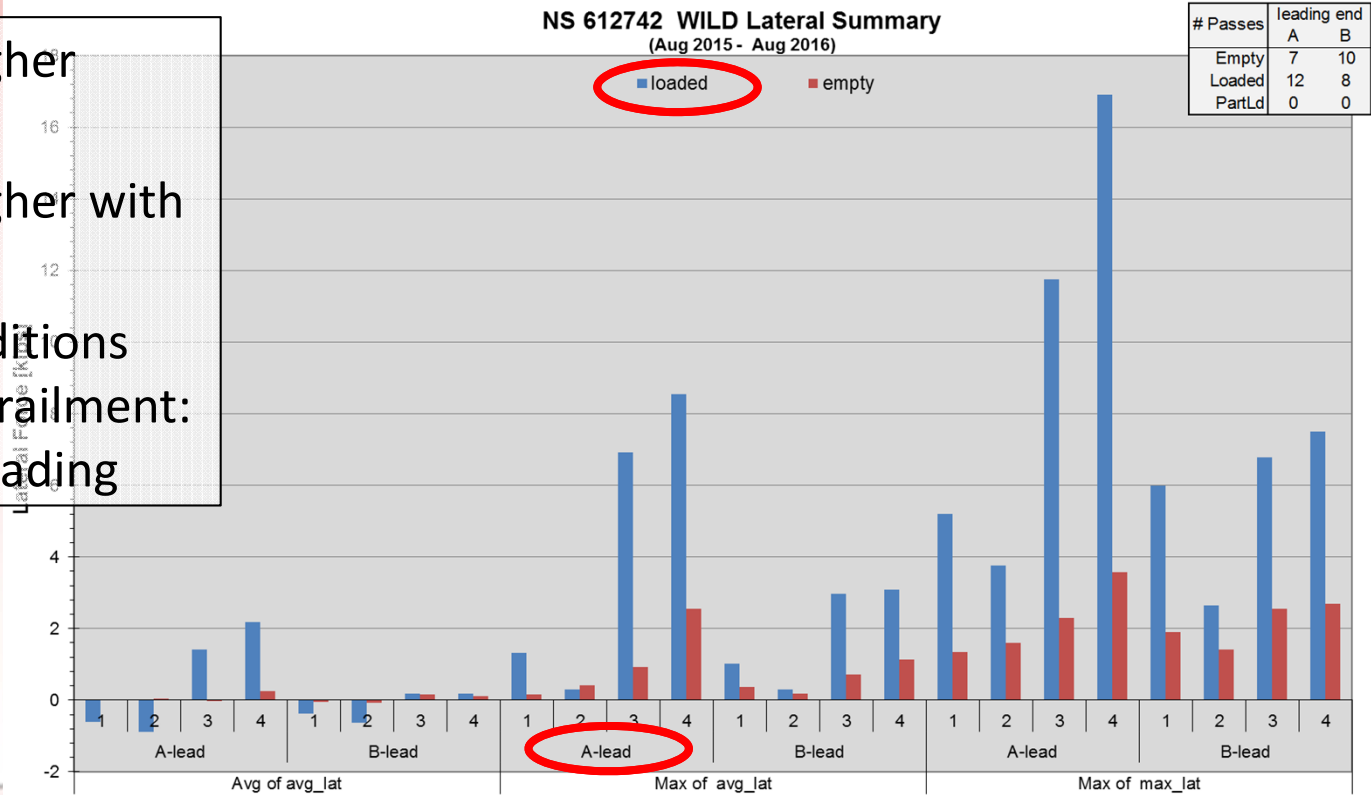
- Lateral forces higher when loaded
- Lateral forces higher with A-end leading
- These same conditions existed at the derailment: Loaded, A-end leading

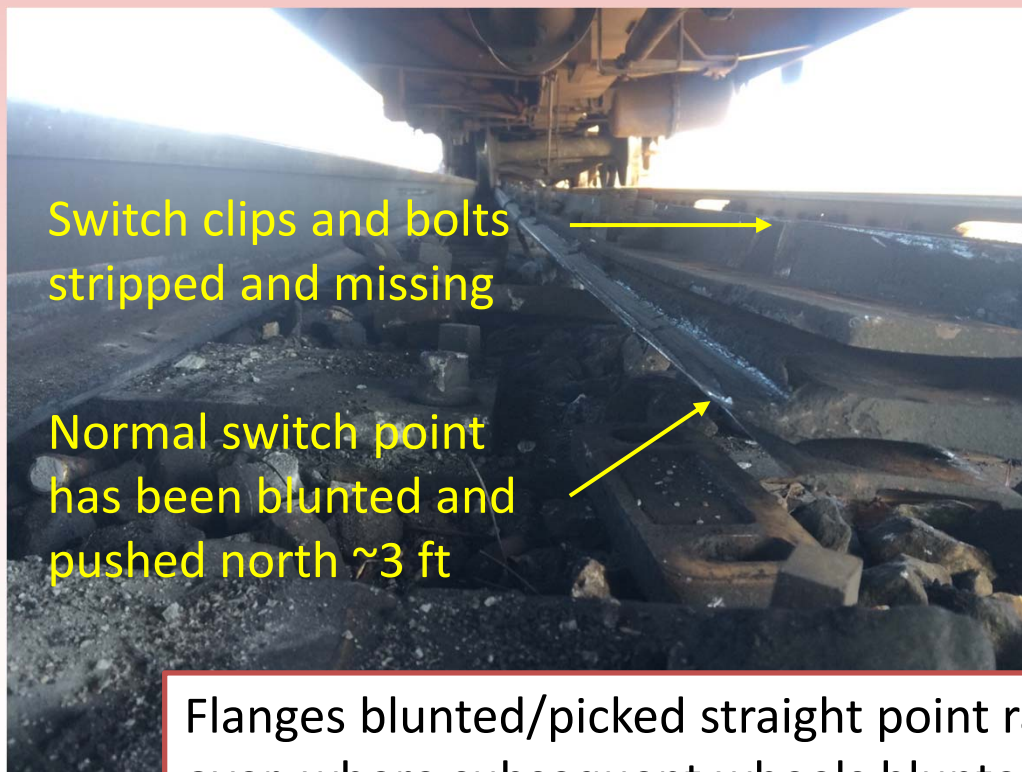
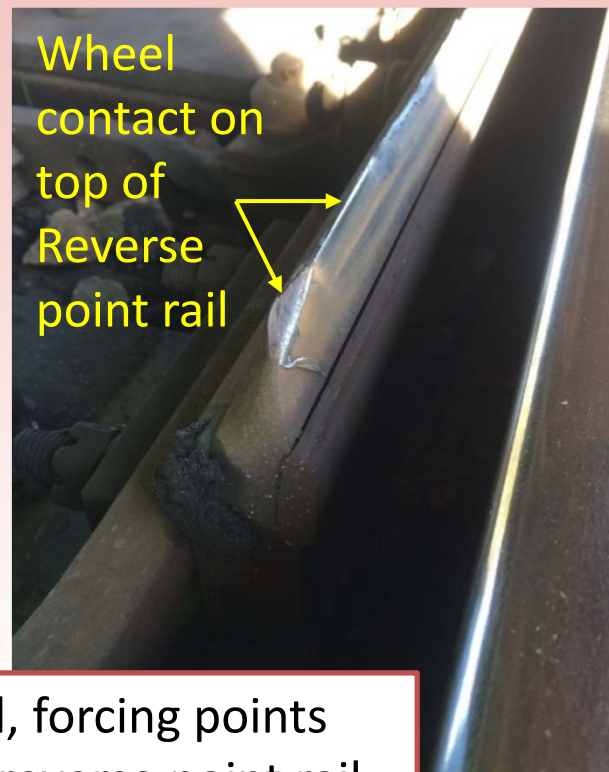
Flanges blunted/picked straight point rail, forcing points over, where subsequent wheels blunted reverse point rail

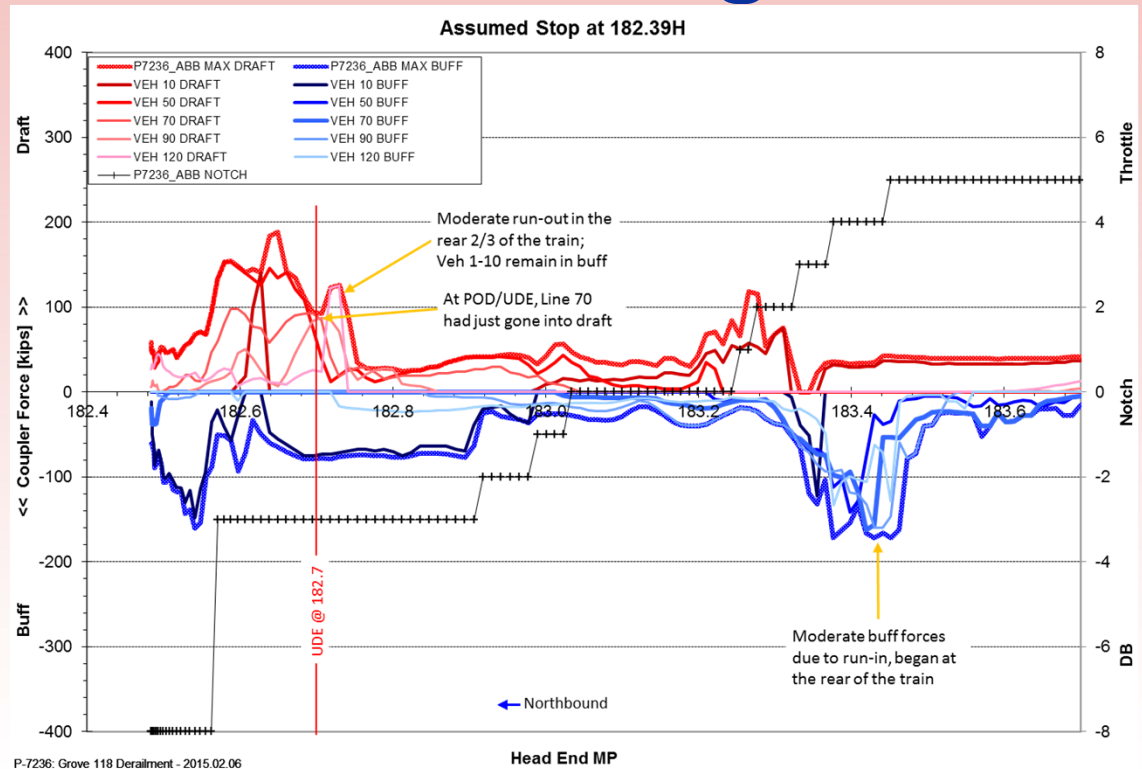
- Moderate run-in at rear of the train
- Moderate run-out in the rear 2/3 of the train
- Maybe enough slack action to aggravate a crabbing truck?
- Last exited a LH curve

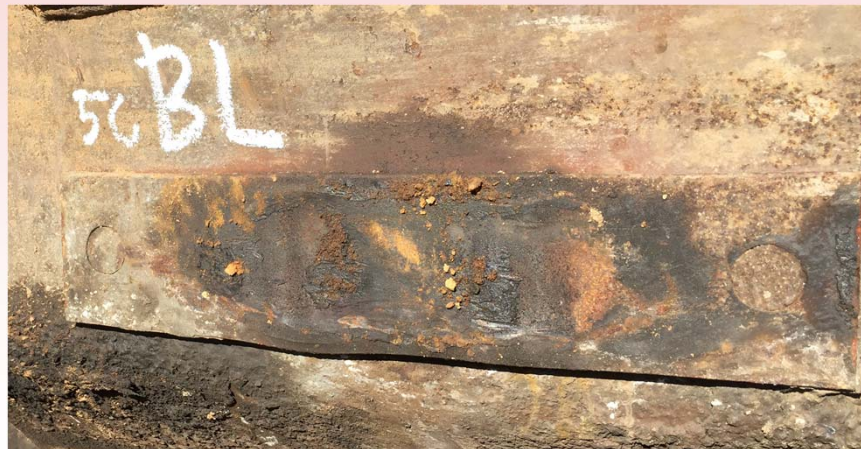
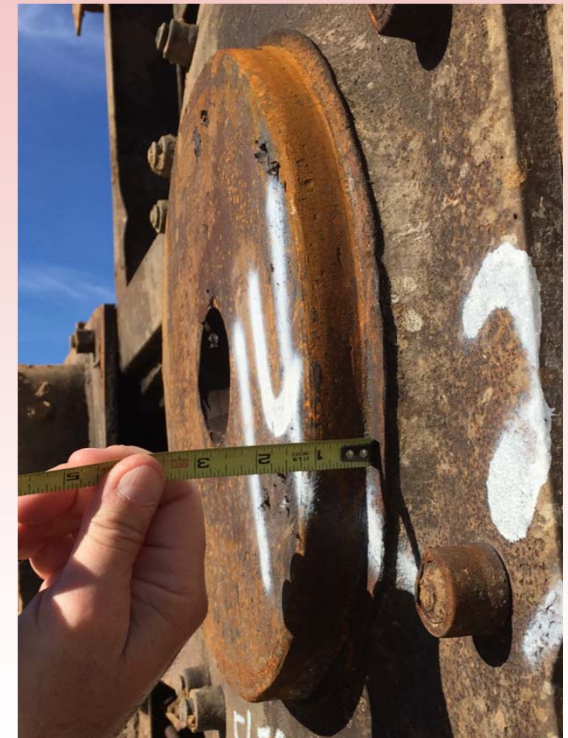
- Line 72, SOU 565282, B-end leading
- B-end centerplate measured approx. 1" in height
- Divots worn into B-end side bearing wear plates

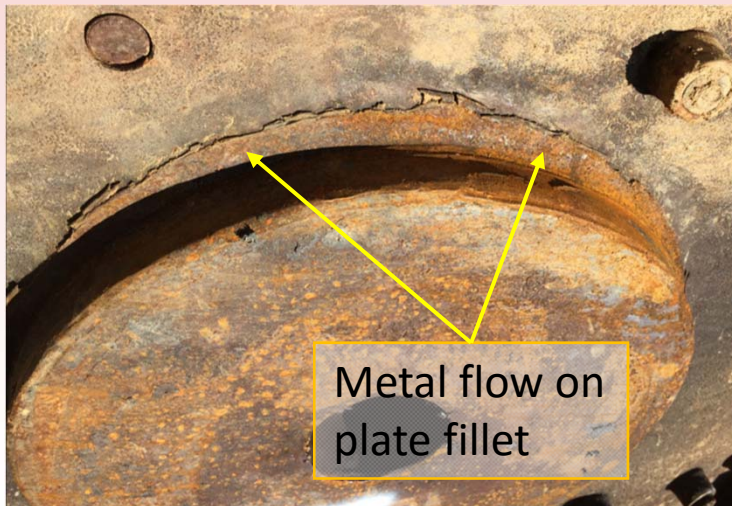
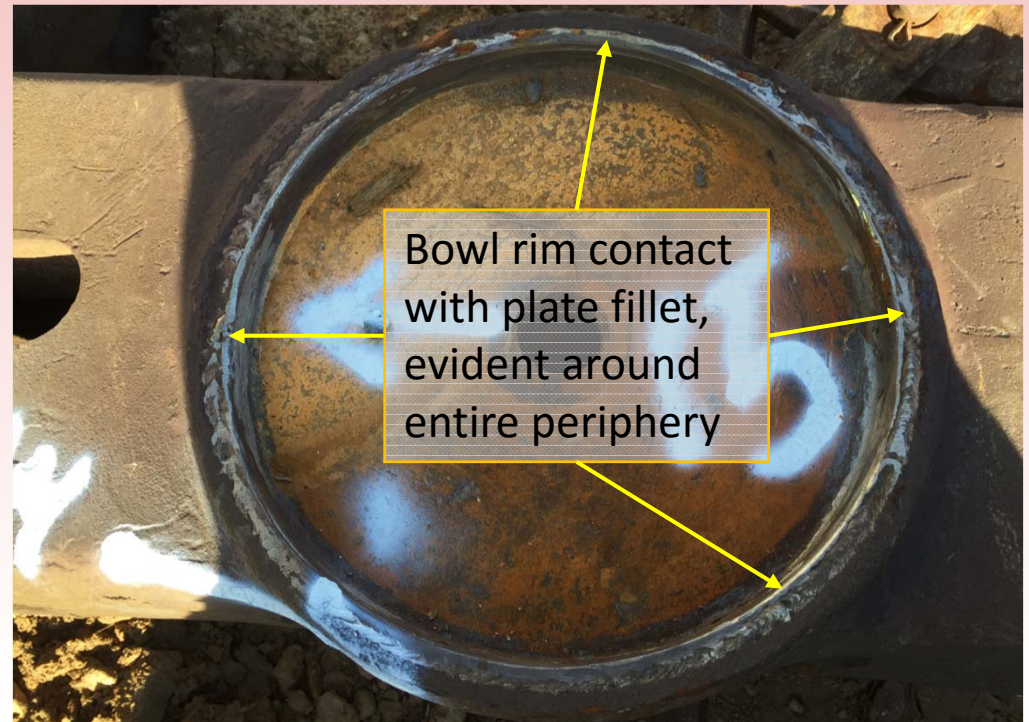
B-end centerbowl rim contact + tight side bearings = stiff-turning truck

- “Lead truck of 69th head car, loaded box SOU 565828, picked normal switch point account B-end centerbowl rim contact created lateral forces sufficient to deflect stock rails and gap switch point.”
- **FRA Cause Code: E4BC** Truck bolster stiff (failure to slew)

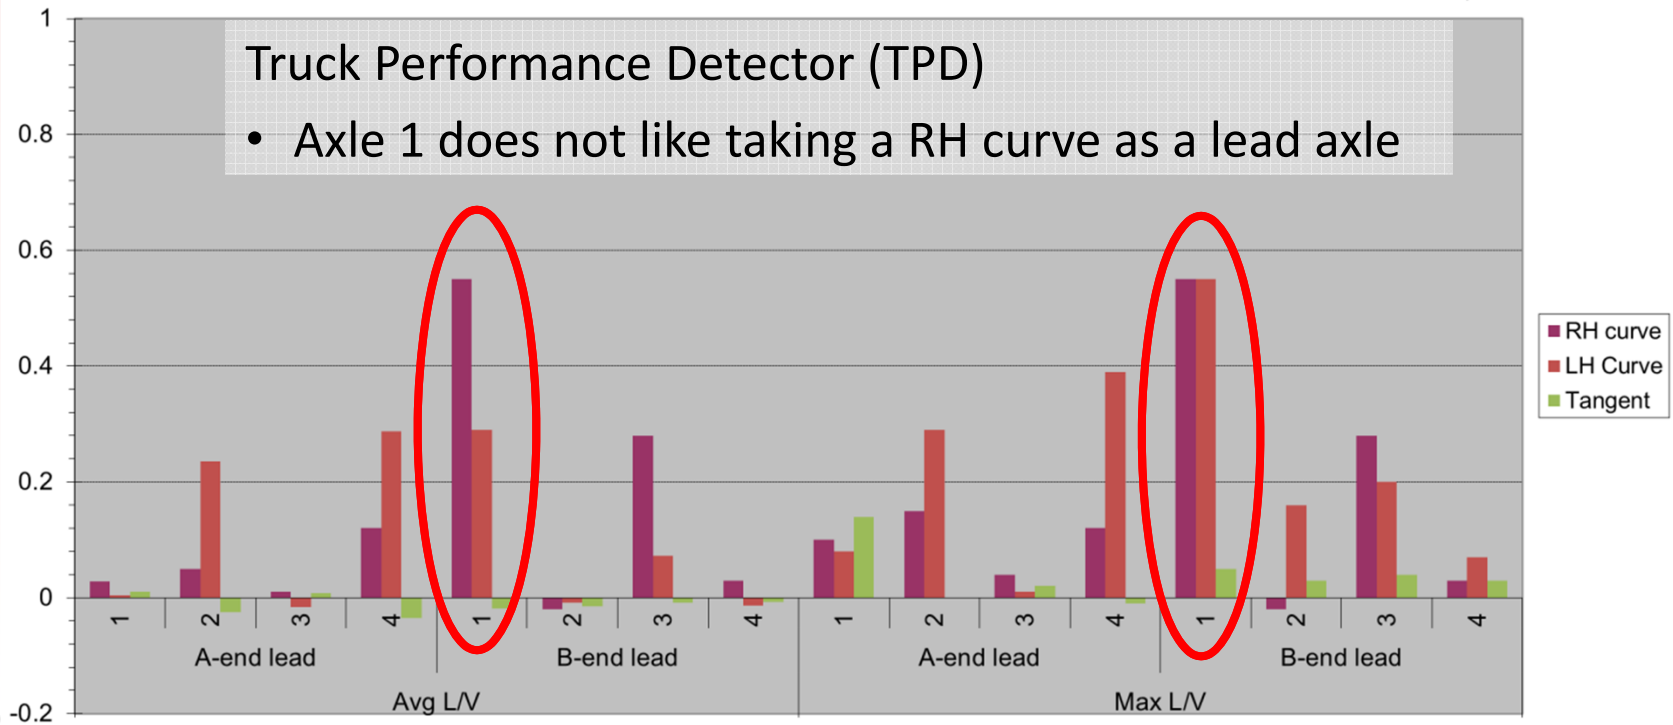
SOU 565282 TPD History - L/V
(Feb 2012 - Feb 2015)

Passes: A-end lead = 2; B-end lead = 2
