Case Study: Investigating a Rail Rollover Derailment

Brad Kerchof
Director Research & Tests
Norfolk Southern Railway

PRINCIPLES COURSE • MAY 1, 2018

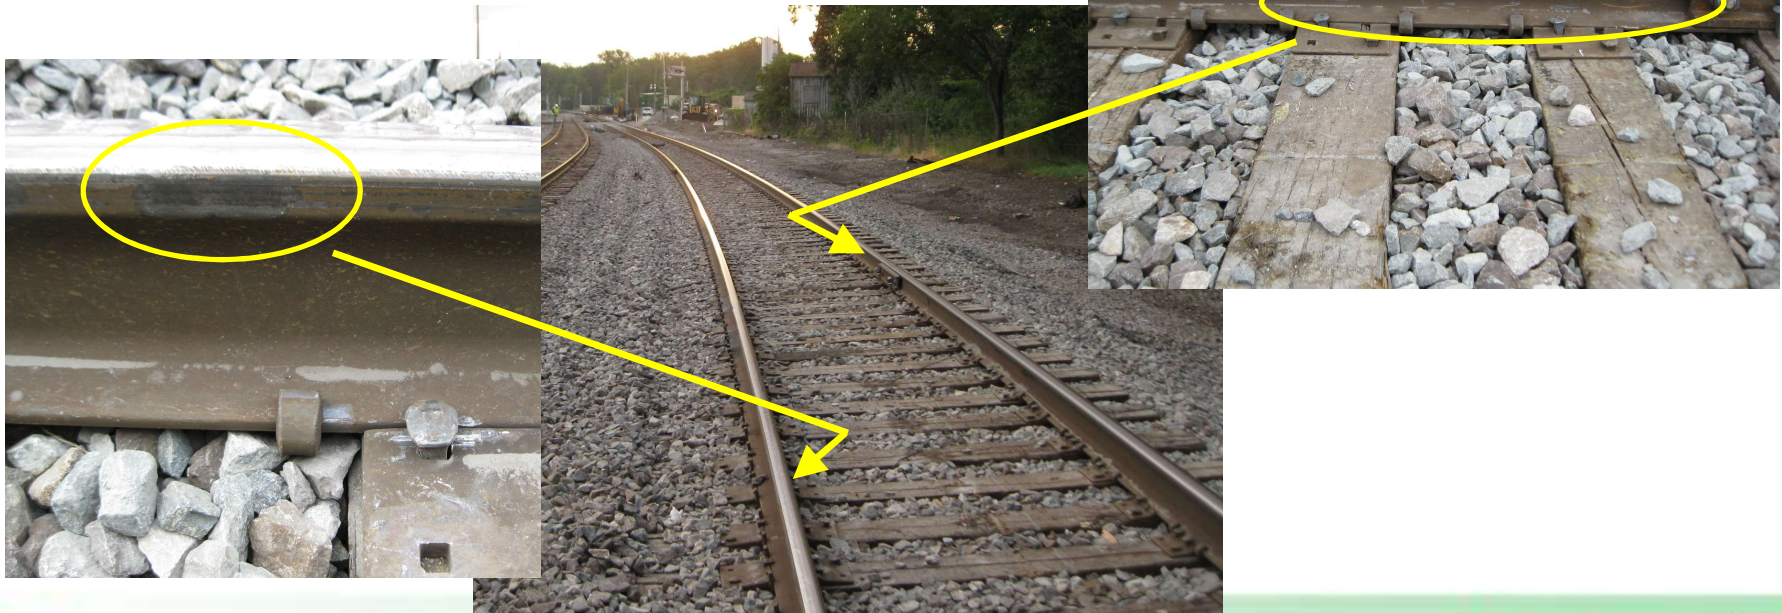
- The division committee identified an area where a low-side wheel dropped in and the high rail showed a flange mark on the web.

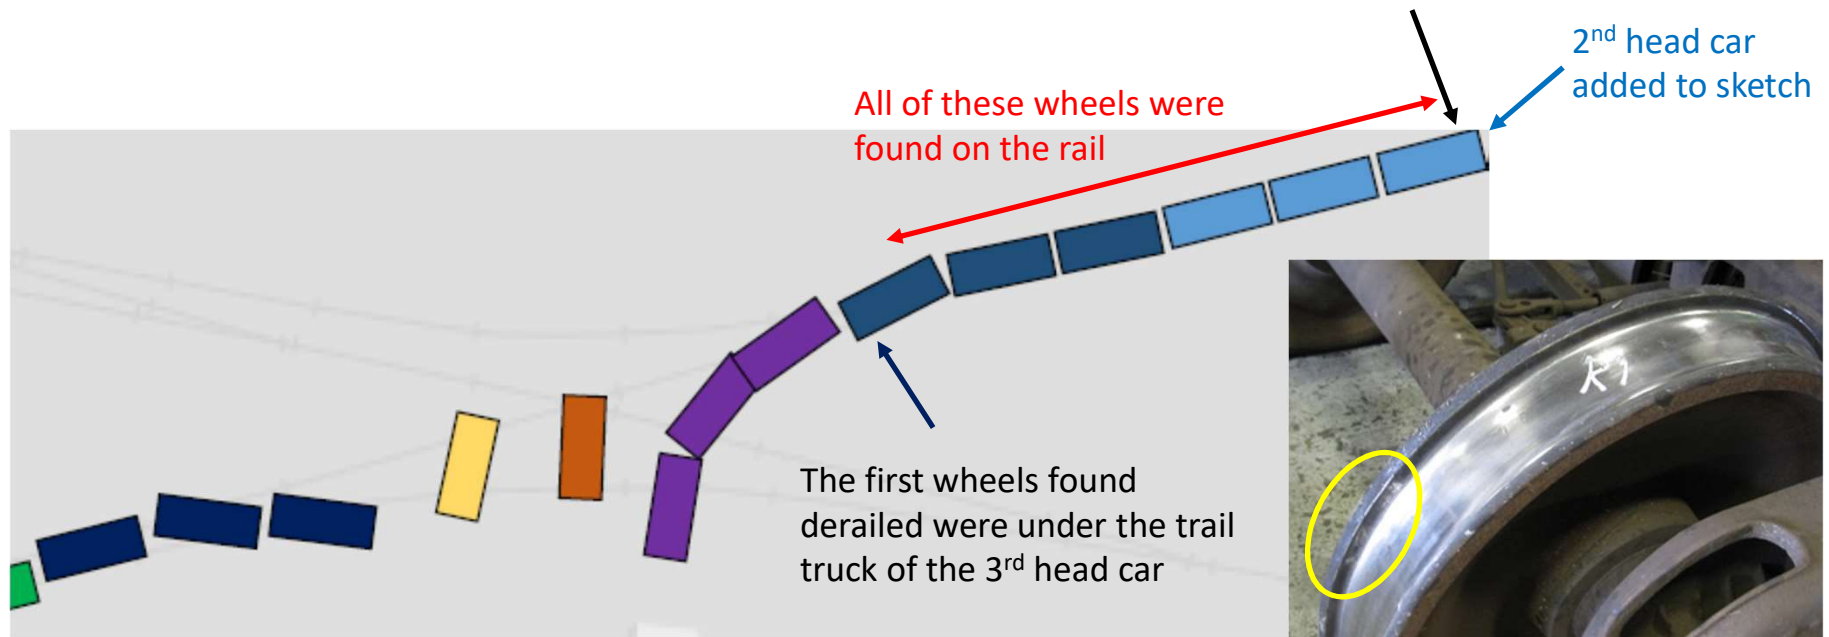
Mechanical identified the 2nd car / lead truck as the first to derail because of white marks on a wheel flange...and suggested that the car then rerailed itself!

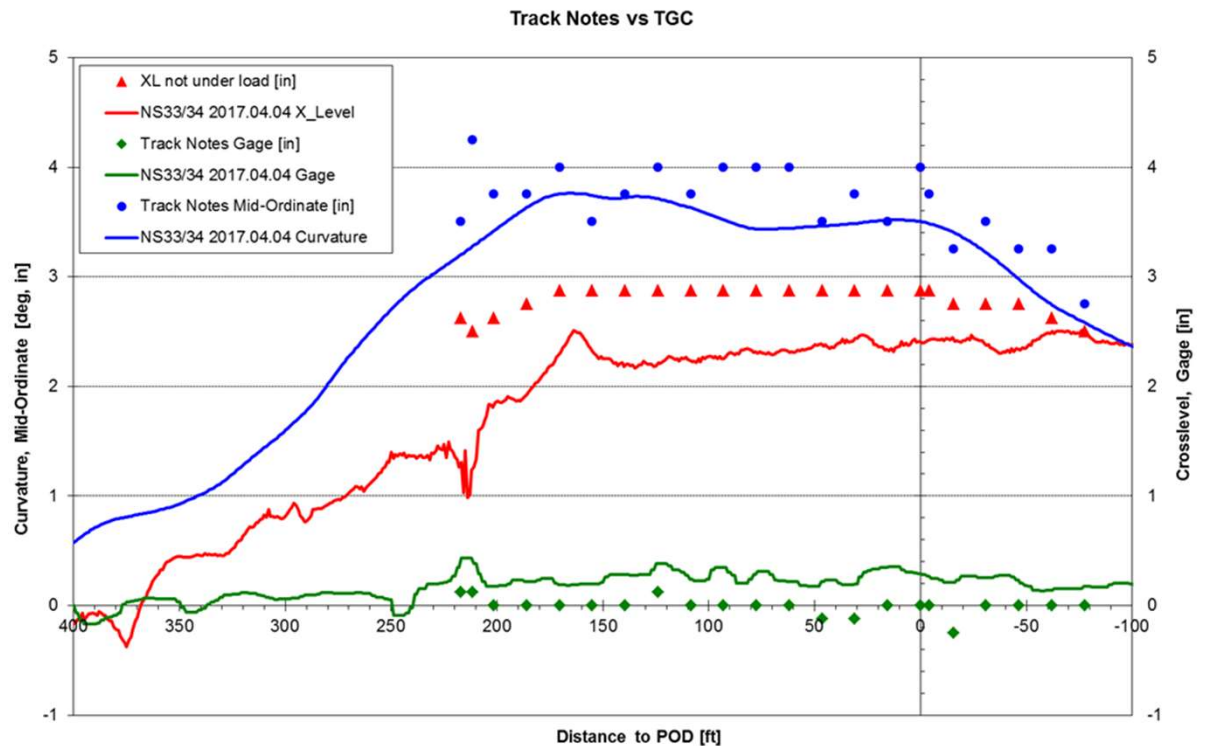
Gage, alignment and crosslevel from the derailment track notes are shown as points.

Same parameters from April 4, 2017 track geometry car test are shown as lines.

Conclusion: line, surface and gage all good!

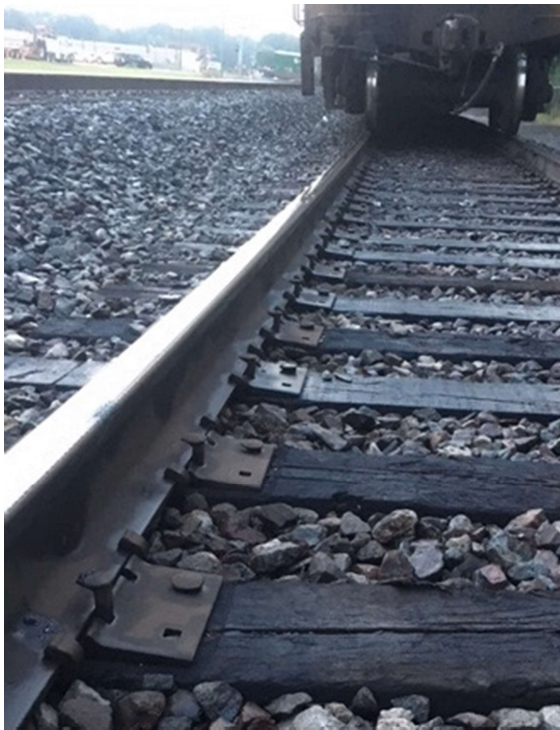
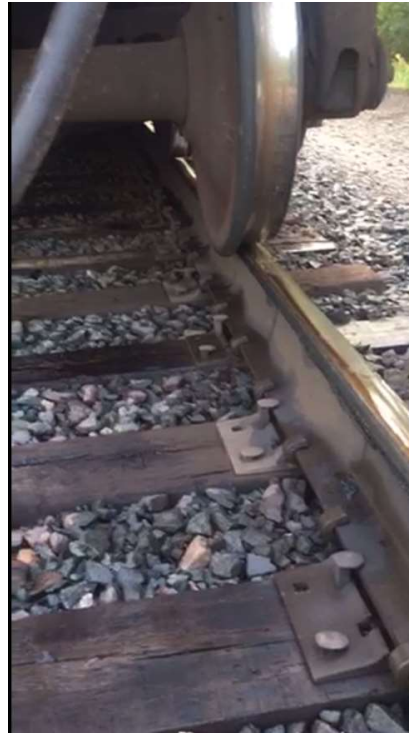
Wheelset is under trail truck of last derailed car.

Note raised spikes on both rails

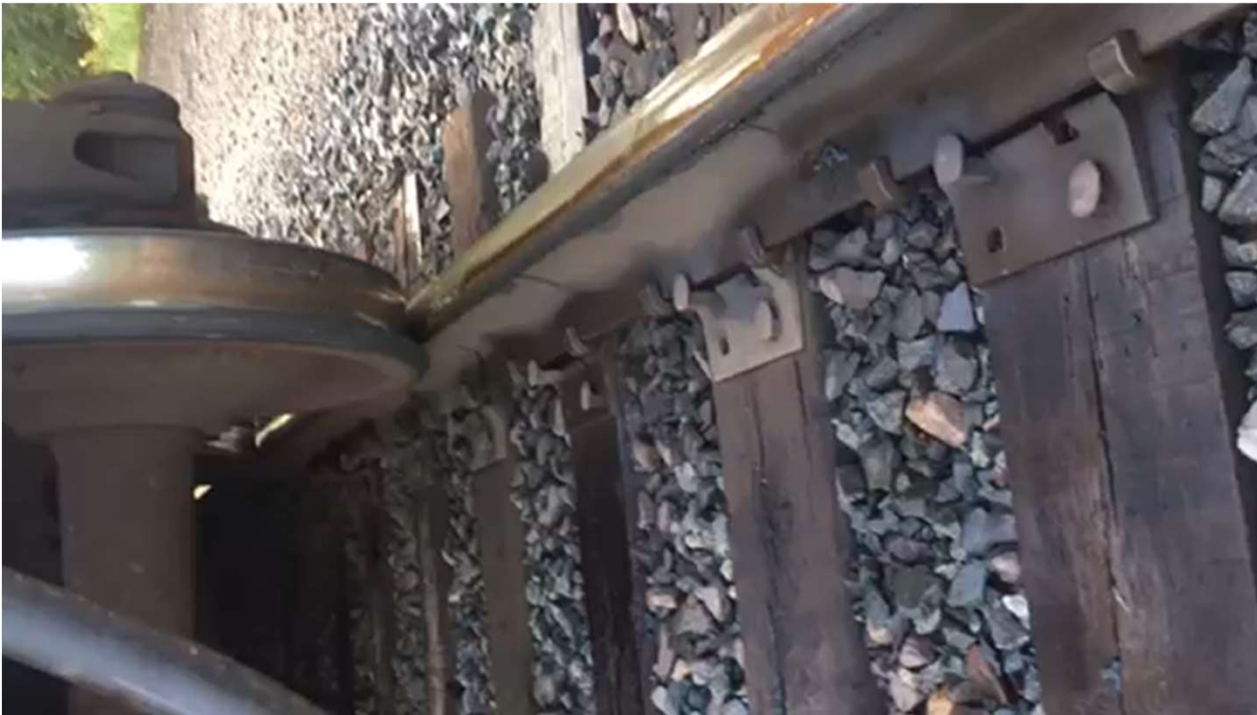
Video taken by Division Engineer

- High rail - spikes lifted for a short distance prior to POD.
- Low rail - spikes lifted for a longer distance prior to POD.

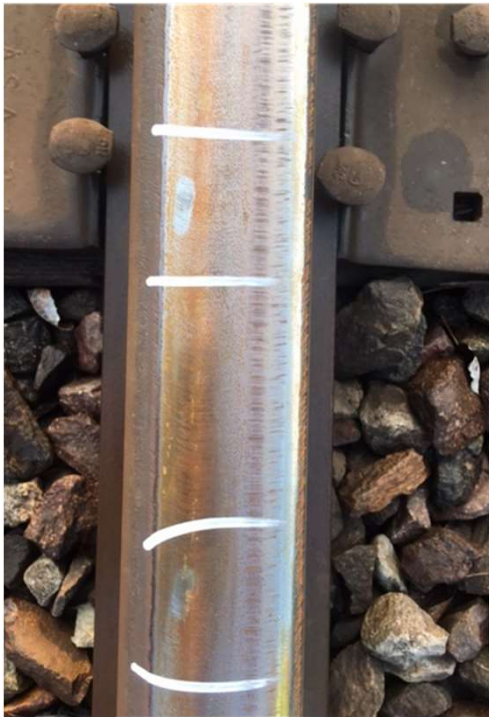
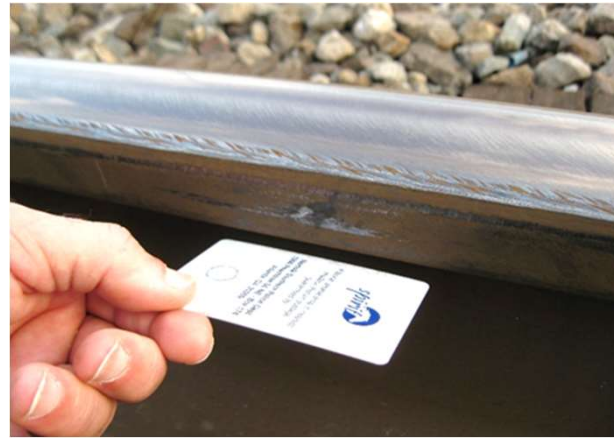
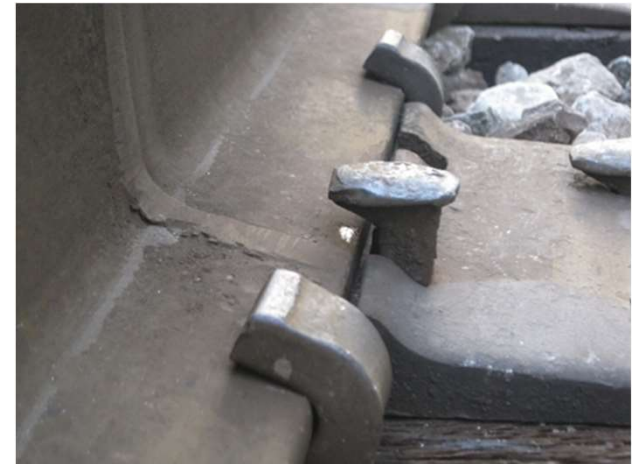
Three unusual conditions were noted on the low rail prior to the POD:

1. Left - scuff marks on field side of the head
2. Middle - wheel flange contact on the gage face
3. Right - evidence that rail had been canting out under load

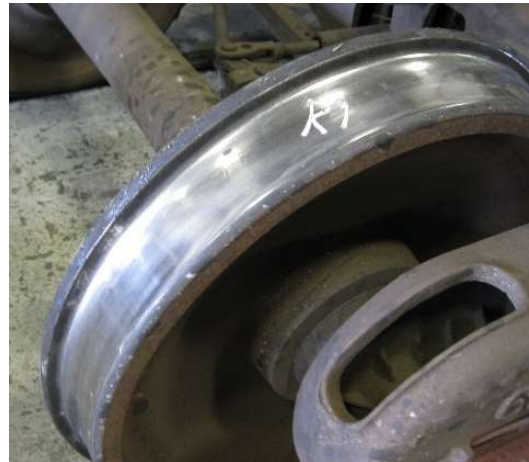
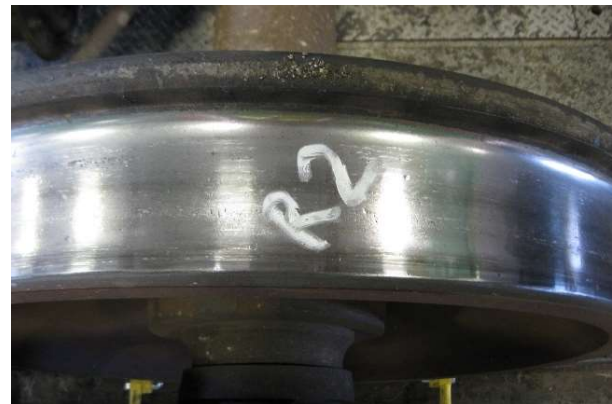
Suspect: 2nd head car, lead truck

R1 showed several white marks on the flange. During a car shop inspection, however, no evidence was found on the tread or flange tip that indicated that the wheel had been on the ground.

None of the other wheel treads or flanges showed evidence of derailment damage.

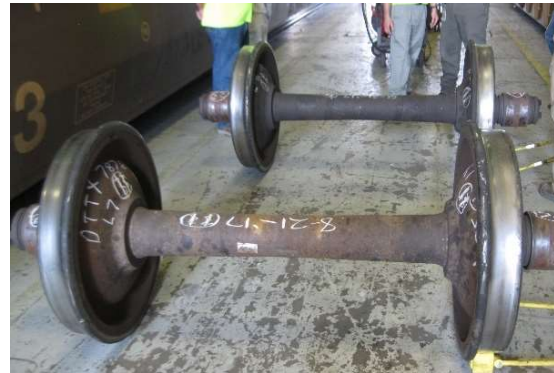
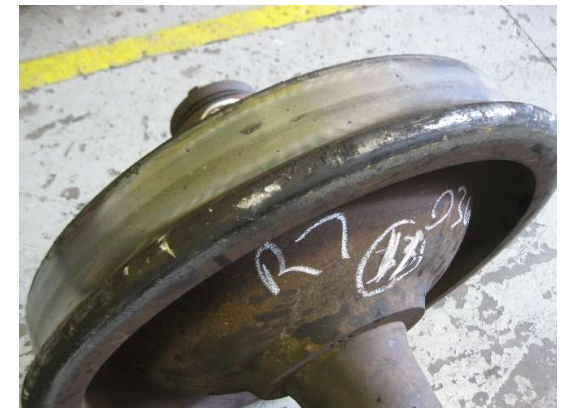
The first derailed wheels were under the trail truck of the 3rd car.

These wheels show some flange contact with the ground, but not enough to have been the first to derail (they would have run over 2 turnouts and a diamond).

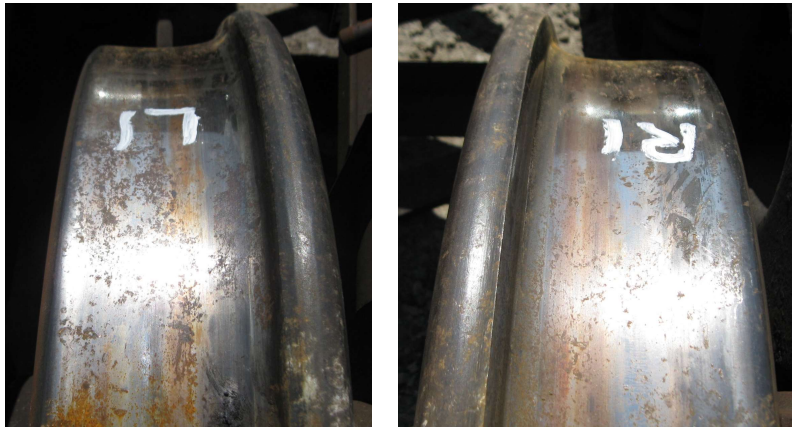
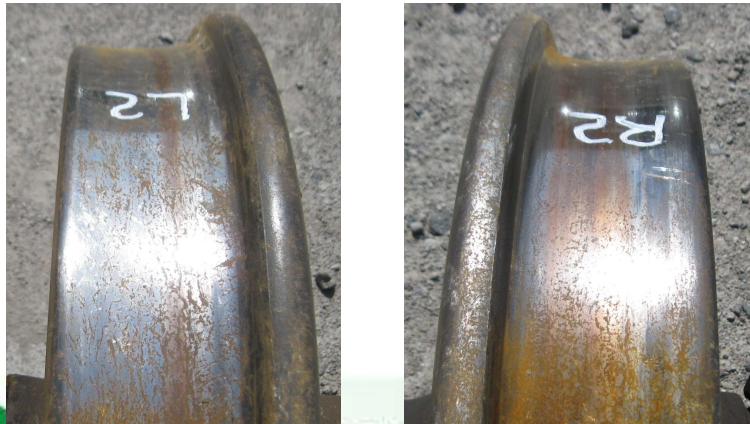
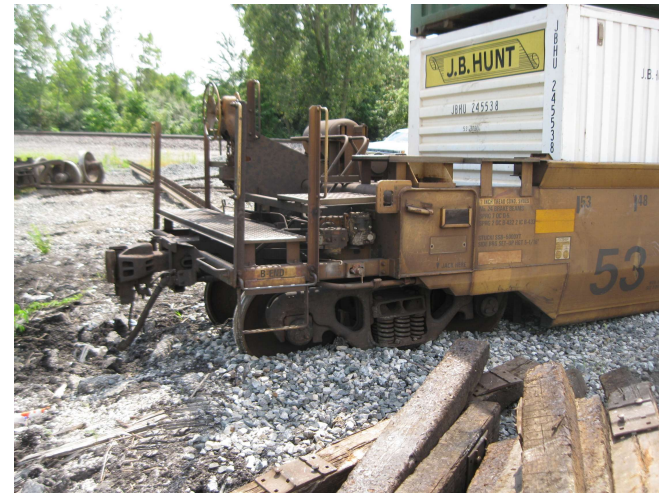
L1 and R1 show minimal damage

L2 and R2 also show minimal damage

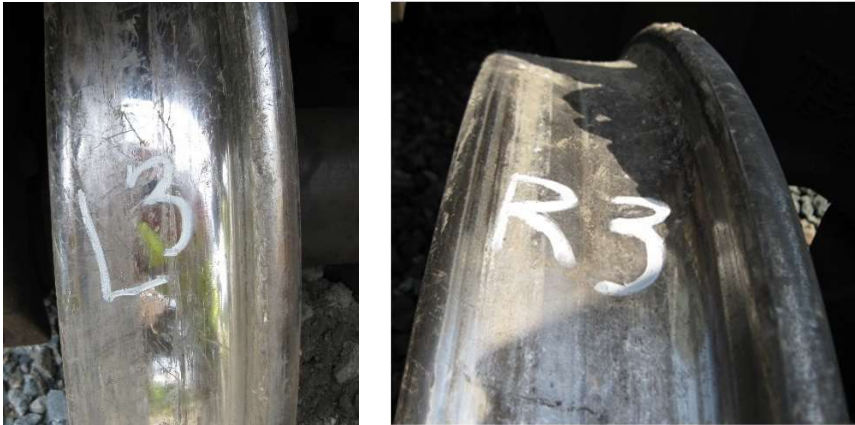
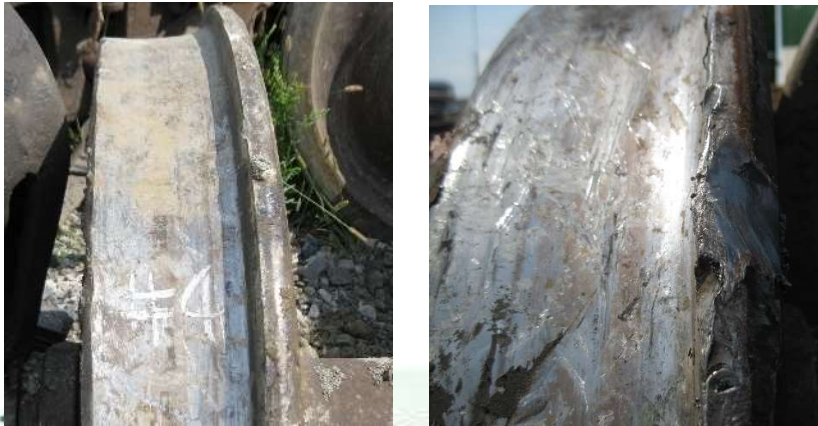
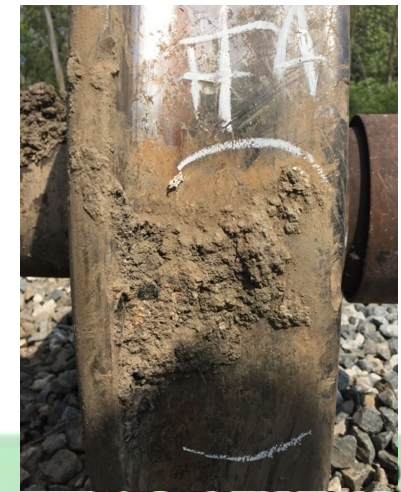
L3 and R3.

Bottom (left to right): L4, close-up of L4 flange, R4, and close-up of R4 tread (note asphalt deposit from Hartzell Rd crossing).

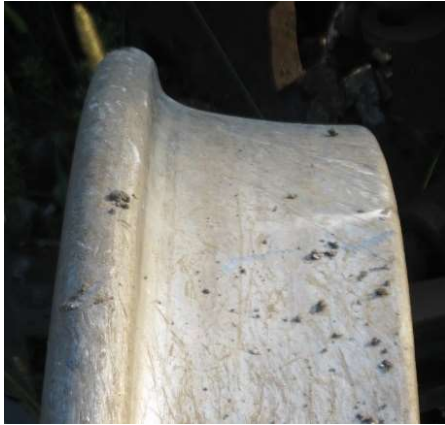
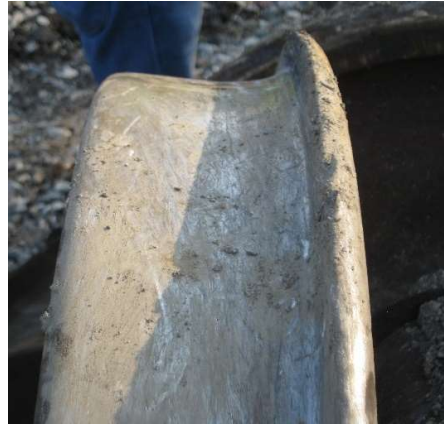
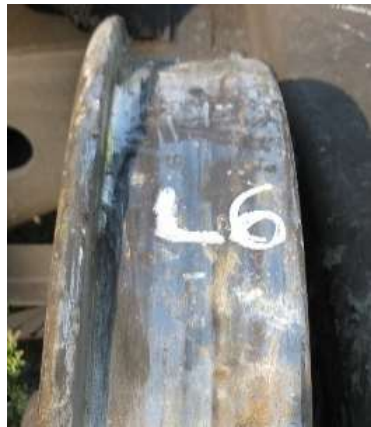
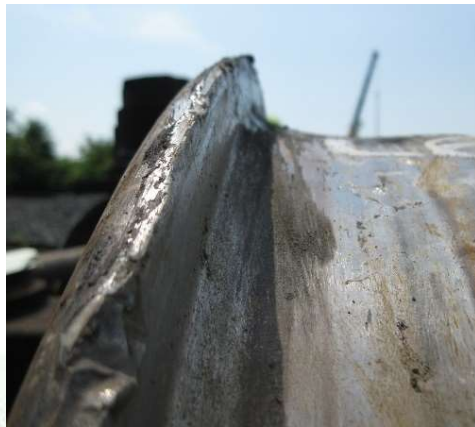
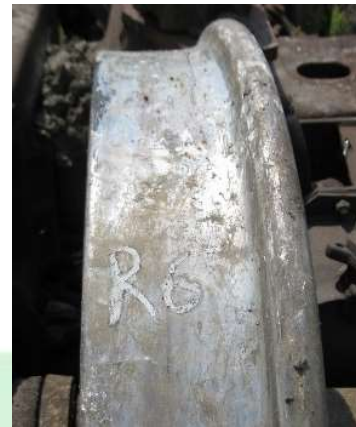
L5 & R5.

Note asymmetric wear – each axle has a wheel with a worn flange and hollow tread, and a wheel with a full flange and normal tread.

L6, close-up of L6 flange & R6.

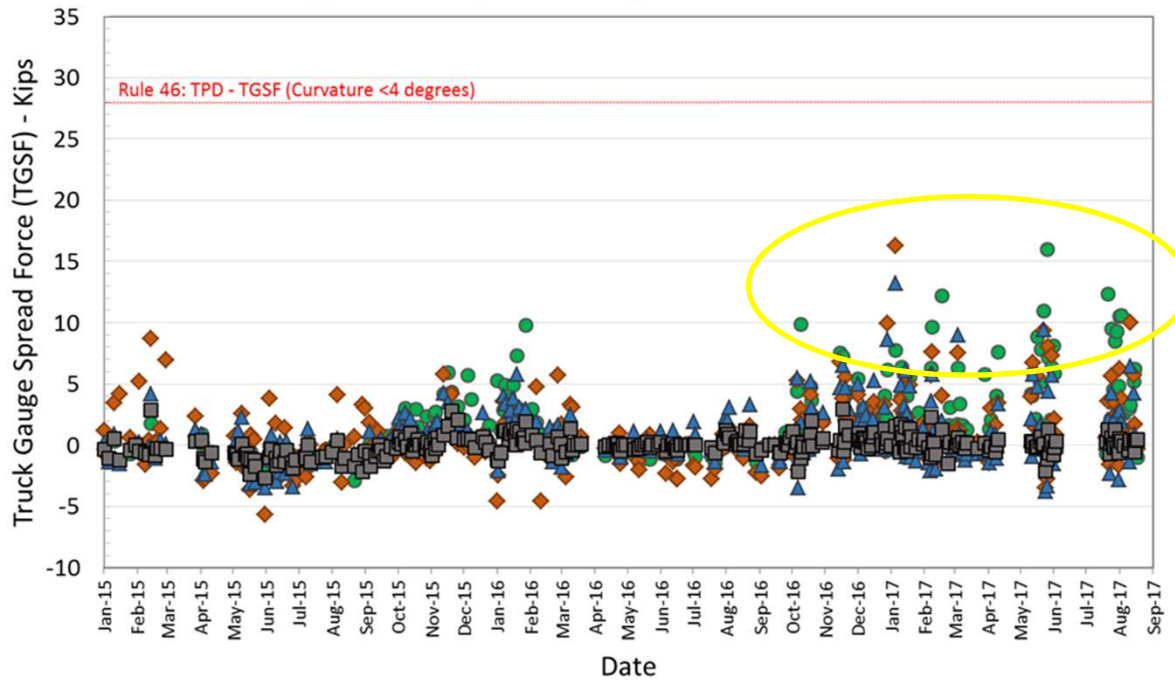
WILD data for DTTX 727311

Gage-spreading force = sum of lateral wheel forces.

B and C trucks, and to some extent D truck, became elevated on a sustained basis in late 2016.

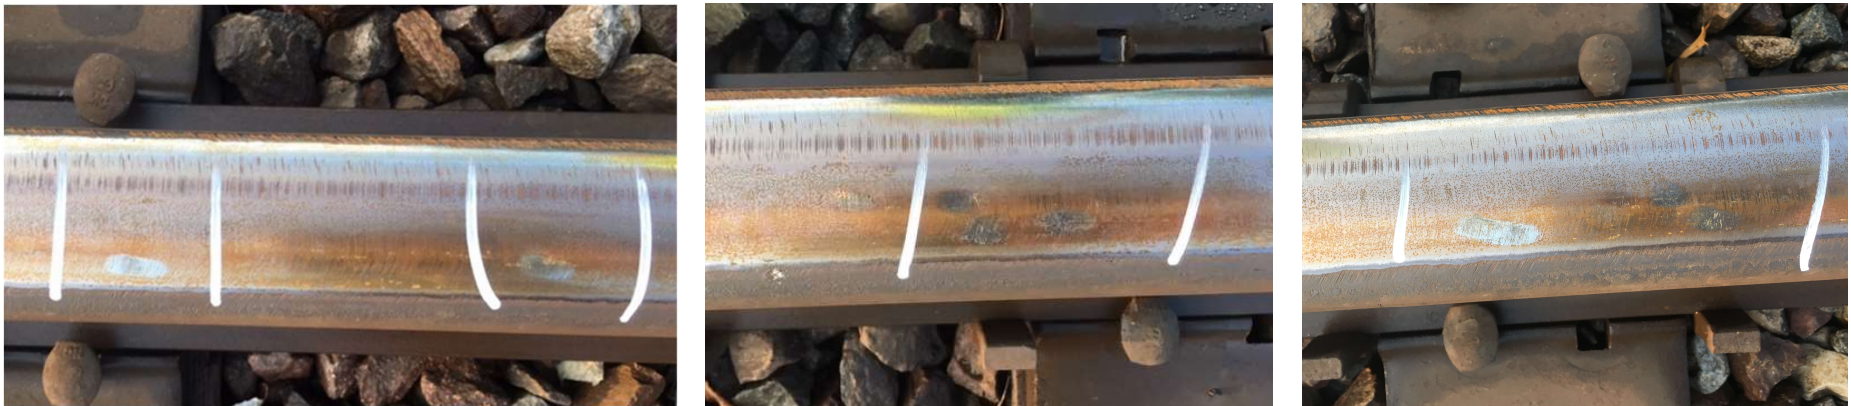
The field side of the low rail showed a series of scuff marks from beginning of curve to the POD

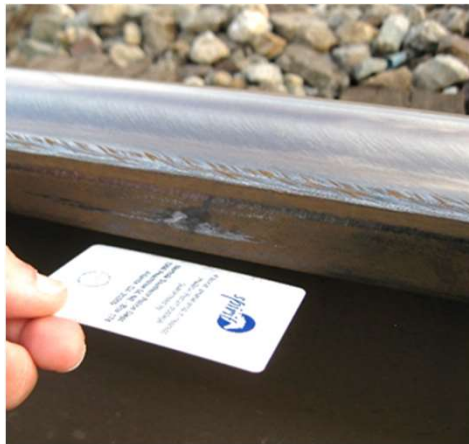
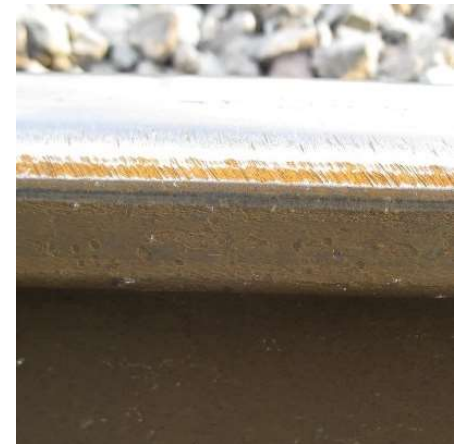
The low rail gage face showed evidence of wheel flange contact from the beginning of the curve to the POD.

Entrance to curve, 350 ft. before POD

In order for wheel flanges to contact this low rail gage face, the rail must be canted out!

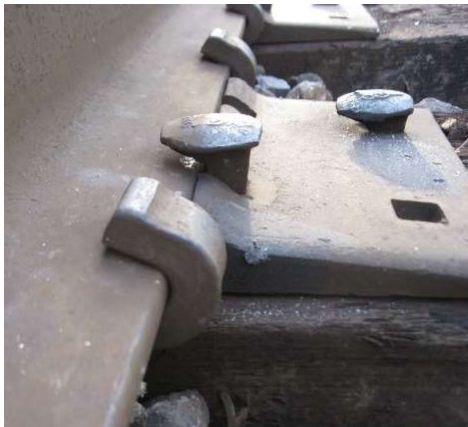
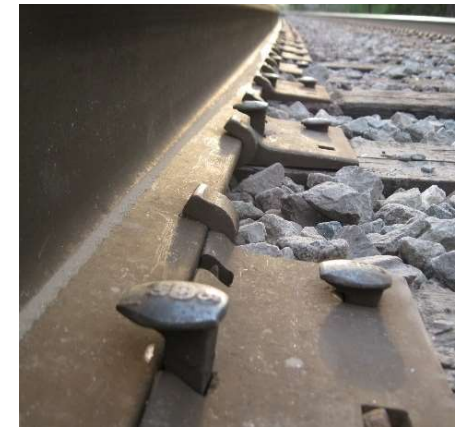
The low rail showed evidence of dynamic cant from beginning of the curve to the POD.

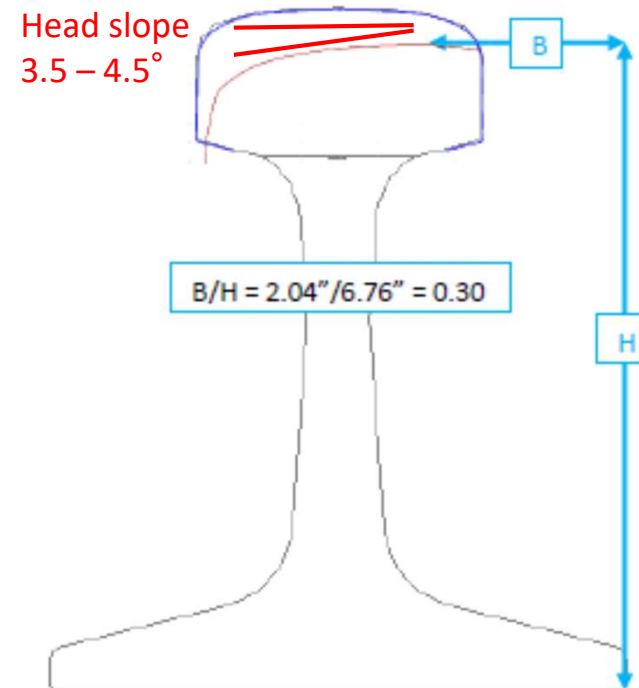
High rail profile from near POD

- $B/H < 0.35$
- Head slope $> 5^\circ$

Actual wheel contact location is influenced by B/H, head slope, rail cant and wheel profile.

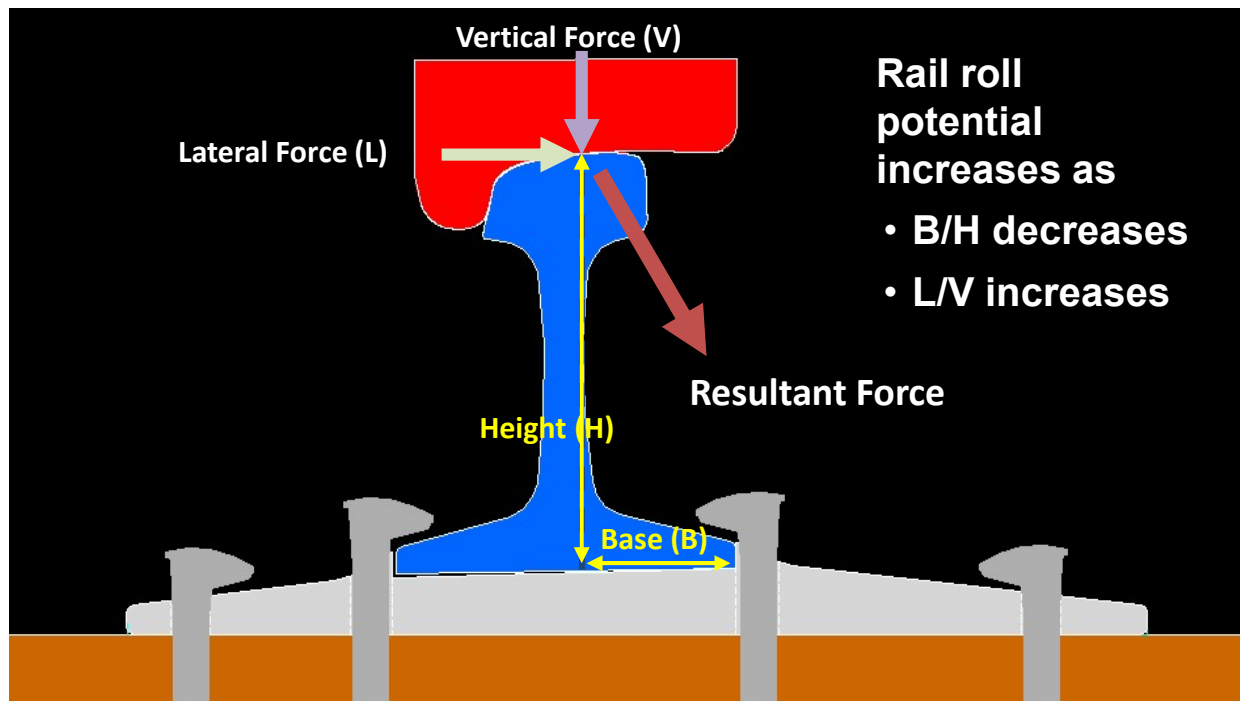
When the resultant force is directed beyond the base, the rail will tend to roll, absent the hold-down strength of gage spikes and torsional resistance of the rail.

A lower B/H moves the resultant force closer to the field edge.

A B/H ratio 0.30 means that the truckside L/V ratio need only exceed 0.30 to initiate rail roll!

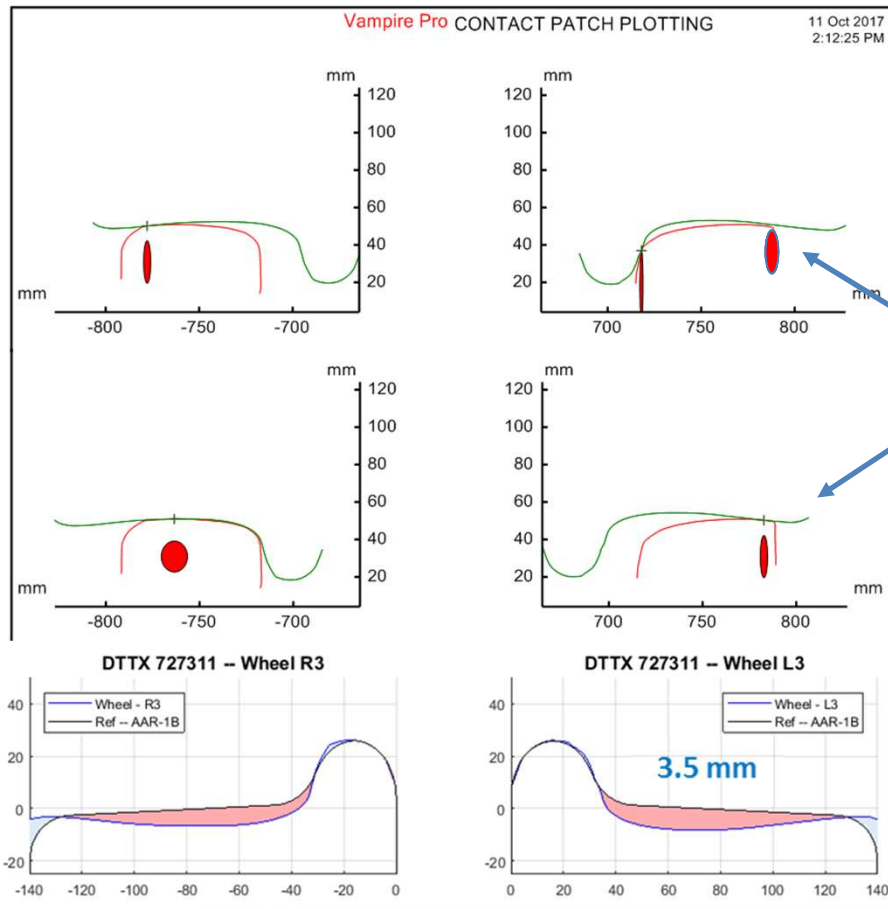
VAMPIRE wheel/rail contact plots – C truck, R3 – L3 wheels

In all tracking positions – from high rail flanging to low rail flanging, the L3 always contacts the field edge of the high. (Field side contact is typical of tread-hollow wheels.)

- ▶ high gage-spreading forces
- ▶ low B/H rail stability

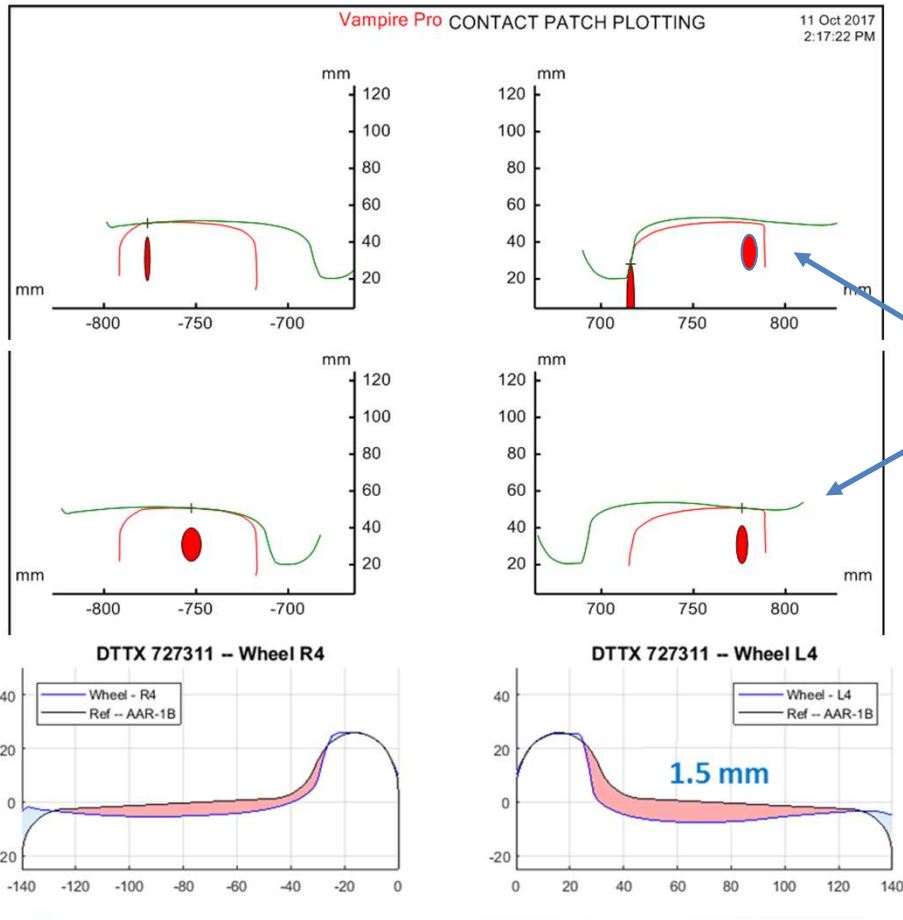
VAMPIRE wheel/rail contact plots – C truck, R4 – L4 wheels

Like the L3, the L4 wheel always contacts the high rail on the field edge, no matter what the tracking position.

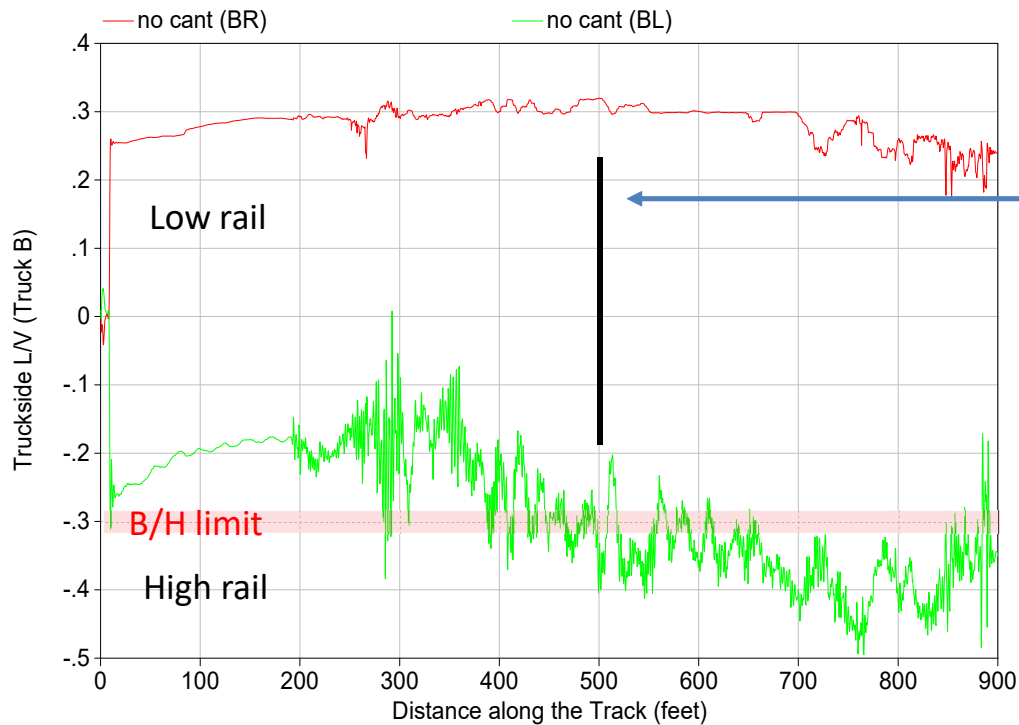
VAMPIRE truckside L/V ratios for B truck

High rail L/V reaches 0.40 in the vicinity of the POD. But the rail hasn't rolled over yet!

How do we know?
Minimal damage to the B truck wheels

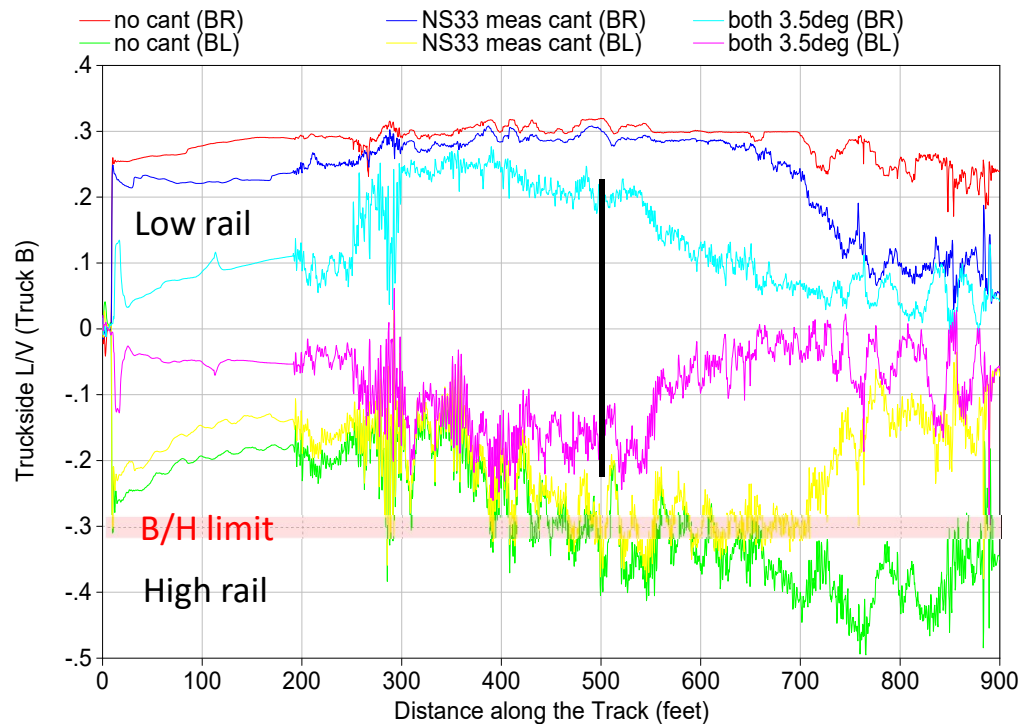
VAMPIRE truckside L/V ratios for B truck

As cant increases, truckside L/V decreases.

There would likely be no derailment if B truck were the only consideration.

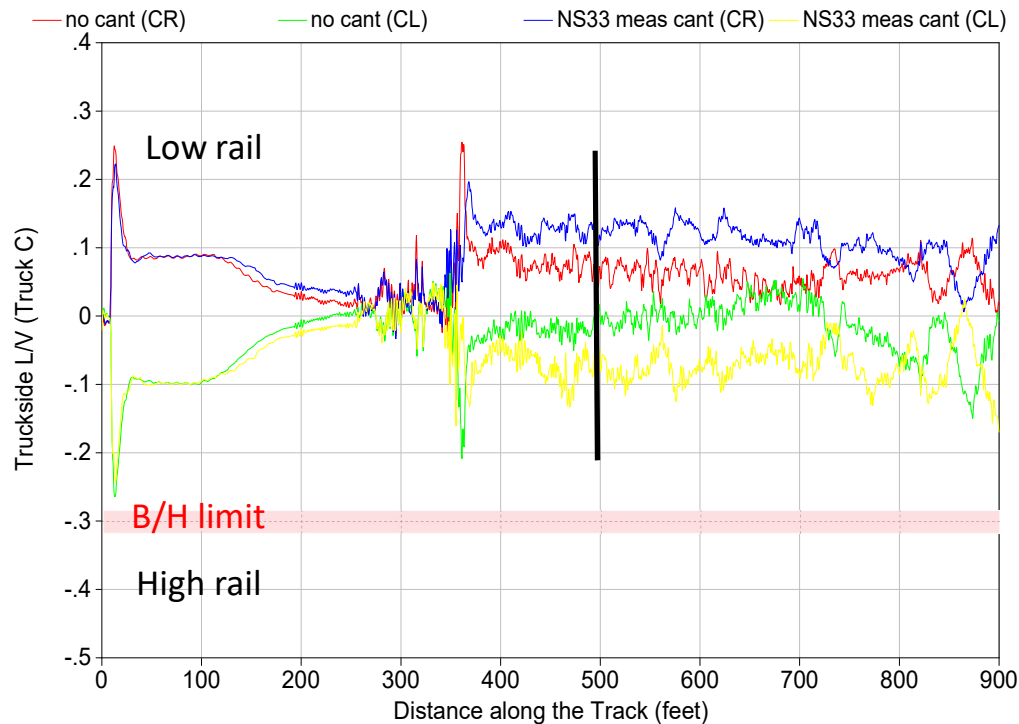
VAMPIRE truckside L/V ratios for C truck

As cant increases, truckside L/V also increases.

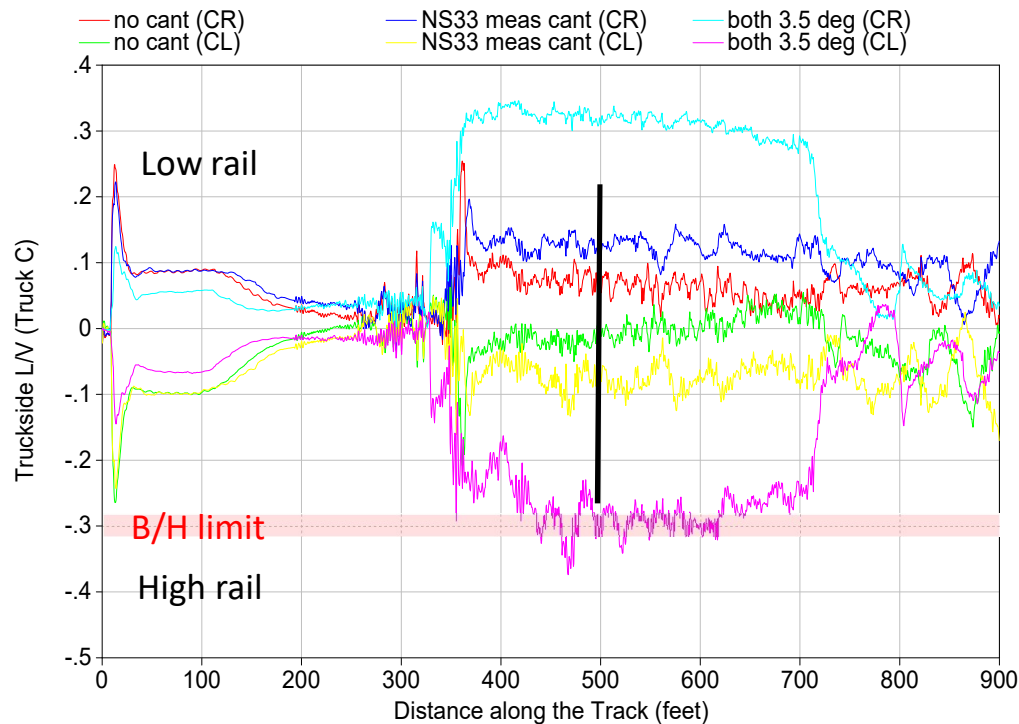
VAMPIRE truckside L/V ratios for C truck

As cant increases, truckside L/V also increases, reaching an high rail L/V close to 0.35. This is self-driving behavior - as cant increases, B/H diminishes.

Conclusion: B truck initiated significant high rail cant, and C truck rolled the high rail over.

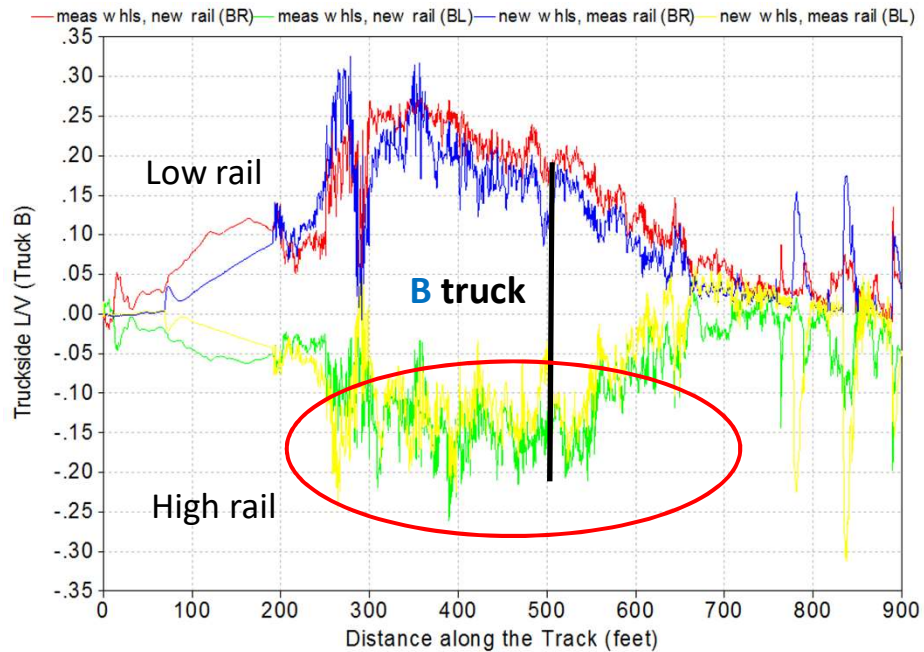
L/V's for worn wheels on new rail (red/green) are approx. equal to new wheels on worn rail (blue/yellow).

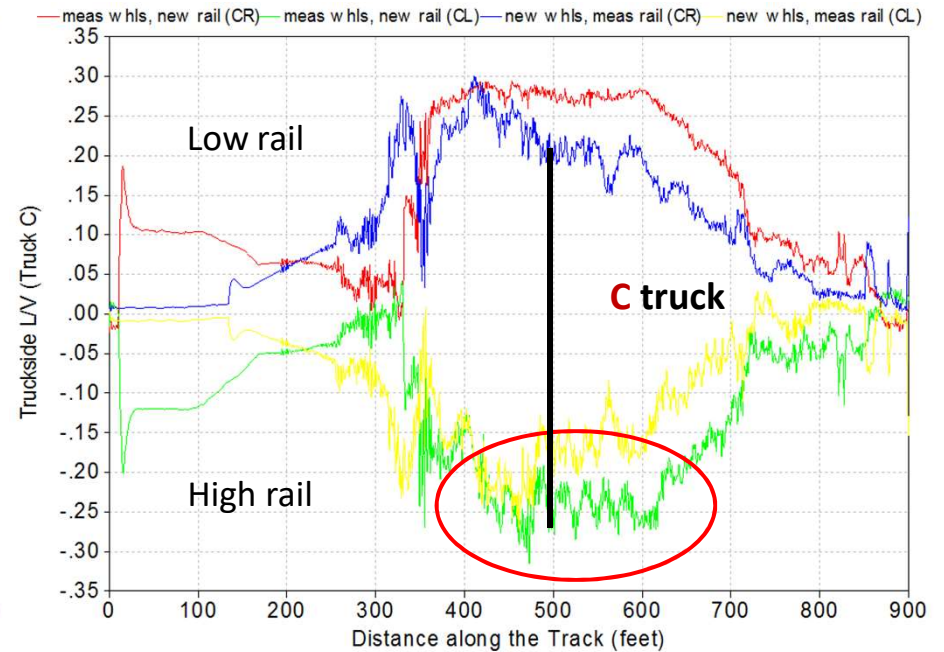
L/V's for worn wheels on new rail (red/green) are greater than for new wheels on worn rail (blue/yellow).

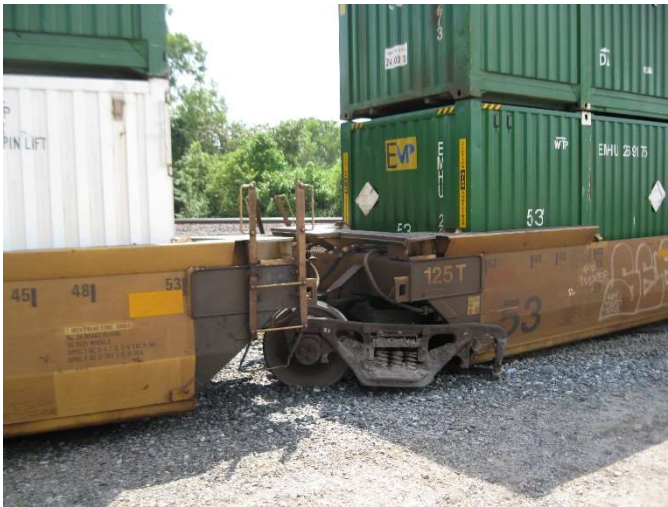
Elevated truckside L/V's under an articulated intermediate truck are particularly dangerous because there is no adjacent truck applying a vertical load to hold down the rail.
