# Derailment Prevention – From Causes to Cures

*Brad Kerchof*  
*Director Research & Tests*

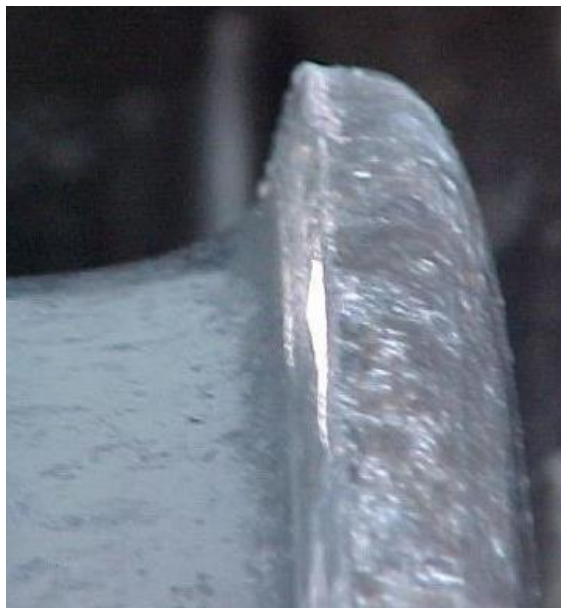
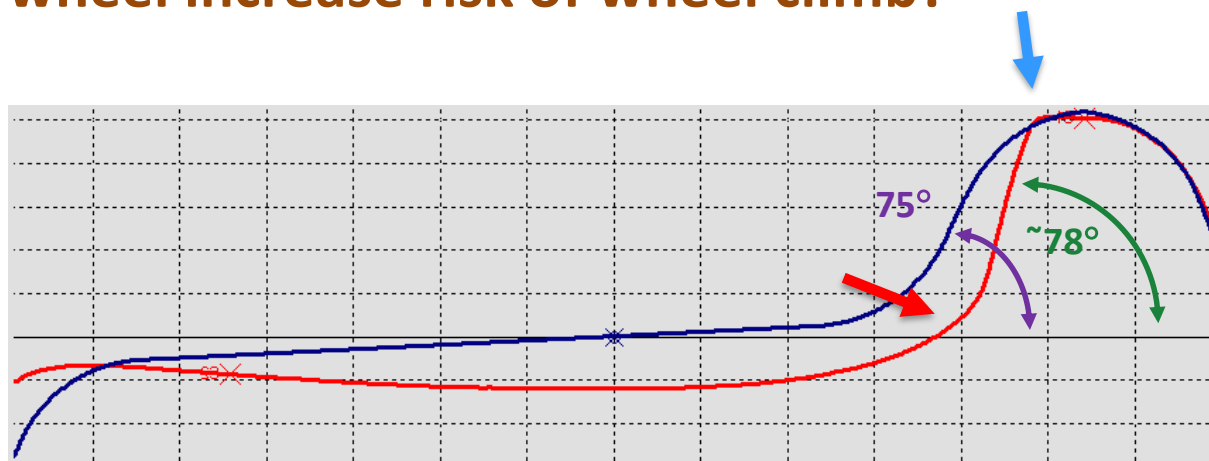
A worn flange root allows the flange tip to get much closer to the point

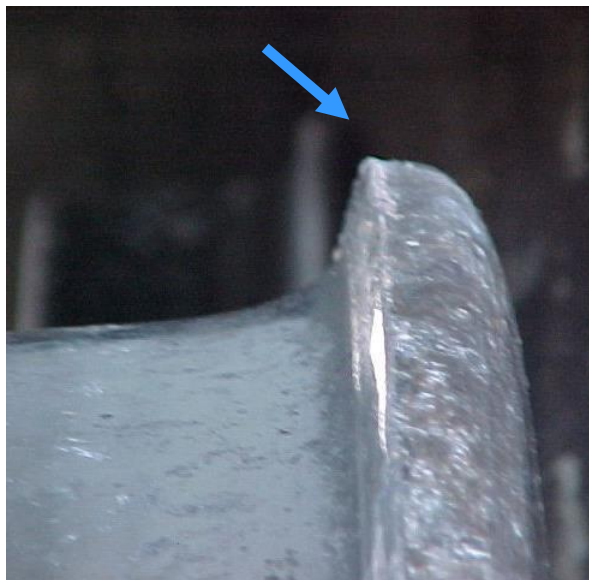
Worn profile and a sharp edge on the flange tip

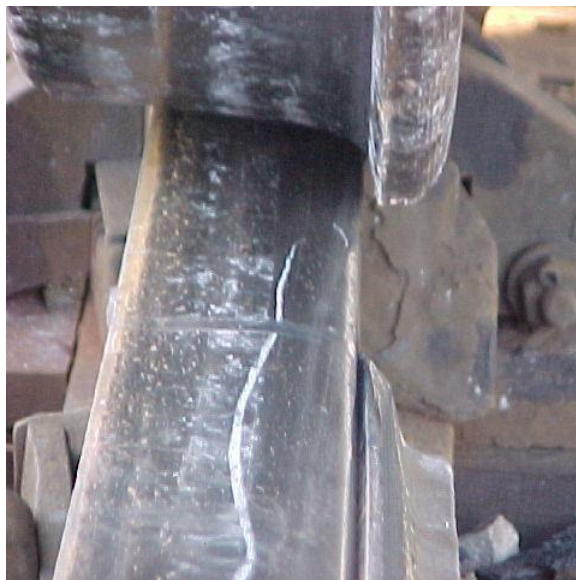
The worn flange is tracking close to the stock rail, approaching a gapped point

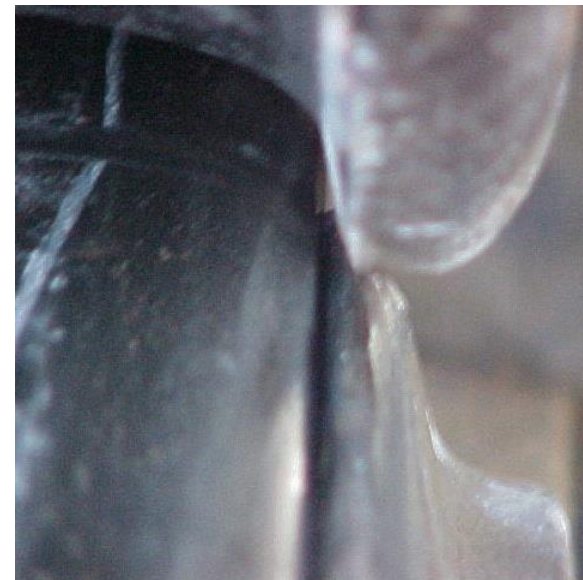
The flange climbs the switch point

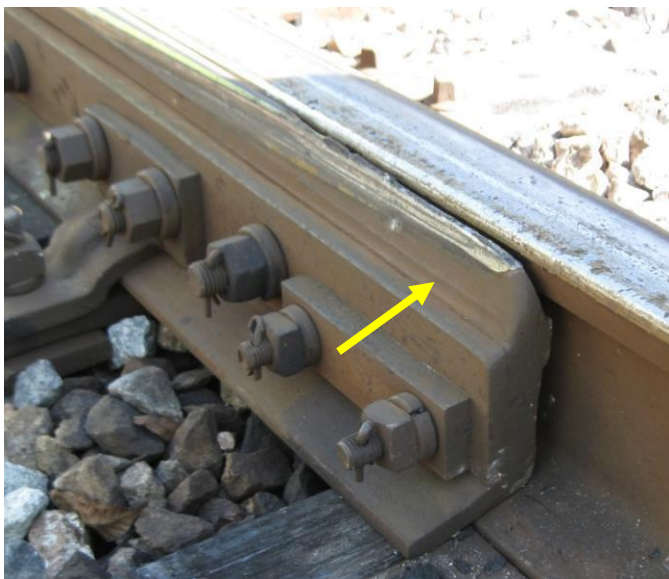
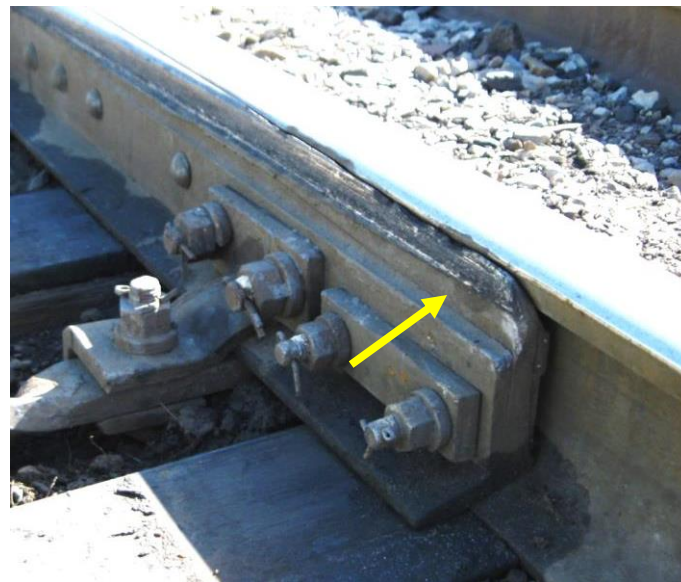
Wheel flange contact at the front of the point

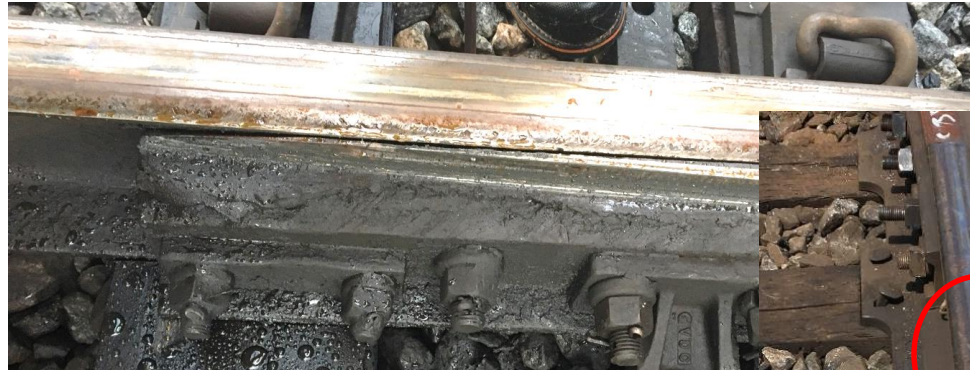
Main track, no. 10 spring switch to a siding, LH diverging point

No indication of wheel climb on the point

However, there was a cross-over wheel mark on the RH point back at the heel block

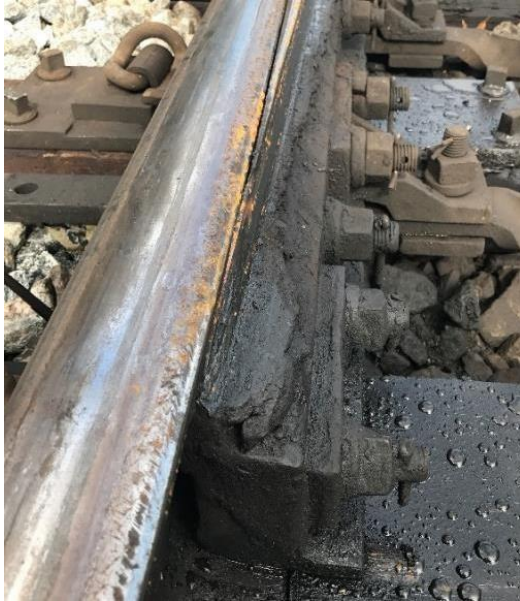
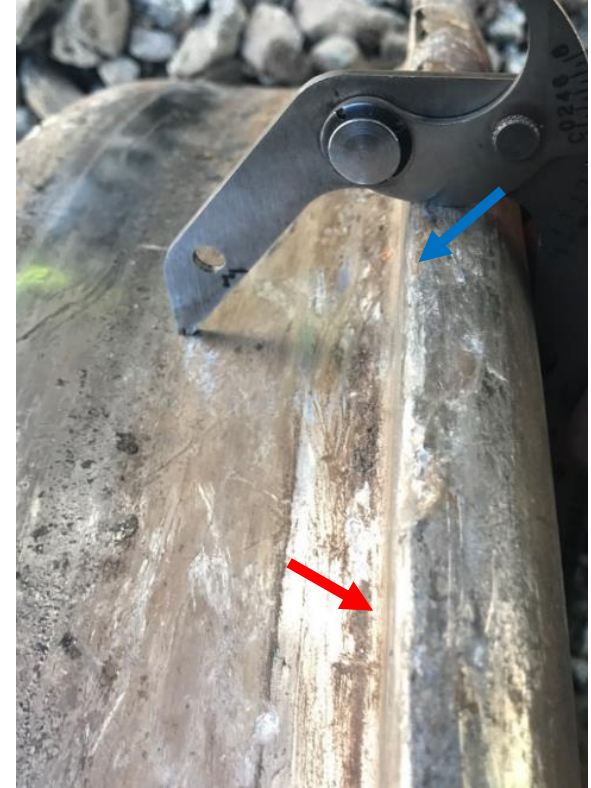
- ✓ Slightly worn point
- ✓ Evidence of flange contact at the tip (tracking position)
- ✓ Worn (but not condemnable) wheel flange

Maintain your switch points with worn wheel flanges in mind!

- Worn flanges are more likely to pick a poor-fitting point
- Worn flanges are common
- Most wheels that climb points are not condemnable
- Good-fitting points should be able to accommodate worn flanges

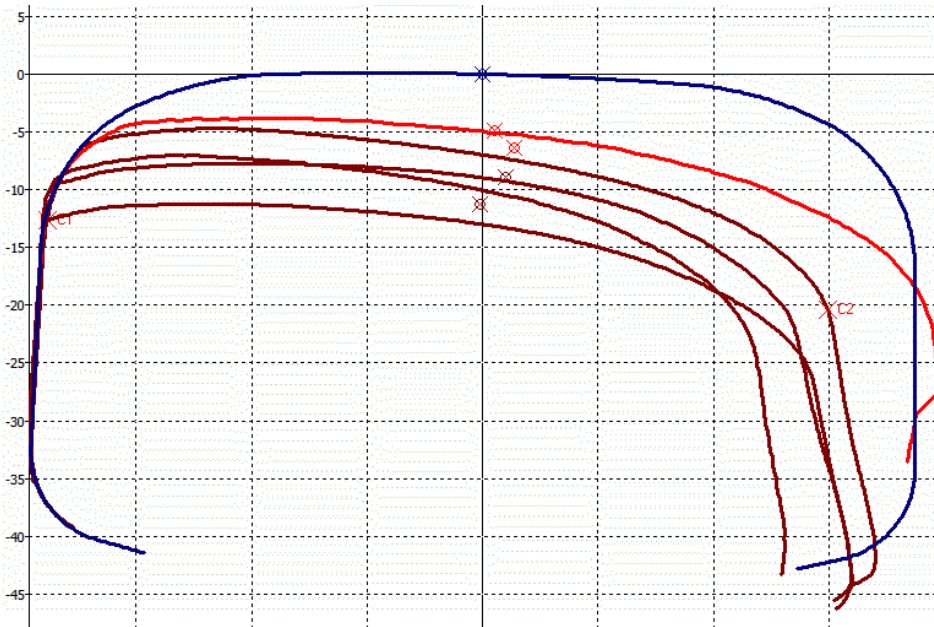
Profiles from 5 rail roll-over derailments

- Significant side wear
- Significant head slope
- Likely some field-side wheel contact

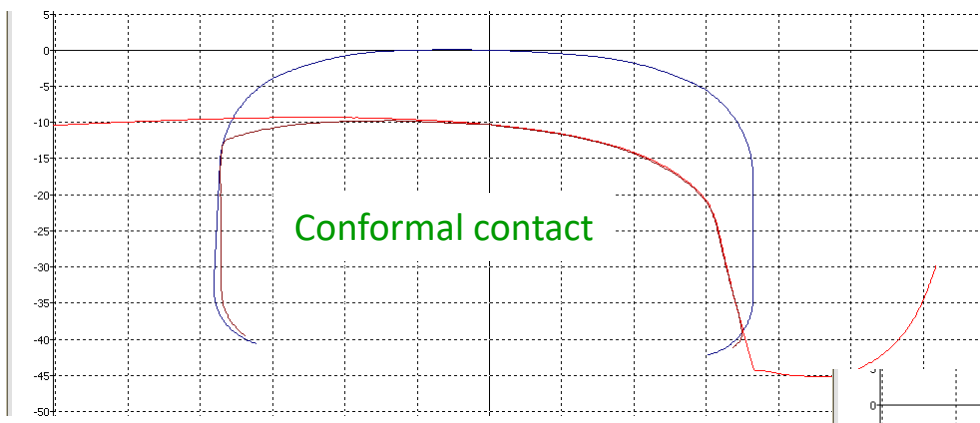
Brown trace - 3° canted rail  
Red trace – worn wheel

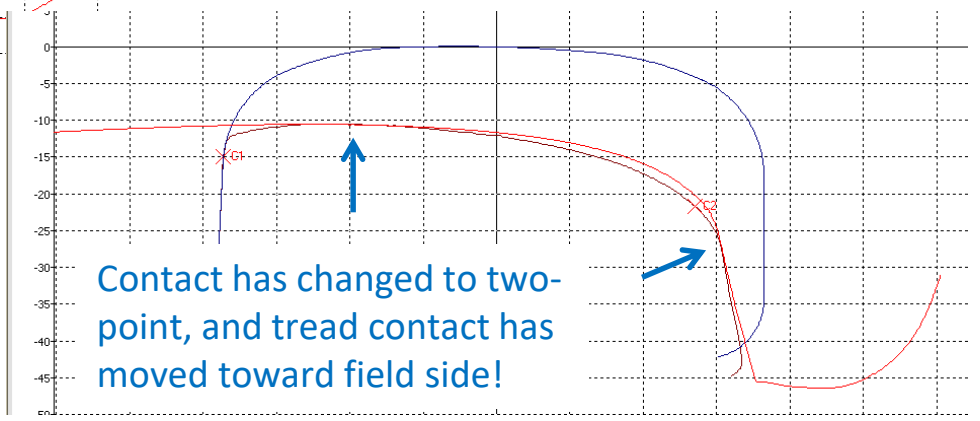
Brown trace - 0° canted rail  
Red trace - worn wheel

Contact has changed to two-point, and tread contact has moved toward field side!

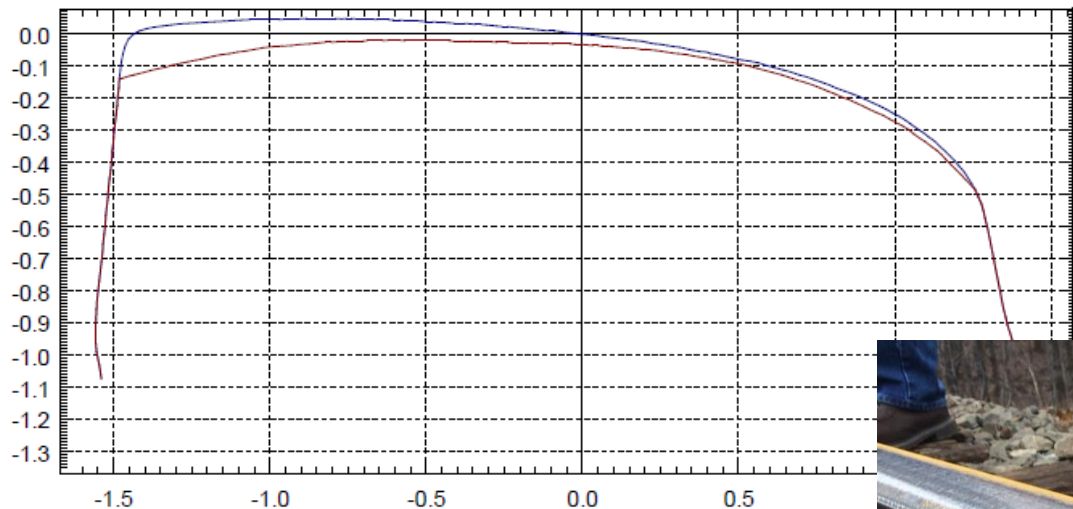
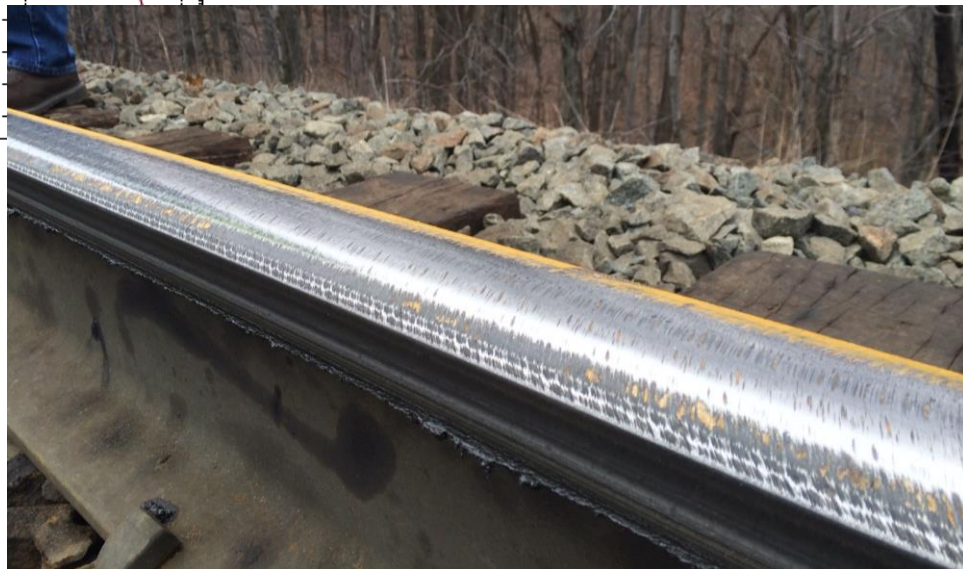
Graph: High rail before and after grinding; 1/8" was removed from the field corner.

Photo: Same rail after grinding (3° cant). Wheel contact has been moved to a much more desirable location.

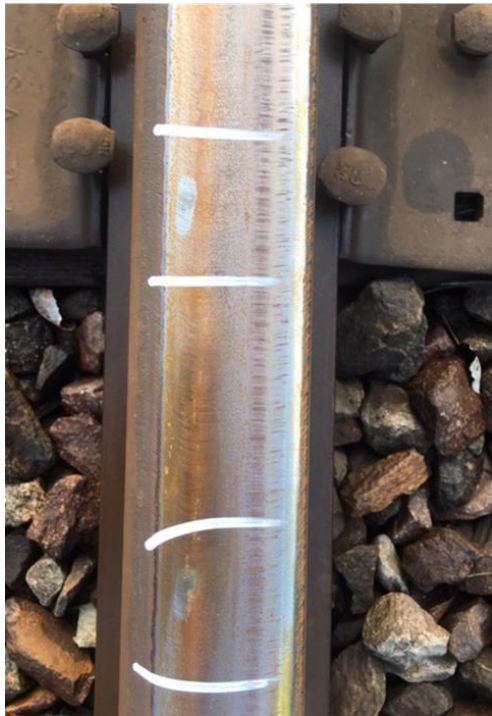
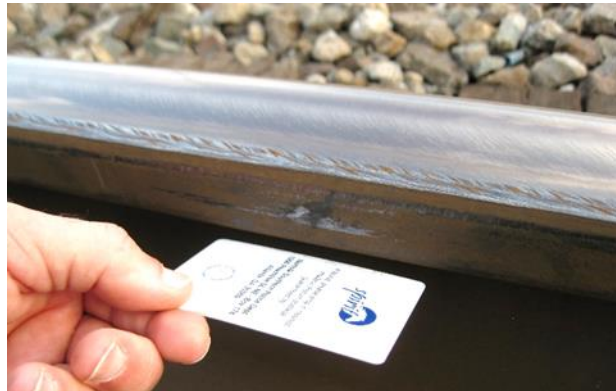
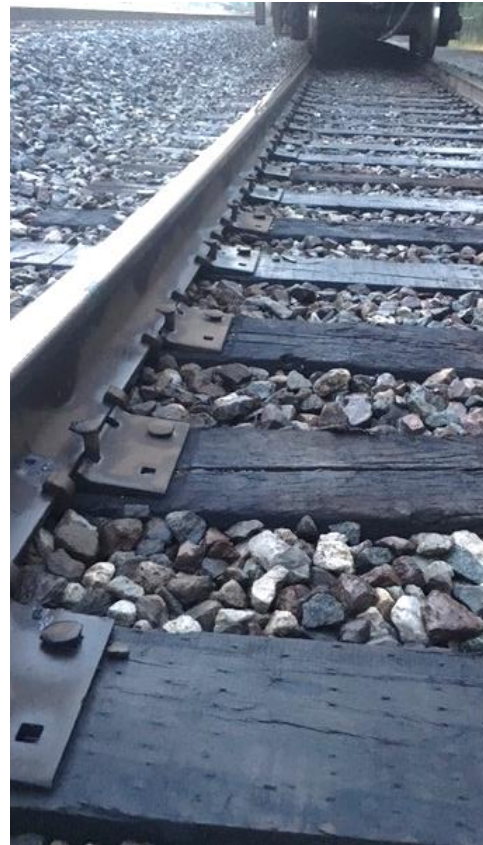
These 3 unusual conditions were noted on the low rail leading up to the POD:

1. Scuff marks on field side of the head
2. Wheel flange contact on the gage face
3. Evidence that rail has been canting out under load

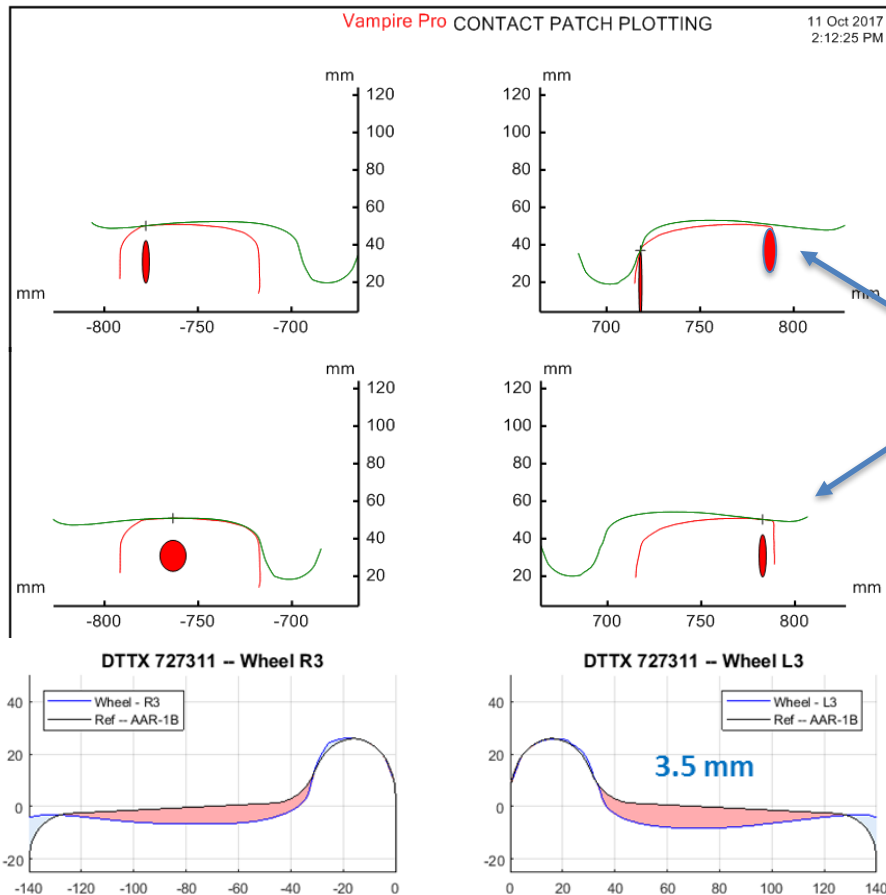
In all tracking positions – from high rail flanging to low rail flanging, the L3 wheel always contacts the field edge of the high rail.

Consequences of this type of contact:

- ▶ high gage-spreading forces
- ▶ poor rail stability

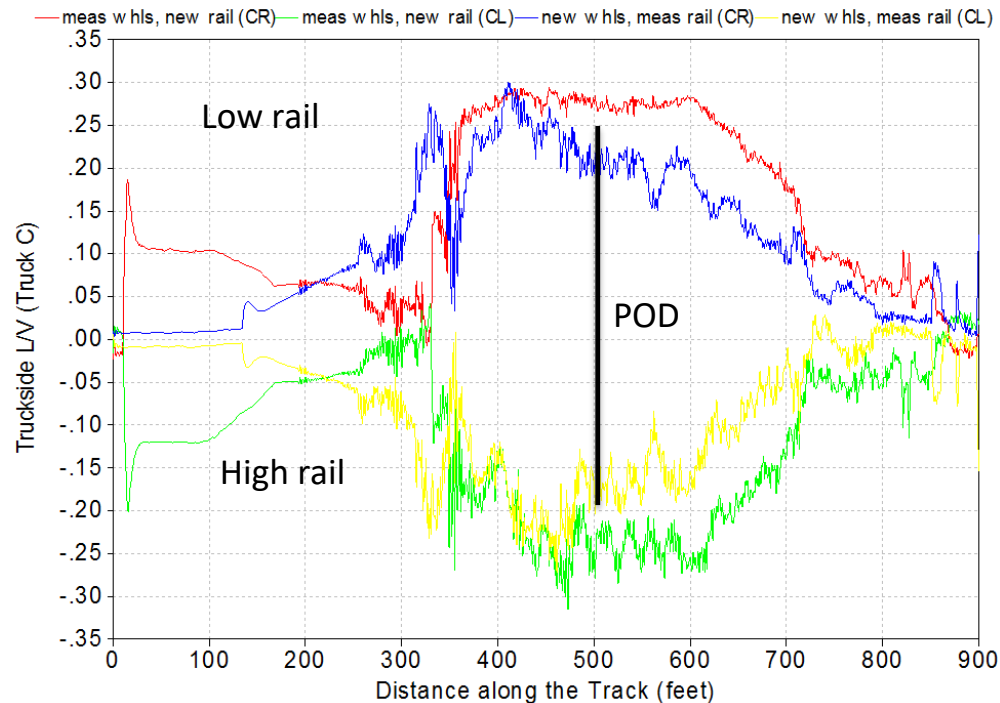
- worn wheels on new rail (red/green) or
- new wheels on worn rail (blue/yellow)?

In this case, worn wheels produced higher L/V.

This, plus the other evidence, allowed us to identify hollow-tread wheels as the primary cause.

- The industry is evaluating whether there is justification for reducing the current hollow-tread limits (5 mm off rip track, 4 mm on rip track)

- Pay close attention to rail profiles
- Corrective grinding
- Look for evidence of spike lift
