Corrective Grinding of Adverse High Rail Profiles

Brad Kerchof

*Director Research & Tests (retired)
Norfolk Southern Railway*

HEAVY HAUL SEMINAR • OCTOBER 20 - 21, 2021

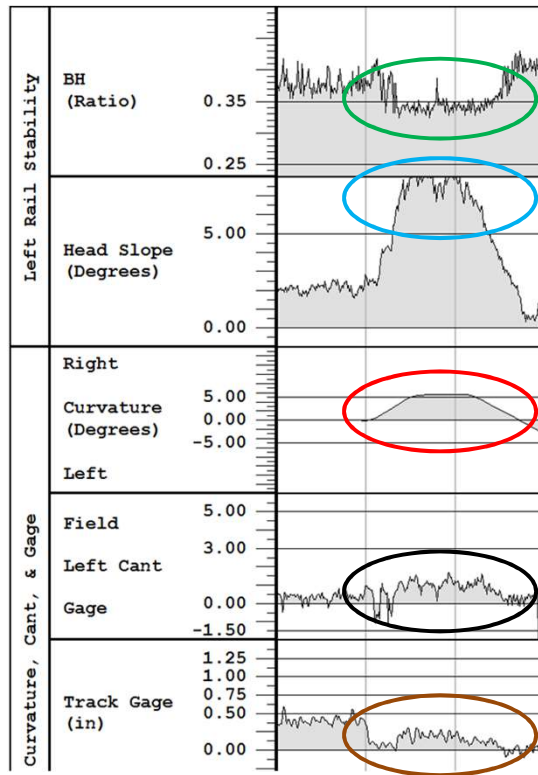
Example of an adverse high rail profile

- B/H 0.34
- Head slope 8°
- Curvature 5°
- Rail cant 1°
- Gage ¼", or 56-3/4"

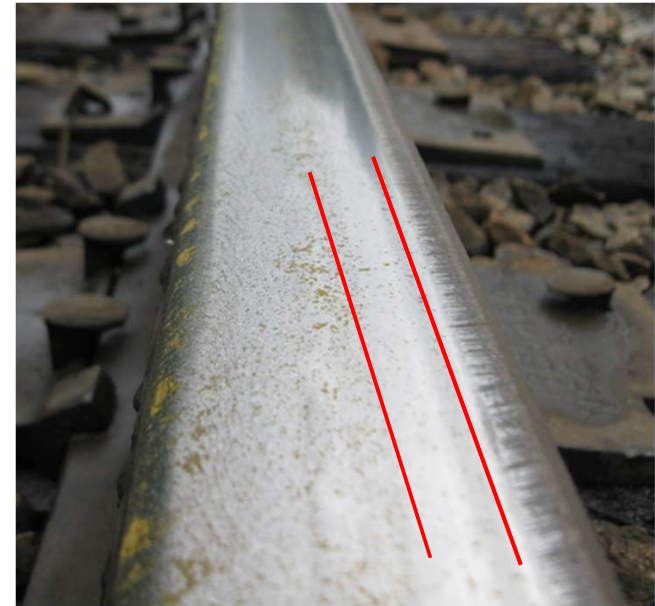
Primary contact band is on field side

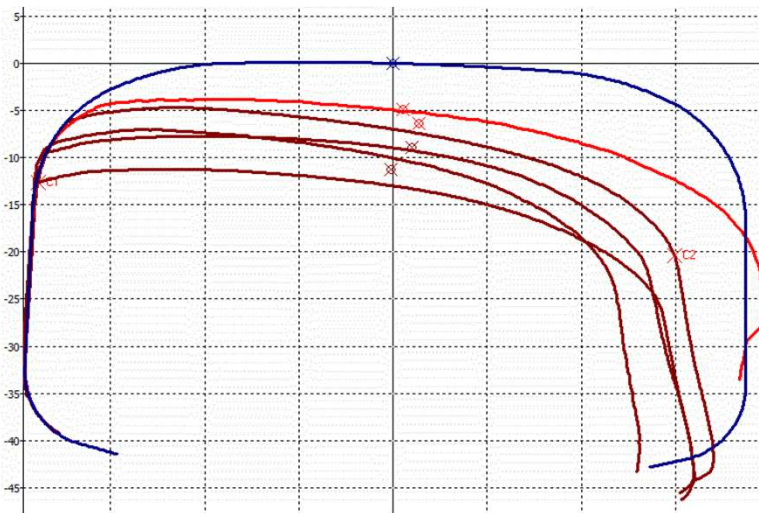
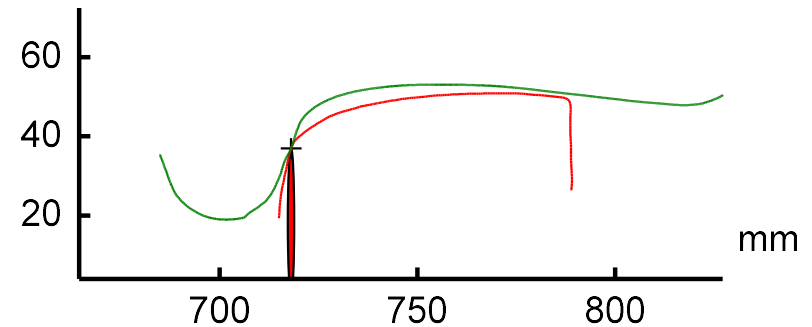
Below: High rail profiles from five NS rail roll-over derailments (aligned on field side with a new 136RE profile, 1:40 inward cant)

Above: Adverse contact produced by curve-worn rail and 3.5mm hollow-worn wheel. Example of extreme 2-point contact.

Hollow-worn treads are more likely to make field-side contact.

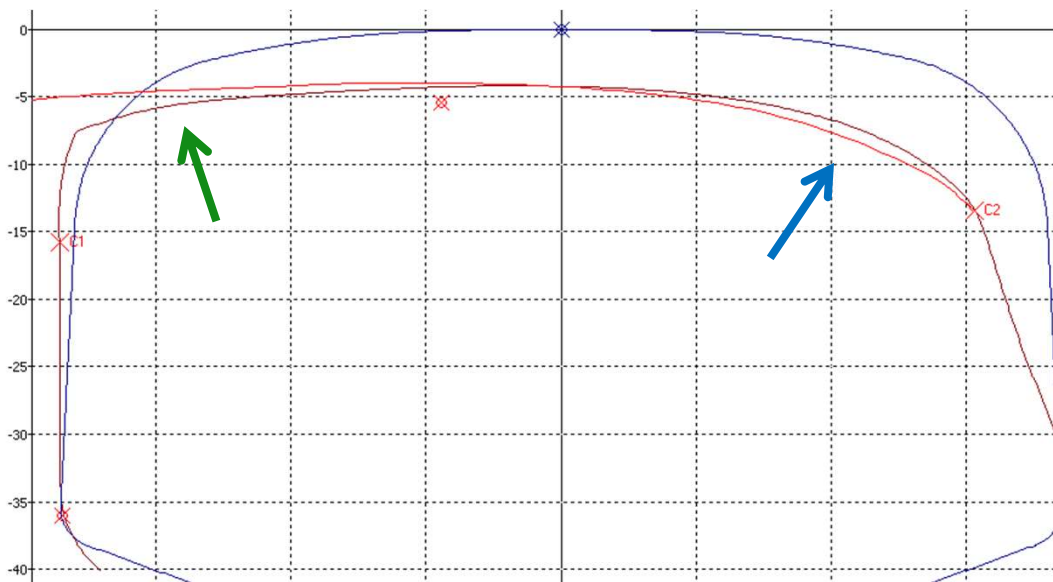
Brown profile: a curve-worn high rail with 3° outward cant

Red profile: high rail template used by Loram & NS

The template can be moved laterally & vertically; it cannot be rotated

A: Significant grinding on the gage side (blue arrow) but no grinding on the field side (green arrow)

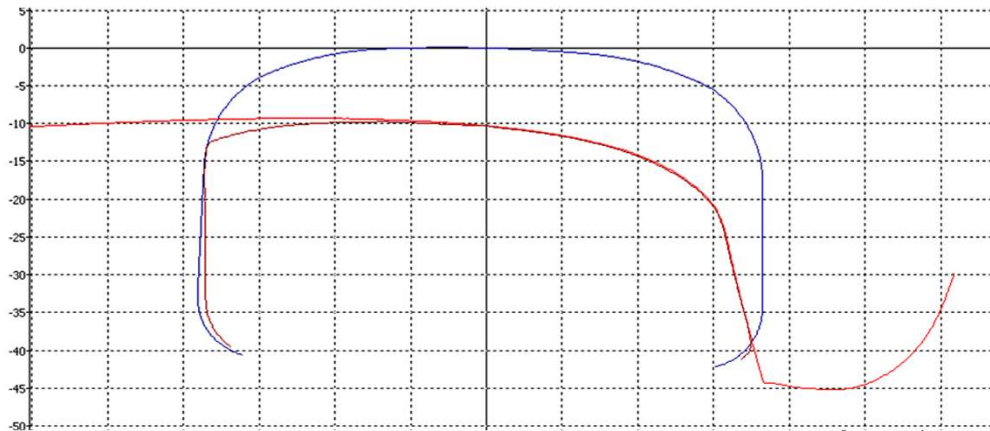
Above: A slightly-worn wheel on curve-worn rail with 3° cant

This is conformal contact, which produces favorable wheelset steering

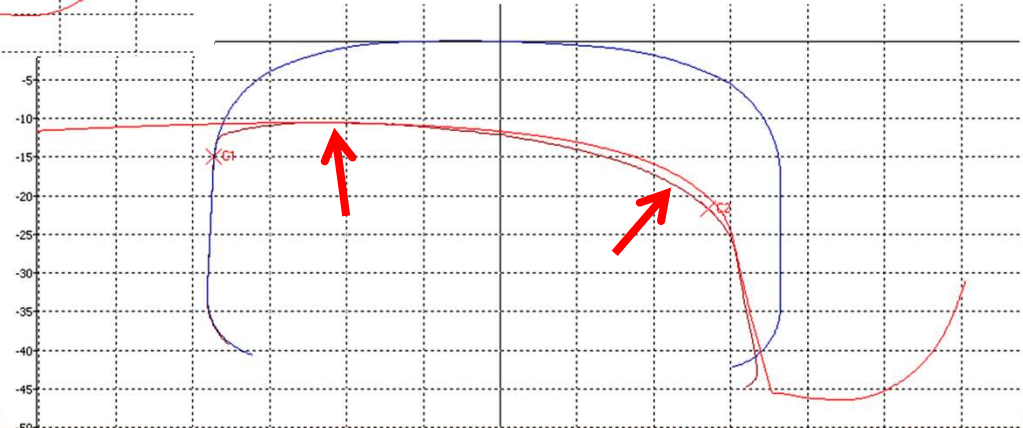
Below: The same slightly-worn wheel and curve-worn rail, but the rail has been set up to 0° cant.

Result: Wheel tread contact has moved toward field side. This is two-point contact, which produces higher-resistance curving.

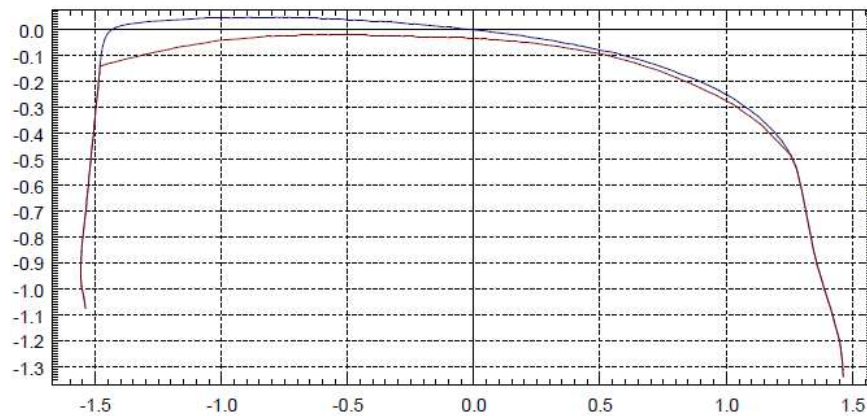
High rail of a 6° curve. The blue profile is pre-grind, and the brown profile is post-grind. A full 1/8-inch was ground off the field-side corner. Both profiles have been rotated to 0° cant.

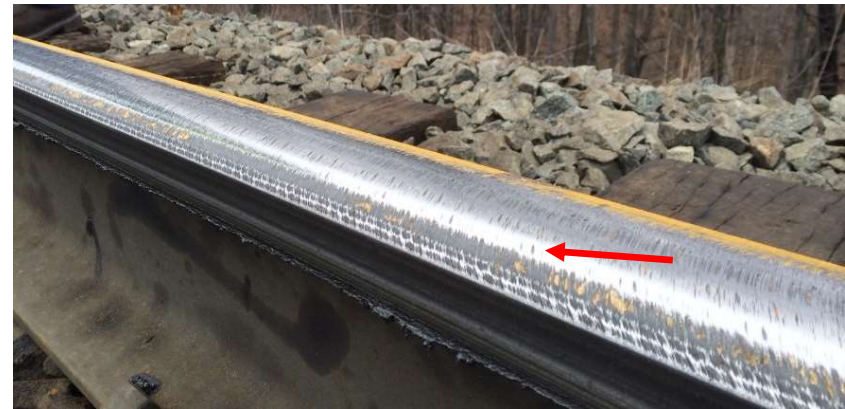
The same high rail several days after grinding. The primary wheel contact band was moved toward the gage side. (Enough metal was removed from the field side to maintain gage-side wheel contact after the rail was gaged).

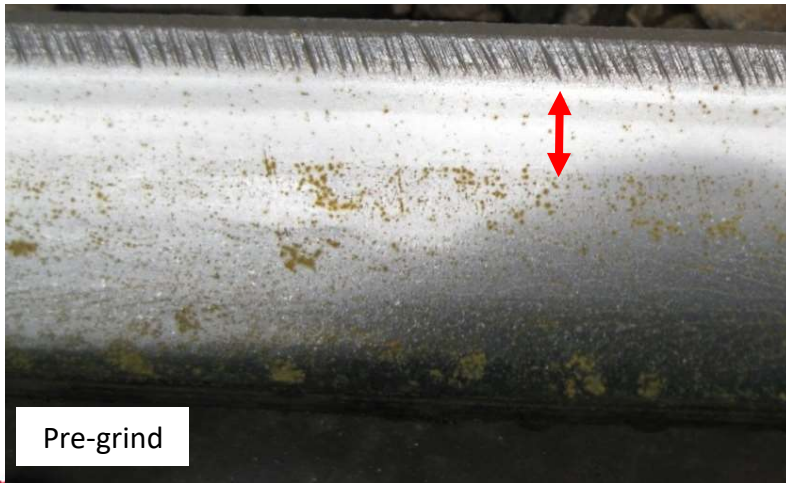
Pre-grind: Primary contact band is on the field side
Side wear 6/16", cant 1.5°, B/H 0.34, head slope 8°

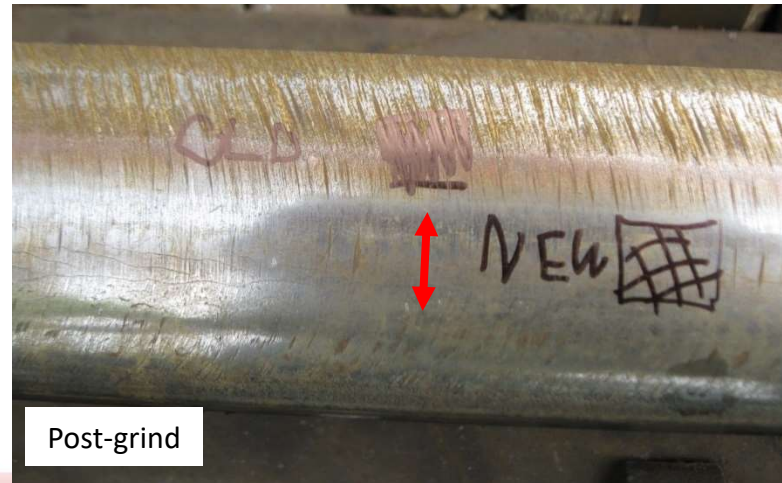
Post grind: Wheel contact shifted toward gage side

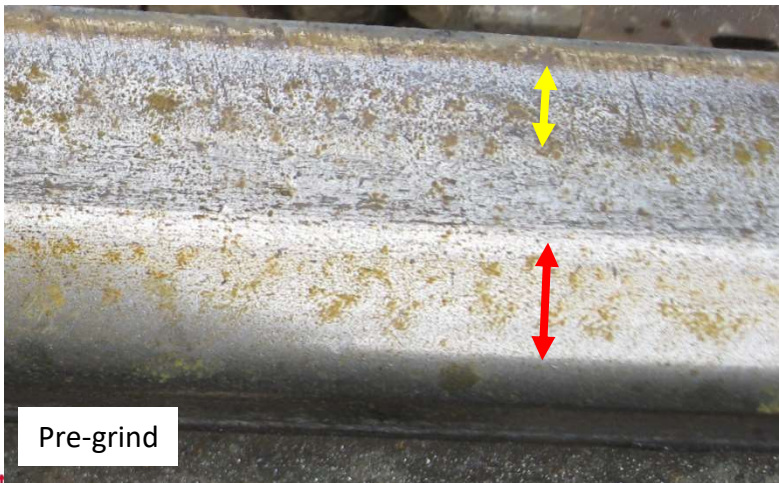
Pre-grind: Primary contact appears to be on gage side (red arrow). There is some field-side wheel contact (yellow arrow), though still-visible grinding marks suggest wheel frequency is low.

Side wear 6/16", cant 1°, B/H 0.35, head slope 6°.

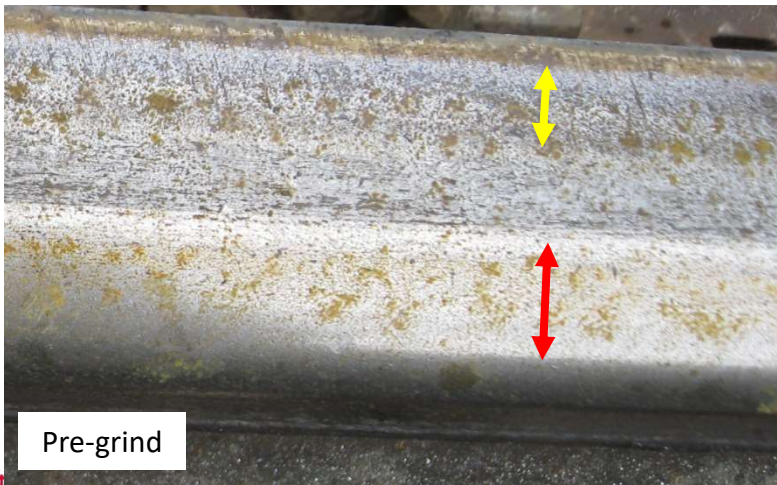
Pre-grind

Post grind: After 3 passes, the primary wheel contact band is more concentrated on the gage corner (red arrow). Field-side contact by hollow-tread wheels is still apparent (yellow arrow).

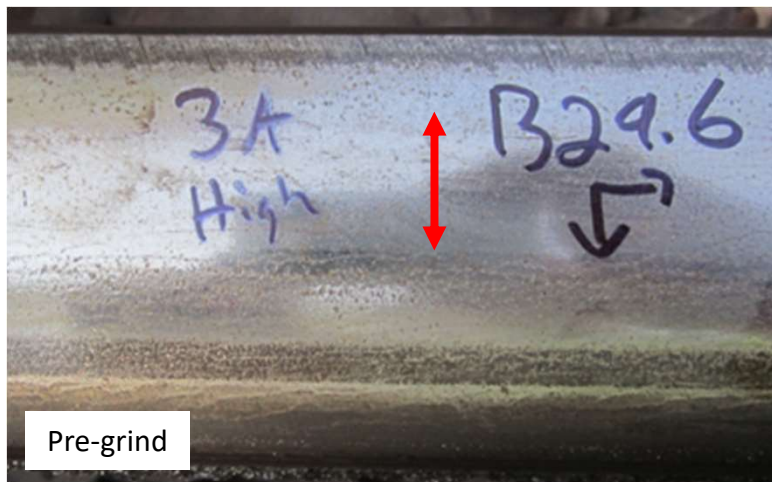
Pre-grind: Primary wheel contact is at the center, though there is evidence of wheel contact over most of the head.

Side wear 7/16", cant 0°, B/H 0.35, head slope 8°.

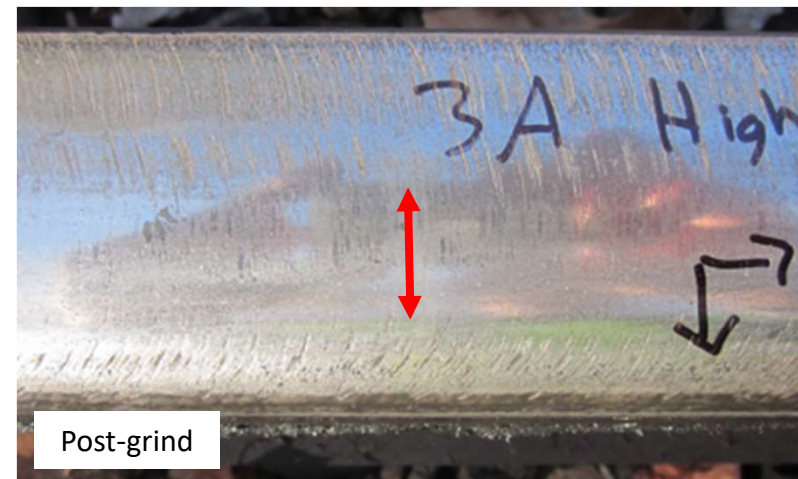
Post-grind: Primary wheel contact has shifted toward the gage side.

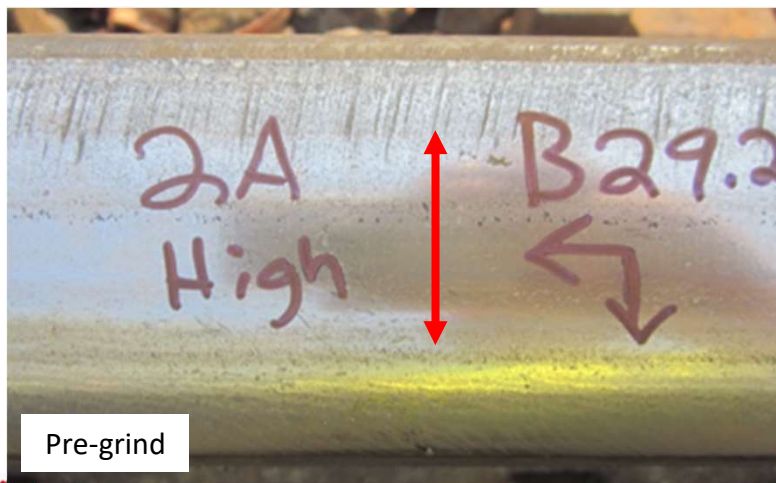
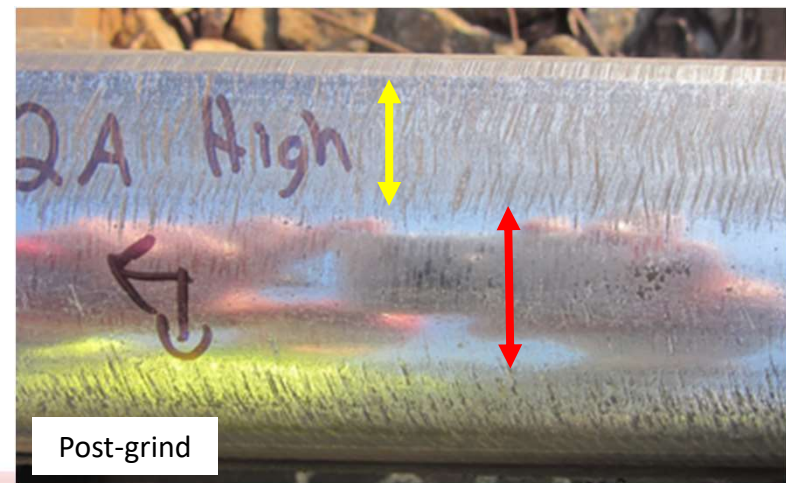
Post-grind: Primary wheel contact has shifted to the gage side of center. Some hollow-tread wheel contact is still evident on the field half of the head (yellow arrow).

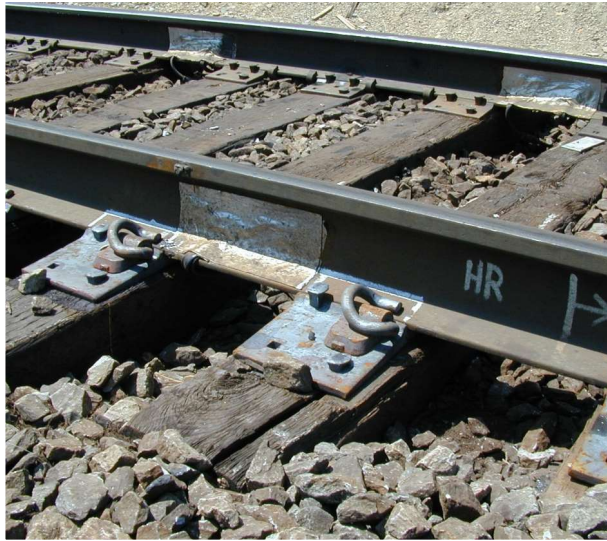
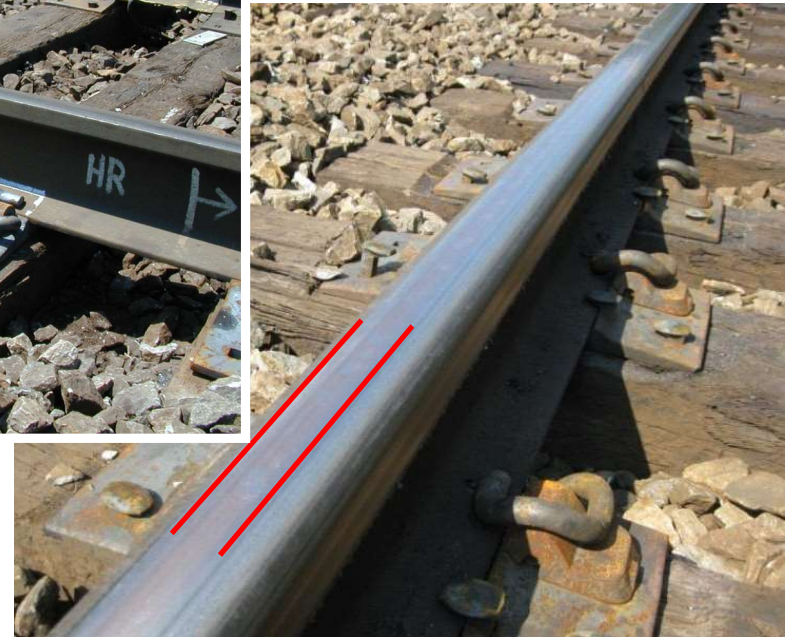
High rail of 8° curve

- Rail had just been gaged with new plates & e clips
- Gage 57-1/2" to 56-3/8"
- Cant 3° to 0°
- Primary wheel contact moved from gage side to field side

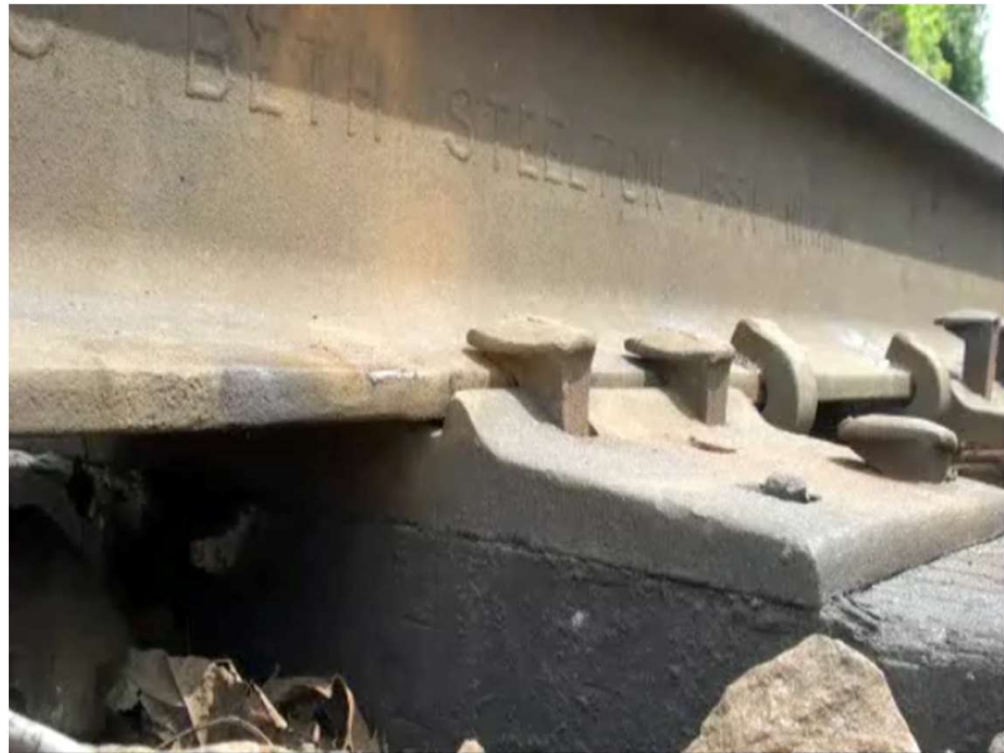
Because of a change in wheel contact on the high rail, the low rail is subjected to higher lateral forces

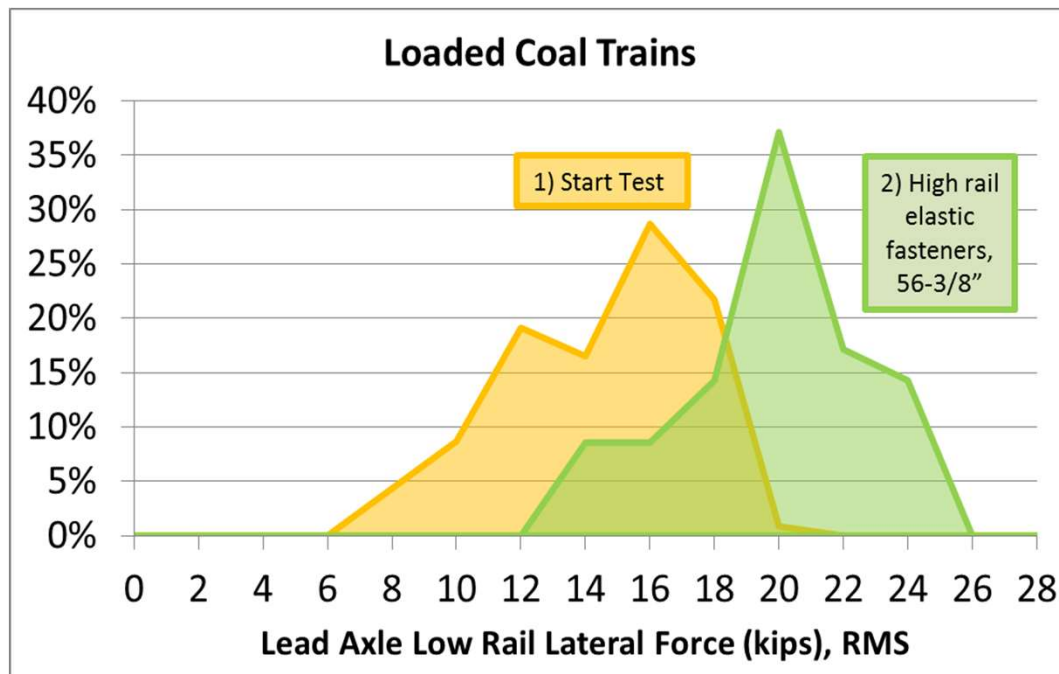
Strain gage measurements converted to lateral force

- Start test: cut spikes & 3° cant on both rails, gage 57-1/2", gage-face lubrication, no TOR
- After trackwork: Victor plates and e clips on high rail, cant eliminated, gage 56-3/8"

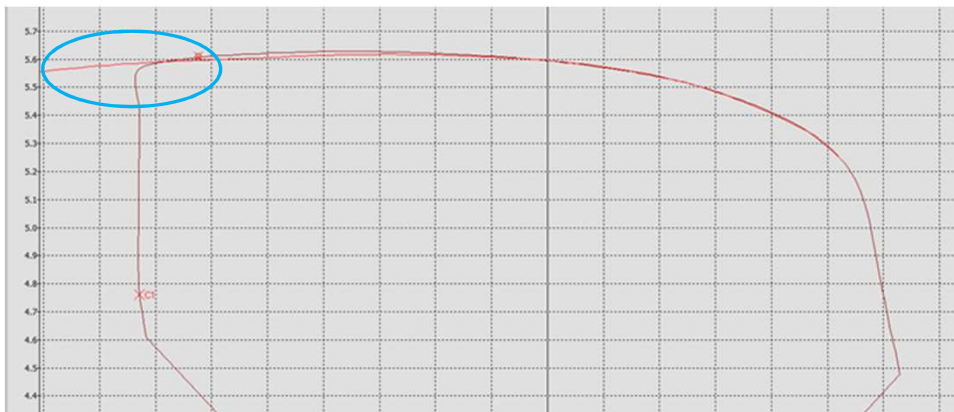
Secondary reason:

A curve-worn rail with template applied. As side wear increases, the template is shifted further to the field side, causing the tail of the template to shift off the rail.
