Transportation
Safety Board
of Canada

Dynamic Simulation of Locomotive Derailment over Crossover Track

WRI SEMINAR, October 20-21, 2021

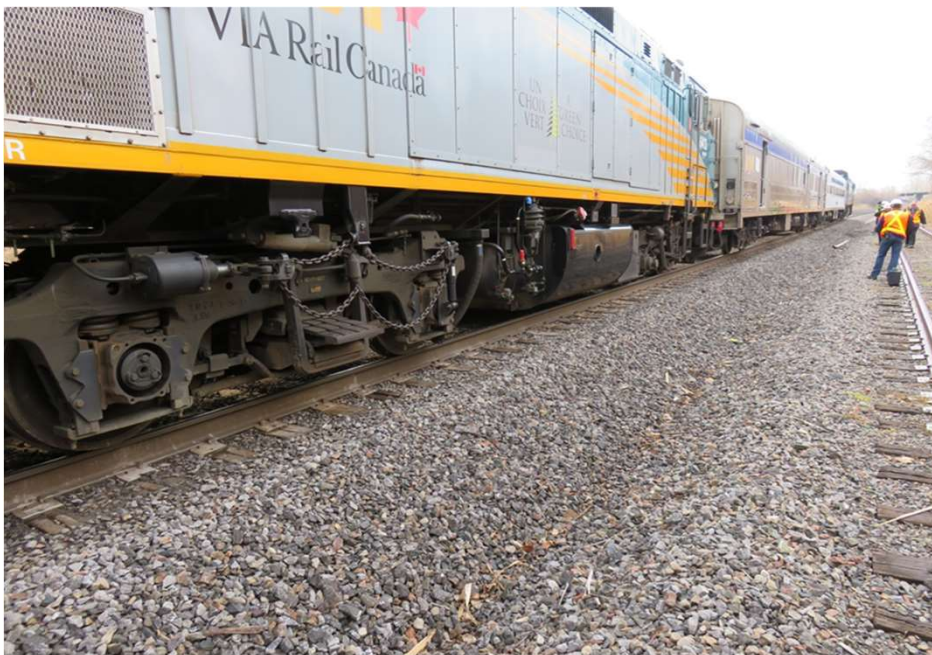
Front Truck of Middle Locomotive Derailed to Left

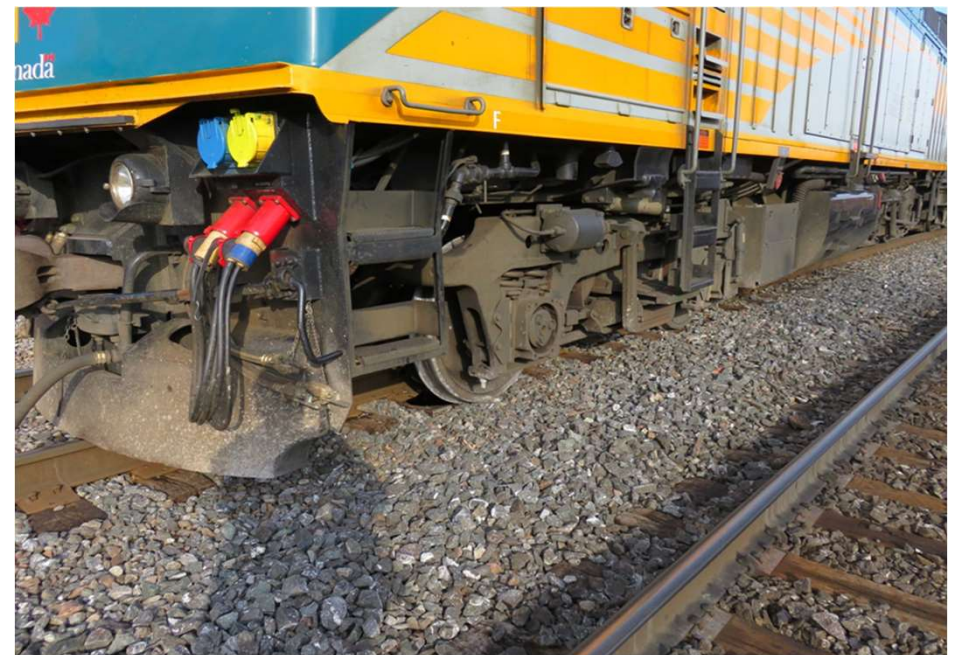
Derailed Truck of VIA 6413

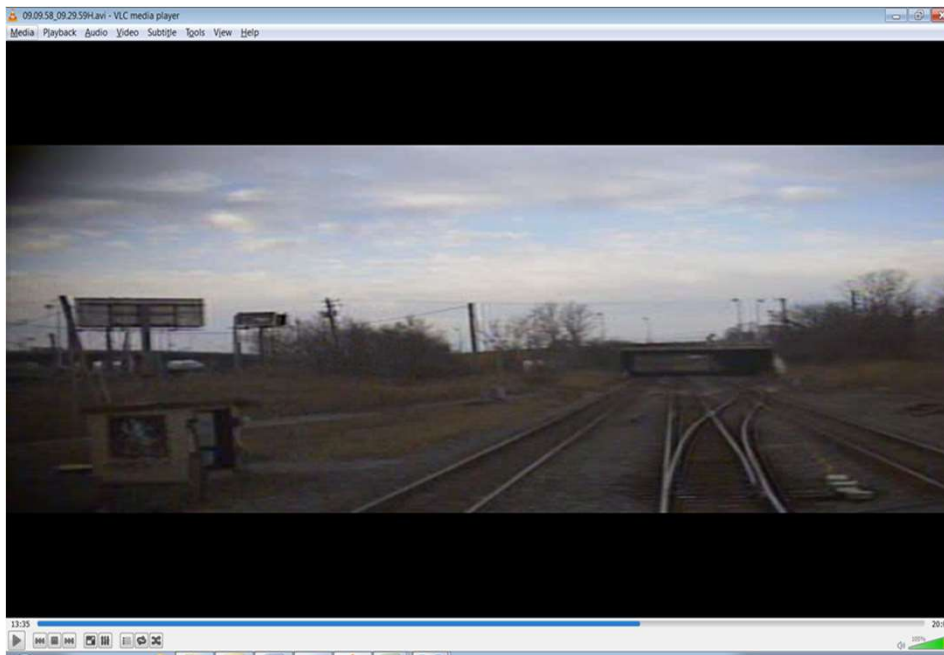
Entering Switch 75A of Crossover 75

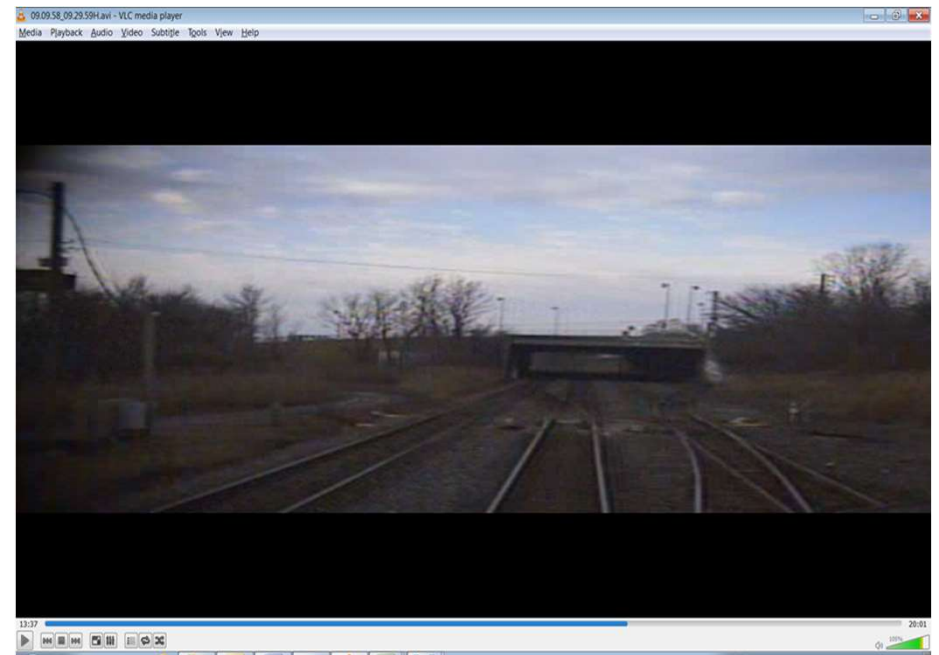
Passing through Crossover Seeing the Exit Switch 75

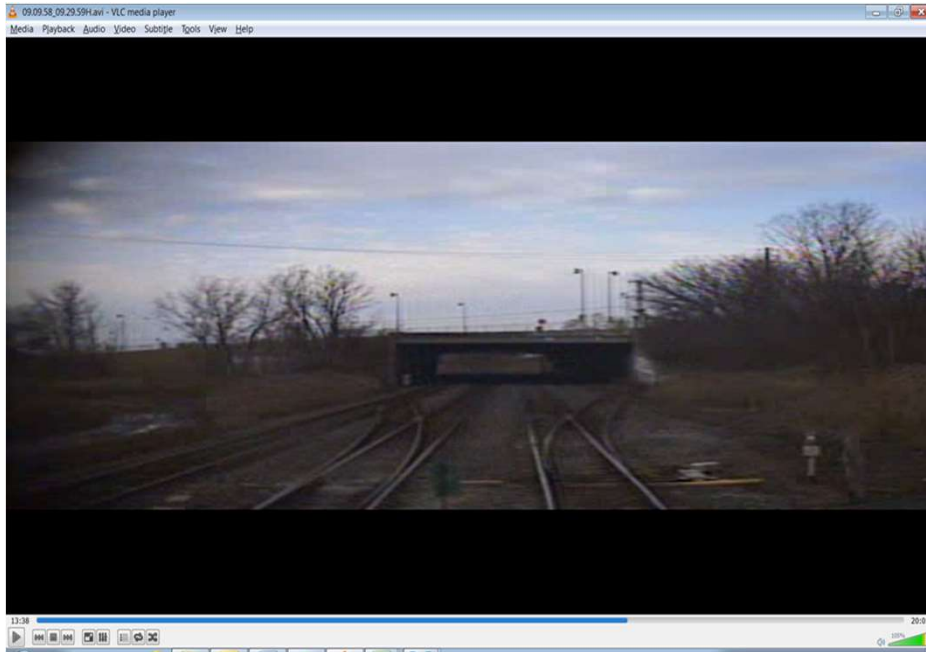
Exiting Switch 75 with Switch 73 on Front-Right

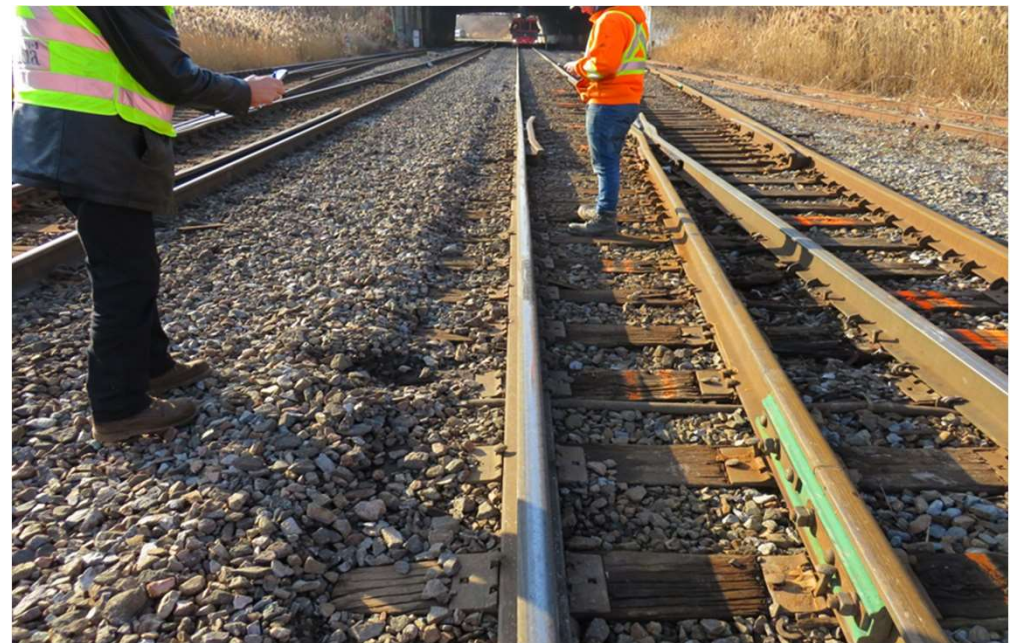
POD with Wheel Drop and Rail Top Contamination

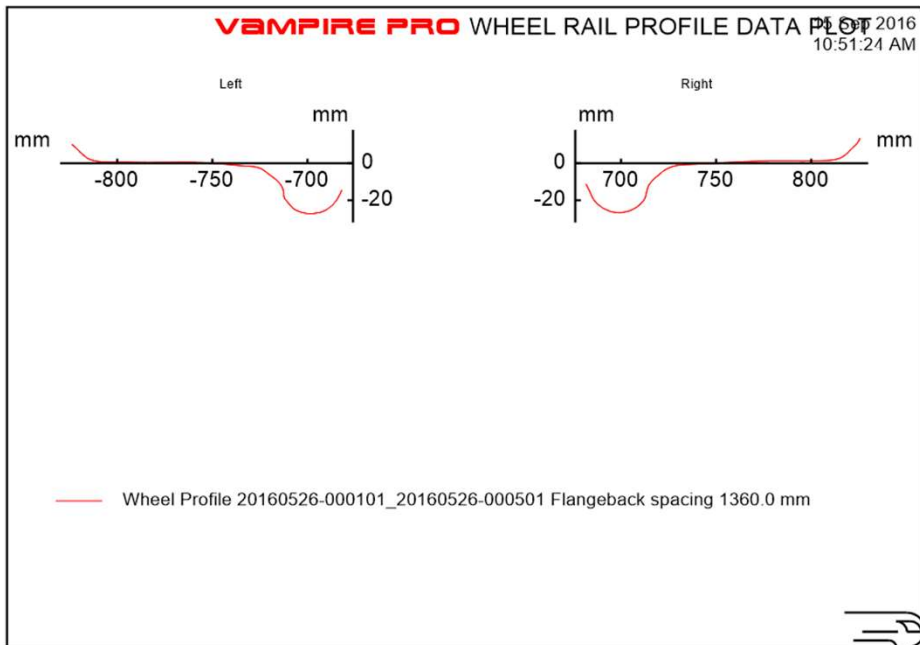
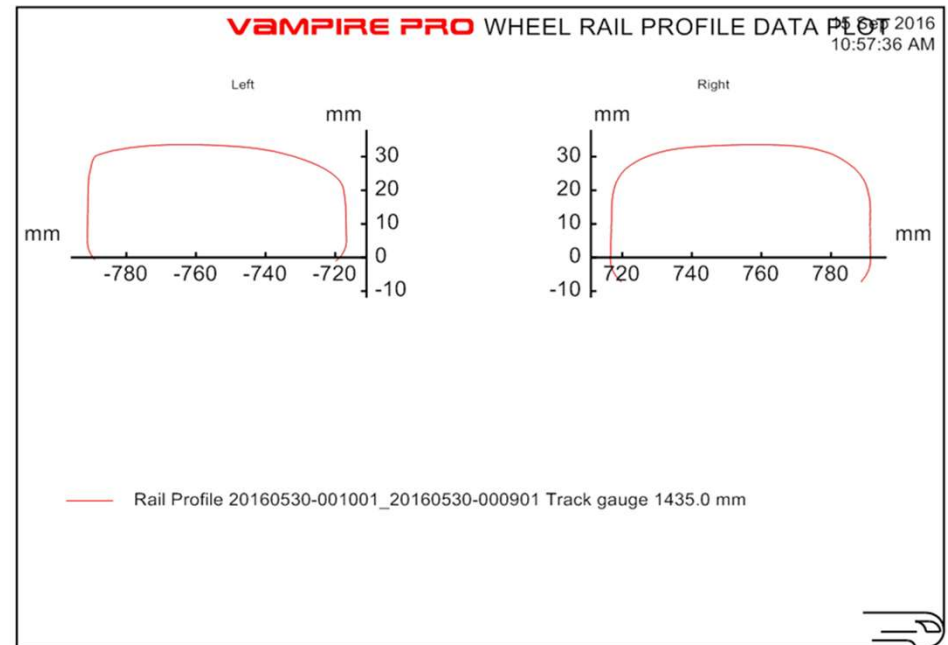
Measured wheel and rail profiles

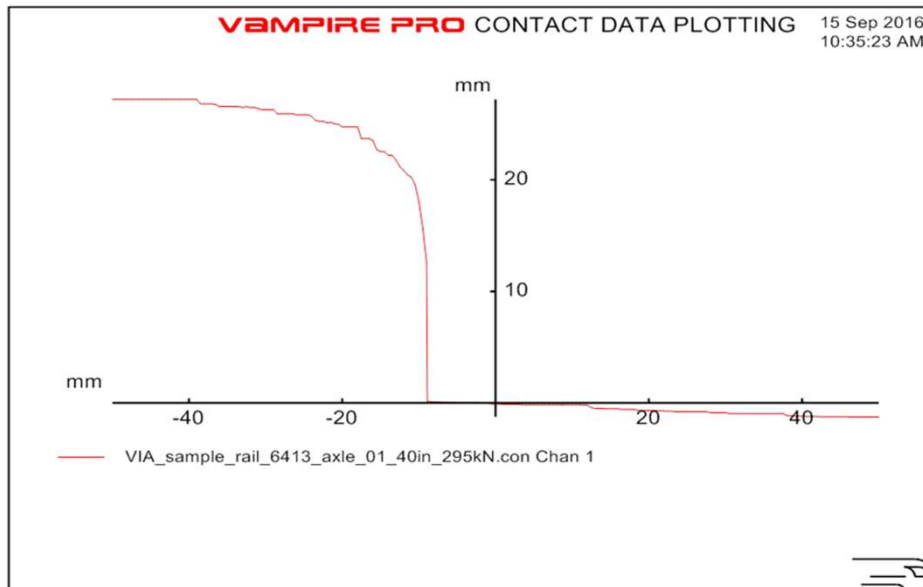
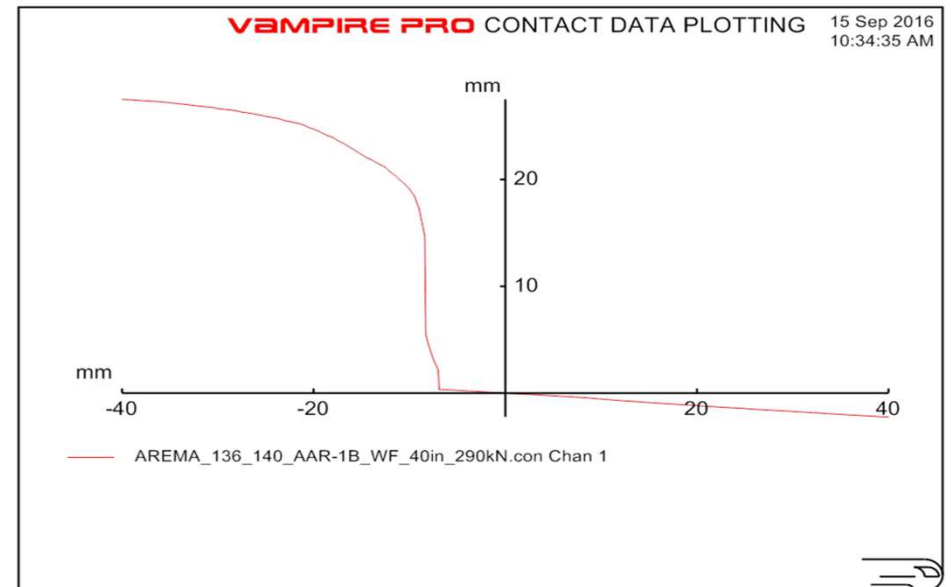
Measured and AAR standard wheel/rail contact

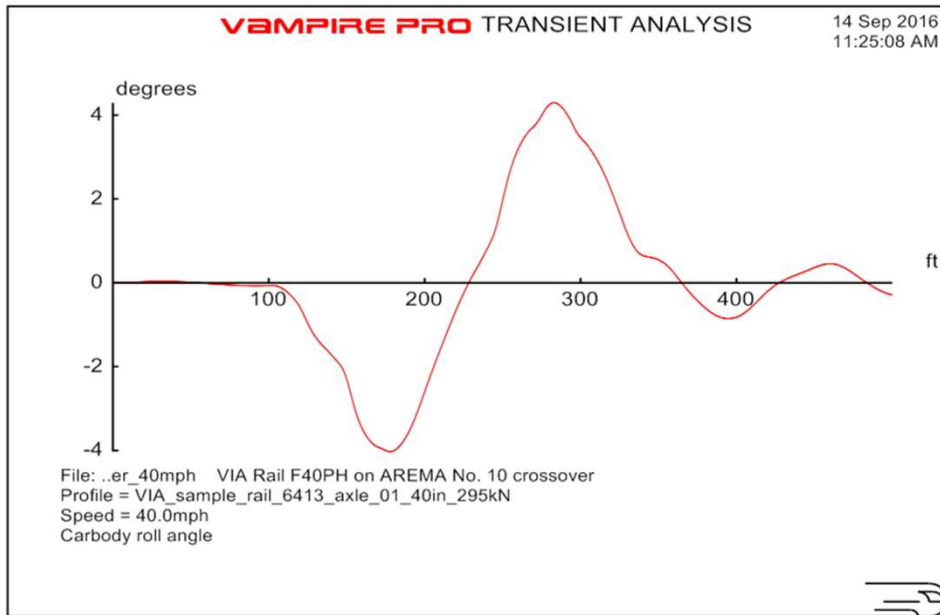
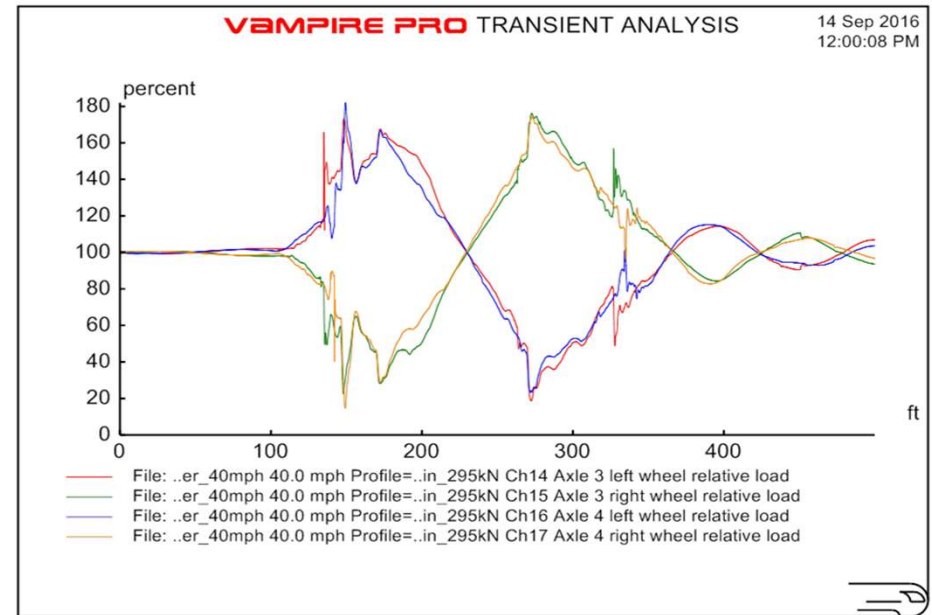
Simulated carbody roll angles and wheel relative loads of No.10 crossover at 40 mph

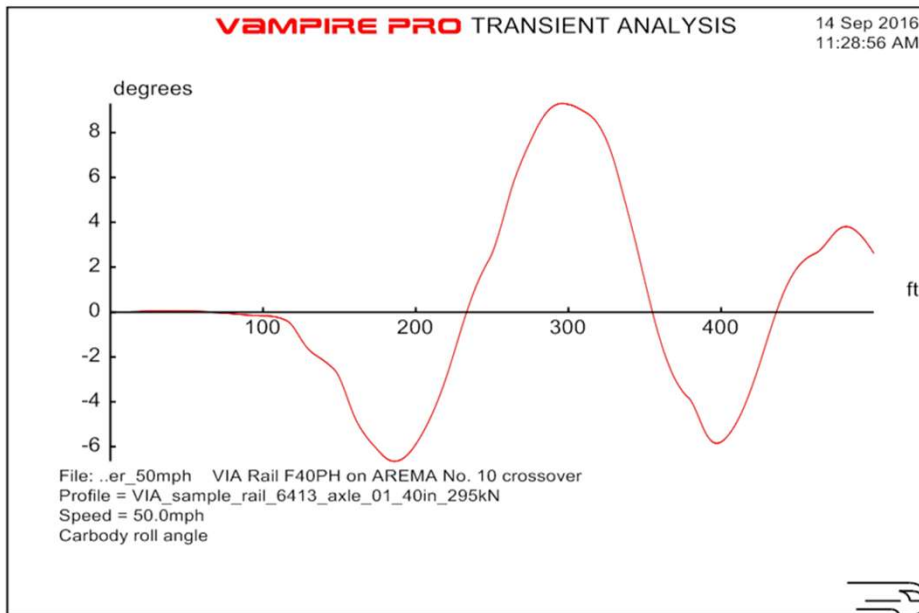
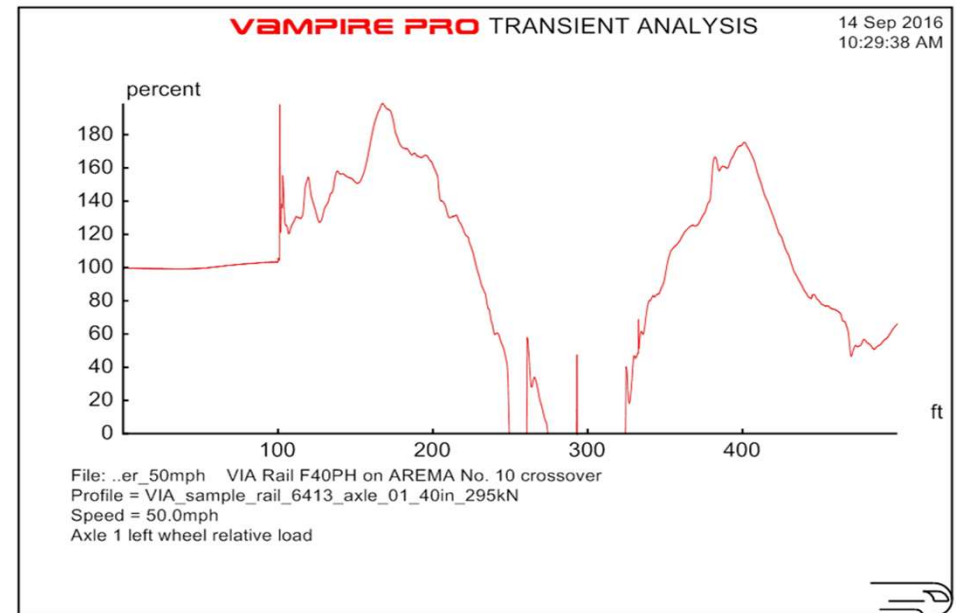
Simulated carbody roll angles and wheel relative loads of No.10 crossover at 50 mph

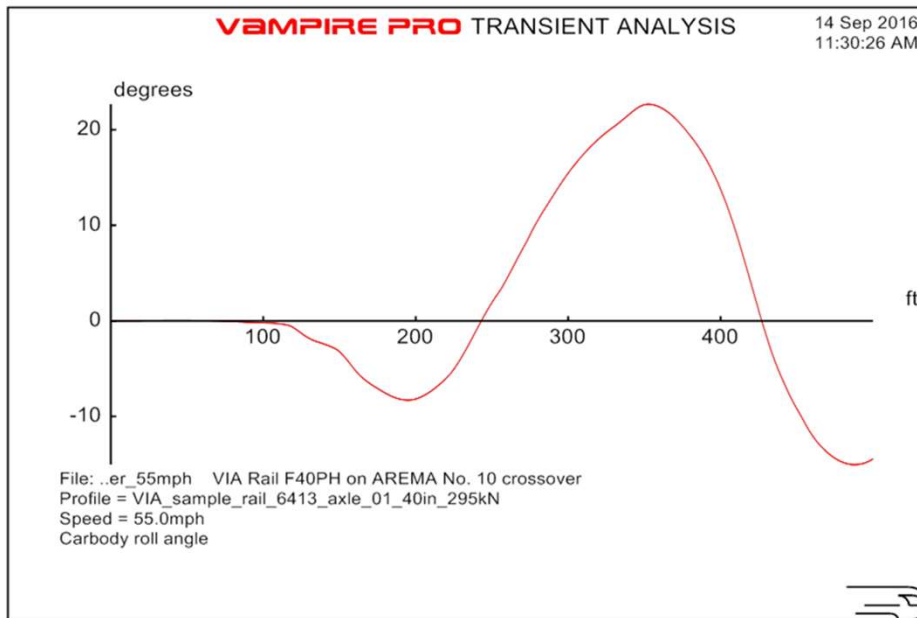
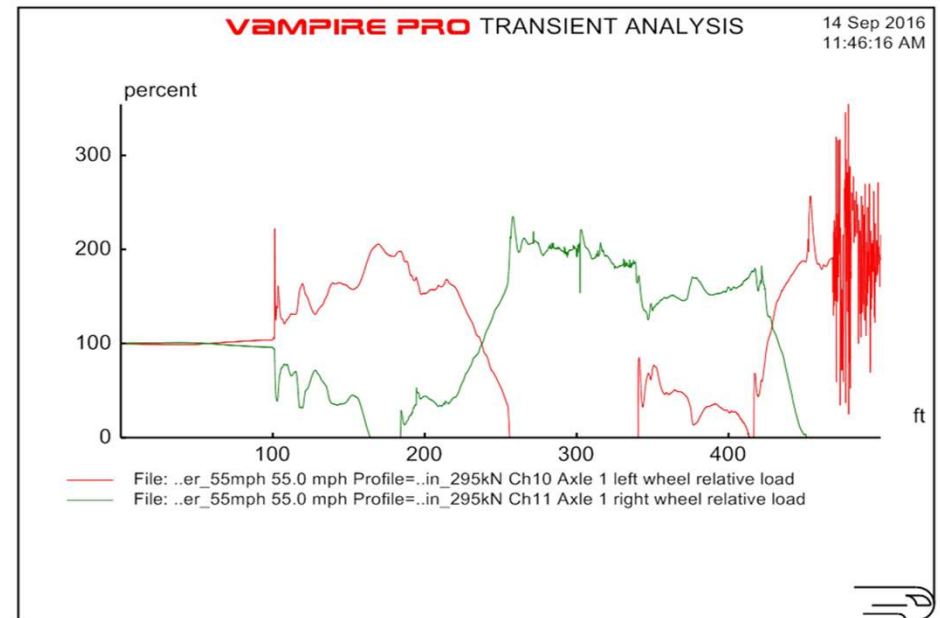
Simulated carbody roll angles and wheel relative loads of No.10 crossover at 55 mph
