Friction Management on *Emova* metro network

Practical Experiences in the Use of Friction Modifiers.

RAIL TRANSIT SEMINAR • JUNE 21

WRI 2022

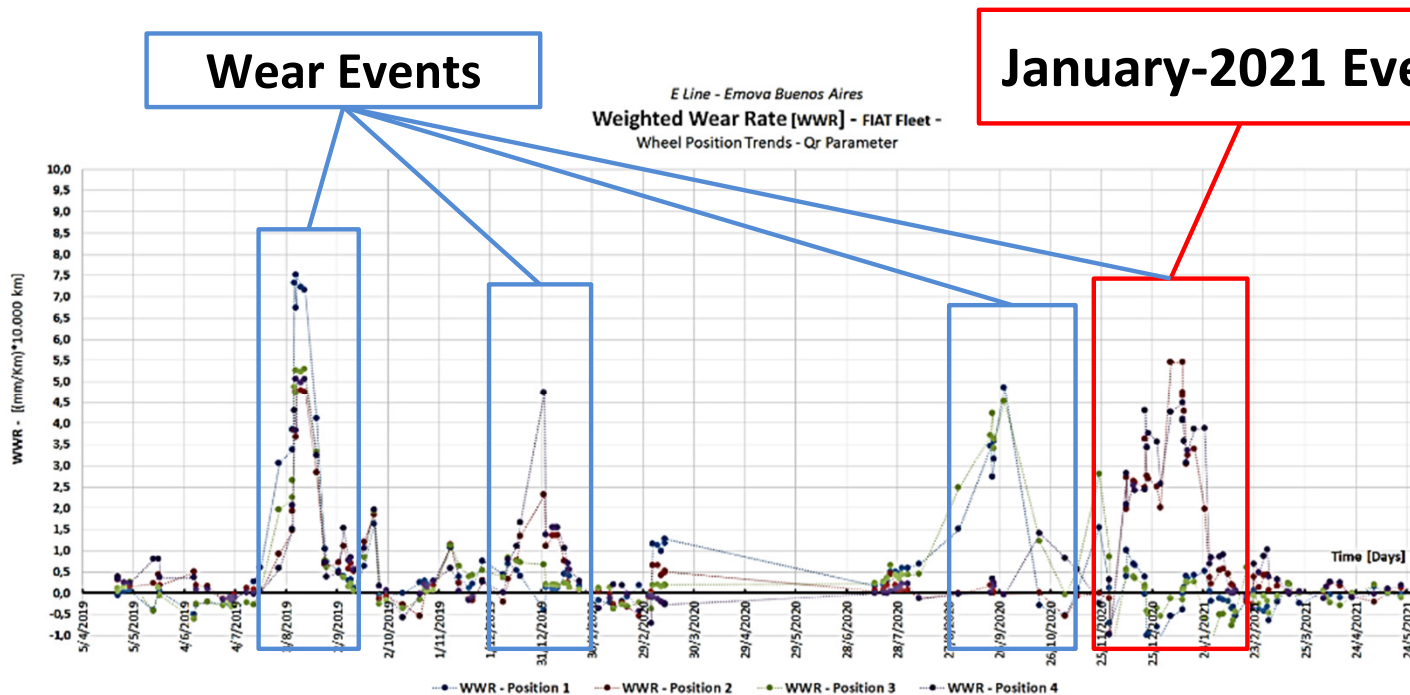
- Many **Wheel/Rail Wear Events** during track Renewal and Extension.

- Happens **unexpectedly**.
- Over a **sizeable population** of trains.
- Defined **Time gap**.

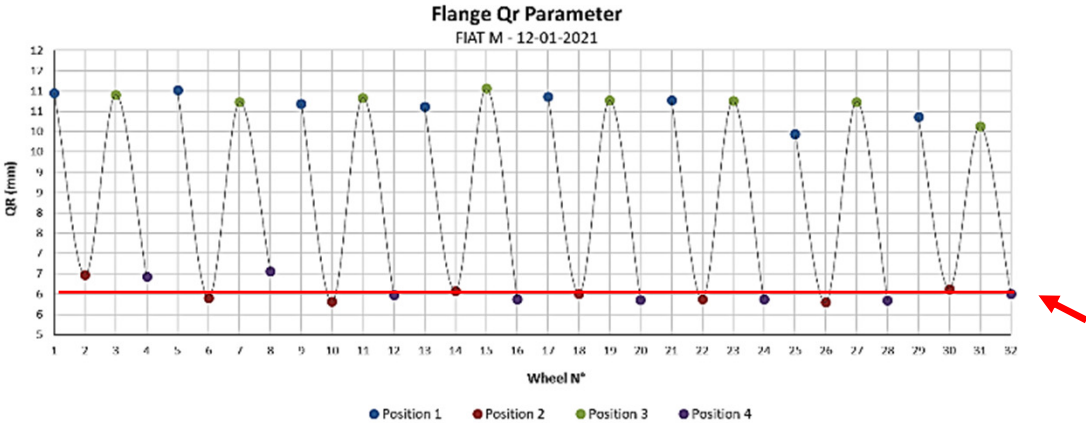
- Identification of **Wheel Position** and **Wear Pattern**

Use of Wheel Qr parameter as reference.

Average of all values in the same relative position.

Lower Limit for Qr Parameter – 6,5mm

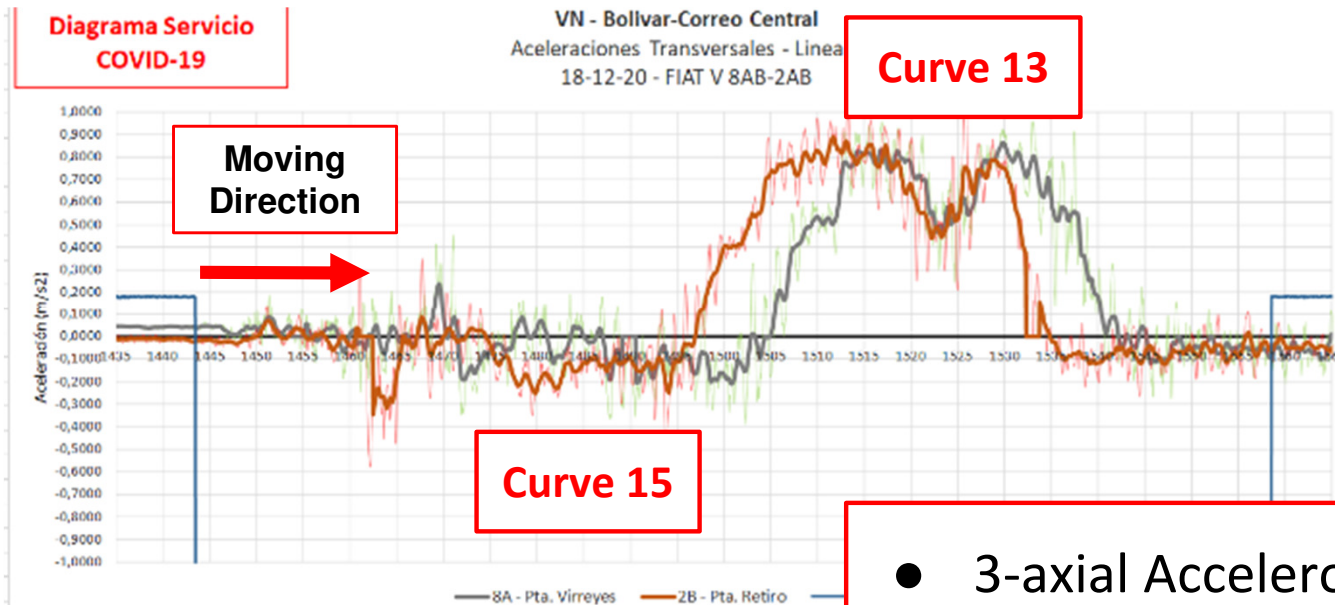
- Transversal Acceleration Mapping

- Low Speed
- Track Cant Excess

- 3-axial Accelerometers, one each cab.
- Commercial Speed Mapping.

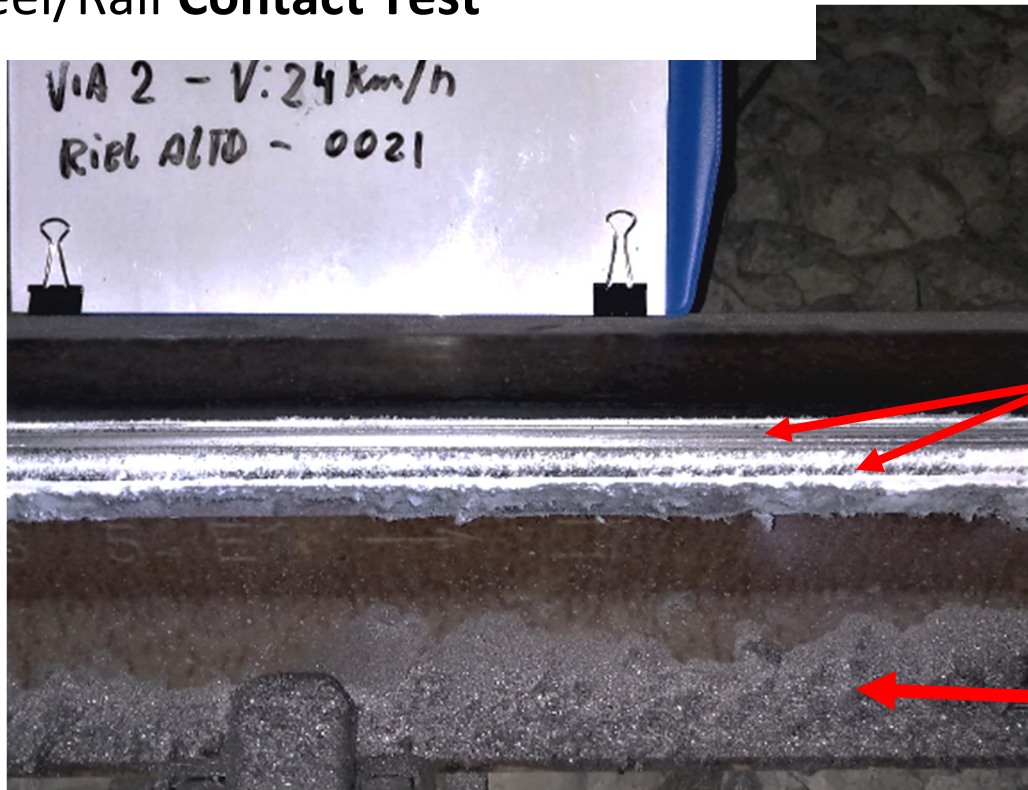
Curve 15

Gauge Corner Contact and
Flange Contact

Wear Debris

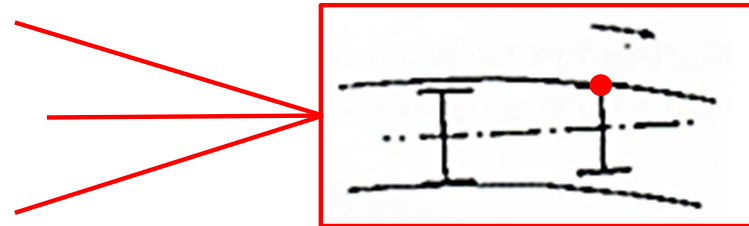
- Low Speed, cant excess
- High Angle of Attack
- Forced condition Bogie in Curve

TOR Friction Management

- Reduce Lateral Force
- Reduce Angle of Attack
- Improve Bogie capabilities in low speed curve negotiation.

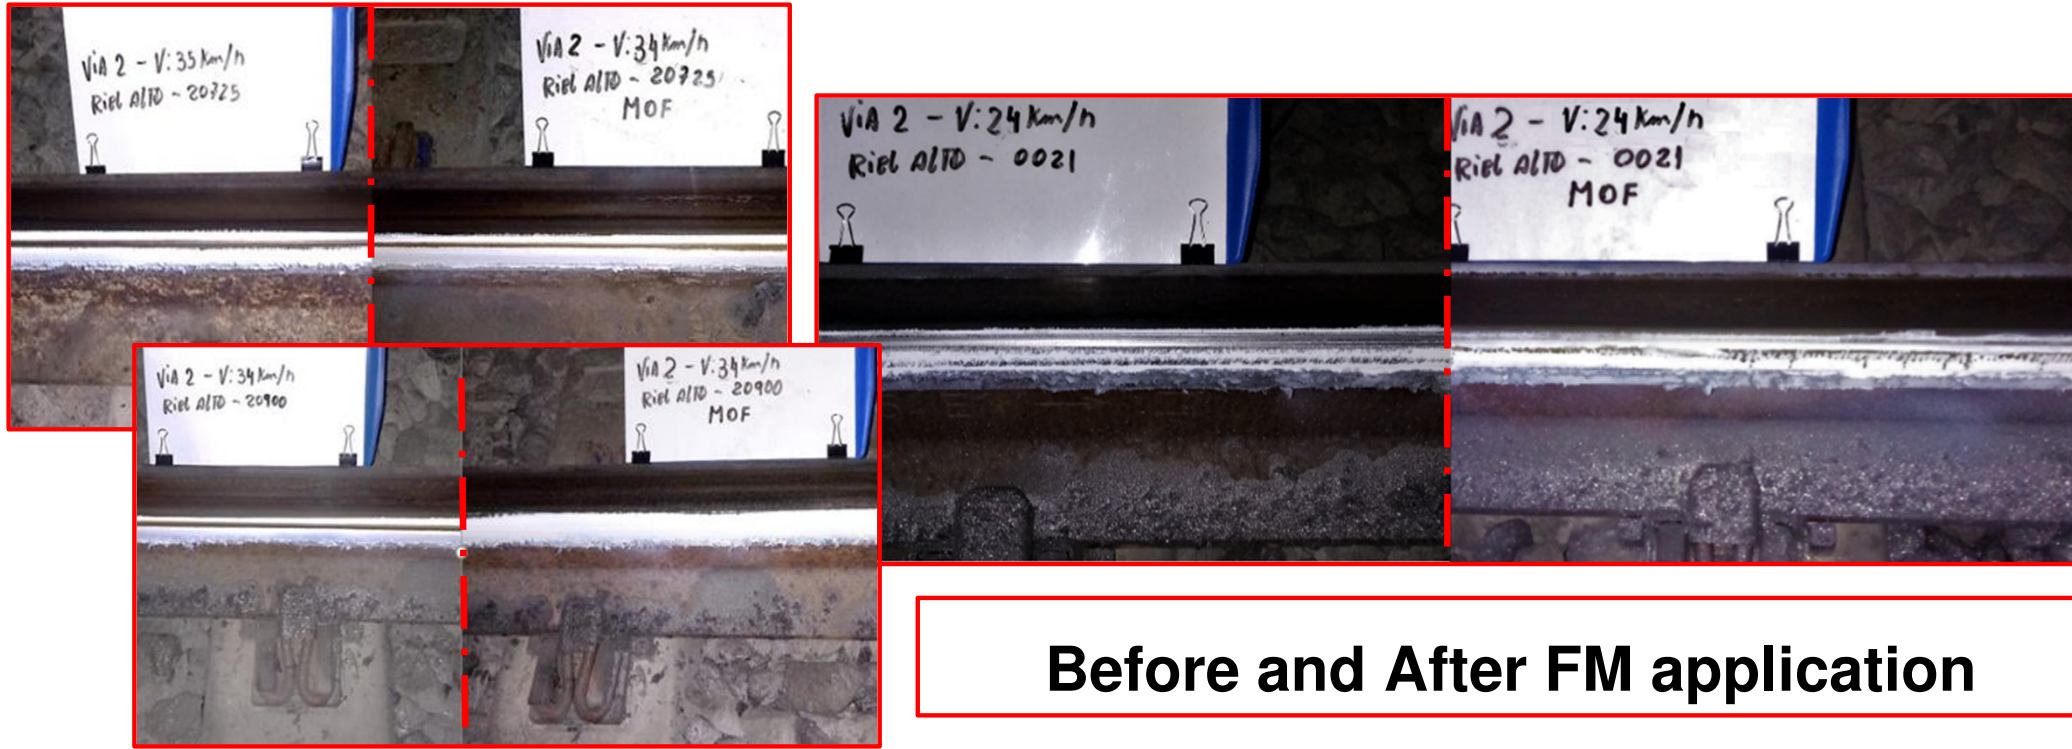
- Wheel/Rail Contact Test

Before and After FM application

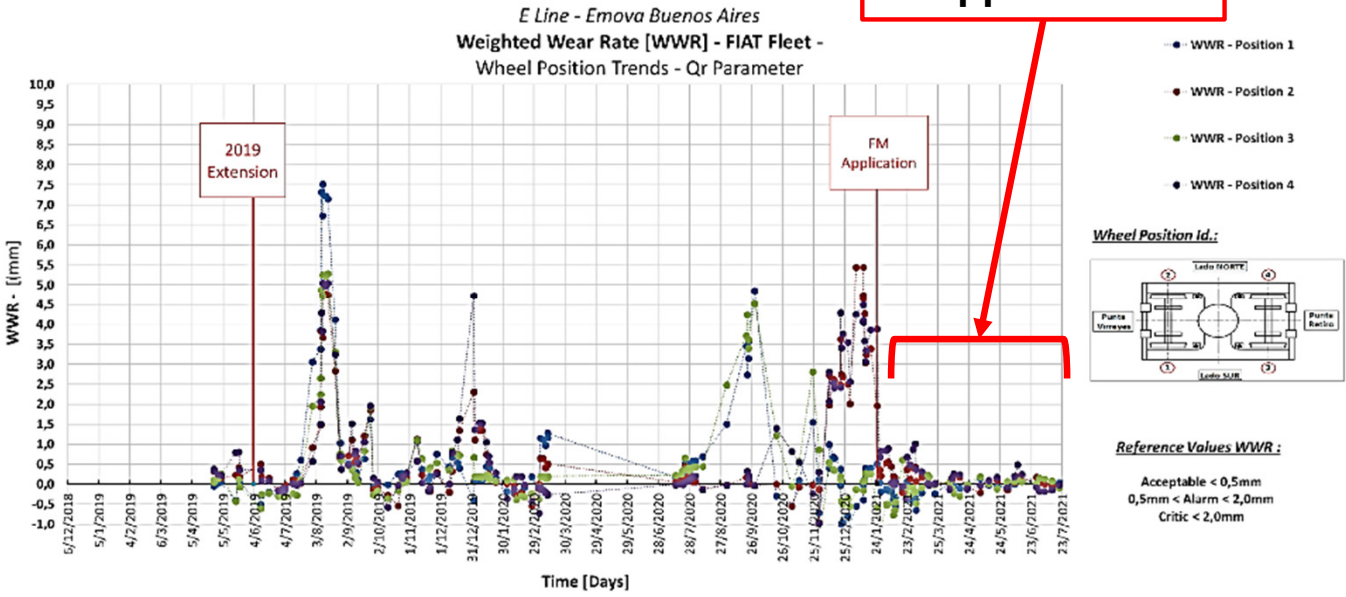
Wear Evolution Post FM application

Successfully Strategy

- Controlled Event
- Wheel Wear Trends to zero.

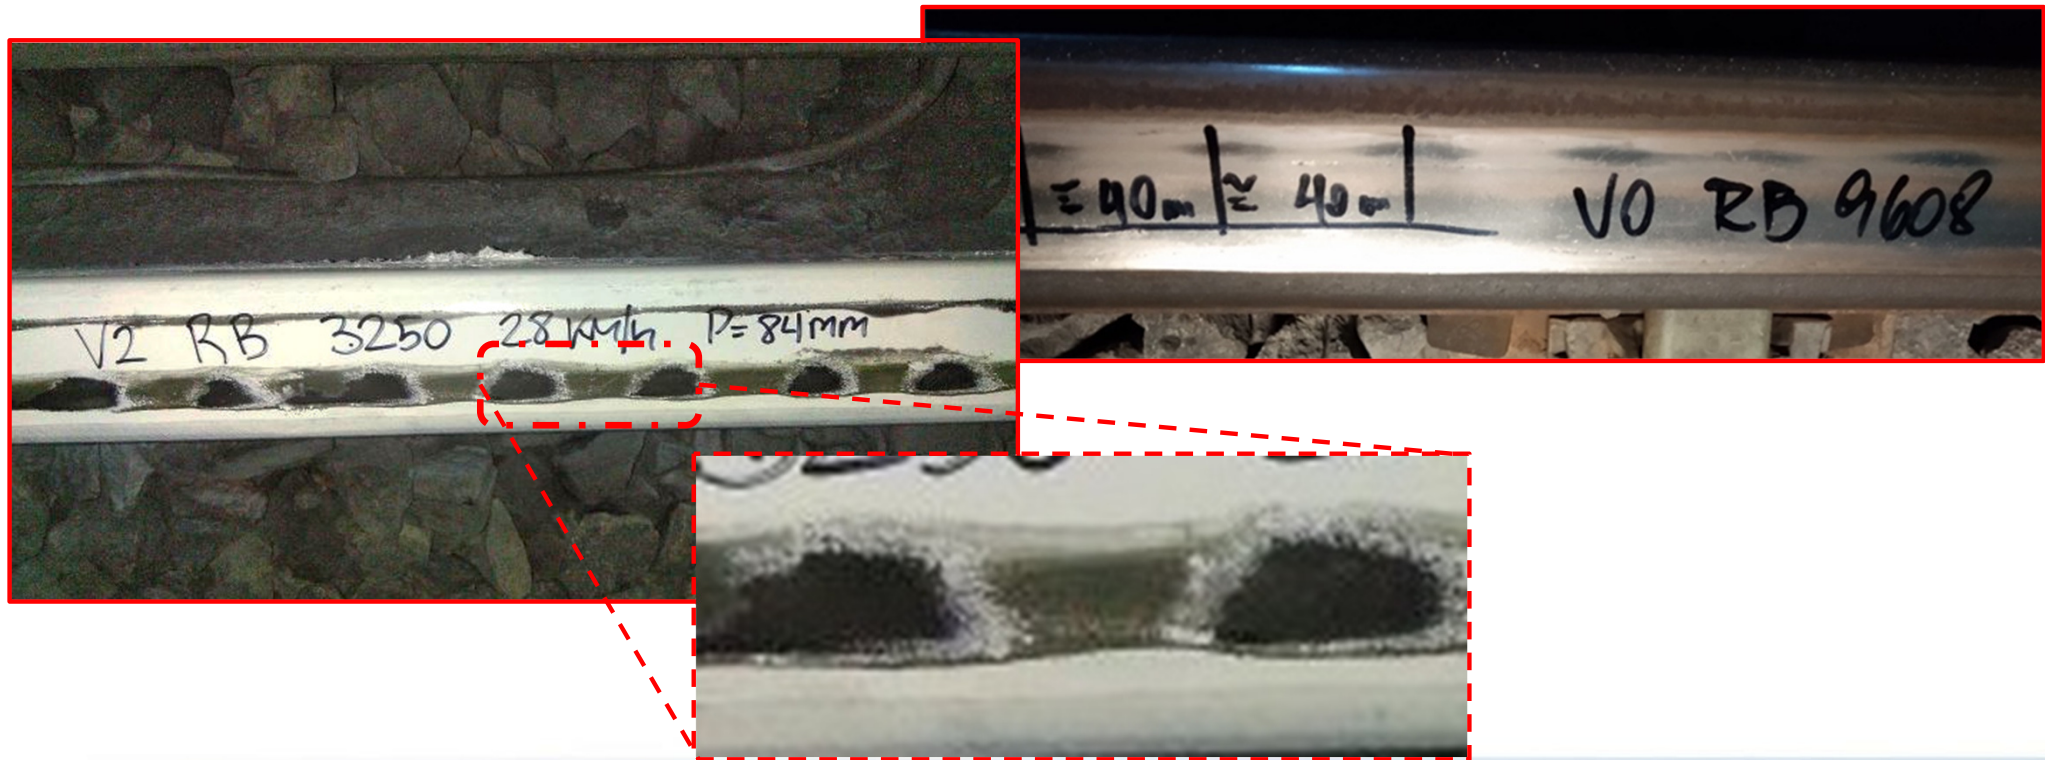
Track visual inspection - Low rail corrugation on curve

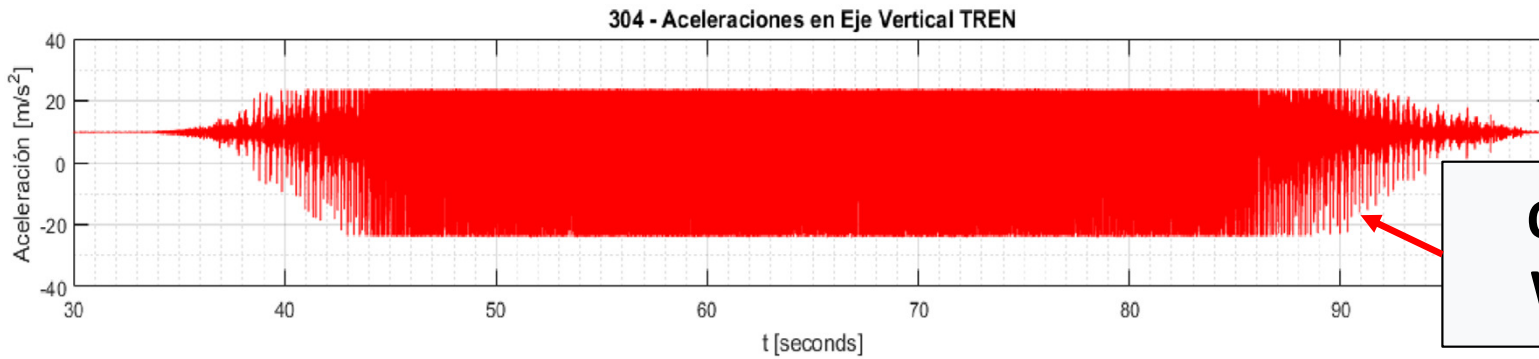
**Out of roundness
Wheel vibrations**

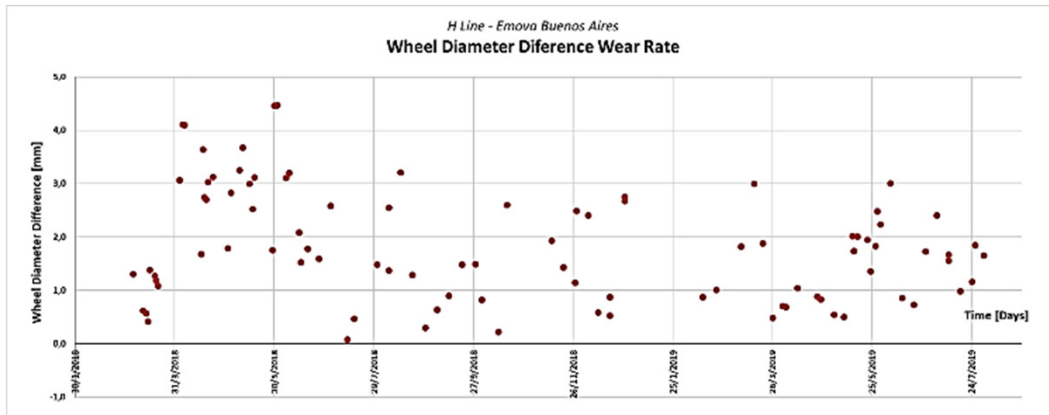
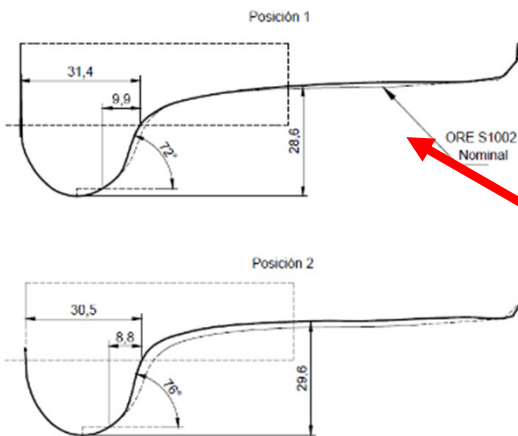
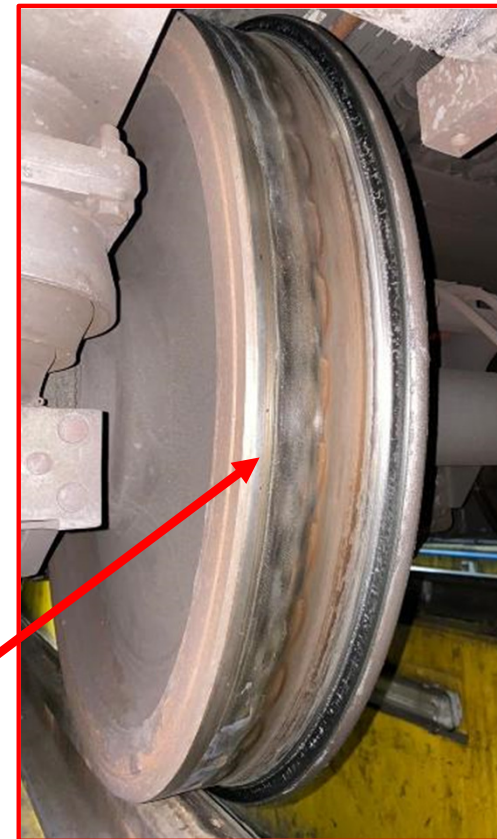
Wheels out of roundness and corrugation

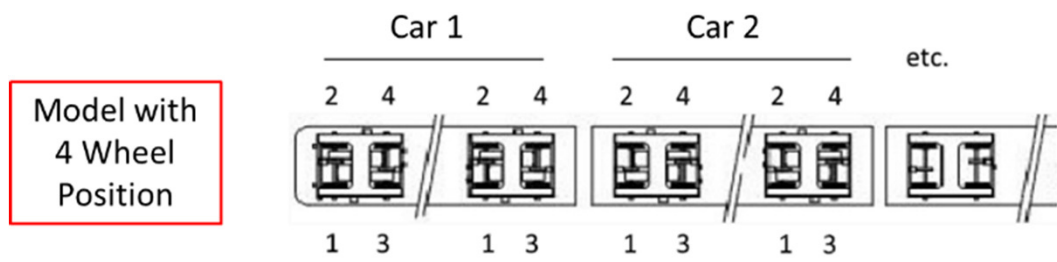
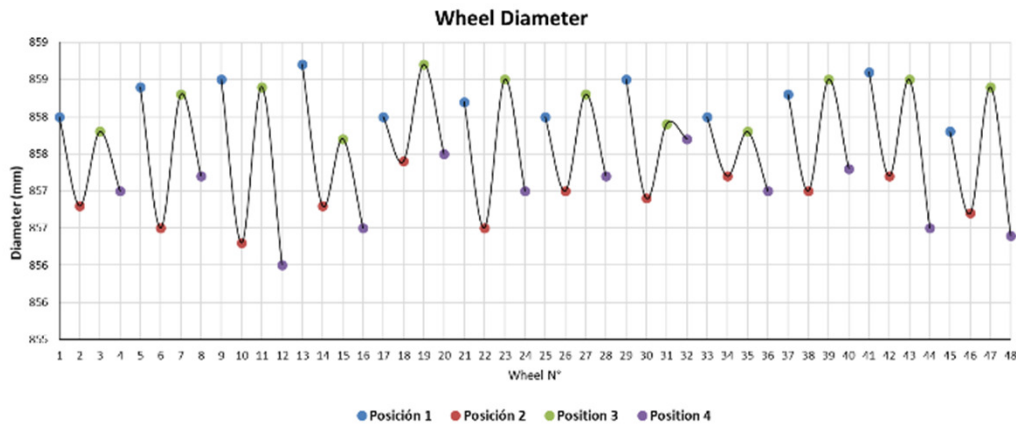
Identification Wheel Position Damage

Wheel diameter average of all values in the same relative position.

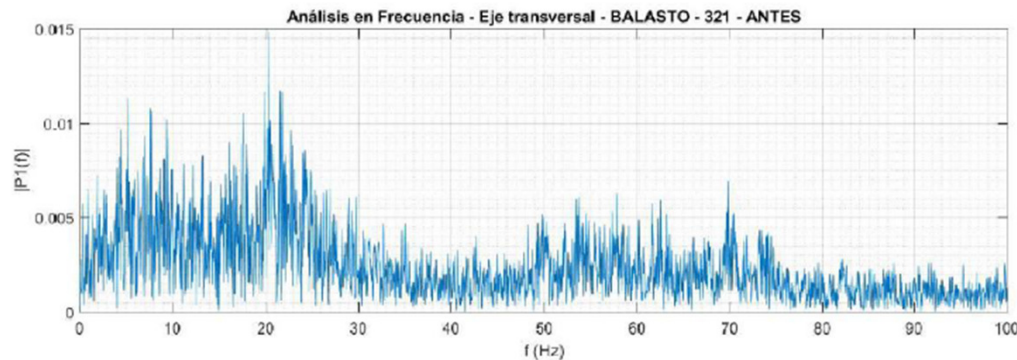
Before grinding rail with good Wheels train. Ballast track

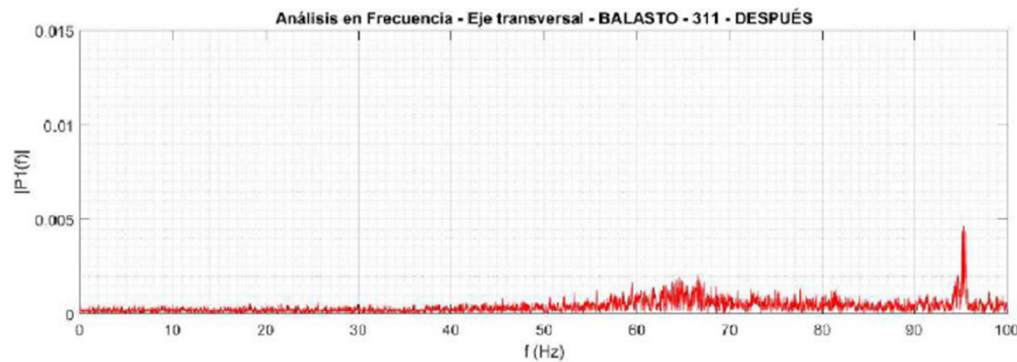
After grinding rail with good Wheels train. Ballast track

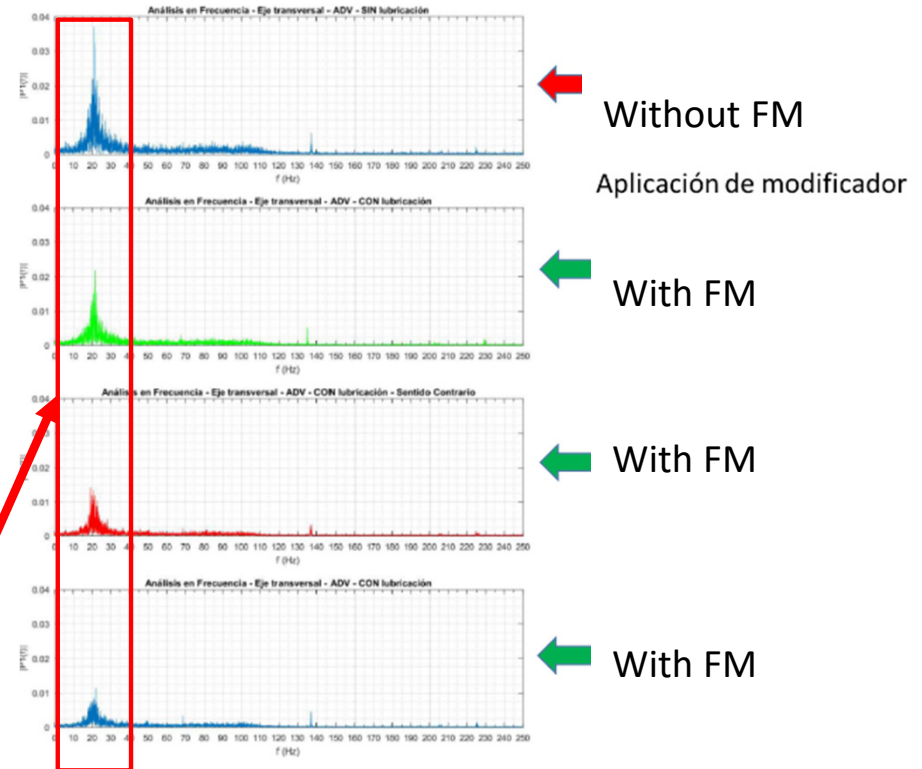
Friction Modifier - Track vibration measurement

Clear **vibration reduction** evidence.

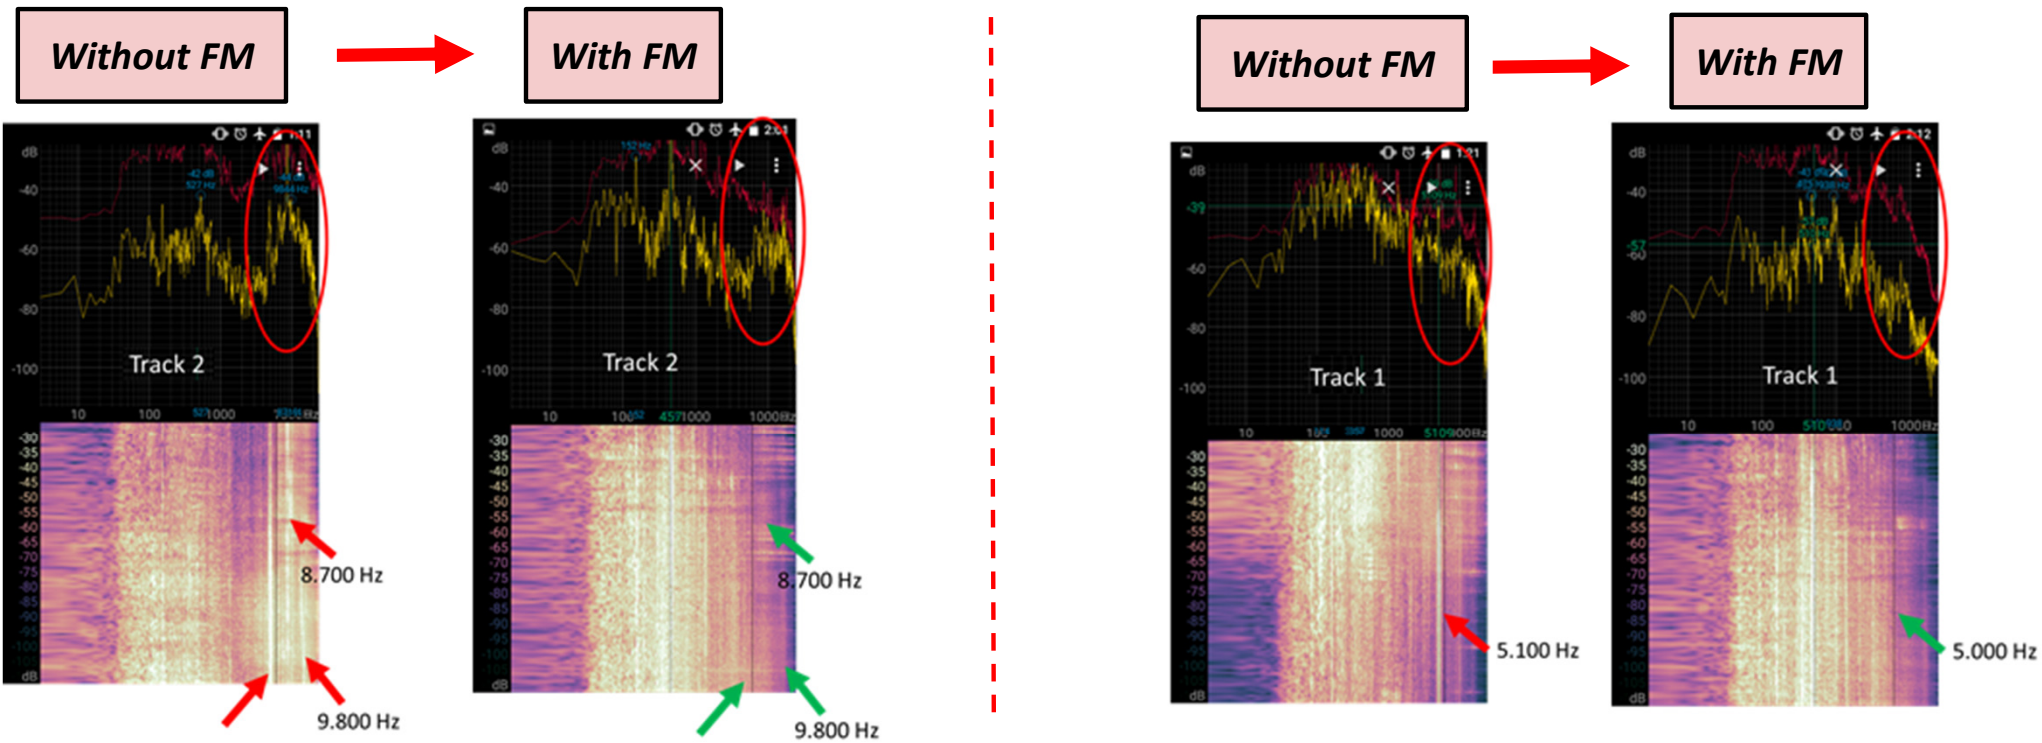
Friction modifier - **Sound emission** - Noise reduction
