Forensic Analysis of RCF defects

Dominick Pagano Technical Adviser, Plasser American

HEAVY HAUL SEMINAR • JUNE 8 - 9

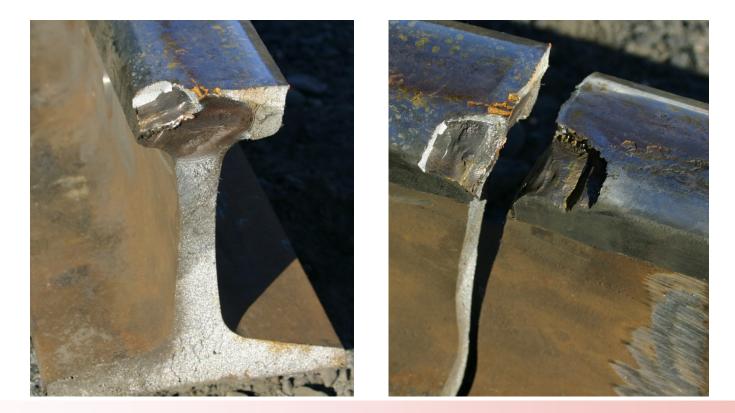
Gage Corner DF

- Since 1995, test frequencies in defect prone areas have increased from 2 to 12 times per year. One of the major metric used to determine the inspection frequency is service failures per year per mile of track.
- In 2005 a study of service failures on Class I railroads by TTCI indicated that certain internal rail defects may be undetectable with the current ultrasonic technology.
- During a 2005 RITF meeting, BNSF reported that while investigating DF service failures they noticed that some gage corner DFs displayed a horizontal component.

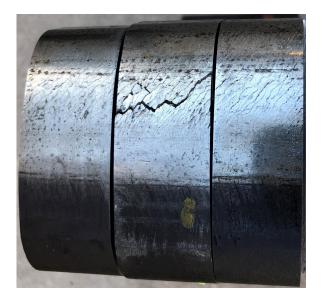
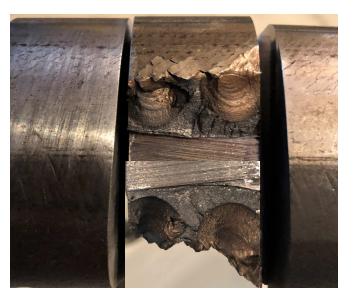
We have found that RCF (head checking) will randomly grow, merge and eventually spawn TD's at the merging zone. Consequently, the same detection problem exists that prevents reliable detection of TD's in and around these condition.

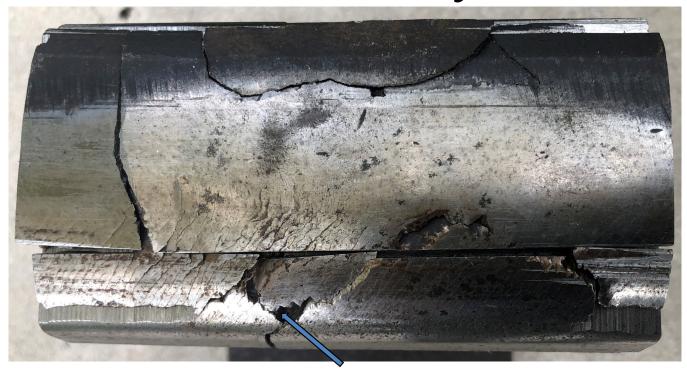
Case Study 1

After many test cycles this sample was tagged as having a small 10% TD

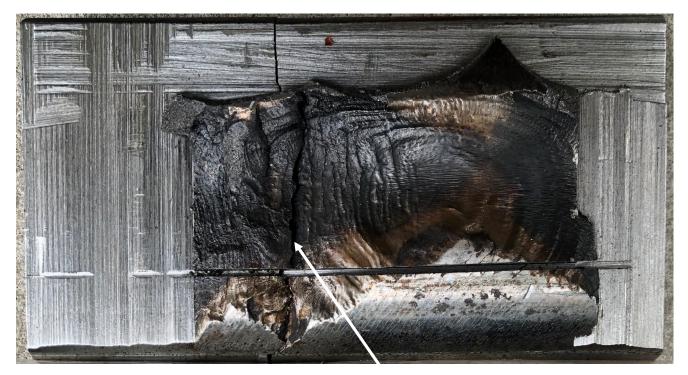
CASE STUDY 1

Our analysis showed the presence of a deep shell approximately 2" wide by 7" Long

Genesis of the TD

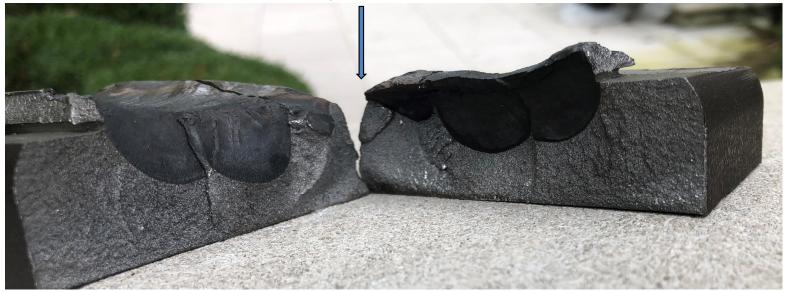
CASE STUDY 1

Gage Corner

Further analysis exposed the presence of three overlapping TD's ranging from 30% to 40%

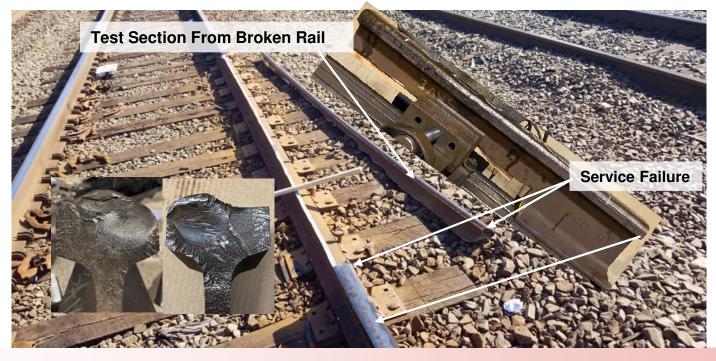
CASE STUDY 2 SERVICE FAILURE

The inability to detect the large TD resulted in a service failure, 15 feet of rail broke off after the trains last car went over the defect area.

The TD, initiated underneath deep head shelling and it appears to have slow growth, however the large deep shell horizontal component blocked its detection before failure.

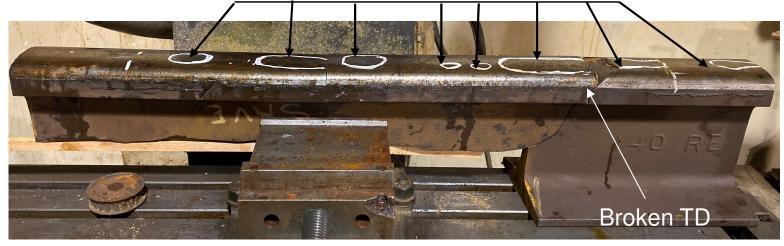
Mapped Boundaries of Deep Shells Within Rail

Field UT examination found moderate to heavy head checking surface conditions. Most of its length was free of any deep horizontal shells (greater than $\frac{1}{2}$ ") however, within a 3' to 4' section around the service failure, we did find at least seven deep shells. These deep shells ranged from $\frac{3}{4}$ " to over 8" in length and $\frac{1}{16}$ " to over $\frac{3}{8}$ " deep.

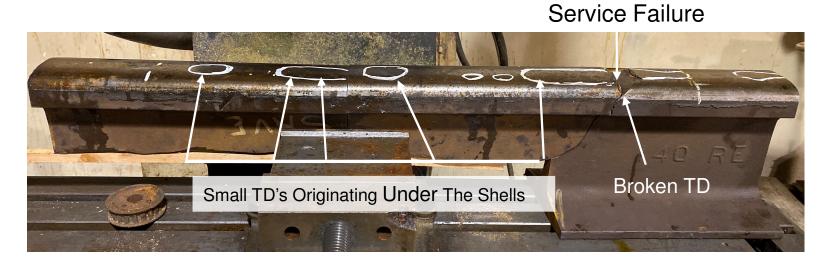
CASE STUDY 2 SERVICE FAILURE

Sectioning and examination on and around the deep shells found several small TDs at different growth stages.

Transvers defects ranging from 5% to 20%
