# Studs, Squats, and similar damage mechanisms

Richard Stock, Mark Reimer and Eric Magel

# Seattle Sound Transit

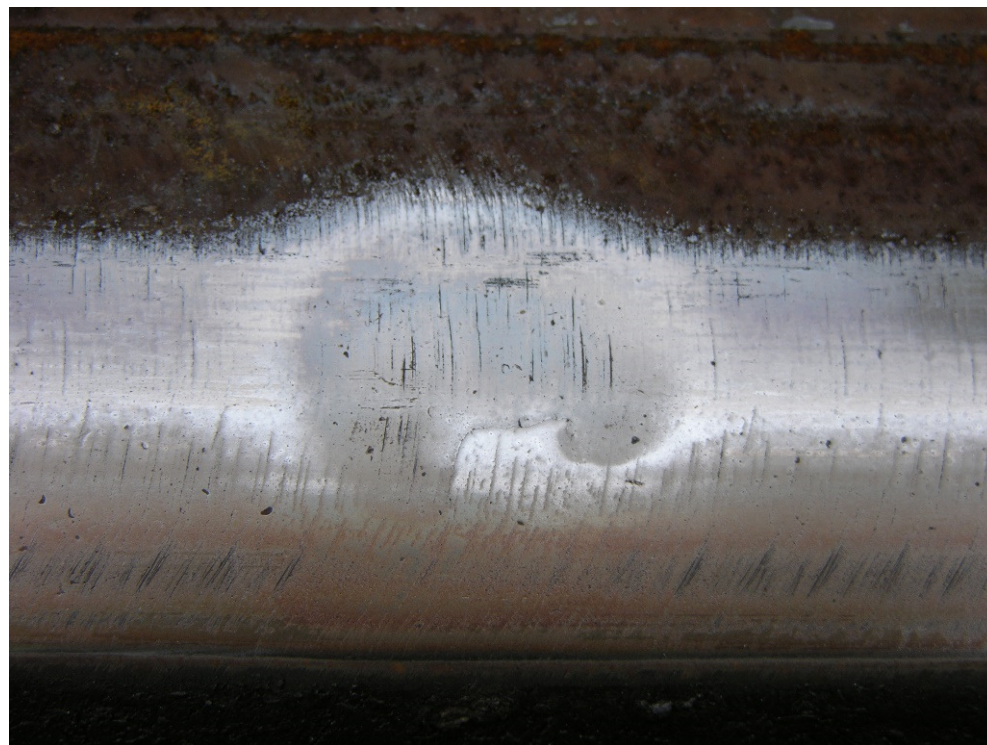
- Kidney shaped widening of the contact band (dark spot)
- V-Crack (gauge side)
- Full grown defect:
  - Crack re-surfacing on field side

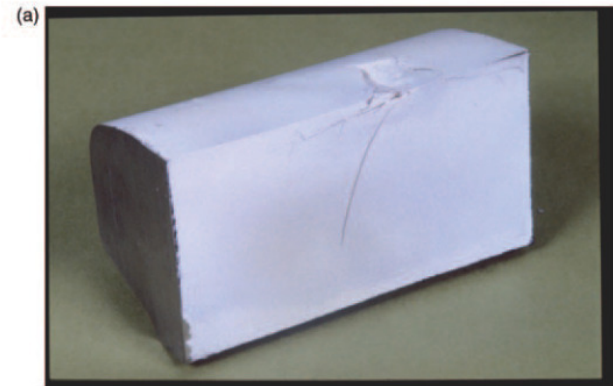
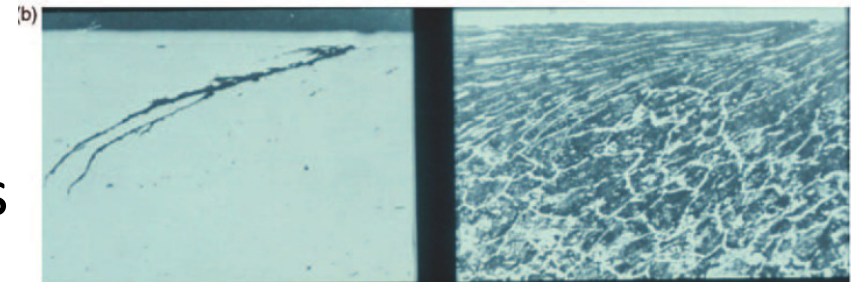
- Heavily sheared rail surface
- Crack initiation and growth by ratcheting (RCF)
- Initiation after a few 10s of MGT
- Slow growth (within 100+ MGT) to full size
- Straight track and shallow curves
- Can result in rail break

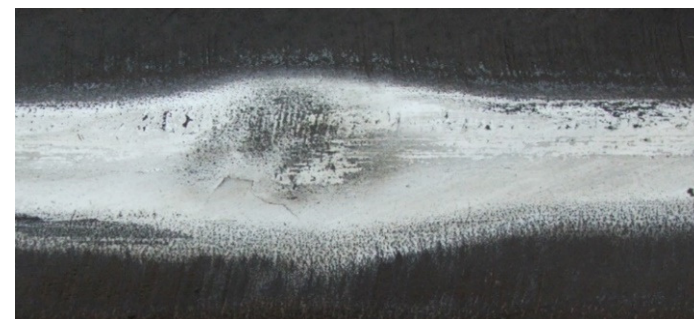
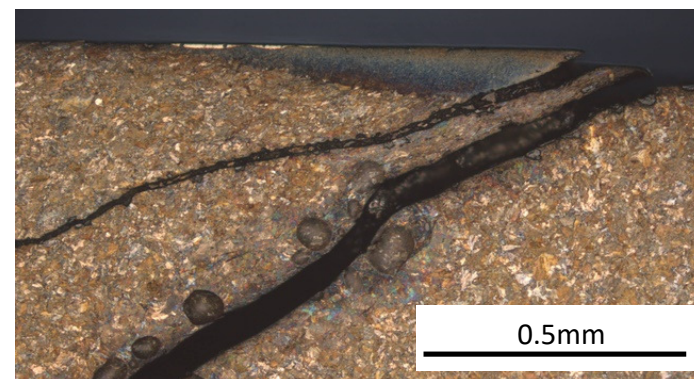
- Characteristics:
  - Almost no plastic deformation
  - Formation within 10MGT or less
  - Old and new rails, tangent and curves
  - Presence of WELs
  - Not found in tunnels
- Preventive rail maintenance strategies of limited mitigation success

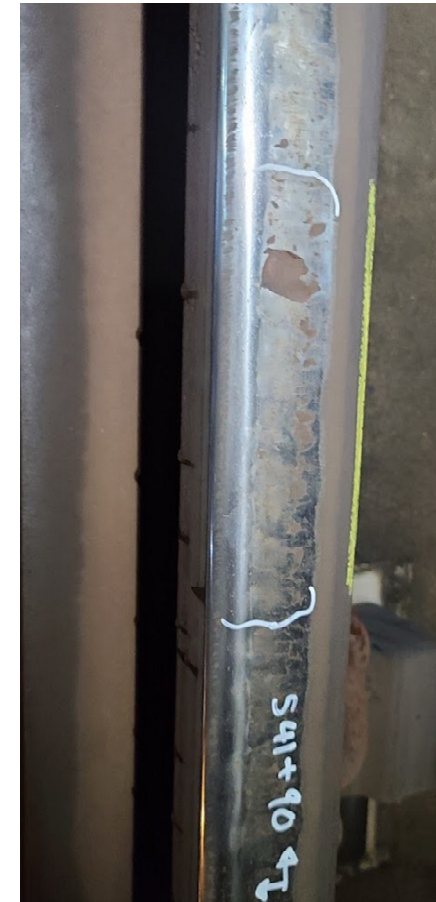
- Specific 5-mile segment of elevated track
  - Includes high speed segment (55 mph)
- Occurs in tangent, curves, and grades
  - First high occurrence area was level, tangent track with corrugation
- Started in small batches and were weld head repaired, eventually ground, milled and/or replaced

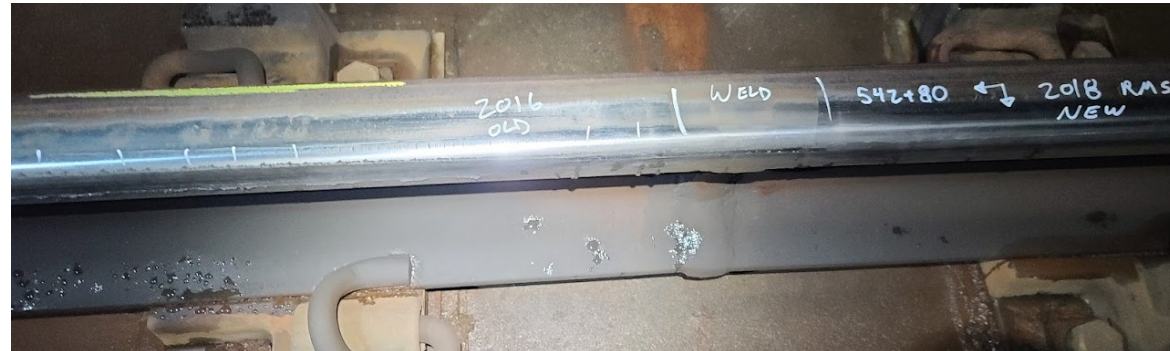
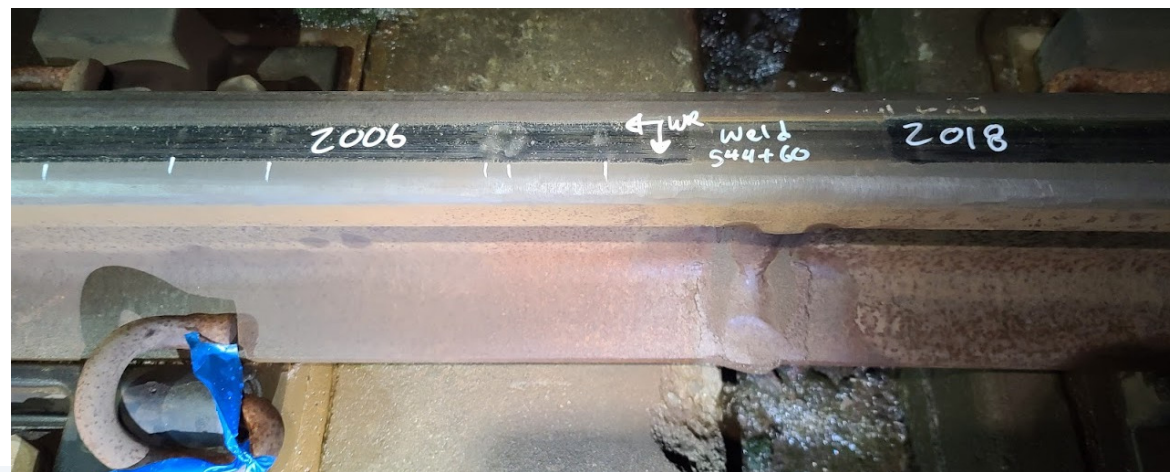
- Suspected originally that defects could be associated with “bad” rail
- Defects found in almost all ages of rail but since 2018 limited recurrence

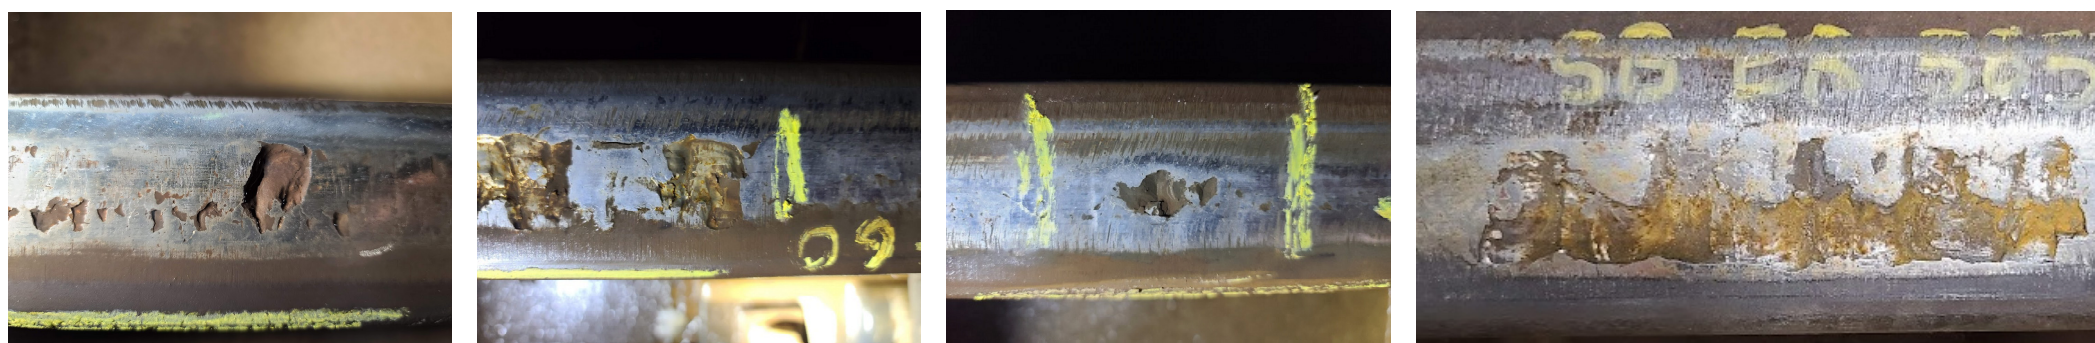
- Major concern was potential for a rail break and safety concerns
  - Secondary: ride quality and noise
- No evidence that rail breaks had or will occur from these defects
  - Operational impact still exists due to slow orders

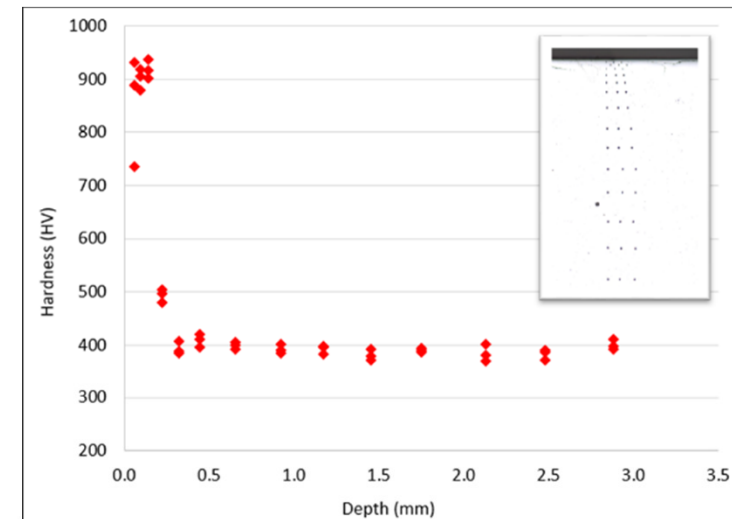
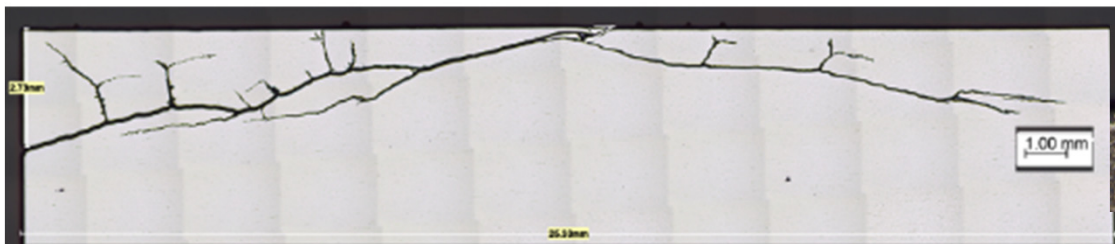
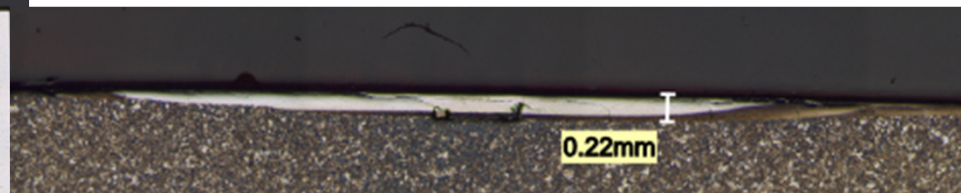
- Metallurgical analysis identified
  - No quality issues with original rail
  - WEL present at all defects
    - Hardness levels as high as 900 Vickers
  - No vertical cracks

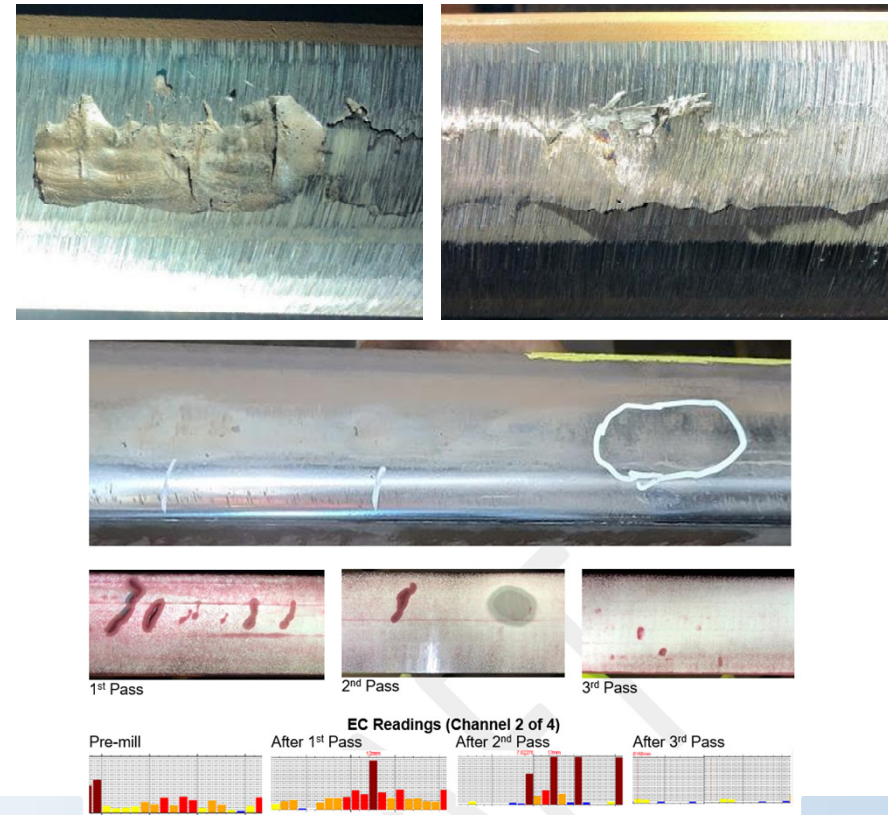
- Rail grinding not efficient even at incipient level
  - ‘exposed’ subsurface cracks
- Rail milling required 3+ passes (4mm and more)
  - Severity would get worse before they got better

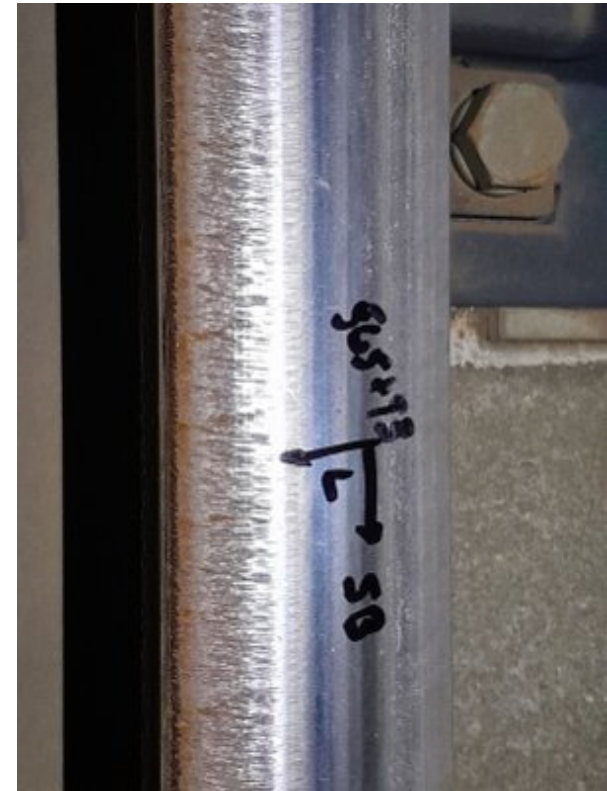
- Milled rail after more than 2 years (~15 MGT) has no signs of defects returning
- Replaced rail (c. 2018 and newer) does not have the level of studs of older rail
- Milled and replaced rail segments have been ground regularly starting in 2018
  - Area with studs scheduled for annual grinding

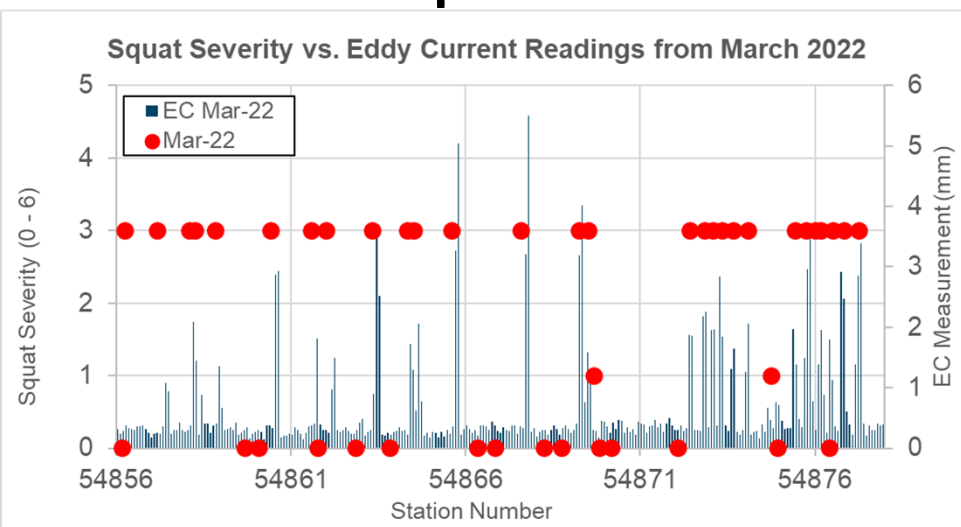
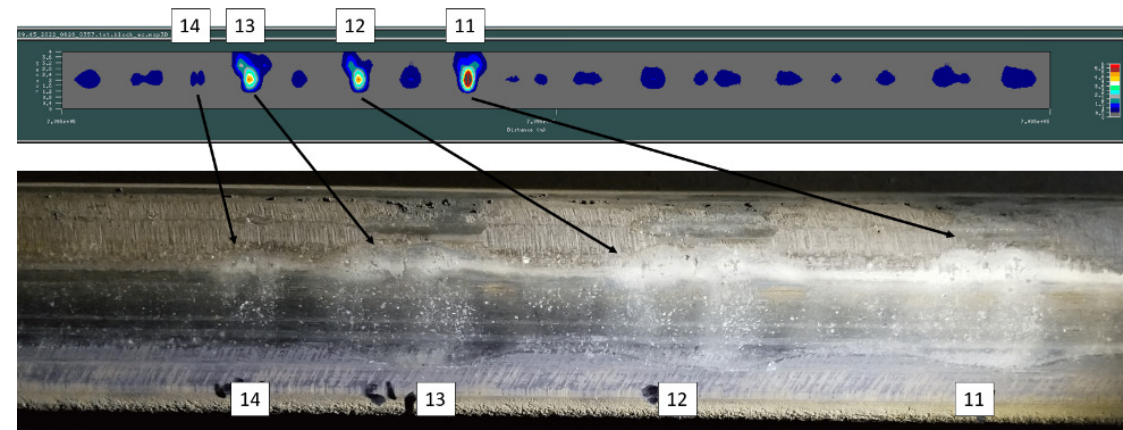
- Use of eddy current and ultrasonic inspections show promise for identifying existing studs

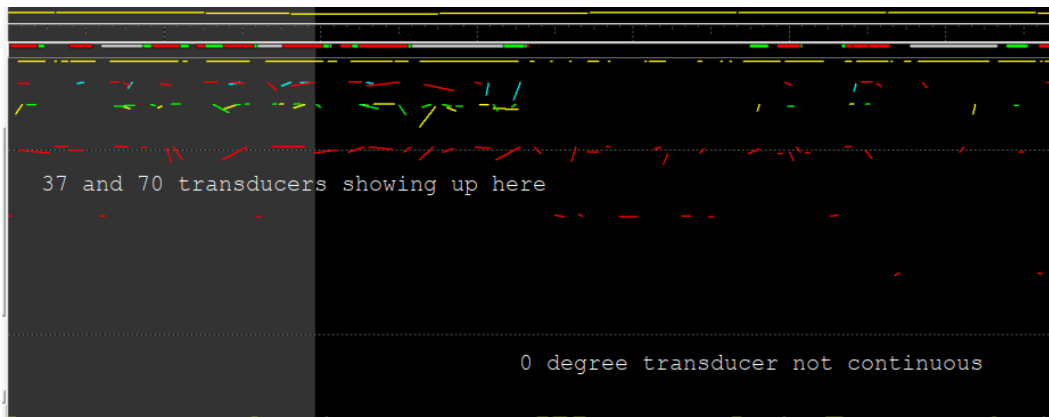
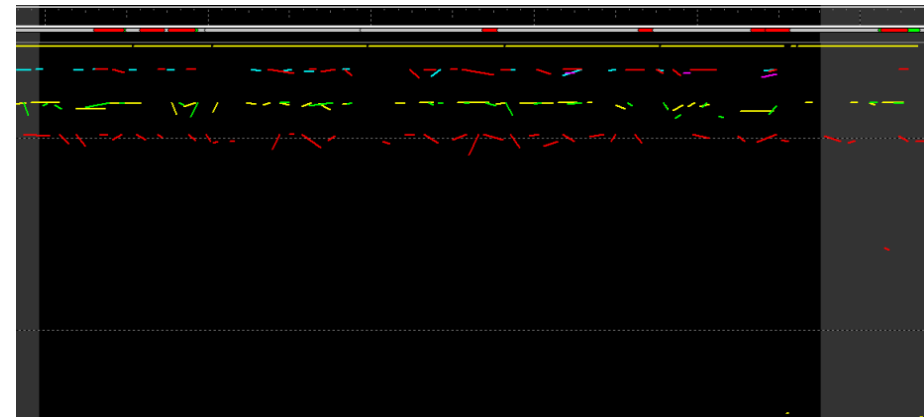
- Use of eddy current and ultrasonic inspections show promise for identifying existing studs

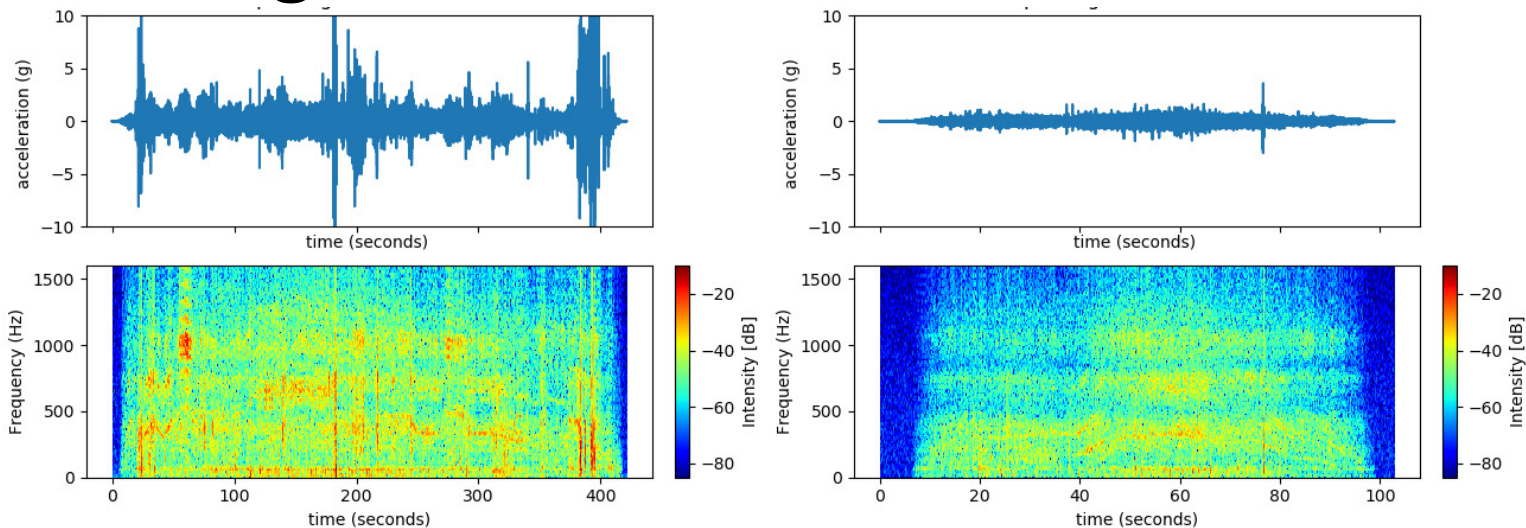
- Use of axle box accelerometers can identify bad acting sections of track

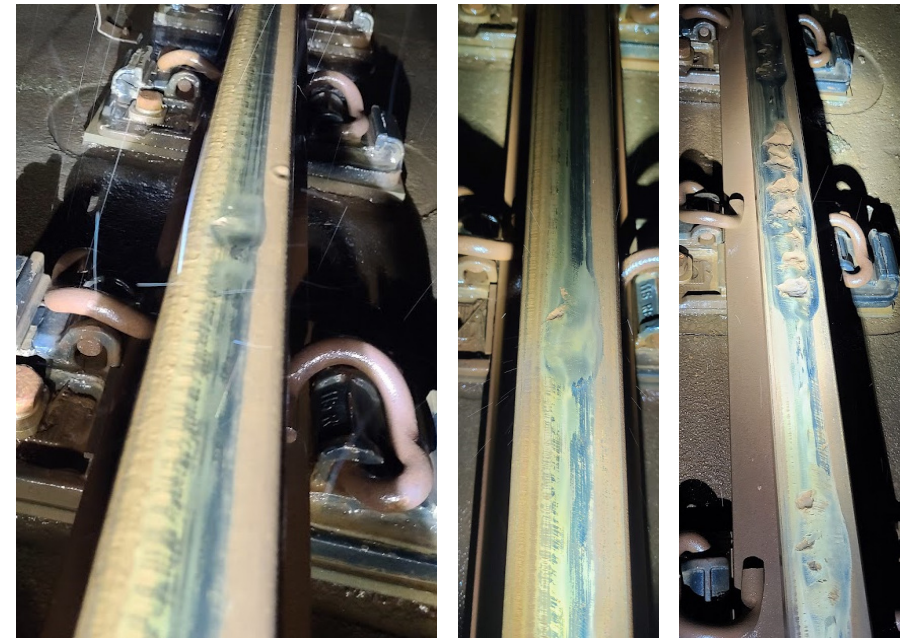
- Some evidence of similar type defects
  - Not pervasive
  - No detailed study
- Annual preventive grinding
- Defects have not worsened in 5+ years
- Slowly being replaced as part of scheduled capital renewal
