# Manganese Cup Bowl Liners for TTX Articulated Well Cars

## Track testing, Lab testing and Field Trials

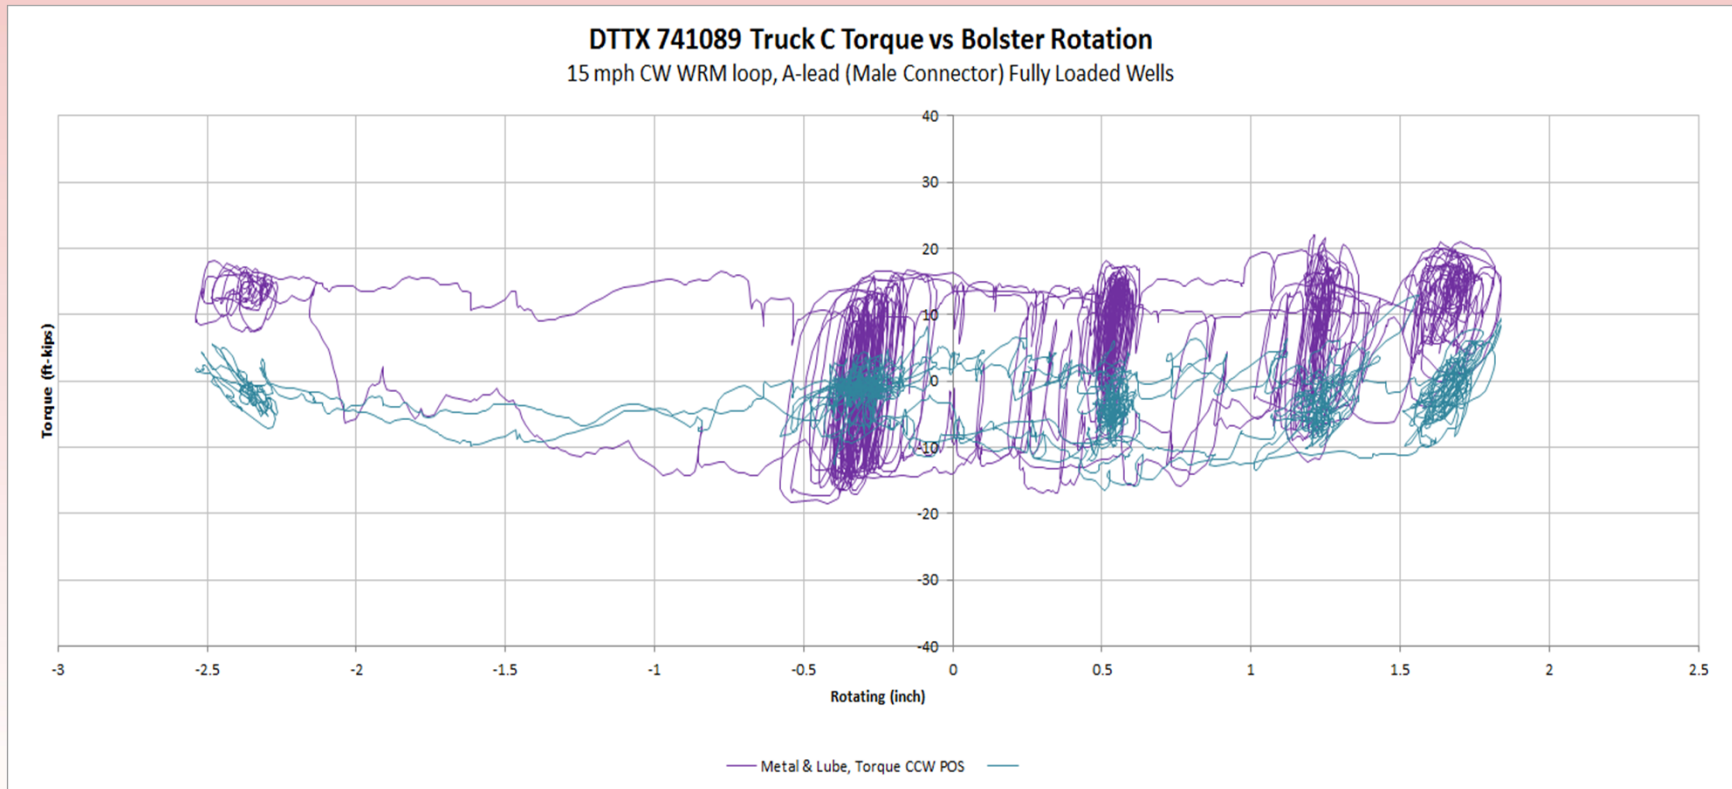
# Torque Measuring Bolster

## Lubed Metal Torque vs. Displacement, UB speed

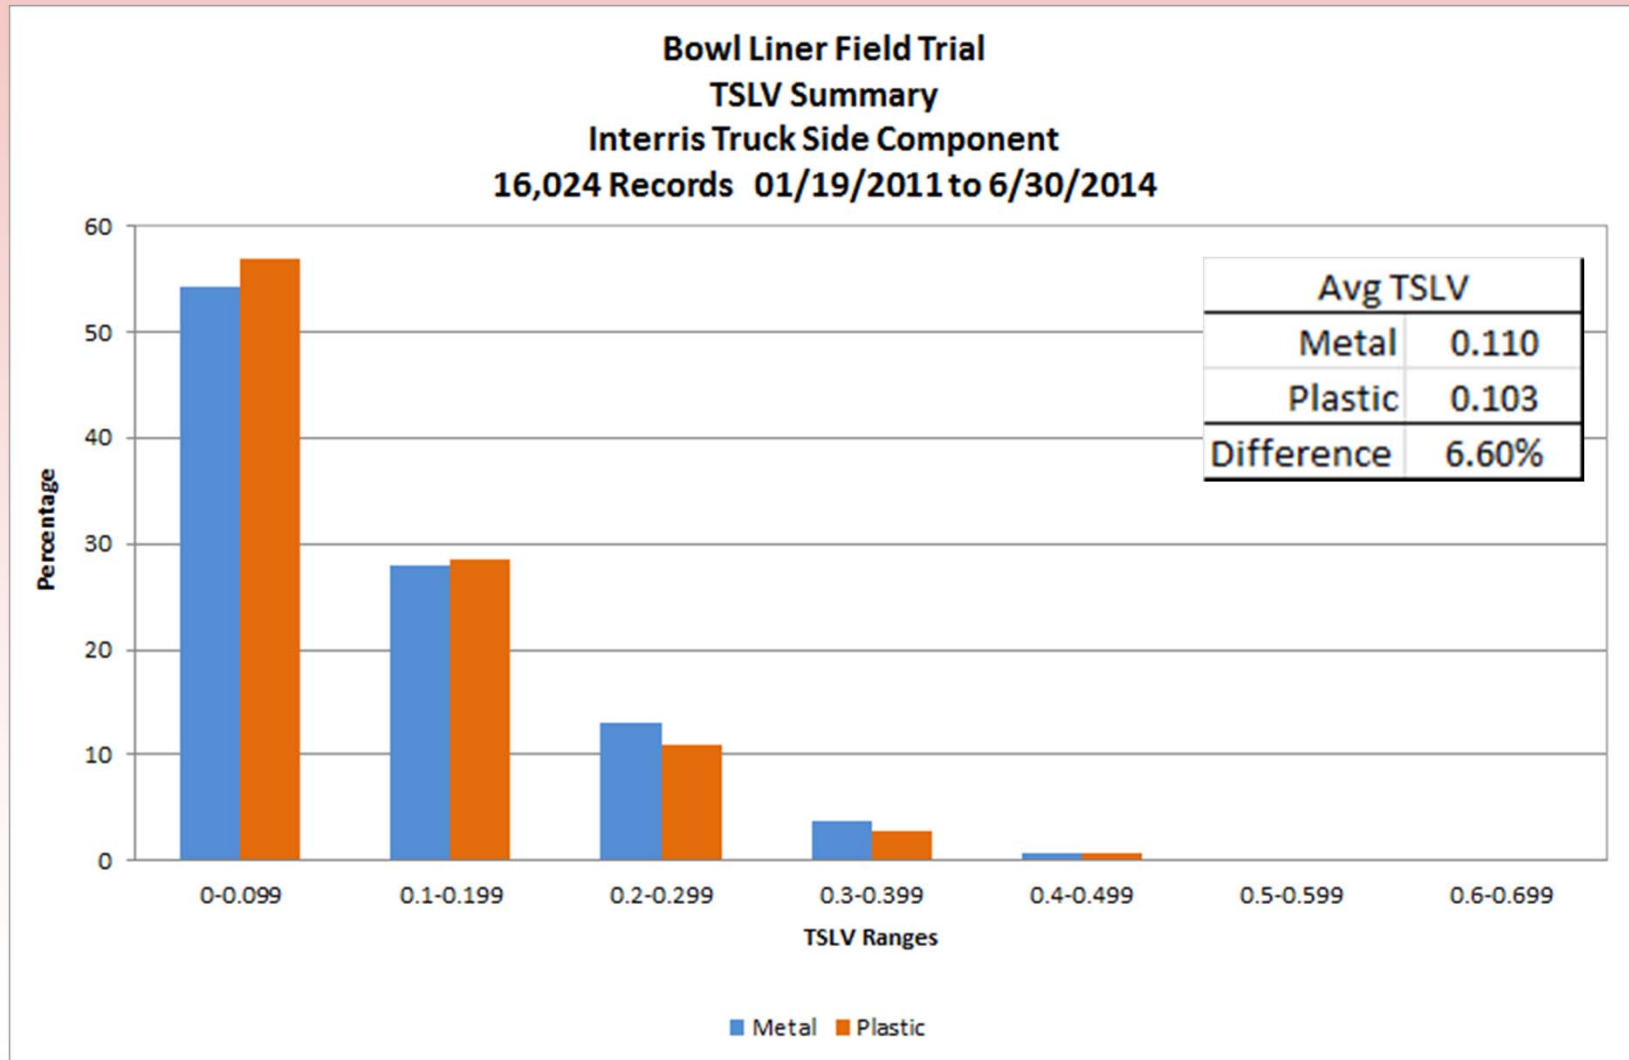
# AAR Field Trial-TPD

1. Started in 2009 with 40 cups
  1. Half of the trucks in the articulated well cars were equipped with Mn-Steel cups and half with non-metallic cups for comparison over TPD and THD detectors.
  2. Used Truck Side L/V (TSLV) from TPD's as this measure increases rapidly with resistance to bolster rotation.
  3. Used Hunting Index (HI) from THD's.

1. Mn-steel and non-metallic cup liners have similar torque values on bolster and similar wheel/rail forces in curves.
2. Slight advantage in curving for non-metallic and a slight advantage to resist hunting for Mn-Steel cups.
3. Expect Mn-Steel cups to have longer life and less thickness loss, perhaps fewer CCSB adjustments.

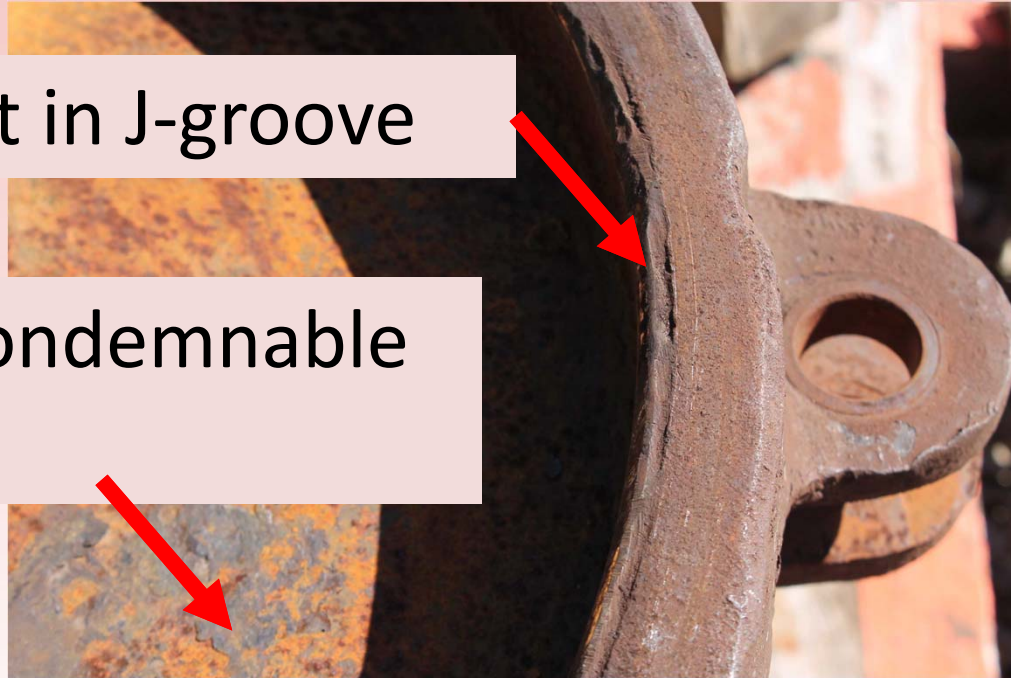
# Issue with weld metal left in Bolster bowl J-groove

Weld left in J-groove

Bowl is condemnable  
depth

- Both Bowl Liner types use J-groove space for turn radius to lip on cup.

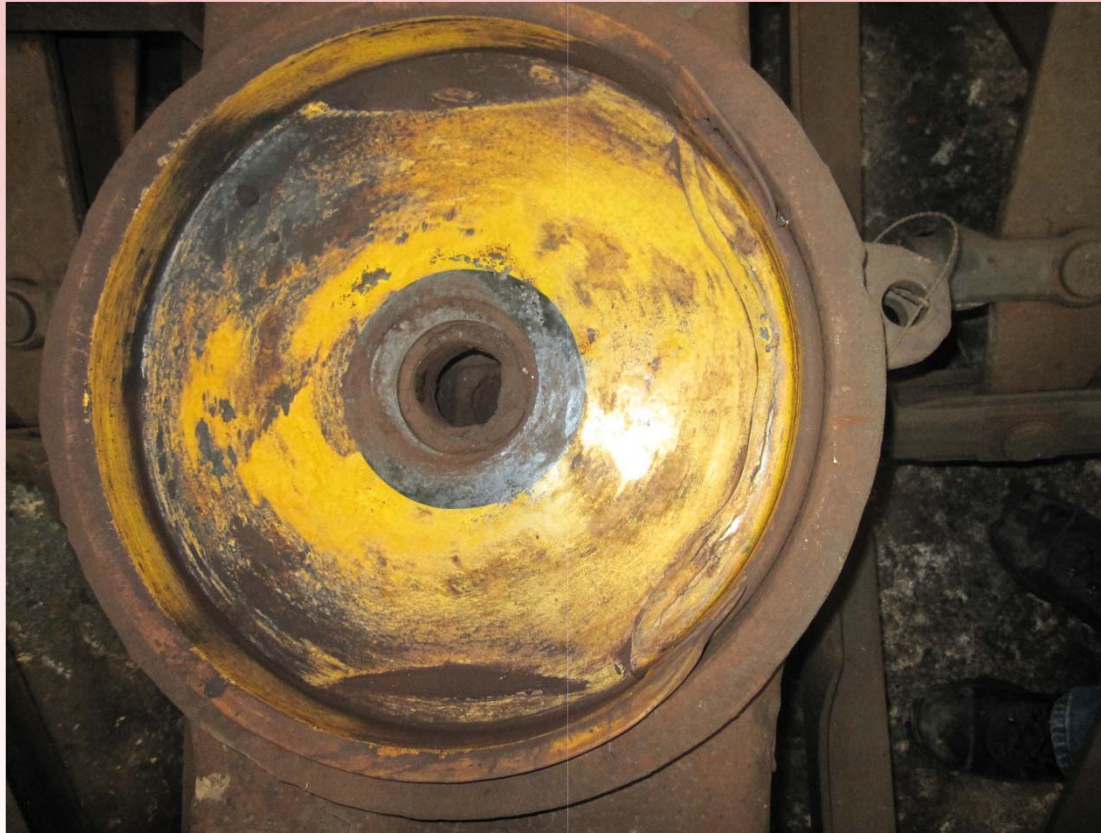
# Weld metal left in bowl J-groove

- Issue with non metallic liners

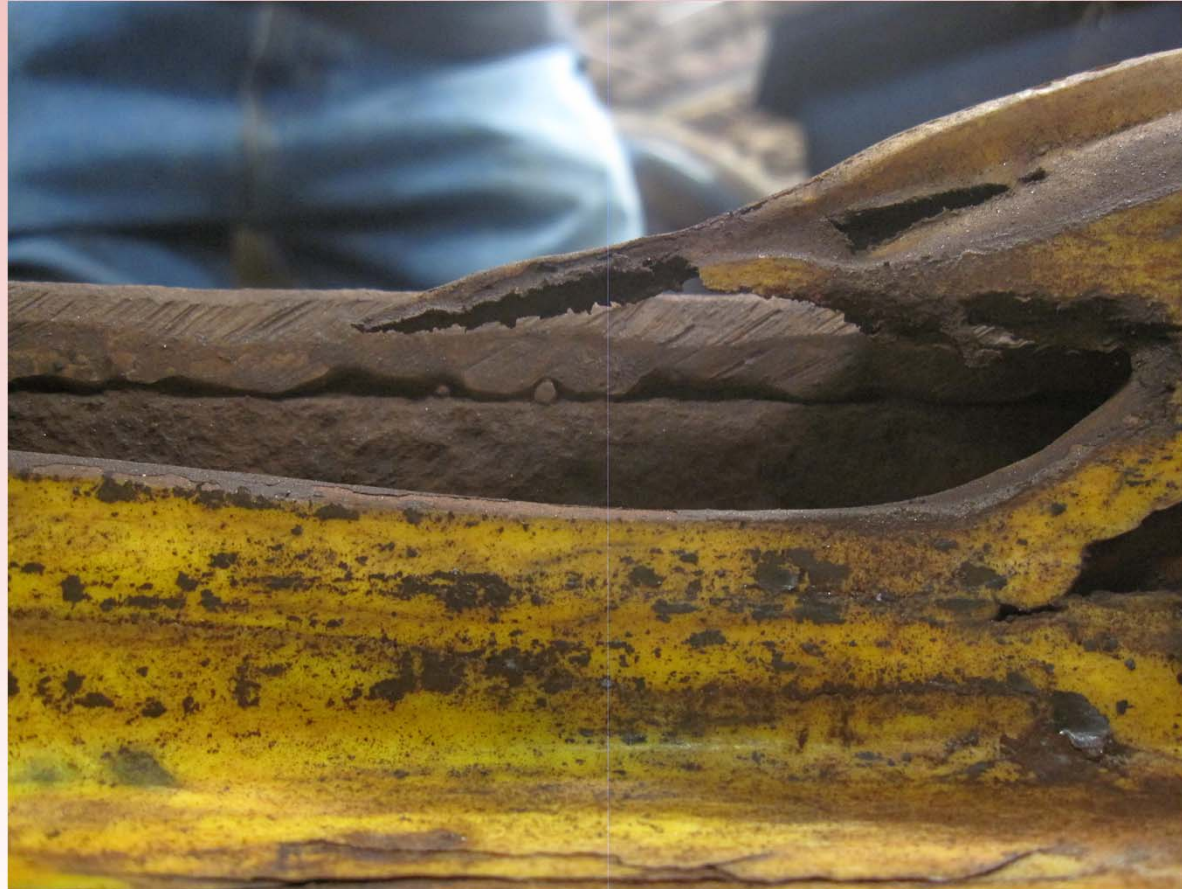
# Weld metal left in bowl J-groove

- Issue with non metallic liners
