# The Effect of Train Mounted TOR-FM on Wheel Life and Defects

John Peters, Union Pacific Railroad

Dave Elvidge, L.B. Foster Company

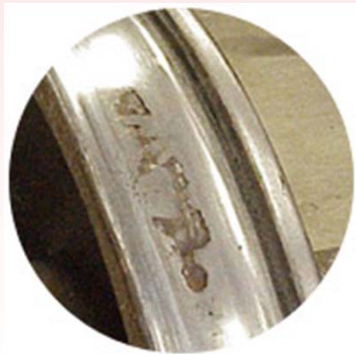
- **Biggest causes of wheel replacement are:**
  - 1) Tread damage, 2) High Kips, 3) Wear
- Tread damage is commonly due to RCF leading to shelling
- High Impact loads (kips) due to either shelling/spalling or flats

**Wheel Shelling**

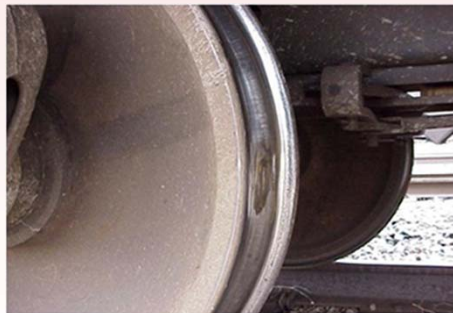
**Wheel Slid Flat  
(high impact)**

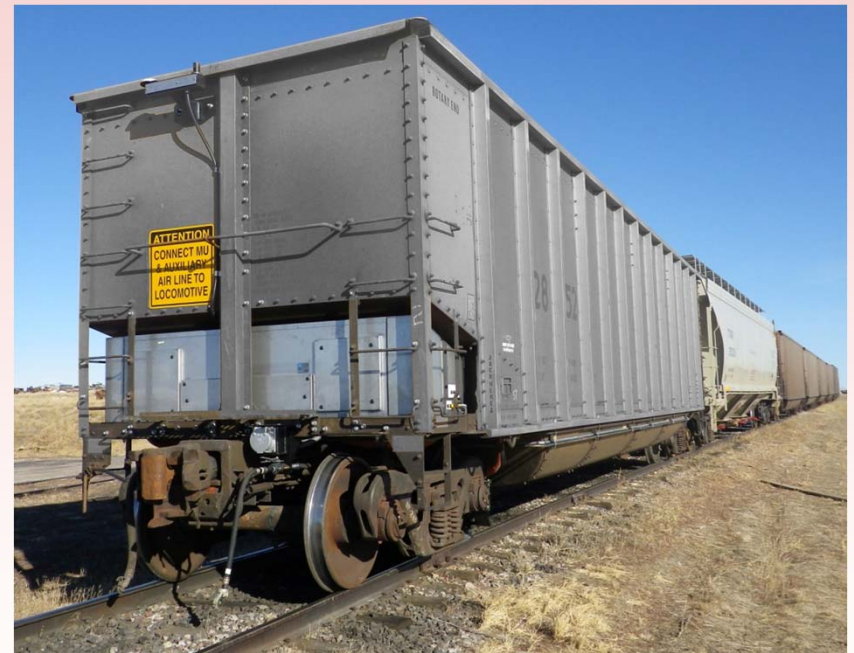
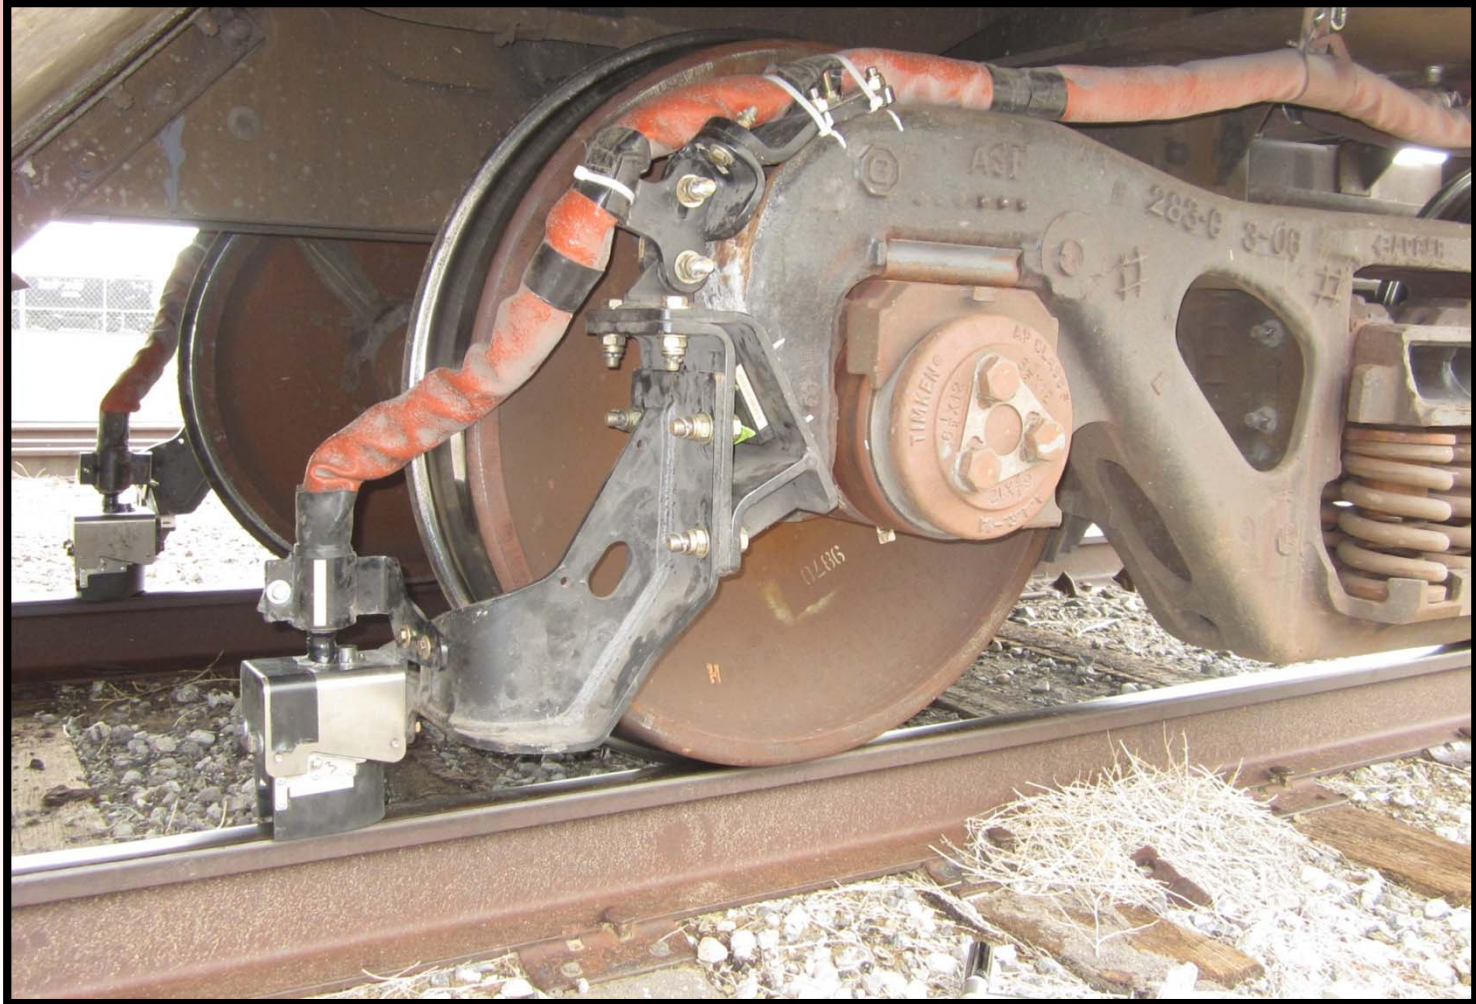
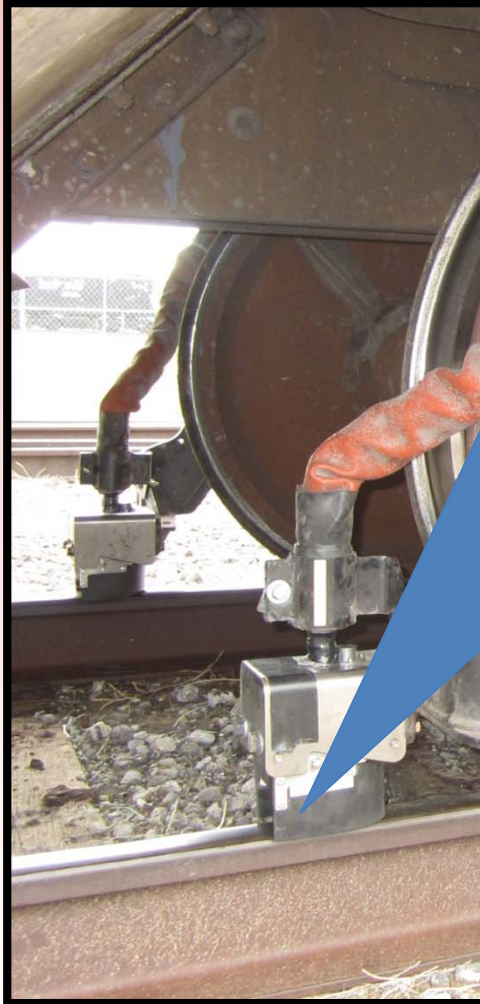
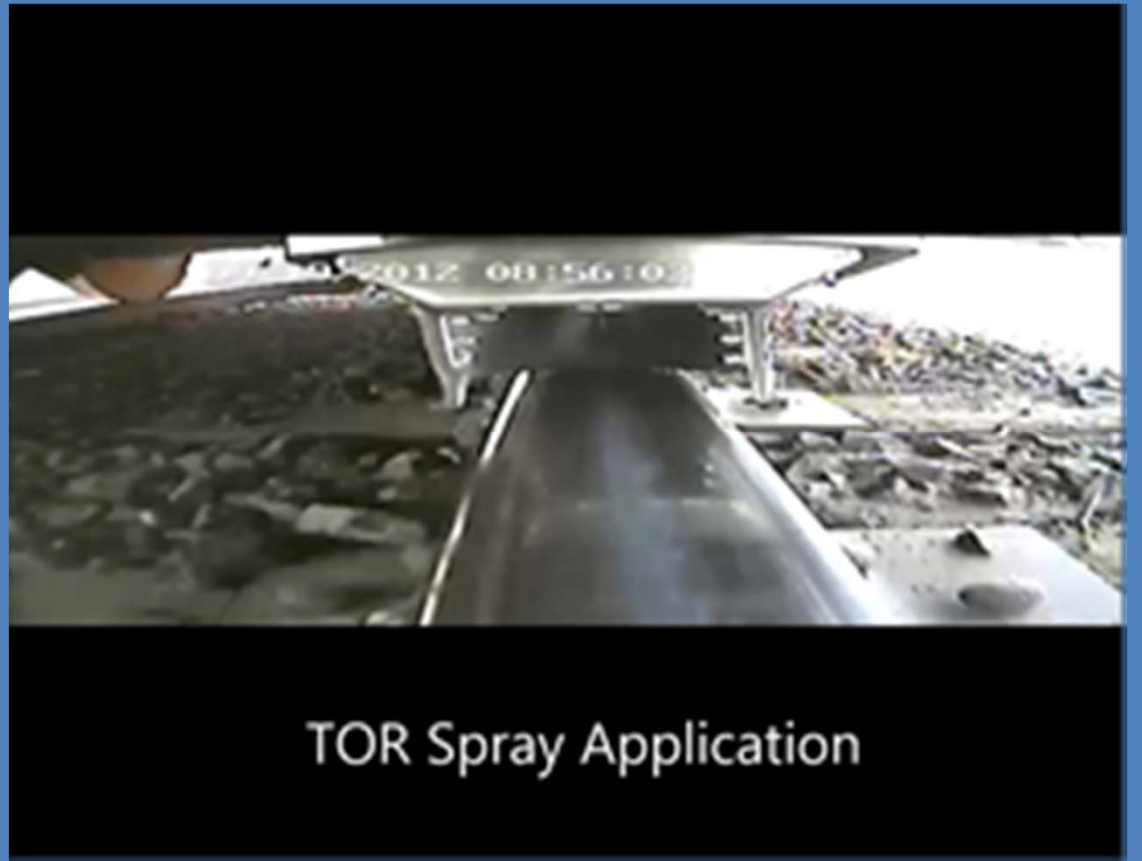
# AutoPilot™ Train Mounted TOR Application

- Delivers a precise amount of Friction Modifier to the wheel-rail interface
  - Large territory coverage
  - Customisable application strategy
  - Minimal train crew involvement
  - Remote Performance Monitoring
  - Outsourced maintenance, high uptime (>90%)

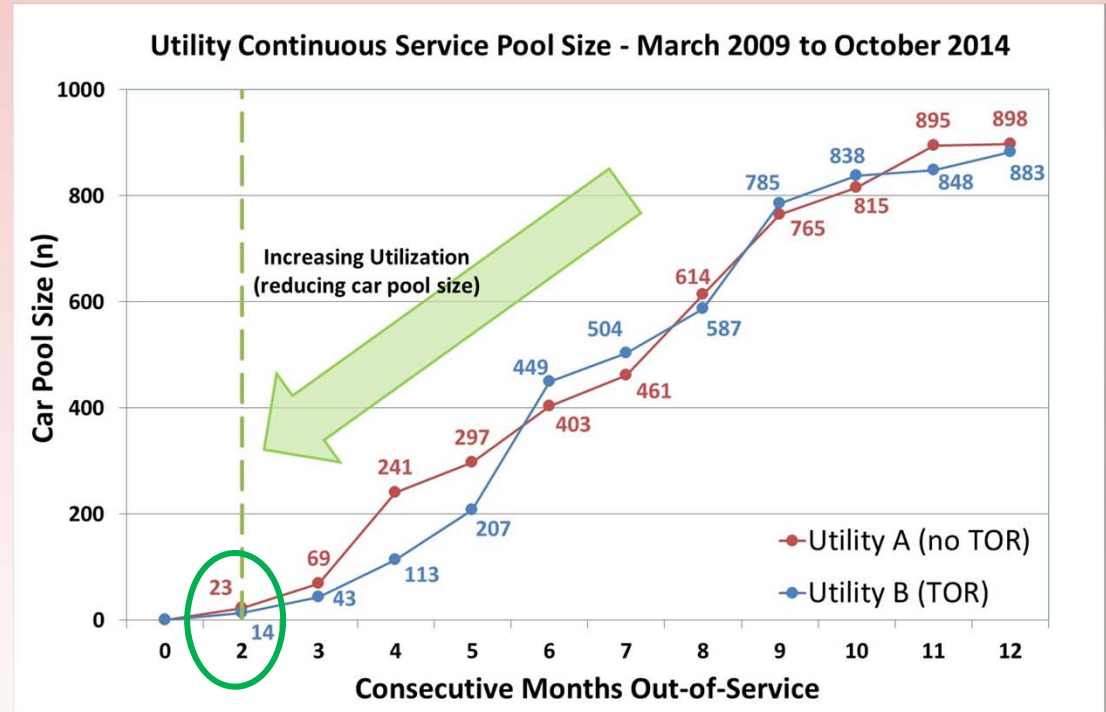
- AEI database analyzed for utility inventory monthly car utilization
- Cars out of service more than 2 months excluded

Utility A (no TOR) = 23 cars

Utility B (TOR) = 14 cars

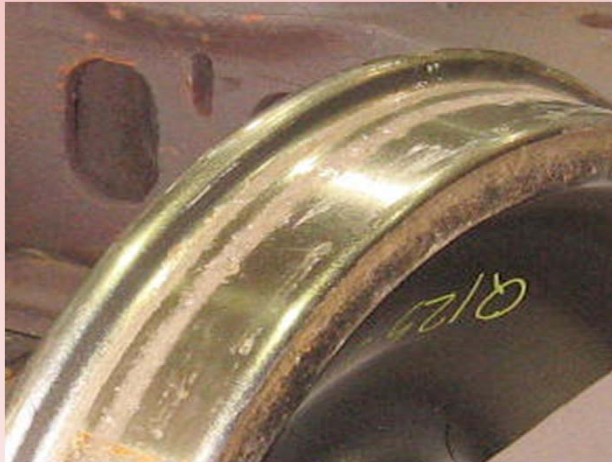
New Wheel Tread

- As tread RCF advances - defect size and scale enlarges increasing vertical impact forces
- AAR regulations regarding high impacts:
  - > 140 kips specify immediate wheel replacement
  - > 90 kips typically wheels replaced within 3 months

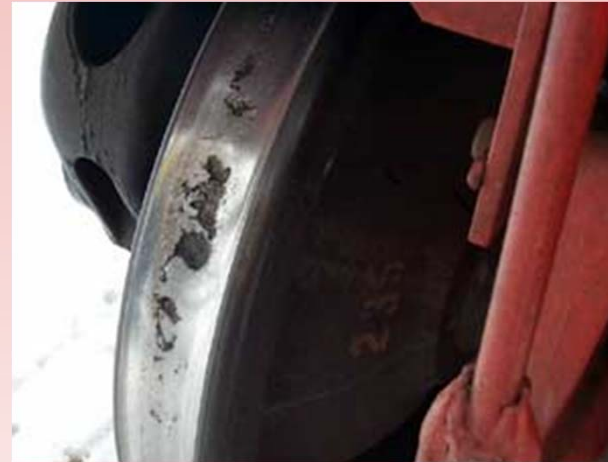
Shelled Wheel Tread

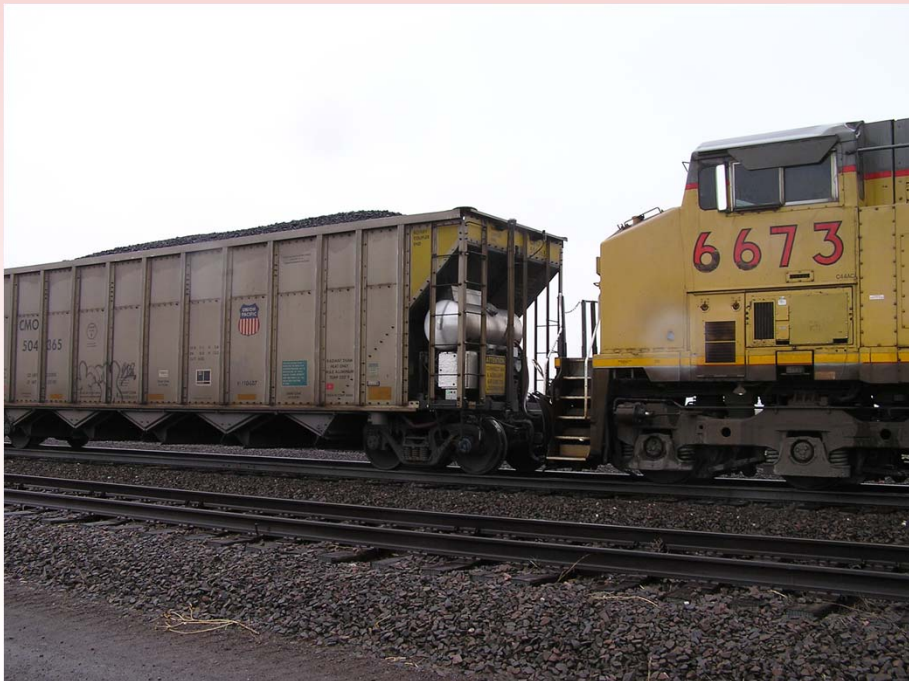
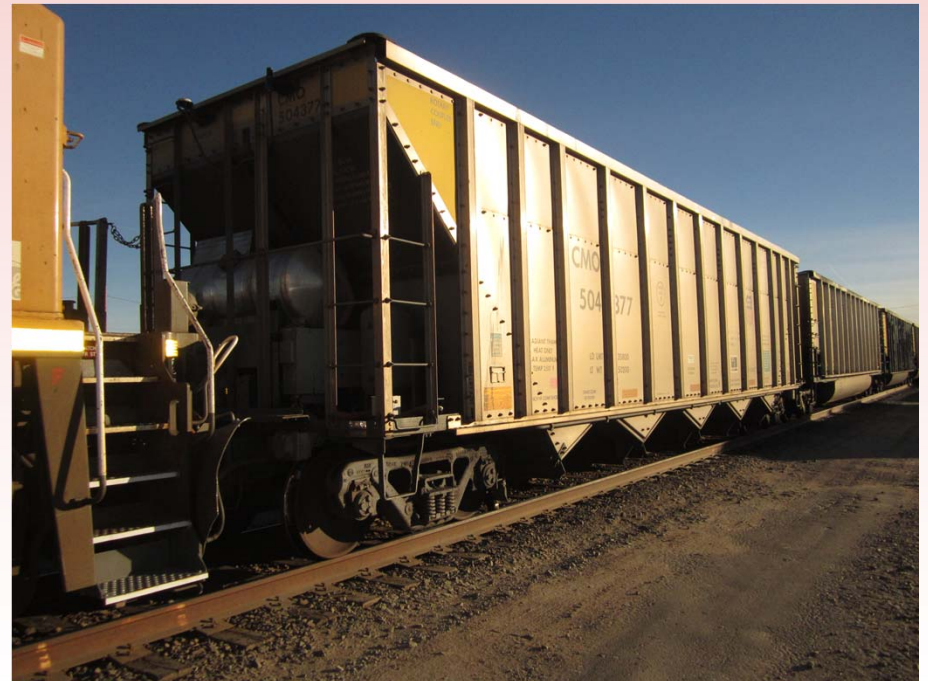
# Wheel Wear Analytical Method

# UP Wheel Profile Measurement Site:

- Gothenburg, Nebraska

- Flange height measurements provided consistent detection of wheel change points
  - Provided progression of tread wear and hollowing

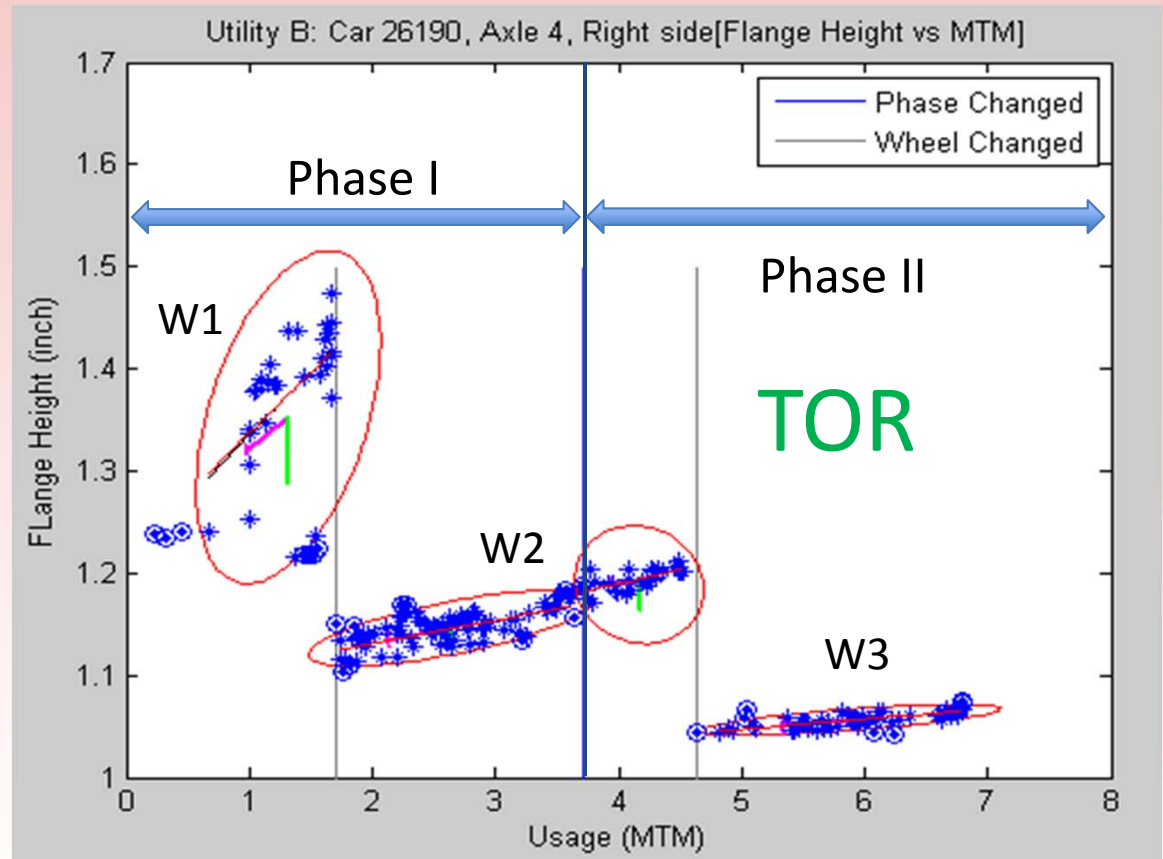
# Determining Wheel Wear Rate (WWR)

- W1, W2, W3 are same position on car, two change outs

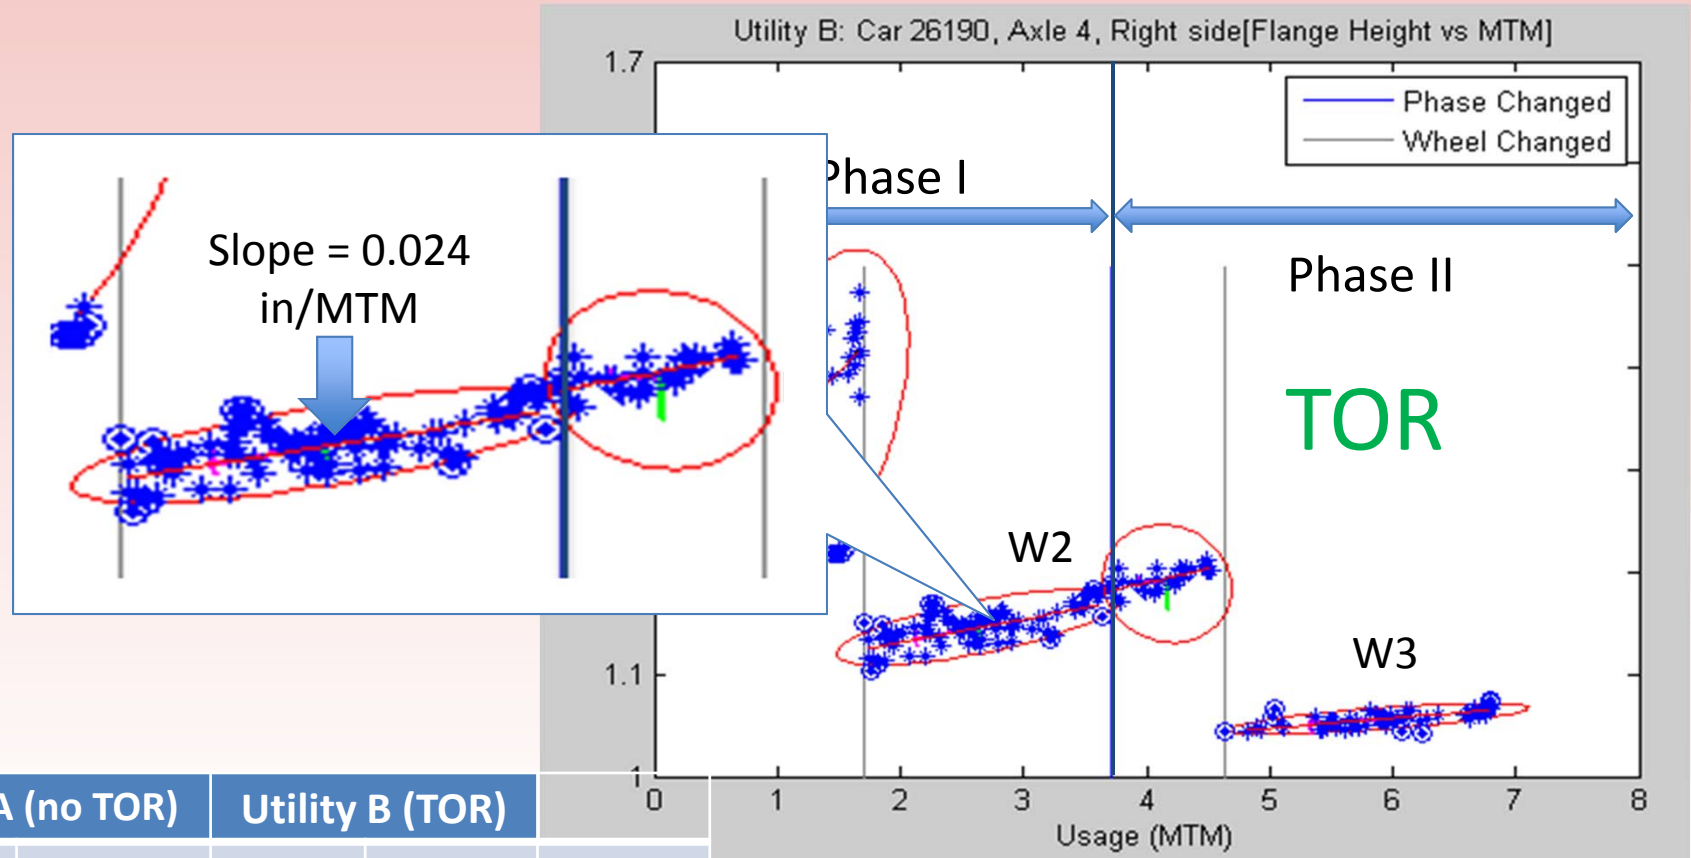
# Determining Wheel Wear Rate (WWR)

- W1, W2, W3 are same position on car, two change outs

Utility A (no TOR)		Utility B (TOR)		WWR segments
Phase I	Phase II	Phase I	Phase II	
276	231	157	141

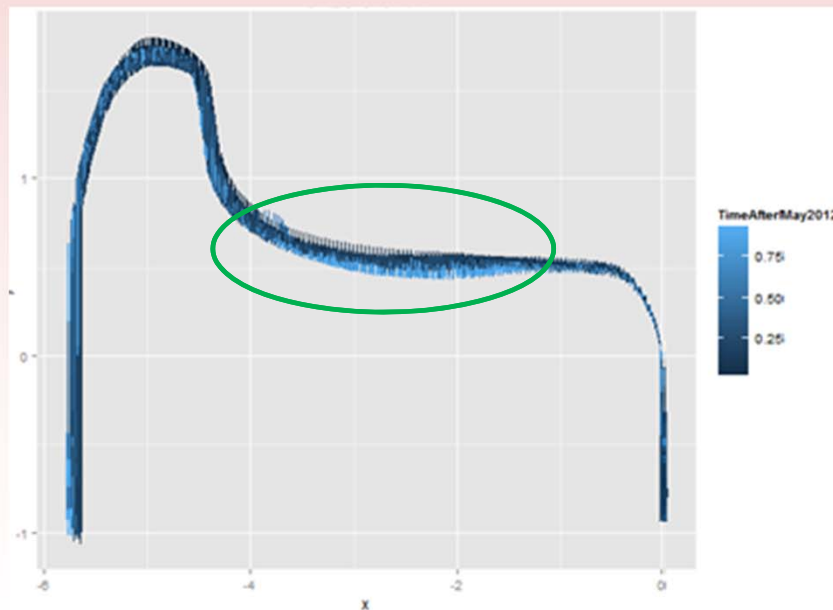
# Typical Wheel Profile Progression for TOR and non-TOR Wheels

- Equivalent MTMs for both wheels during Phase II

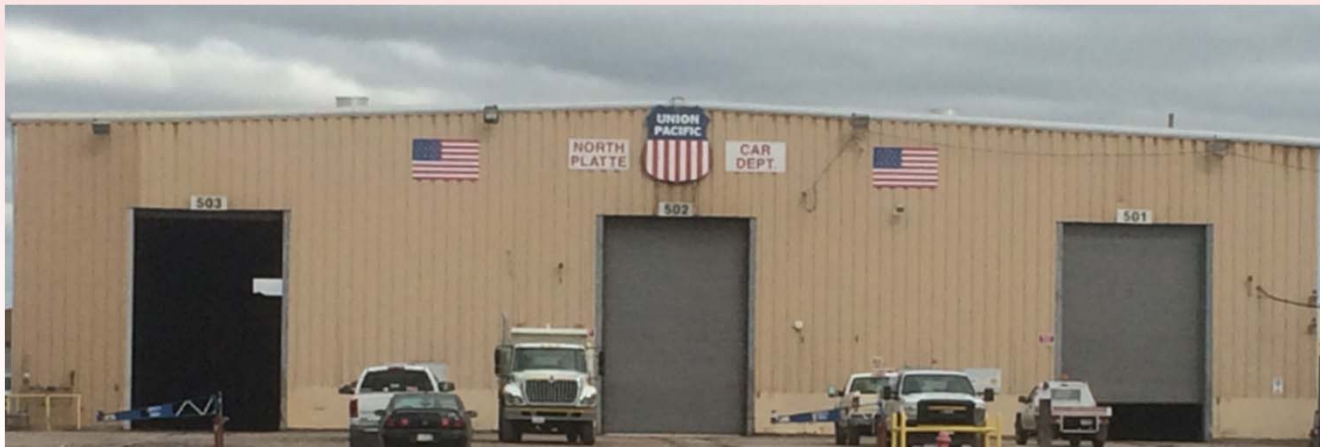
# UP Car Repair Billing - CRB

- Wheel Wear and WILD data analysis is leading indicator for further UP CRB analysis
- Provides specific change out billing dates for comparing back to Wheel Wear and WILD analysis
- Ability to drill down for specific wheel change removal reasons (Why Made Codes)

**Determine Impacts to the Railroad**
