Correcting Adverse High Rail Profiles to Promote Desirable Wheel Contact and Rail Stability

Brad Kerchof

NS Research & Tests

May 21, 2015

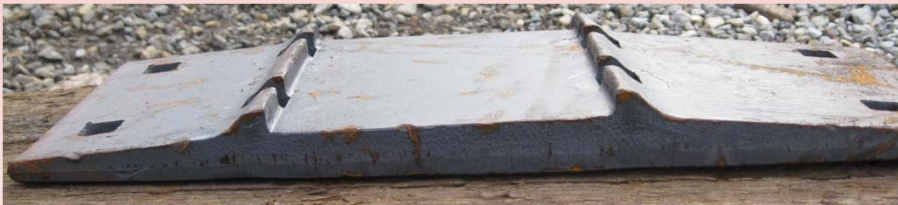
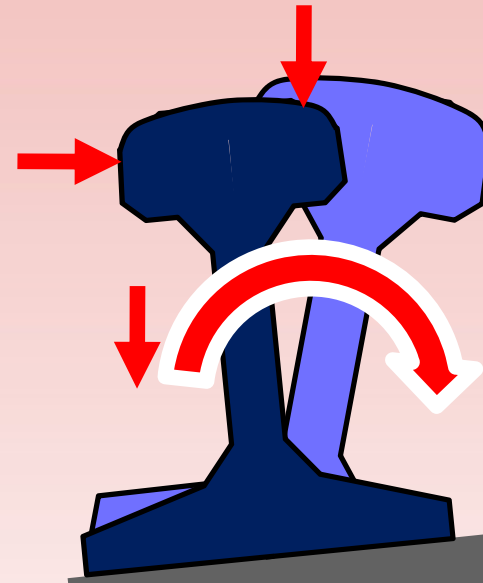
Rail cant

Cant is the amount of rail rotation referenced from standard tie plate position (typically 1:40 inward).

Tie plate rail seat wear and plate cutting into the tie can cause **outward** cant, as much as 3° from the 1:40 position

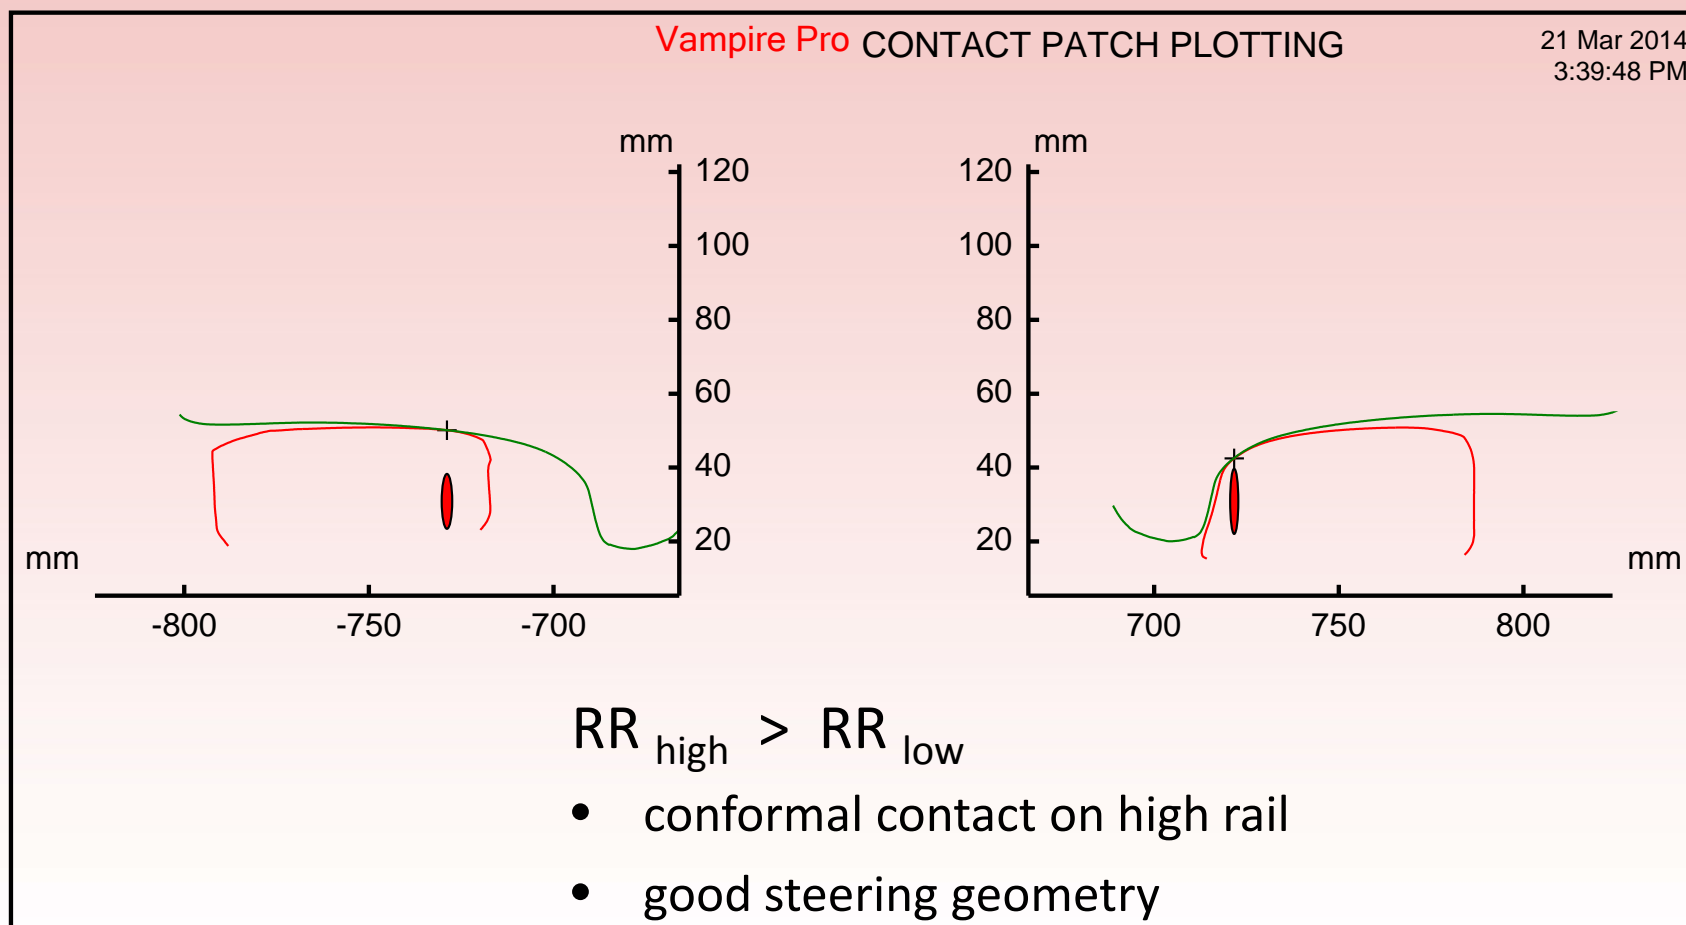
Wheel / rail contact patch plot on curve, conformal contact

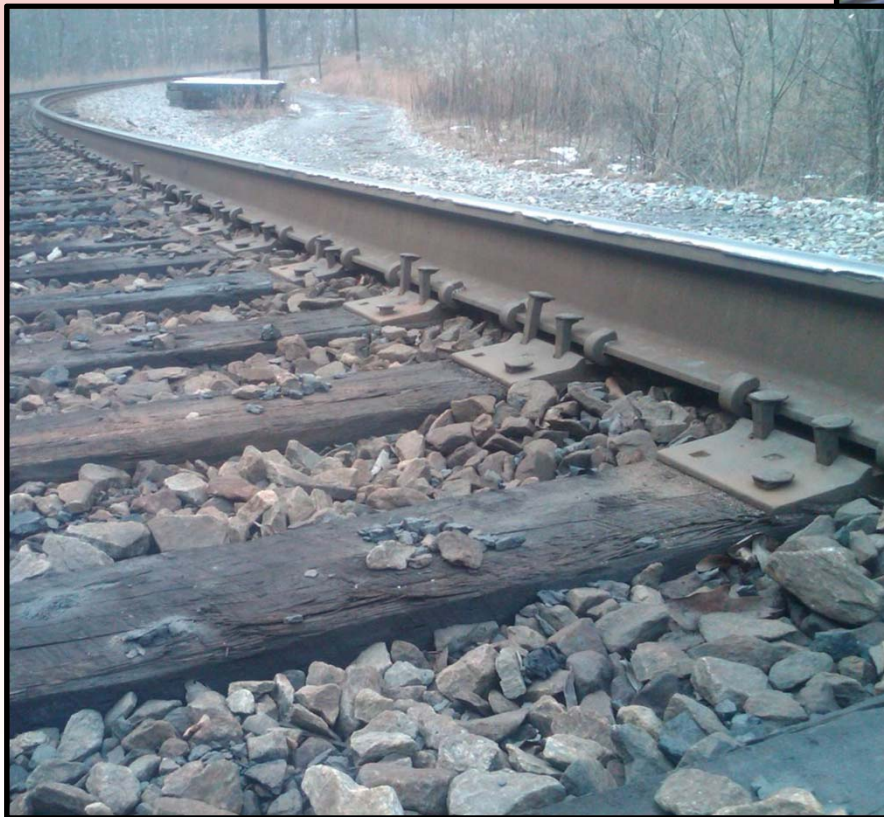
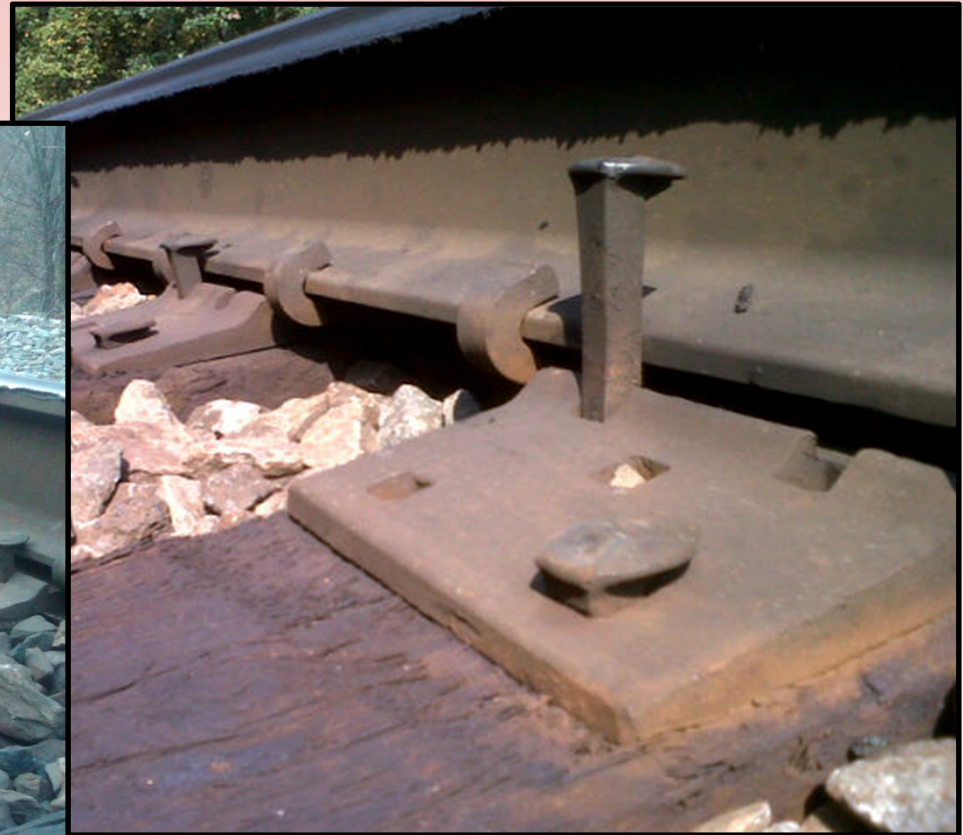
Understanding the impact of rail cant on rail grinding and rail profiles

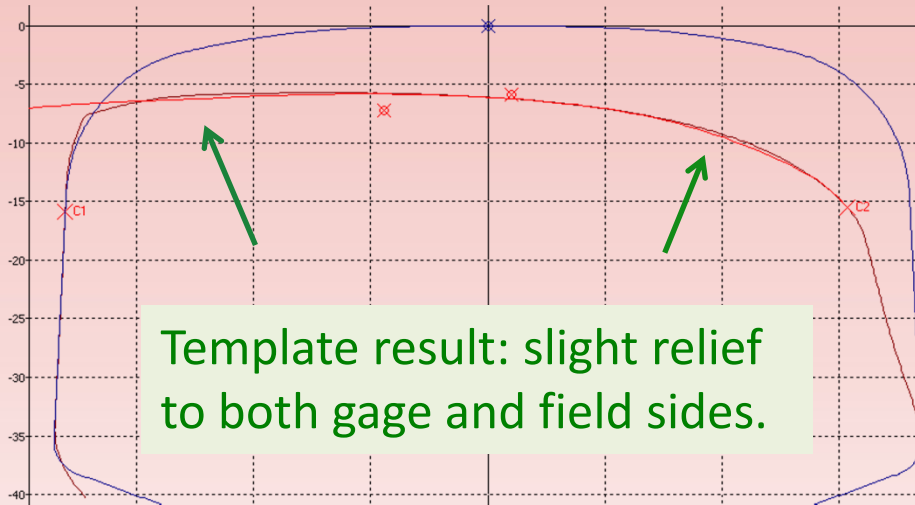
Grinding template applied to rails with 0° and 3° cant

High rail with 0° cant

- Brown – worn rail
- Red – template

High rail with 3° cant

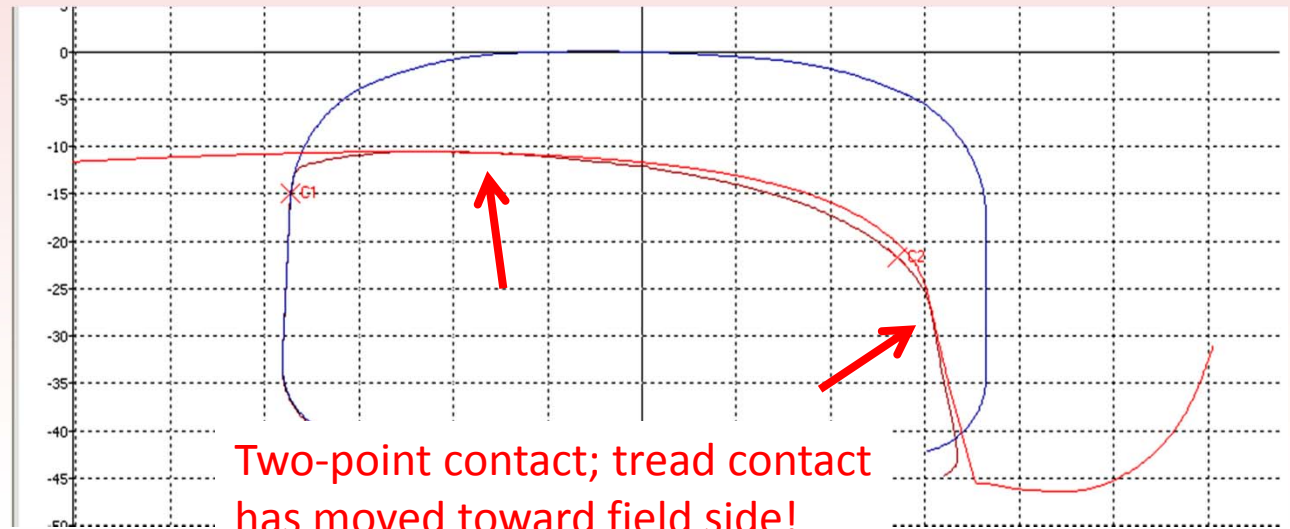
Worn wheels applied to rails with 3° and 0° cant

- Brown – 3° canted rail
- Red – worn wheel

- Brown – 0° canted rail
- Red – worn wheel

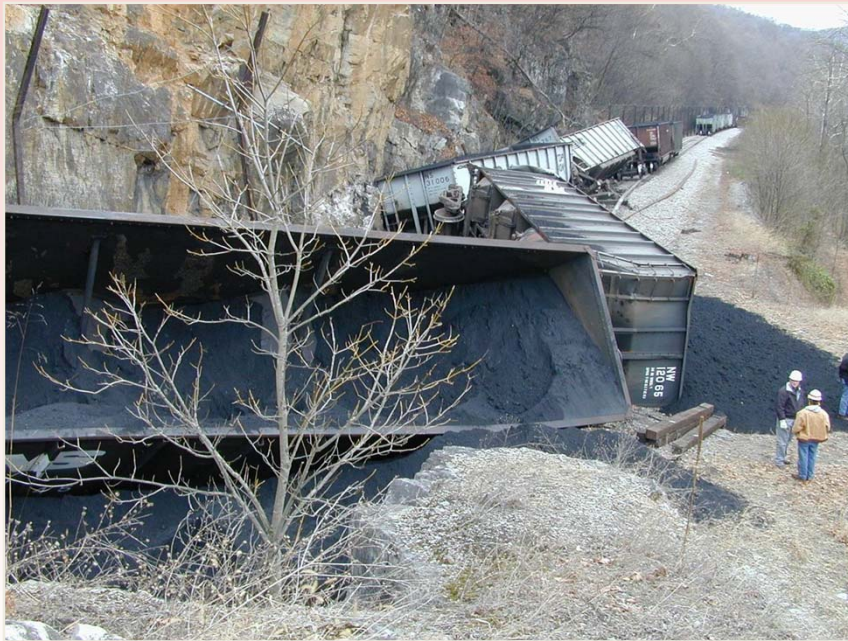
Because of rail roll-over derailments in curves with these characteristics:

- Curvature of 6° to 9°
- Previously canted rail, up to 3°
- Currently, excellent tie condition (new ties installed or high rail gaged)
- Gage $< 57''$ (sometimes $< 56\text{-}1/2''$)

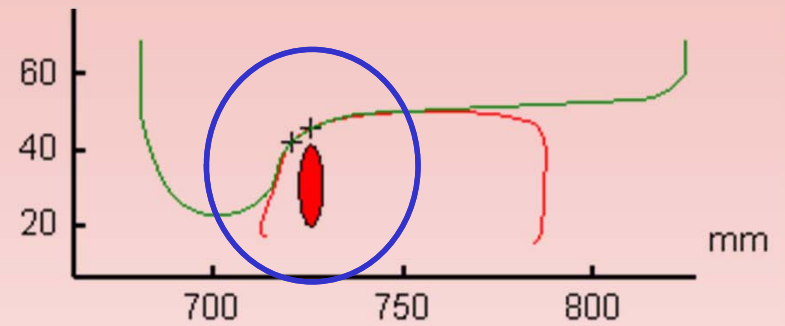
Contact patch plot for new AAR-1B wheel on high rail with 3° cant

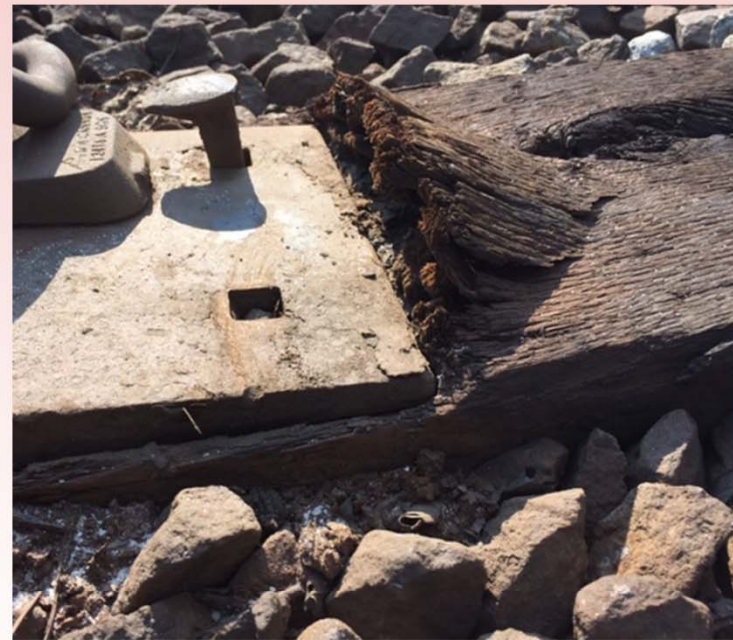
Following a number of rail rollover derailments, NS established this process

- Before gaging or tie replacement, curves with worn high rails are identified for further analysis
- High rails that have
 - $B/H < 0.35$
 - Head slope $> 5^\circ$
 - Cant close to 3°are likely to have wheel contact move to the field side if the cant is corrected
- We use a rail grinder to change the rail profile so that desirable wheel contact will continue after the rail is “set up”

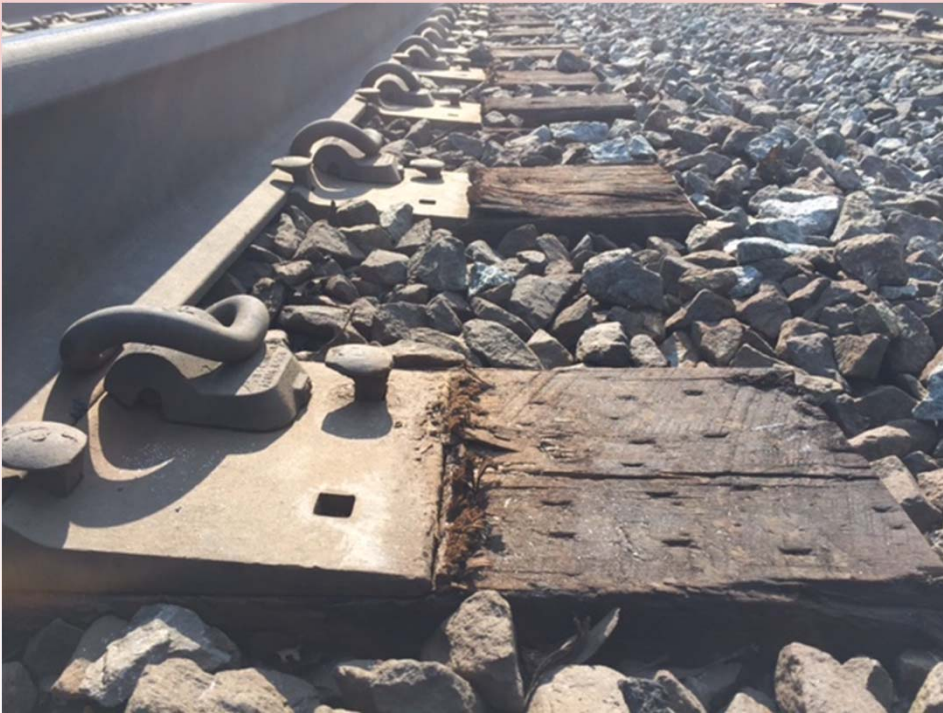
The Cresson (PA) subdivision wanted to gage the high rail of several curves

From a recent track geometry car test, we found these curves to have:

- significant tie plate cutting resulting 2° to 3° of cant
- B/H ratios between 0.33 and 0.35
- head slopes between 5° and 7°

These are conditions that would result in a significant shift in wheel contact position if the high rail were to be set up.

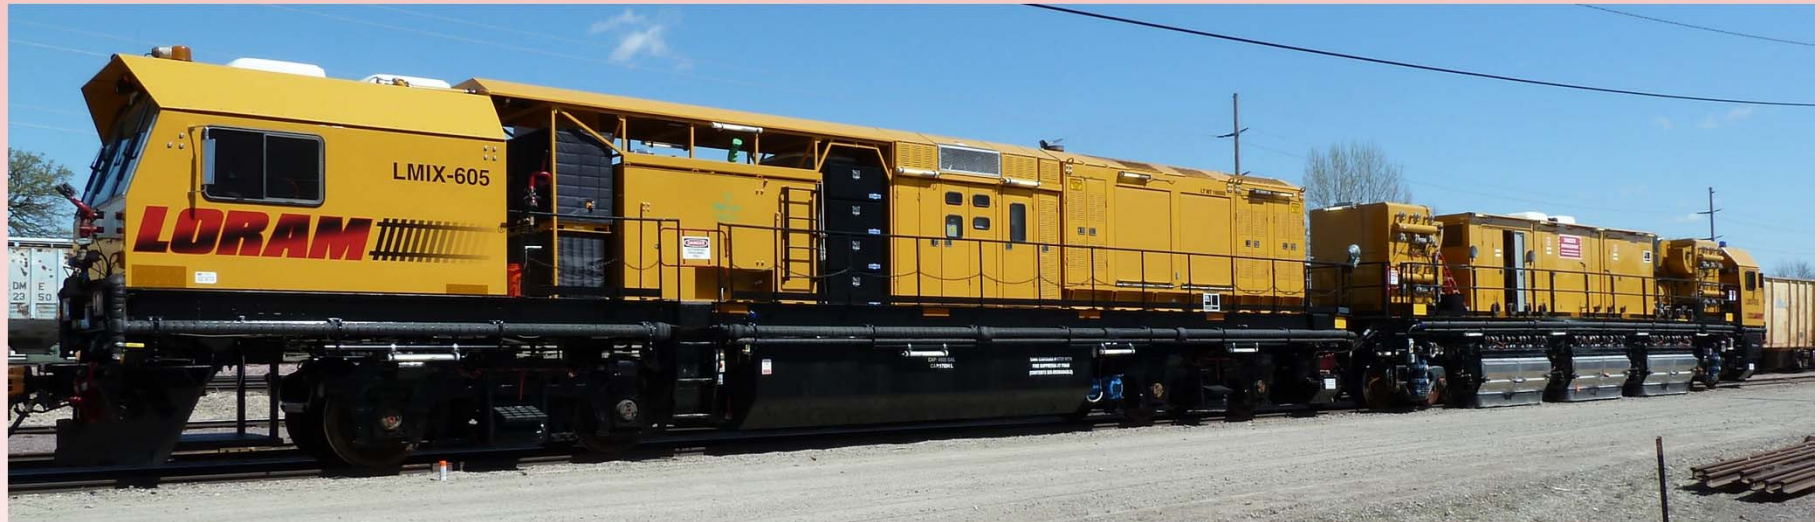
Switch grinder instead of big grinder

- If we were using a big grinder, Loram could have used its pre-grind rail inspection program to determine patterns, passes and speeds.... automatically. But a big grinder was not close by.
- We did have the RGS2 switch grinder two days away.

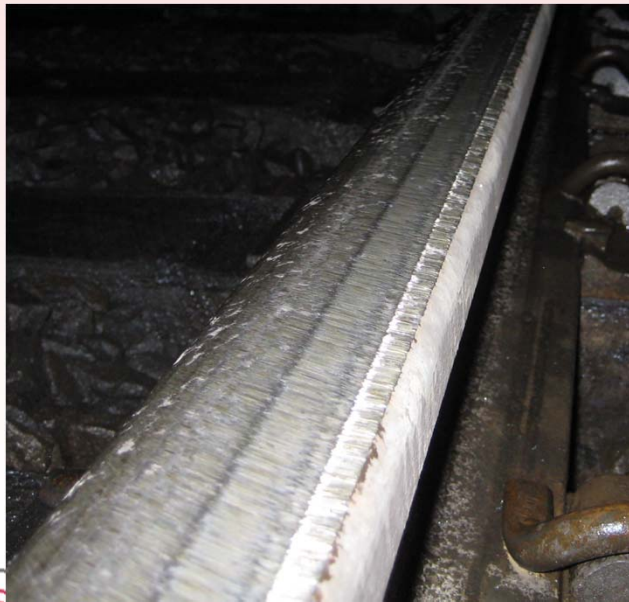
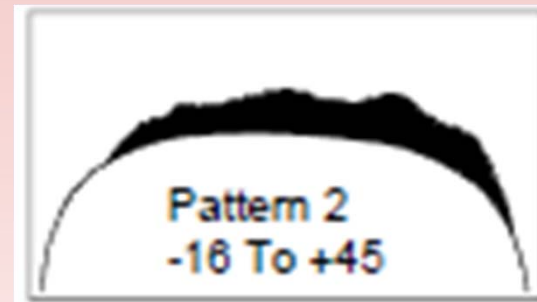
Field RG 401 Gage

The grinding program

Bob Harris developed a grinding program for each curve using the switch grinder. He created 2 patterns (or pattern sequences):

- Pattern A provided field-side relief (stone angles from -18° to 1°)
- Patterns B1, B2, B3 & B4 provided full ball coverage (-16° to 45°)

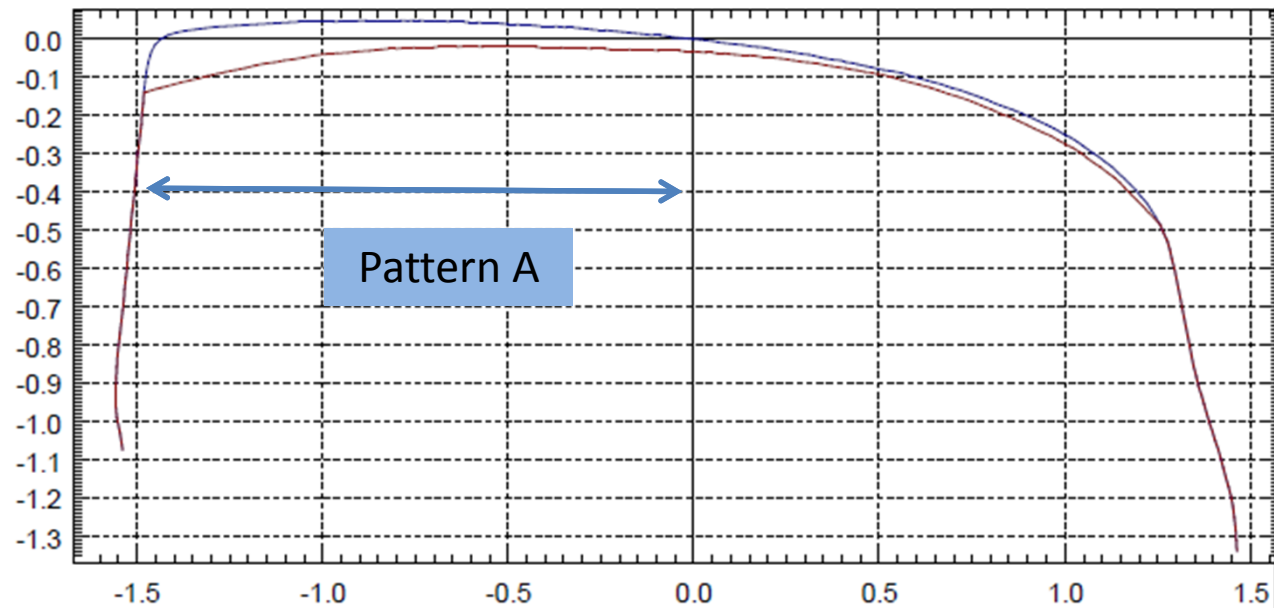
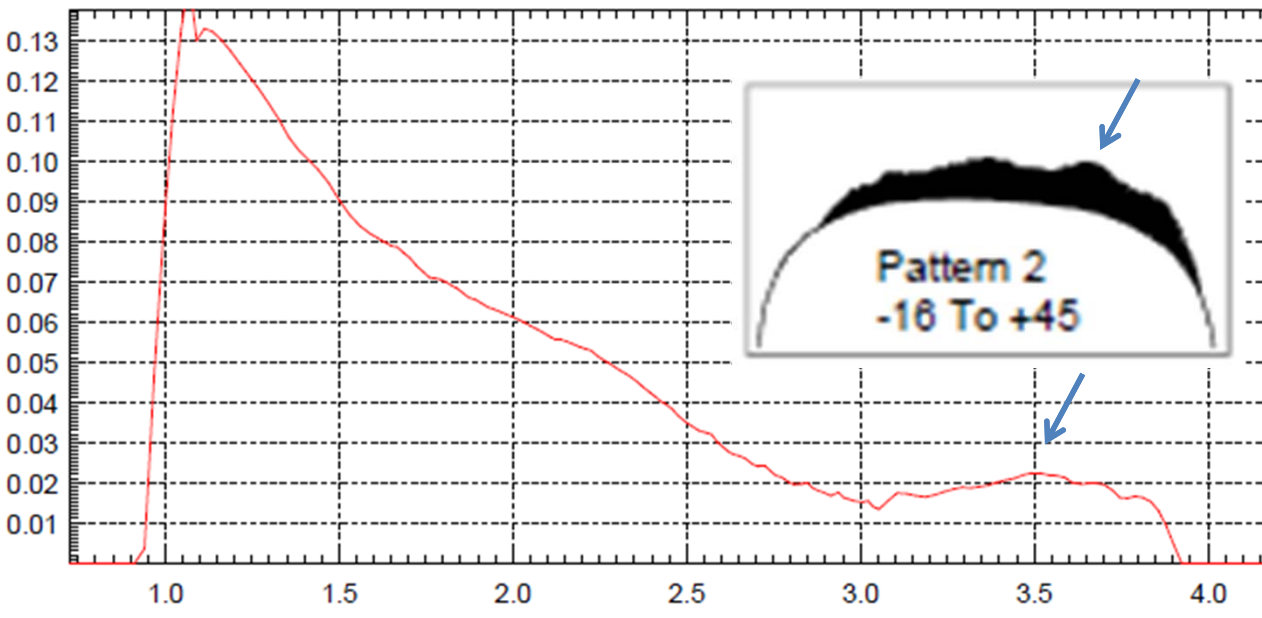
For Scotch Run, the curve needing the most work, Bob specified:

- 8 passes with Pattern A at 5 mph
- 1 pass each with Patterns B1 – B4 at 5 mph

- Actual (pre-grind) rail profile set up to the 1:40 position (blue)
- Expected profile after grinding and gaging (brown)
- Expected metal removal, max is 0.14 inches (3mm+) at the field corner
- Insert is RG 401 pattern 2, which reflects an increase in metal removal near the gage corner

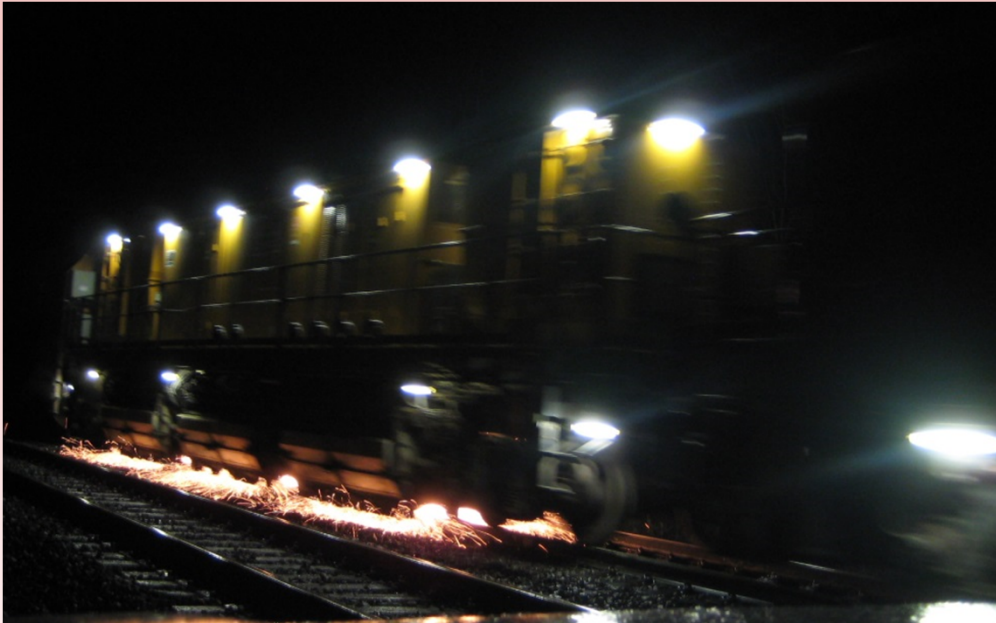
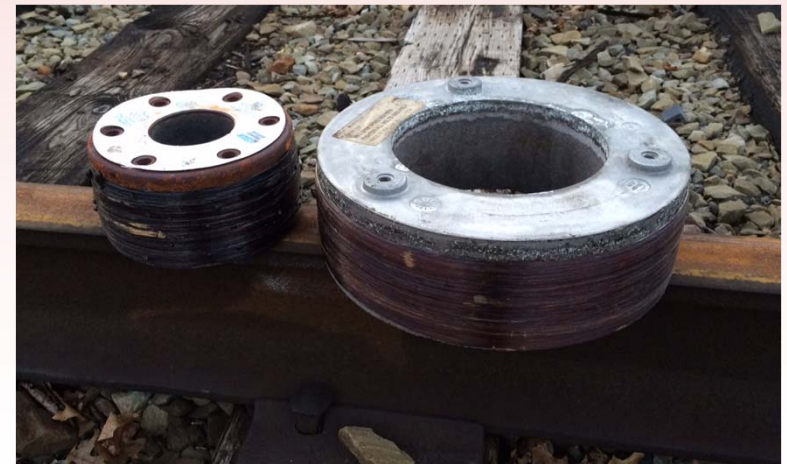
RGS2 switch grinder

- RGS2 has 24 stones – 8 six-inch and 16 ten-inch (a big grinder has 96 ten-inch stones)
- The smaller stones are meant for close clearance work (road xings, guard rails)
- For this project, Loram replaced the small six-inch stones with ten-inch stones

- The RGS2 worked six curves during one night shift
- The number of passes on the high rails ranged from 6 to 12

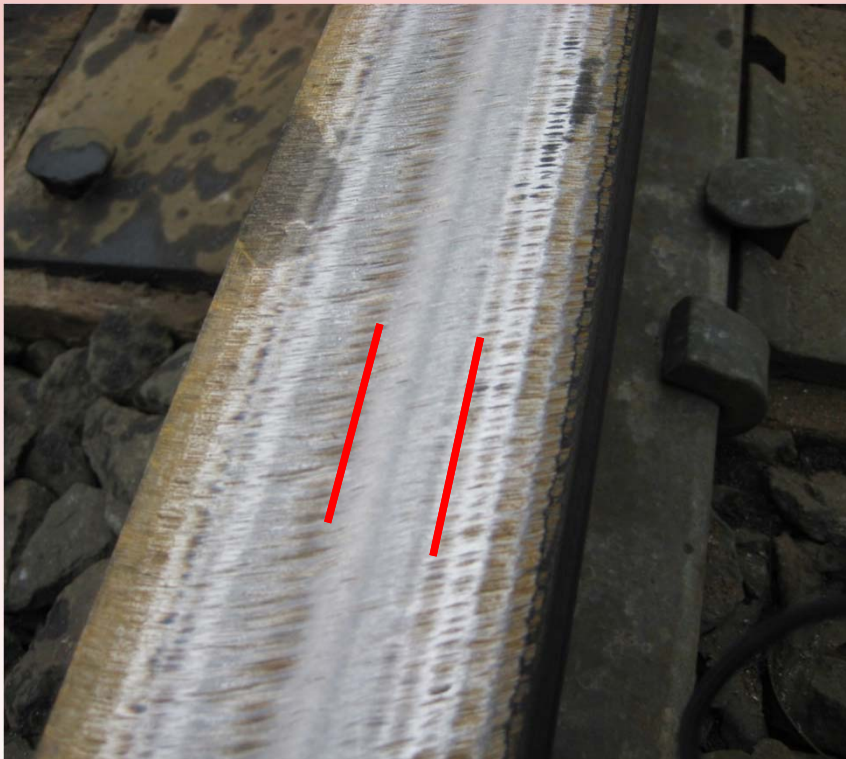
Results after grinding, before gaging

Grinding complete and several trains have run; note primary contact band is on the gage side of center

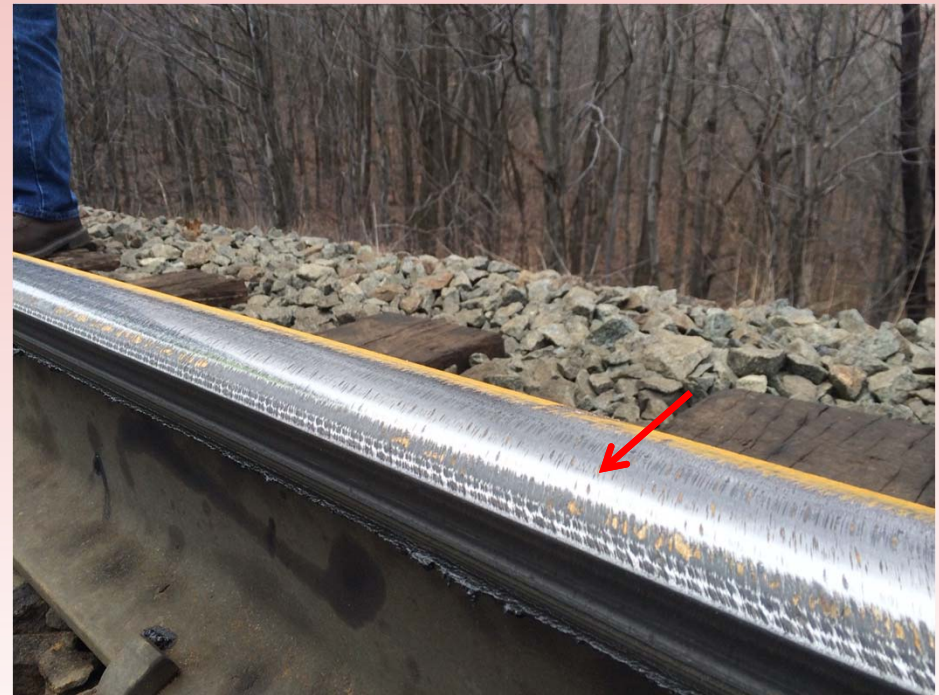
Results after grinding and gaging

High rail shows wheel tread contact band on the gage side of center (desirable); but it also shows two-point contact (undesirable). Photos taken one week after grinding and gaging.

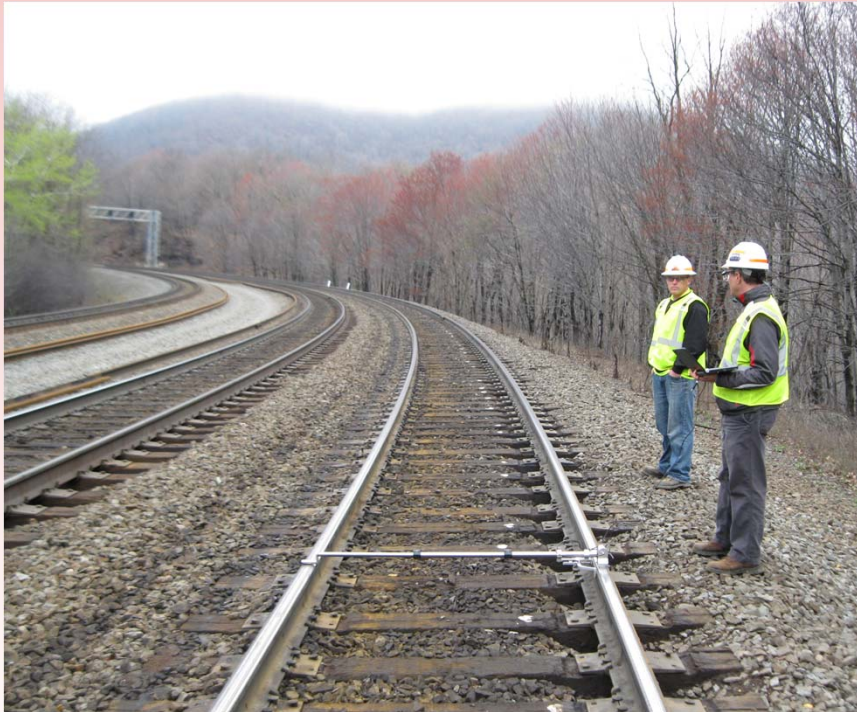
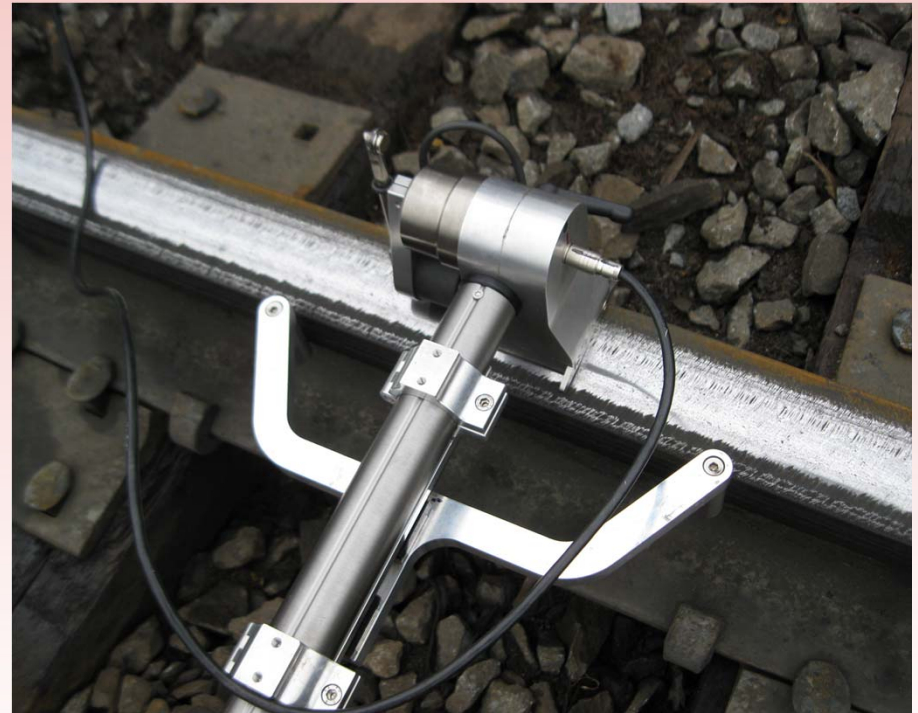
Mini-prof profiles after grinding & gaging

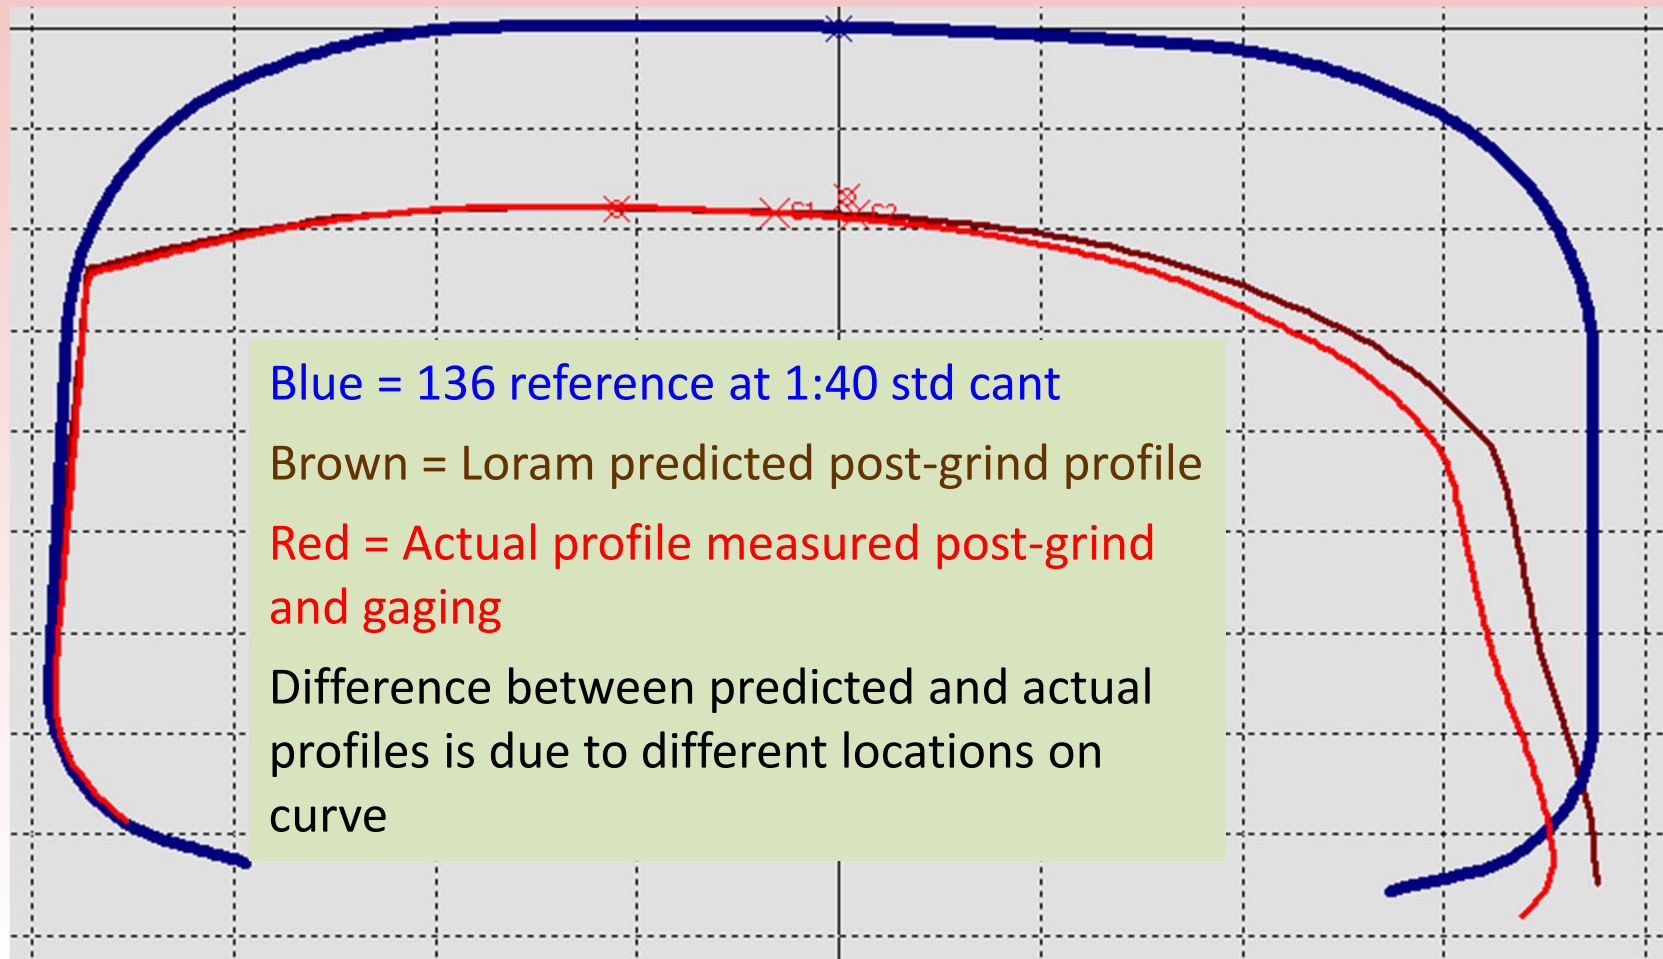
Predicted post-grind profile compared to Mini-prof post-grind profile, Scotch Run Curve

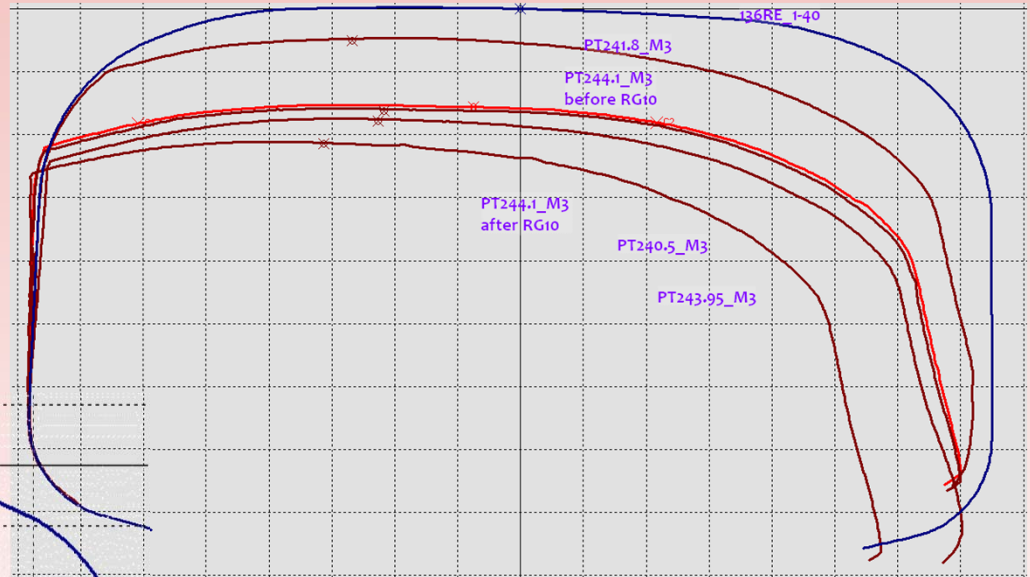
Mini-prof high rail profiles from four curves after grinding and gaging

Profiles of high rails from Cresson compared with high rails from recent NS derailments

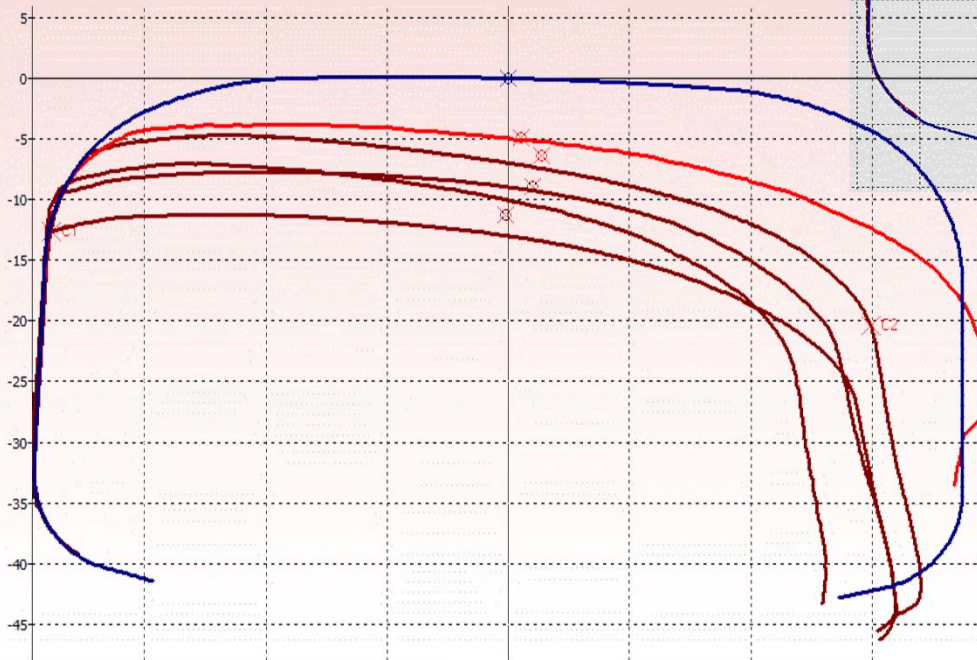
High rail profiles from five NS rail rollover derailments. All have been oriented to the 1:40 standard cant.
