# SkyTrain's Experience in Mitigating Noise

Matt Doyle

BC Rapid Transit Company

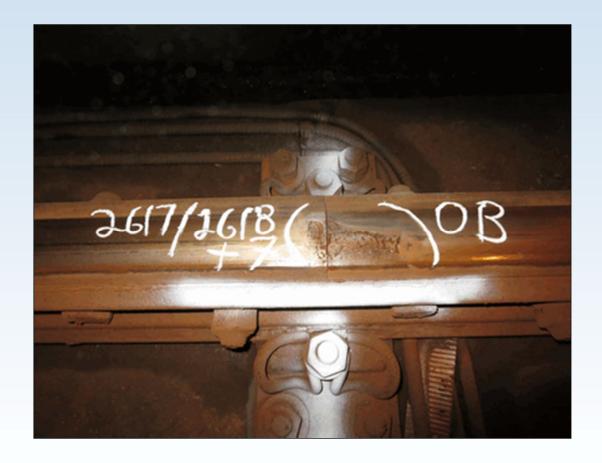
## Rail Spall

- New vehicle introduced (with a wheel profile designed for a different system)
- Wheel turning set at 60K for MK-I, and 80K for MK-II
- Start of rail spalls at joints in the system

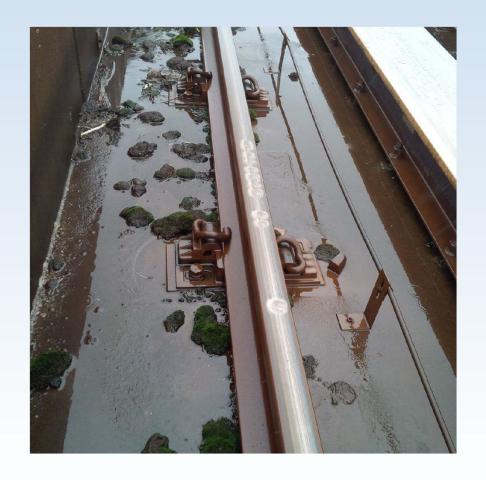
### **Rail Defects**

- 48 new cars added to existing fleet
- Visual evidence of rail defects accelerating in growth and appearance
- First rail break discovered in 2012
  - At weld repair location
- Corrugation back across the system
  - Issues keeping rotary grinders in service
