Monitoring and Managing RCF and Rail Surface Conditions (ICRI and collaborative projects)

**Eric Magel – Principal Research Officer, National
Research Council, Canada**

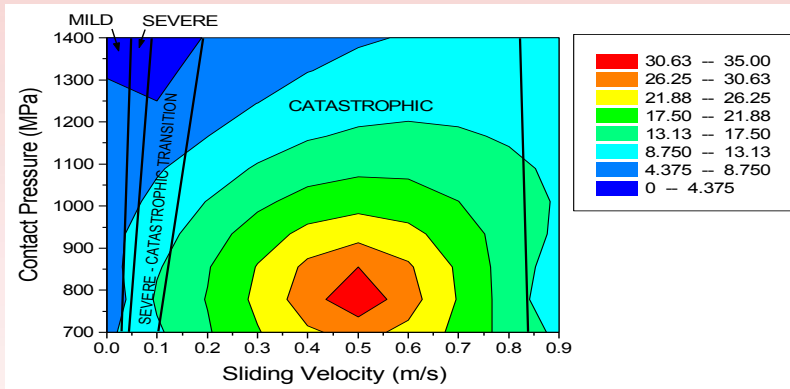
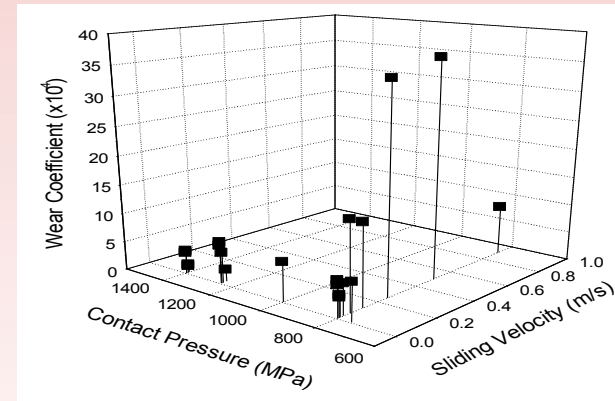
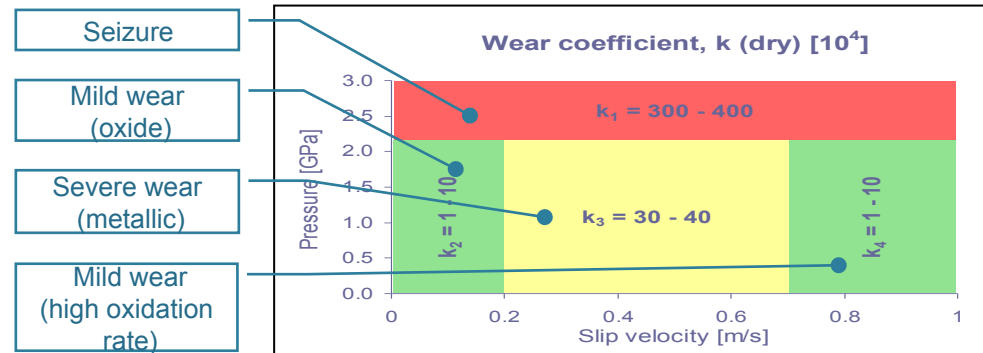
Previous Wear Maps

- KTH Archard wear coefficient map extensively used

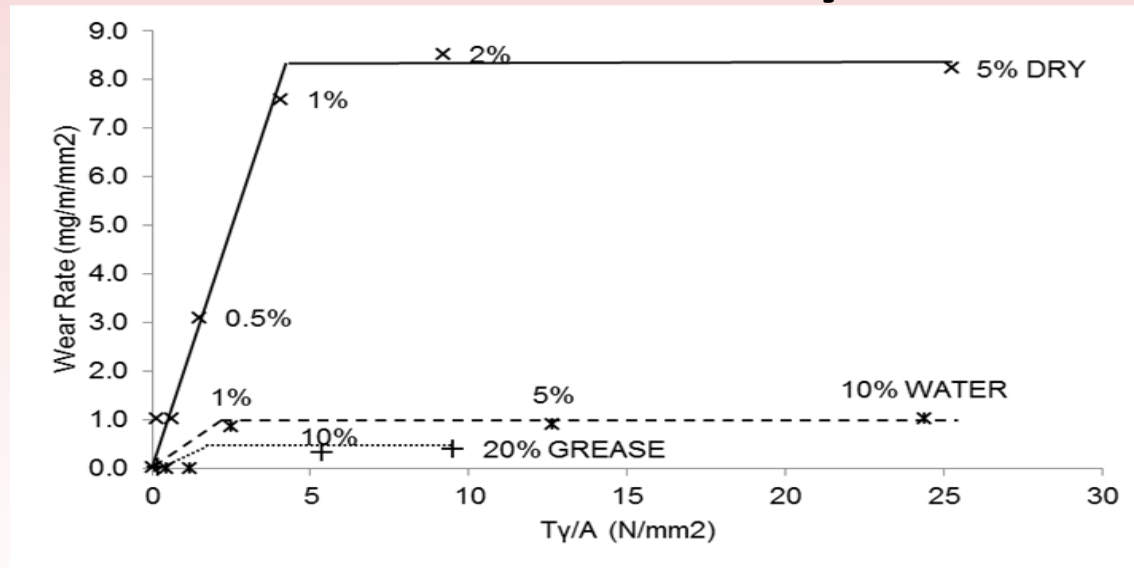
Effect of Third Body Materials

- Wet and grease conditions compared with dry

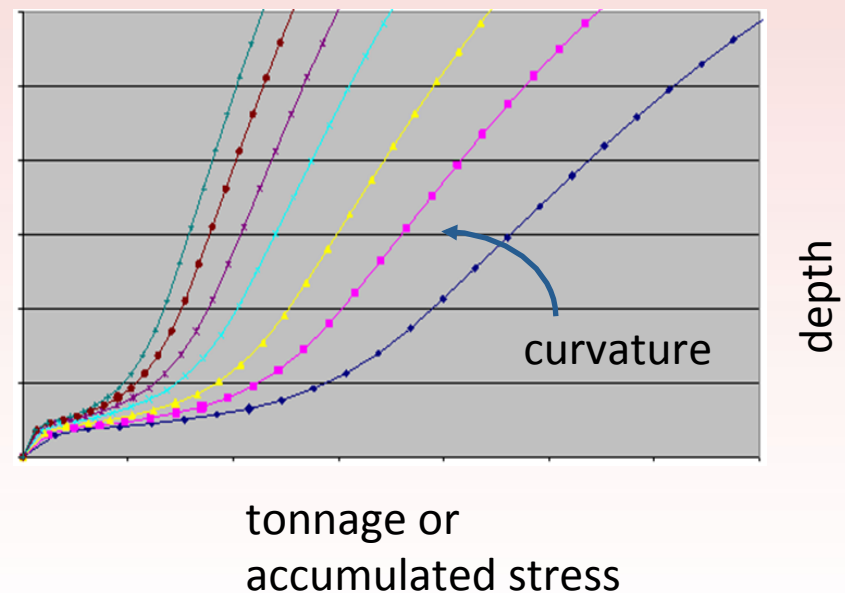
A family of crack growth curves

- probably differs for
 - rail steels
 - curvatures
 - traffic types (e.g. passenger, transit, freight)
 - environmental conditions
 - friction regimes

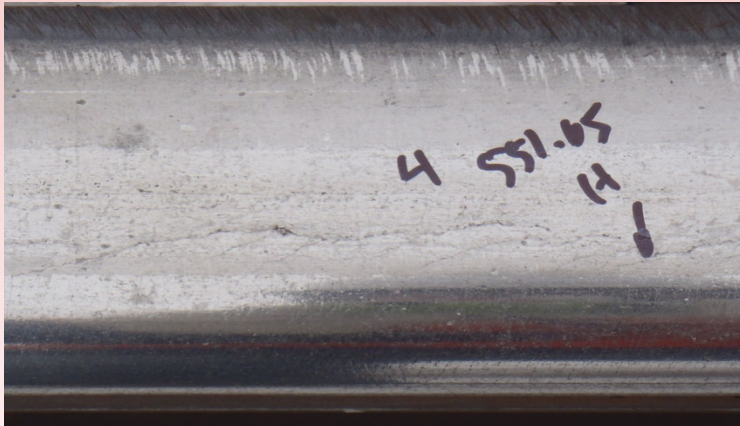
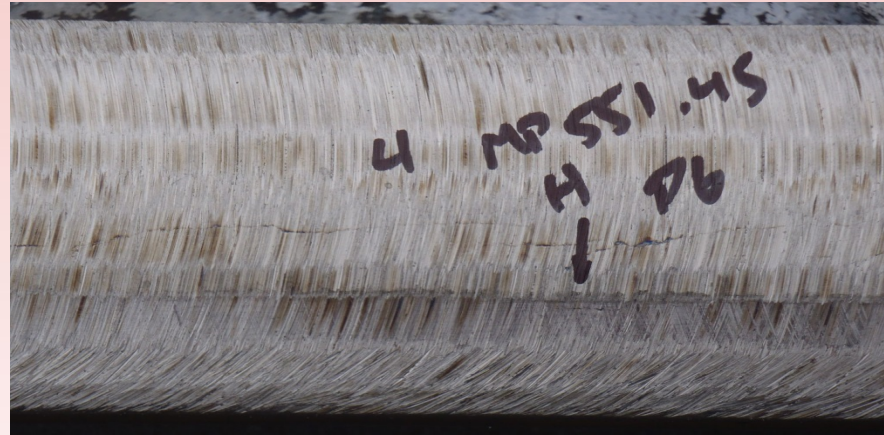
High Rail
1.55 mm
of metal
removed
at crack
location
(6 passes)

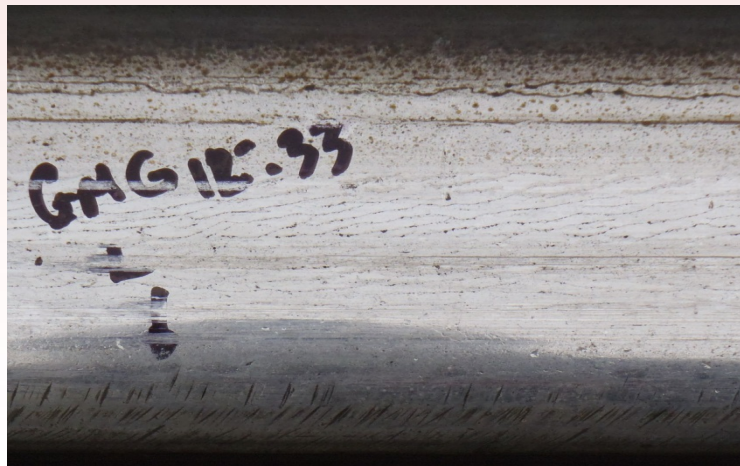
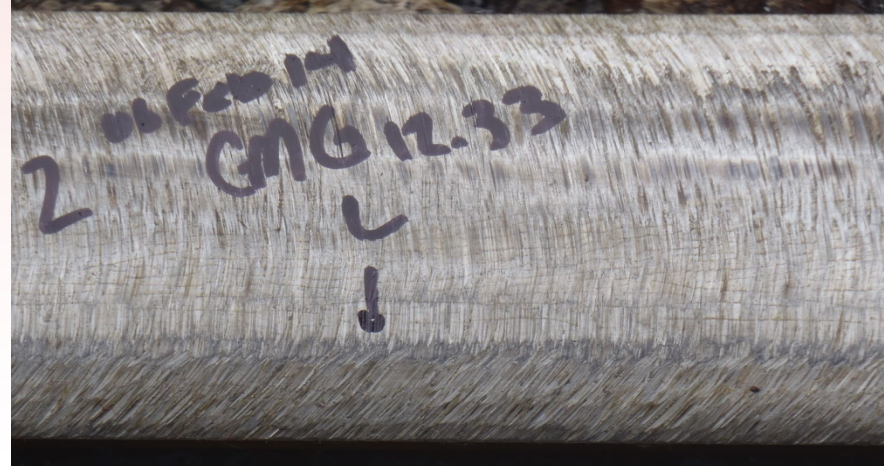
Low Rail
0.67 mm
of MR at
crack
location
(3 passes)

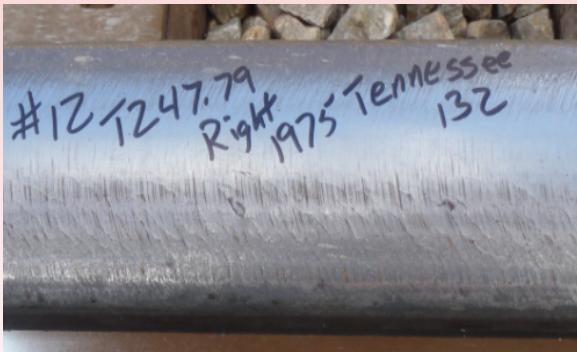
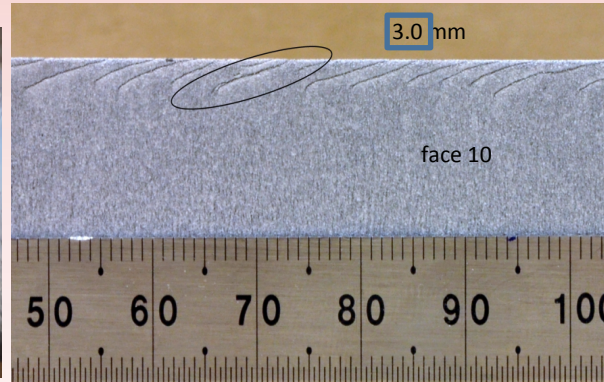
CSX Blue Ridge Subdivision Sample #12

MP T247.79 RIGHT
 Rail Manufacturer: Tennessee
 Rail Year: 1975
 Rail Type: CC
 Rail Weight: 132

Measured crack depth
 MRX: 6.9
 Rohmann: >5.0

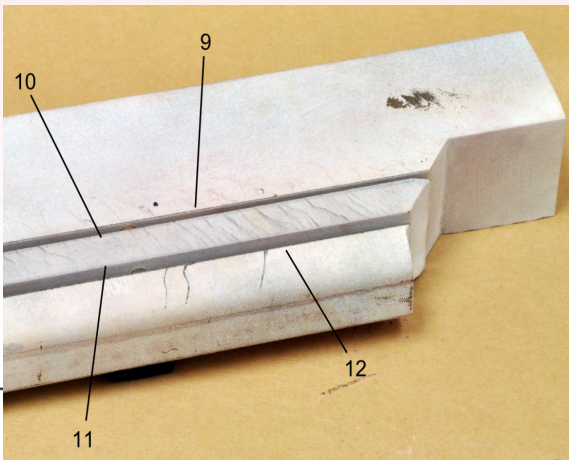
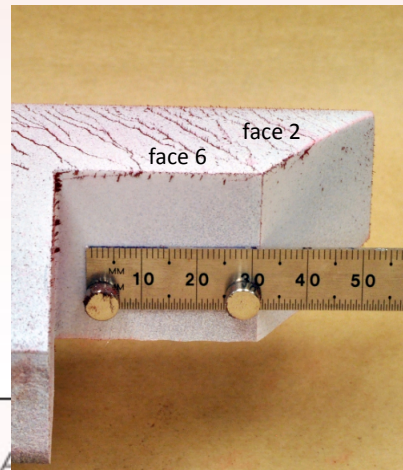
<u>Magnetic Particle Inspection</u>		
	Face 2	Face 6
Max Length (mm)	3.8	2.0
Crack Angle (deg)	23	75
Max Depth (mm)	1.5	2.0
Surface Angle (deg)	46	46

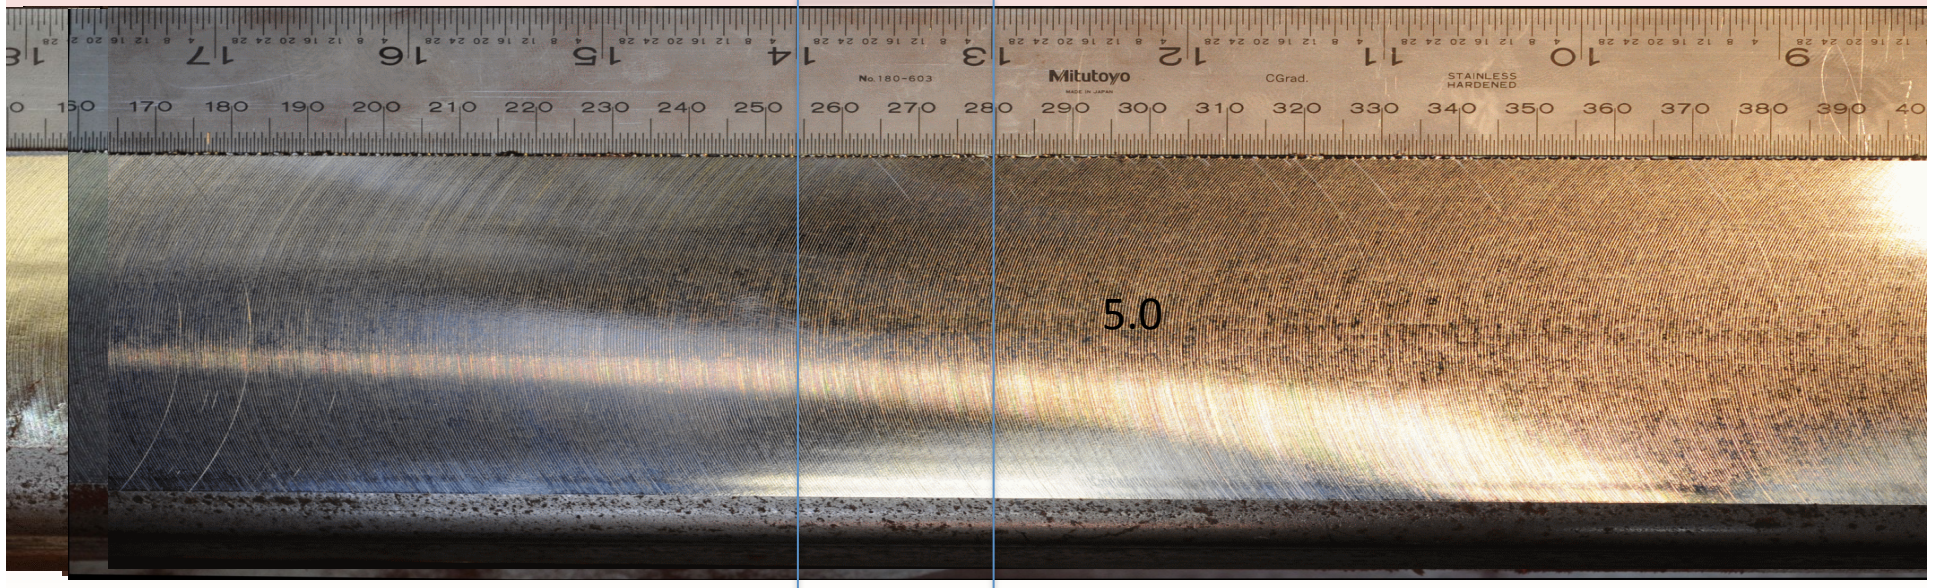
Sample 3

field side

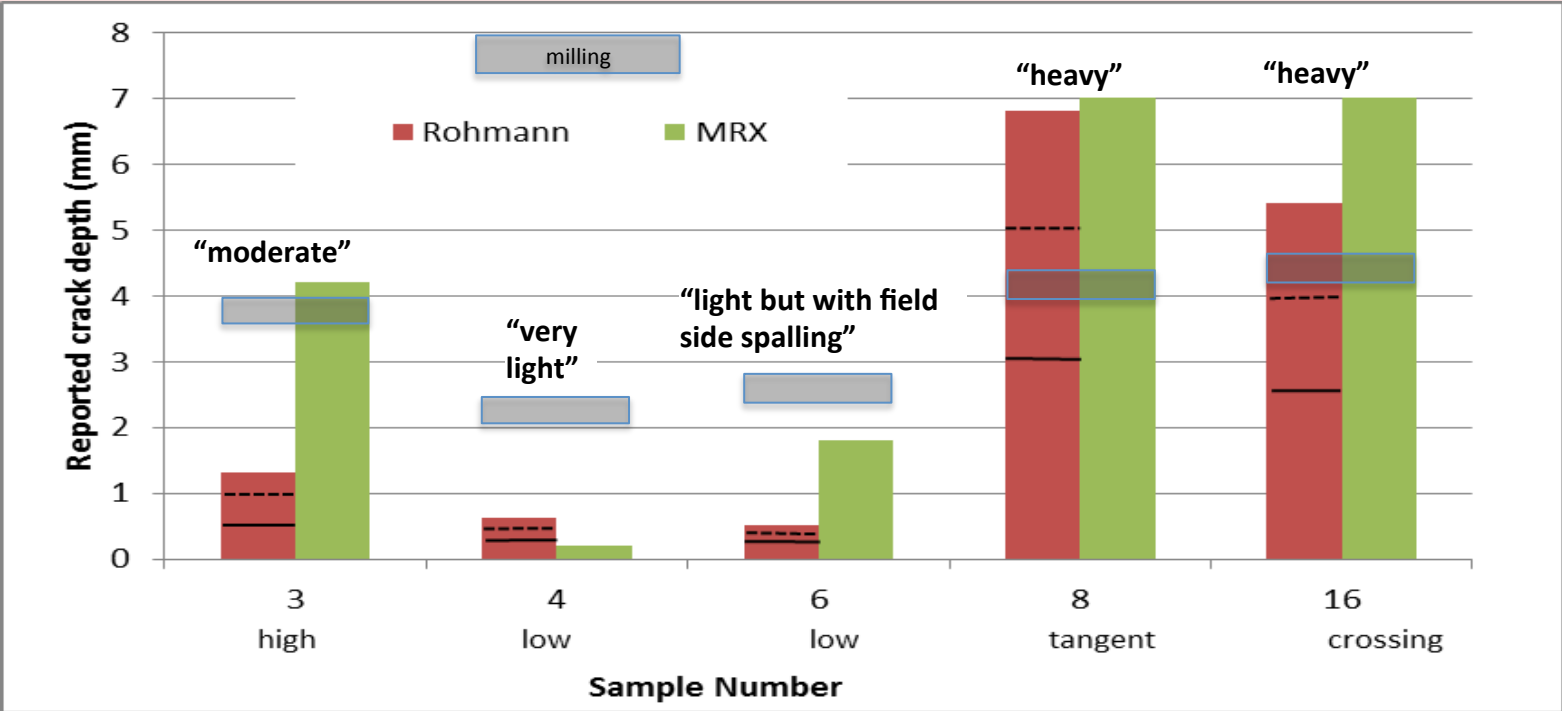
BNSF Staples - Results

Rohmann

2ND CURVE, HIGH RAIL

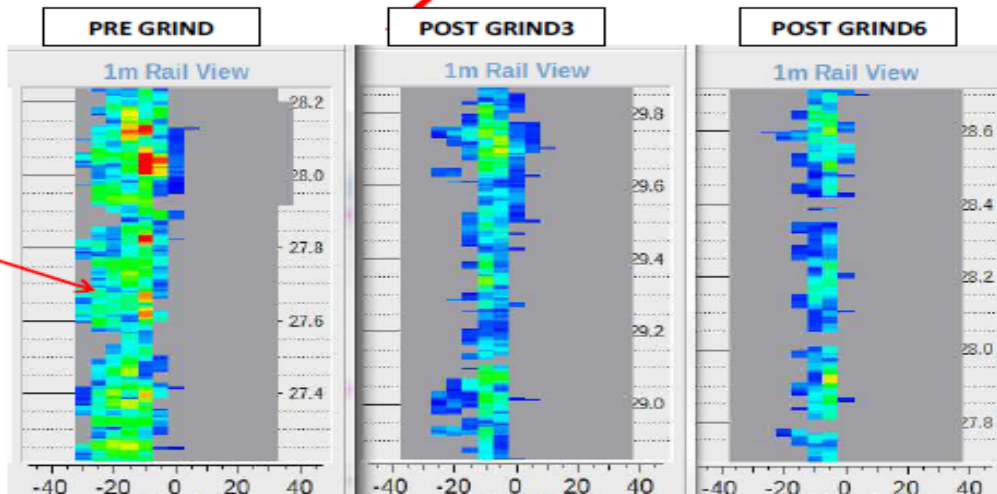
BAND OF RCF CRACKING

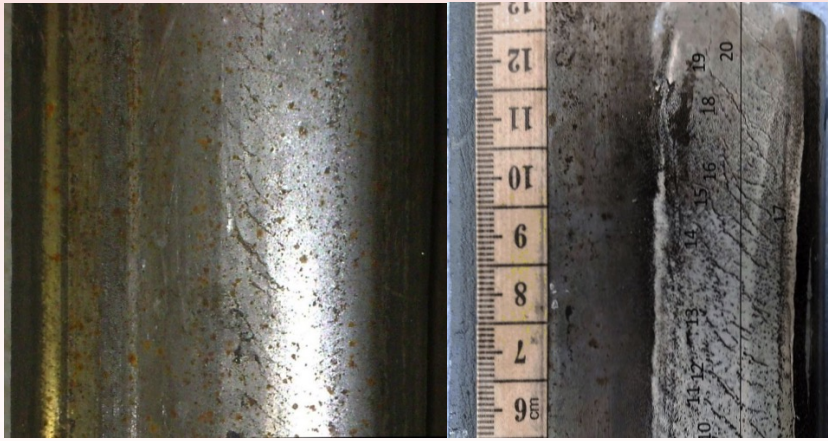
High	Low	Tangent	S&C	Railroad: BNSF	Date: removed from track
Metallurgy: 13225 USS Illinois 1972 I				Subdivision: Staples	25NOV14
				MP: 210.7 M1	
				Curvature: 1°

Surface crack length				10 to 17 mm	
Start/end position				8 to 22 mm	
Surface Angle				Approx. 45 degrees	
Crack depth (milling)				1.7 to 2.8 mm	
Spacing (avg) = 4.14 mm

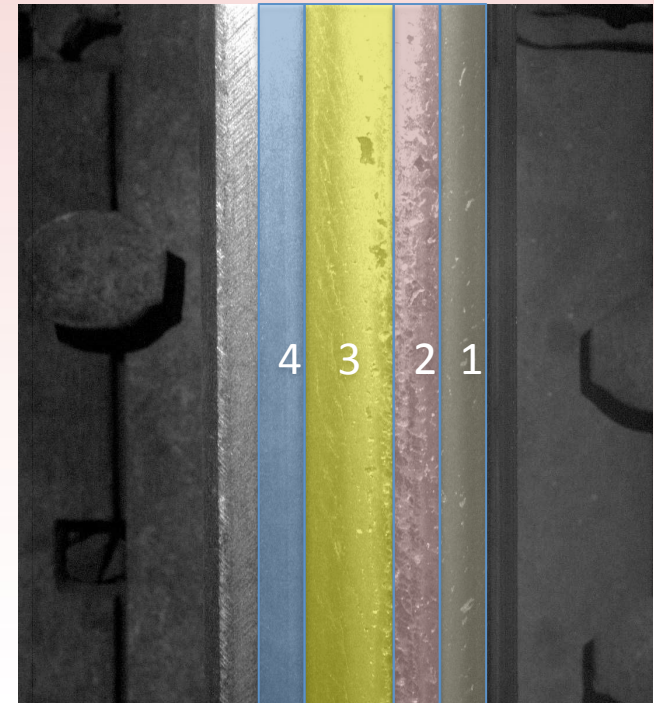
Machine Vision Systems

- 0 None
- 1 barely perceptible, but clearly regular pattern (preventive grinding < 0.5mm).
- 2 clear, well-defined, distinct individual cracks – but no pitting at tip (maintenance, depth < 1.0 mm)
- 3 clear cracking, pits up to 4 mm diam (corrective grinding 1.0-2.5 mm deep),
- 4 pitting greater than 4mm < 10 mm (preventive gradual, up to 3.5 mm deep), or “heavy” cracks with clear lifting of metal or separation of crack faces
- 5 isolated pitting/shelling/spalling > 10, diam (up to 5 mm deep)
- 6 Shelling/spalling: regular pitting, >10mm diam (busted, near impossible to catch up on)
- 7 Shelling/spalling: any defect > 16 mm diam, >20mm length
