# Fixing What's Broken: Implementing Compatible Wheel/Rail Profiles for Transit

– *Wyman Jones, LA Metro*

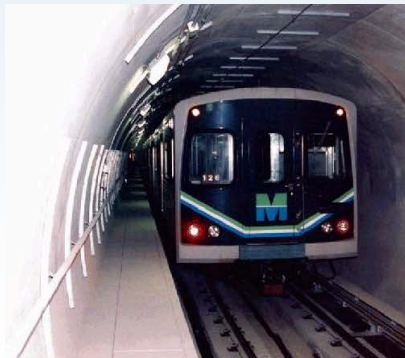
- Since the System Testing was required before the New Heavy Rail Cars were provided, RTD acquired loan of what was said to be a similar Heavy Rail Transit Car for Acceptance Testing.
- Miami Heavy Rail Transit Vehicle (28" dia. Wheels)

- During system testing.
  - Showed no wheel wear
  - No abnormal rail wear

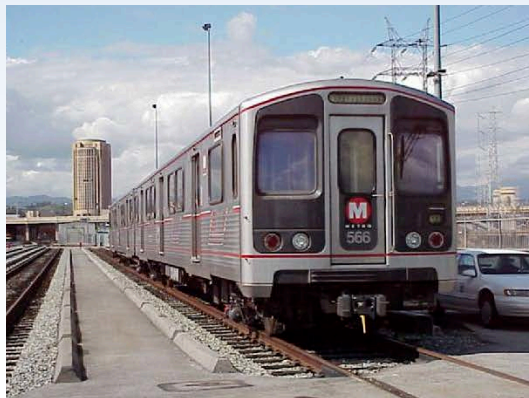
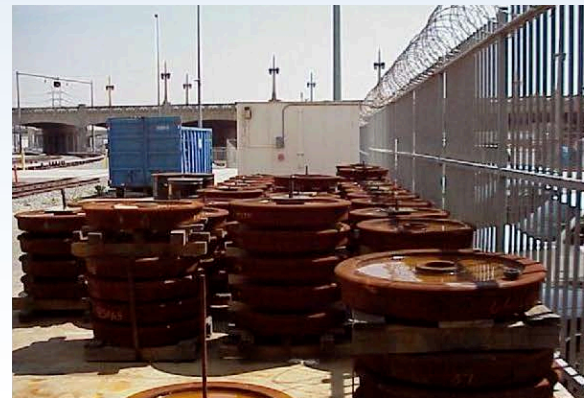
- Continuous build-up of metal shavings in curves and switch areas, Wheel Flanges required truing every 5,000 to 7,000 miles.
- BRENDA Heavy Rail Transit Vehicle
- (34½" dia. Wheels)      (7'-7" Axle Spacing )      (Wheels Tossed after 19,000miles)

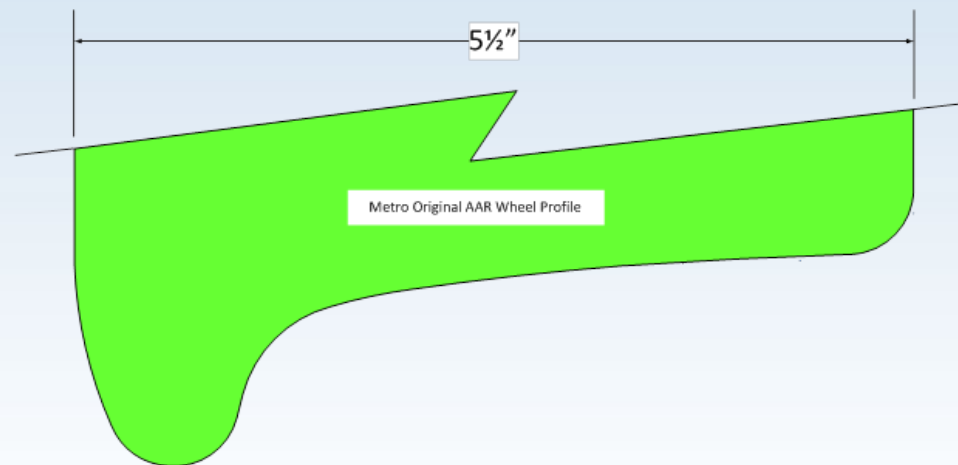
- Original AAR Standard 1:20 Wheel

- Resulted in less than 19,000 miles per wheel
- Not close to expected wheel Life of 200,000 miles

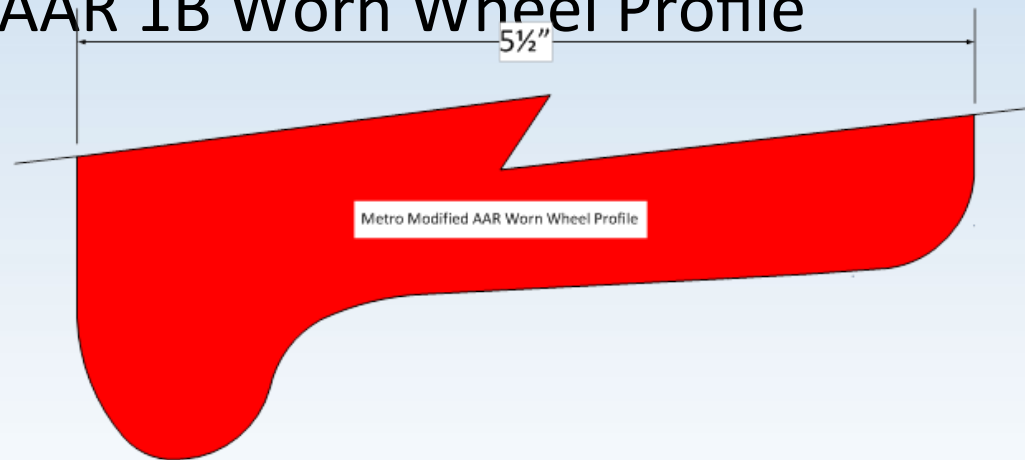
- Change to AAR 1B Worn Wheel Profile

- Improved Wheel Life to between 20,000 to 25,000 miles, still not close to 200,000 miles

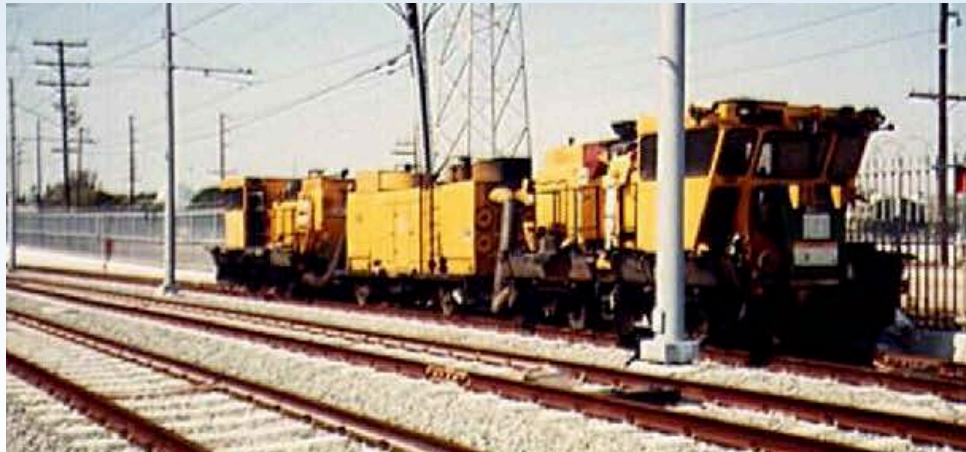
- Resulted in LA Metro acquiring a re-furbished Fairmont-Tamper RGH-16 Rail Grinder.

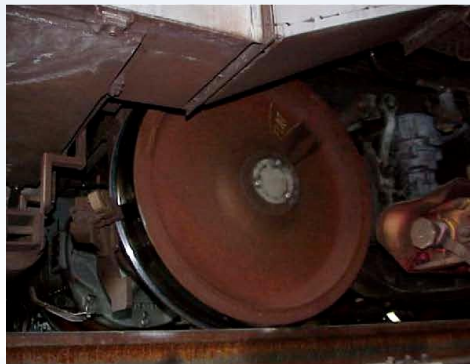
- Introduce the addition of Kelsan LCF (Low Coefficient of Friction) stick lubricators.
- Mounted in a cassette bracket on all wheels.

- By changing Wheel Profile to an AAR 1B Worn Profile, the Wheel Life moved from 19,000 miles per wheel to 25,000 miles.
- By adding Flange Lubricators to all wheels, the Wheel Life jumped from 25,000 miles per wheel to 75,000 miles.
- The Traditional Mitigation Methods did not provide any solution towards a 200,000 mile expected wheel life.

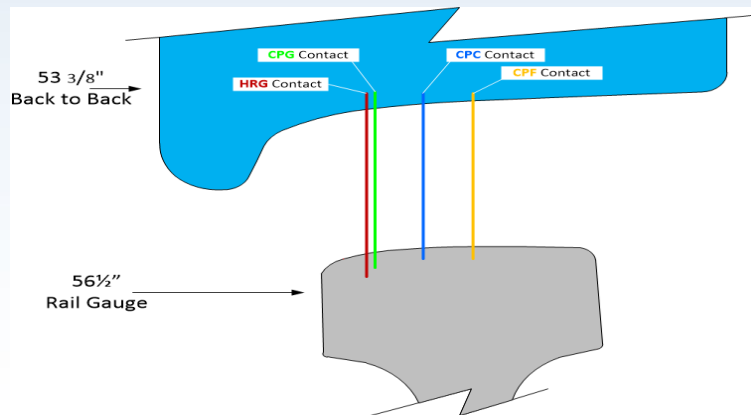
- Created a special set of Custom Rail Grinding Templates for Curve Negotiation to support the Metro Custom RESCO Wheel Profile.

- Curves > 5,000 feet = CPC.
- Curves < 1,500 feet = CPG & CPF
- Curves < 1,000 feet add HRC

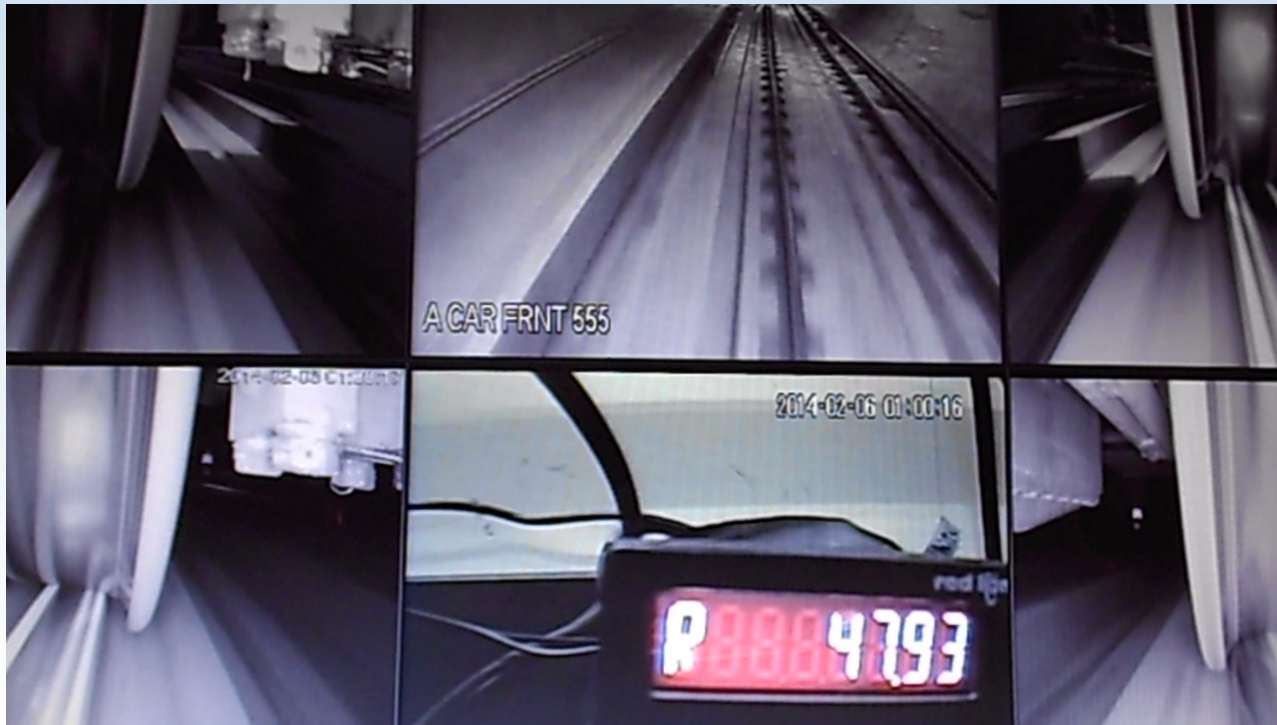
# •High Speed Curve Performance: (47 mph to 53 mph)

- **Existing Vehicle Performance Evaluation:**
  - **On High Speed Curved Track**
    - **Little to No Flange Contact**
    - **No excessive Noise Issues through curved track**

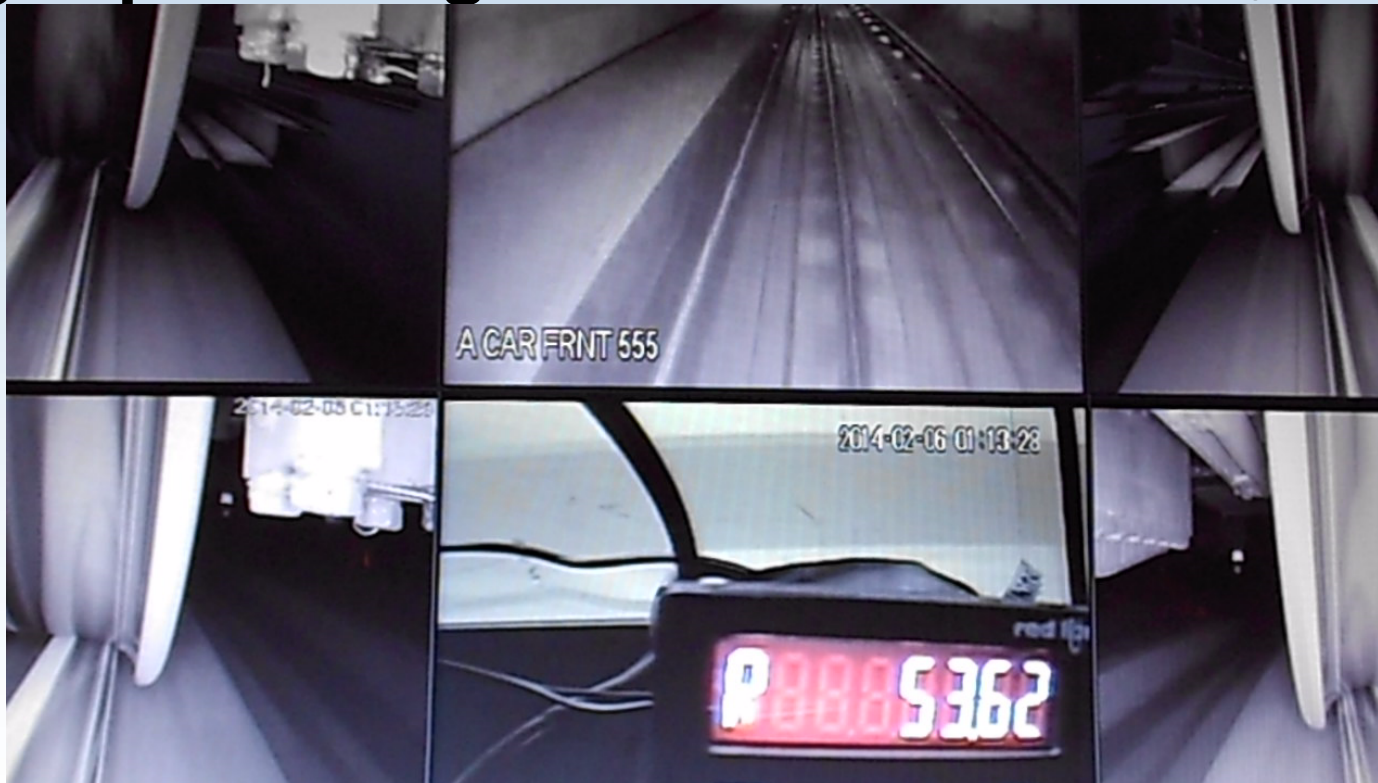
• **High Speed Tangent Performance:** (53 mph to 69 mph)

- **Existing Vehicle Performance Evaluation:**
  - **On High Speed Tangent Track**
    - Little to No Hunting
    - No apparent Noise Issues on tangent track
