Toronto's New Subway Cars

**Raffaele Trentadue - Head of Rail Cars and Shop
Subway Operations, Toronto Transit Commission**

RAIL TRANSIT SEMINAR • JUNE 5, 2017

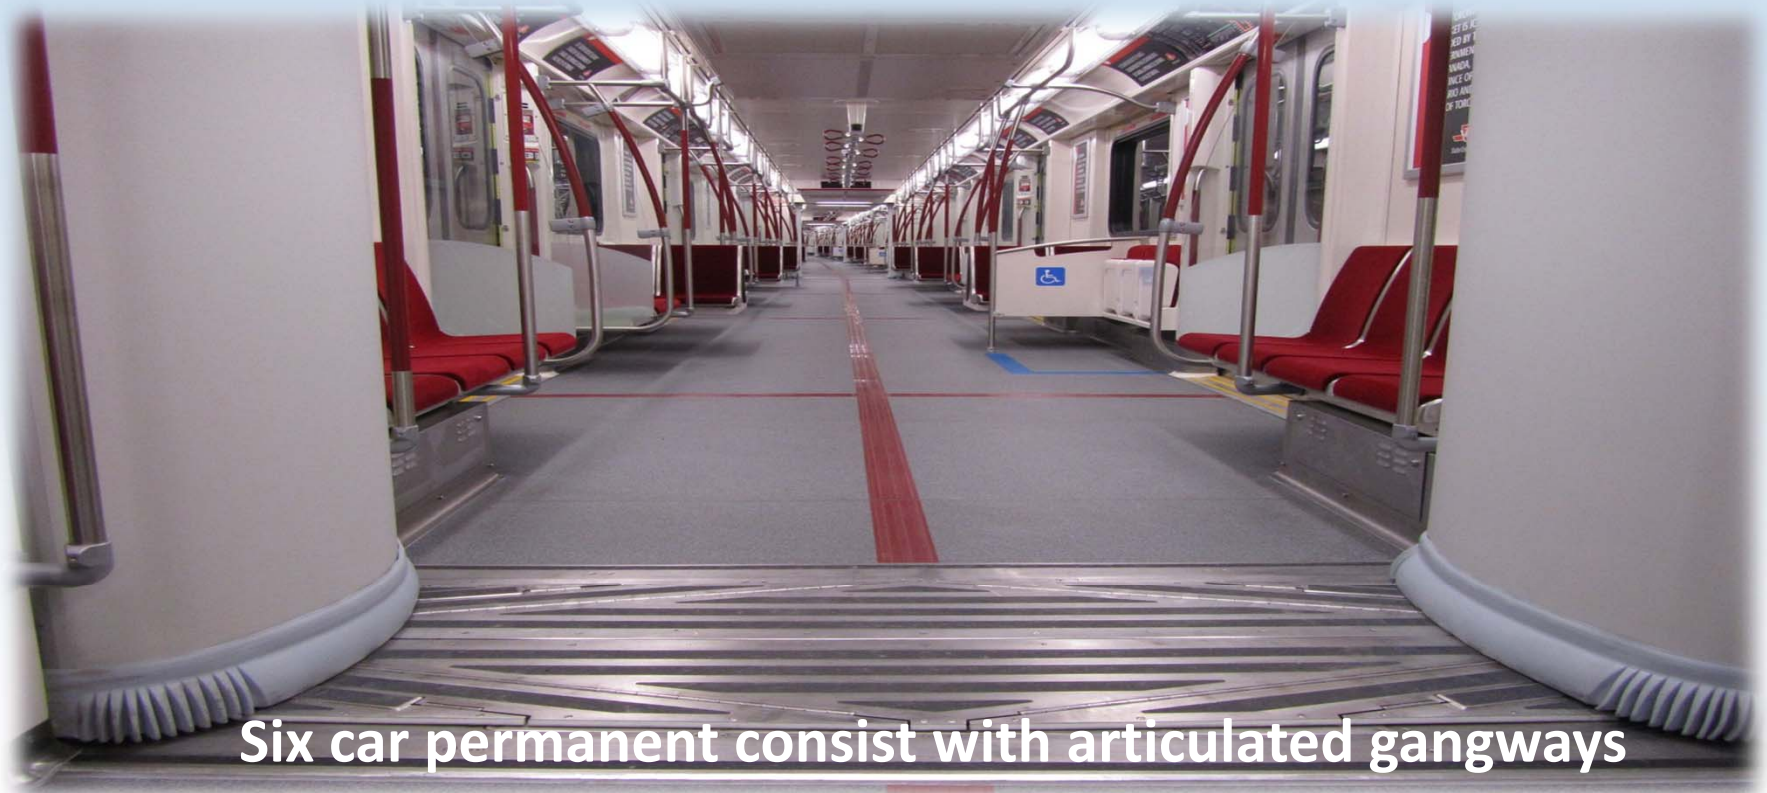
Six car permanent consist with articulated gangways

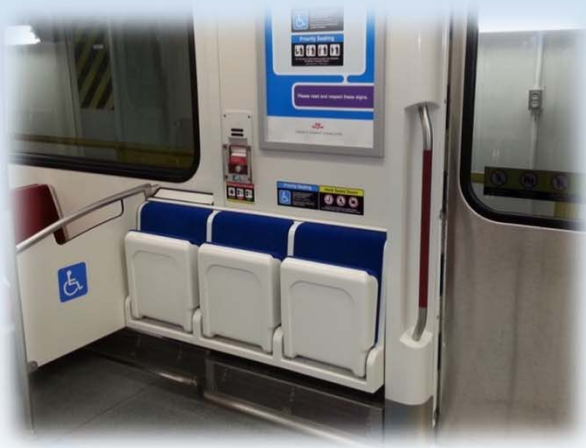
Accessibility for mobility seating

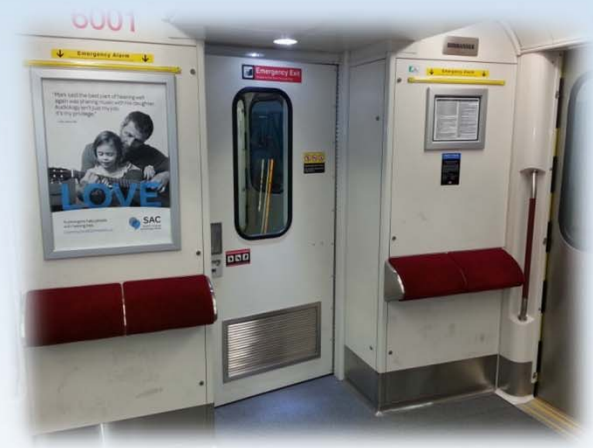
Perch Seating for increased standing room

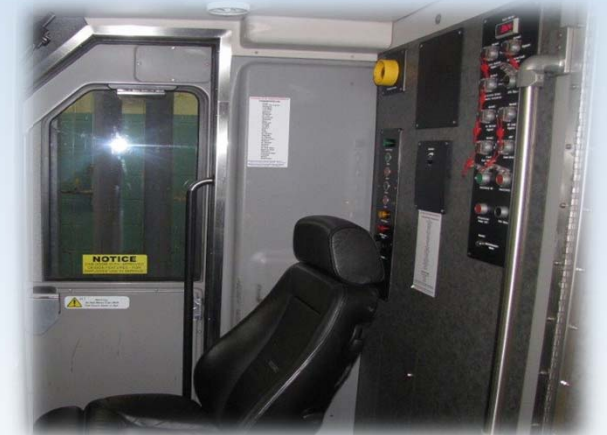
Operator Cab

- Improved Security for Operator (isolated cab)
- Improved Security for Passengers
- Improved passenger assistance and intercom

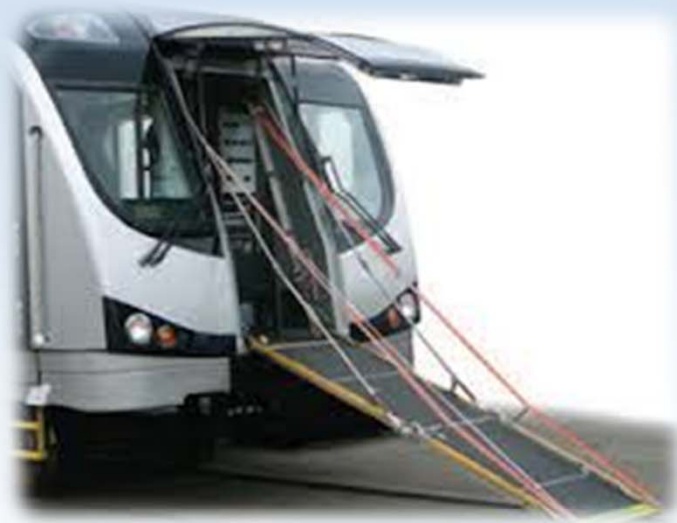
Can evacuate
1500 people
within 30 minutes

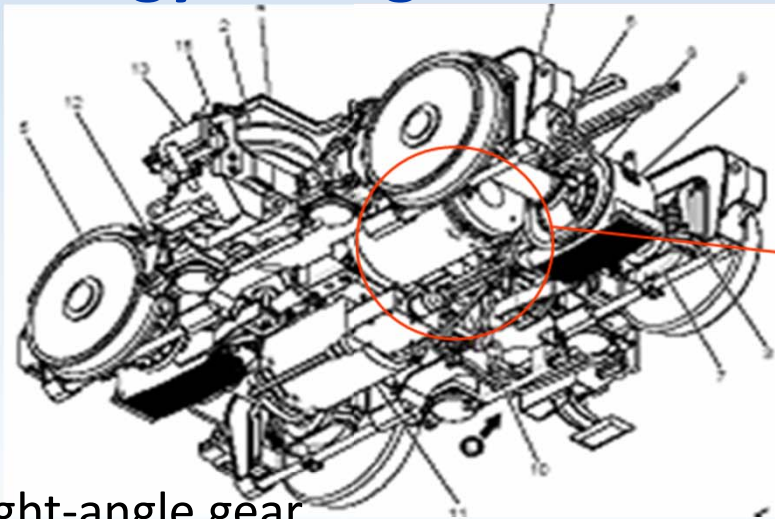
T1 right-angle gear

Produces annual traction energy saving, i.e. 82 TR trains will save:

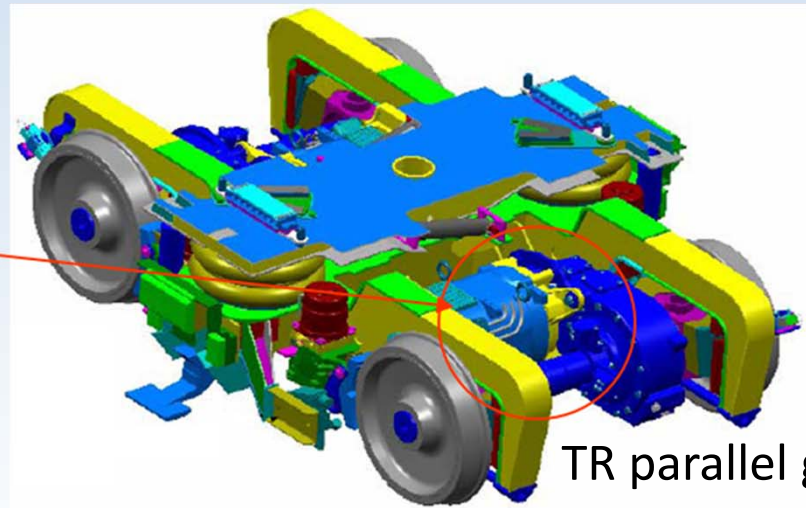
TR parallel gear

$P \cong 10,000,000$ kW

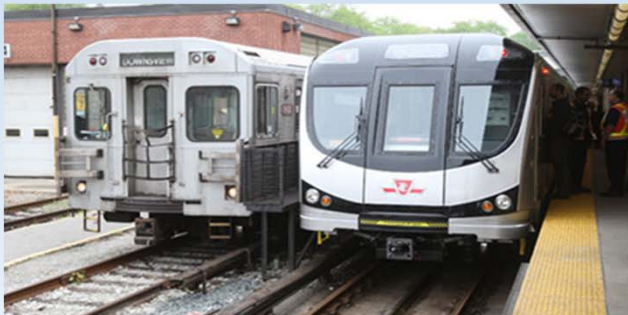
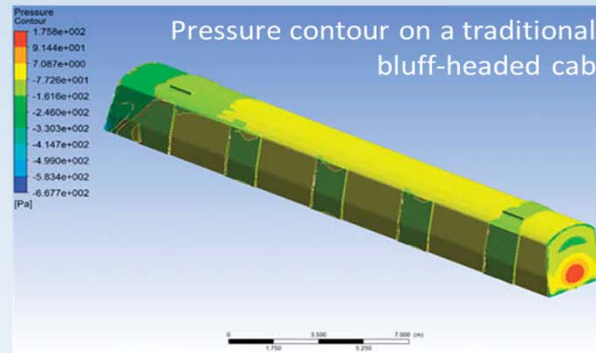
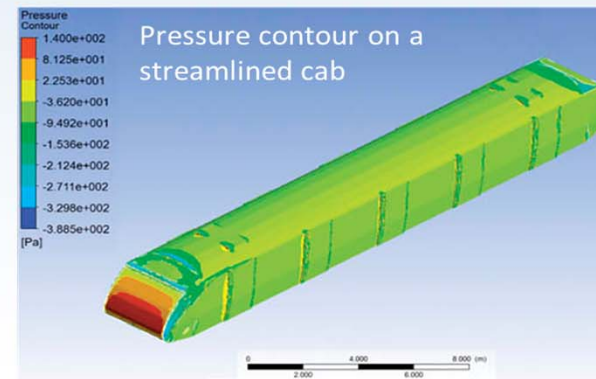
Drag Forces (Newton)	Bluff Head	Streamlined Head
Drag due to head shape	1484	506
Skin friction	140	182
Total	1624	688

Modelling demonstrates potential Energy Savings due to increase of aerodynamic efficiency from cab design

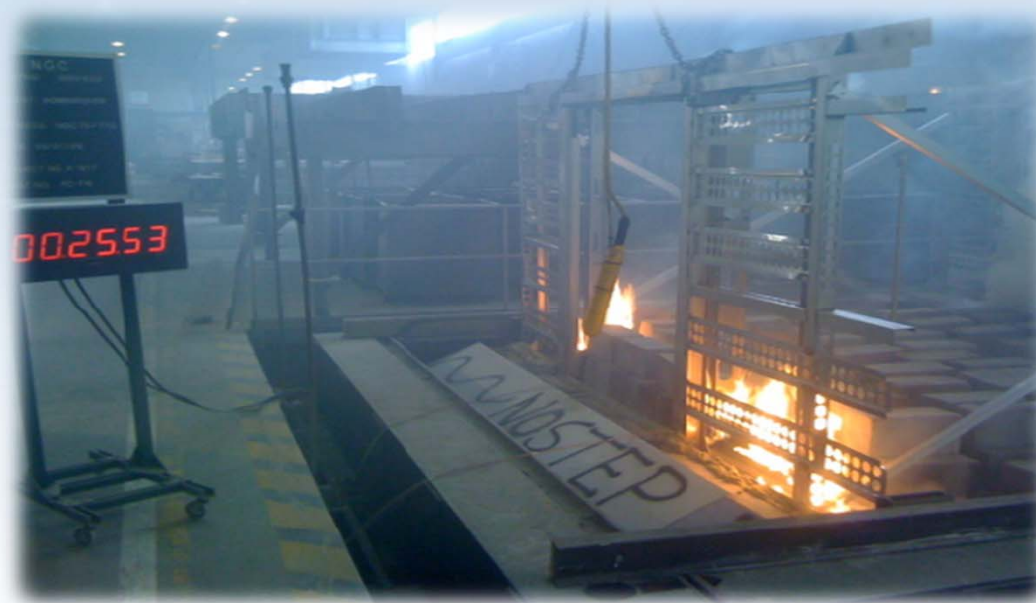
Improved fire rating standard

- TR floor is tested to ASTM E119 (fire resistance) for 30 minutes
- T1 Specification called for ASTM E119 but only 15 minutes rating which was in alignment with the FRA guidelines* at that time.

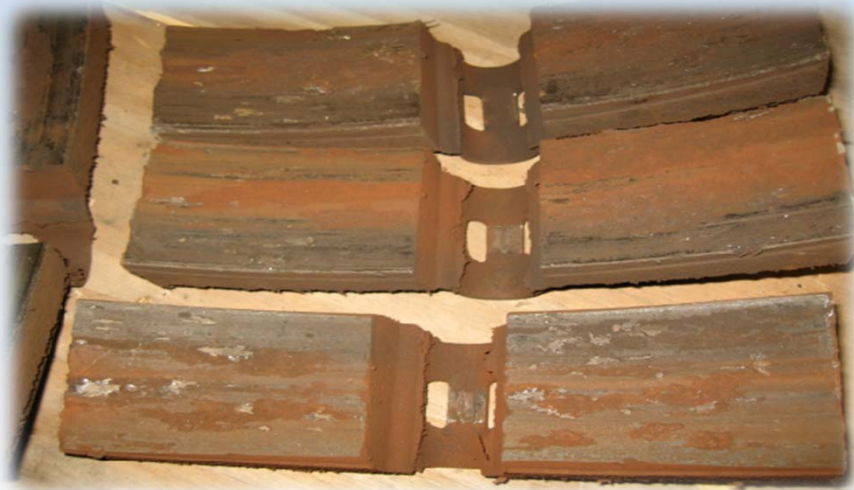
**Excessive Grease Picked up by
Wheels and Transferred over
on Brake Shoes**

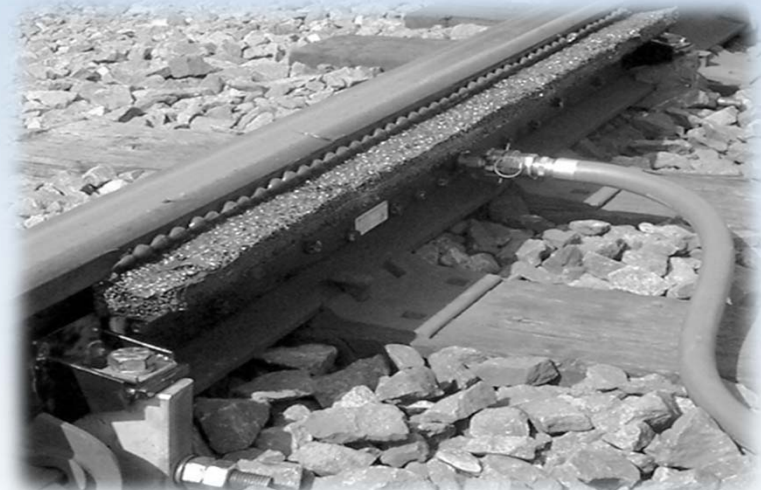
**Track Lubricators
(Fine Tuning the Lubrication
Rates)**

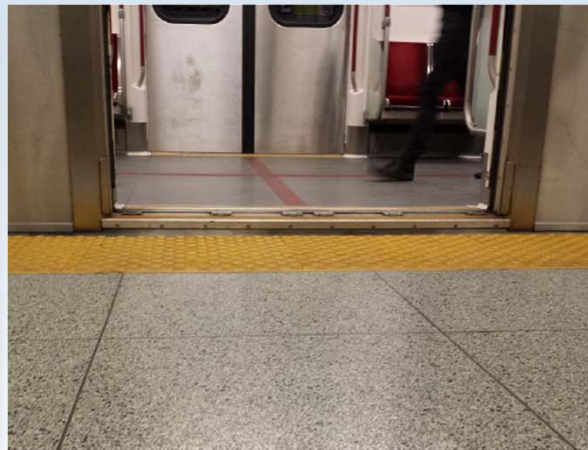
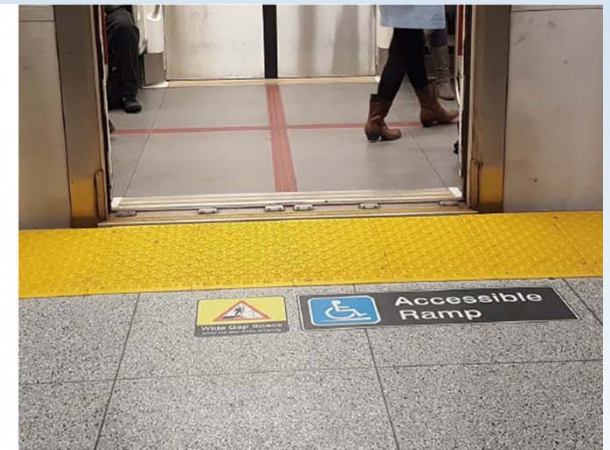
Car Floor level with platforms

Cars ToFF had been set within tight guidelines for fleet consistency and deficient areas within the network were addressed

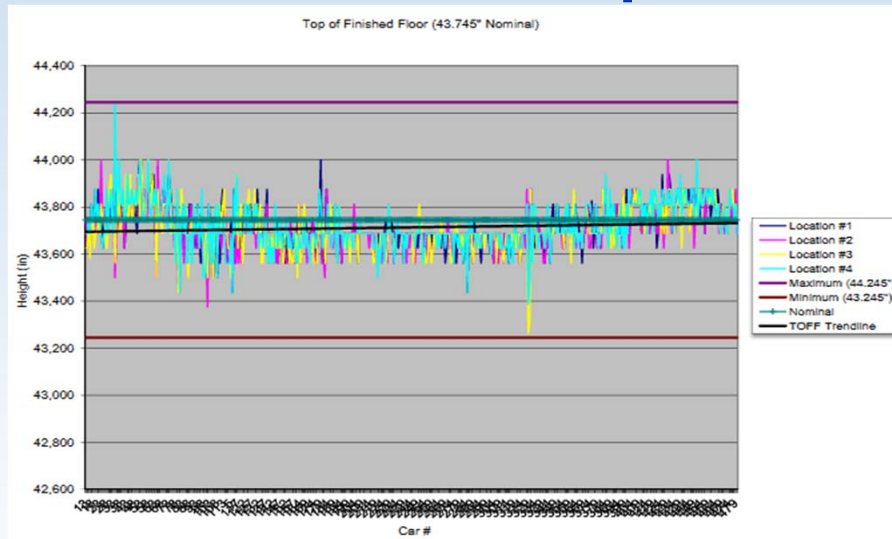
Car Floor level with platforms

Tight control during production was implemented in order to ensure that acceptable level of consistency in cars floor height tolerance was achieved $\pm 0.5''$

- **Managing platform and vehicle interface within AODA framework.**
- **Documented the differences in height of platforms vehicle during train test runs**

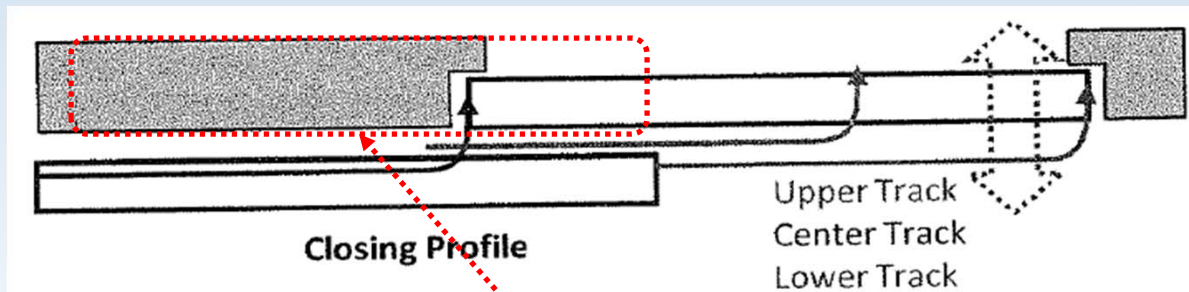
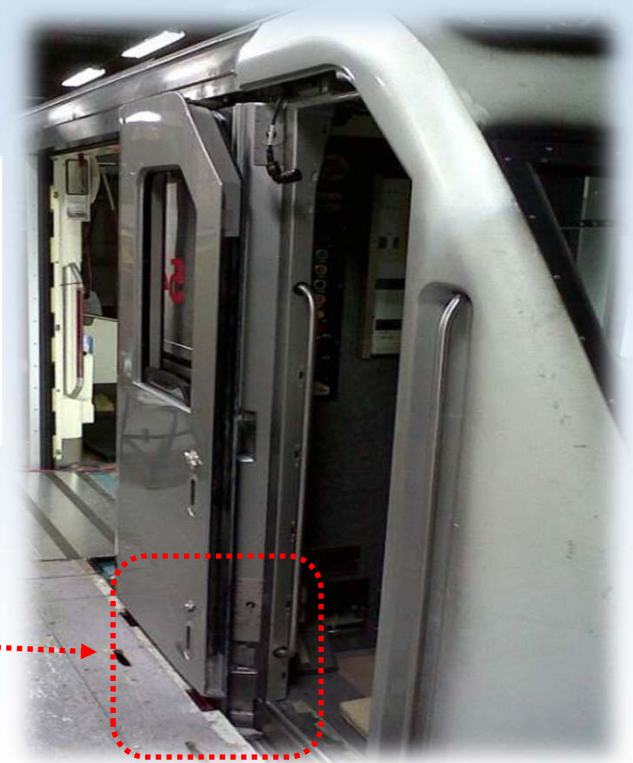
Cab door dynamic envelope

Inconsistent structural tolerance clearance infringed on Cab Door "Open Position"

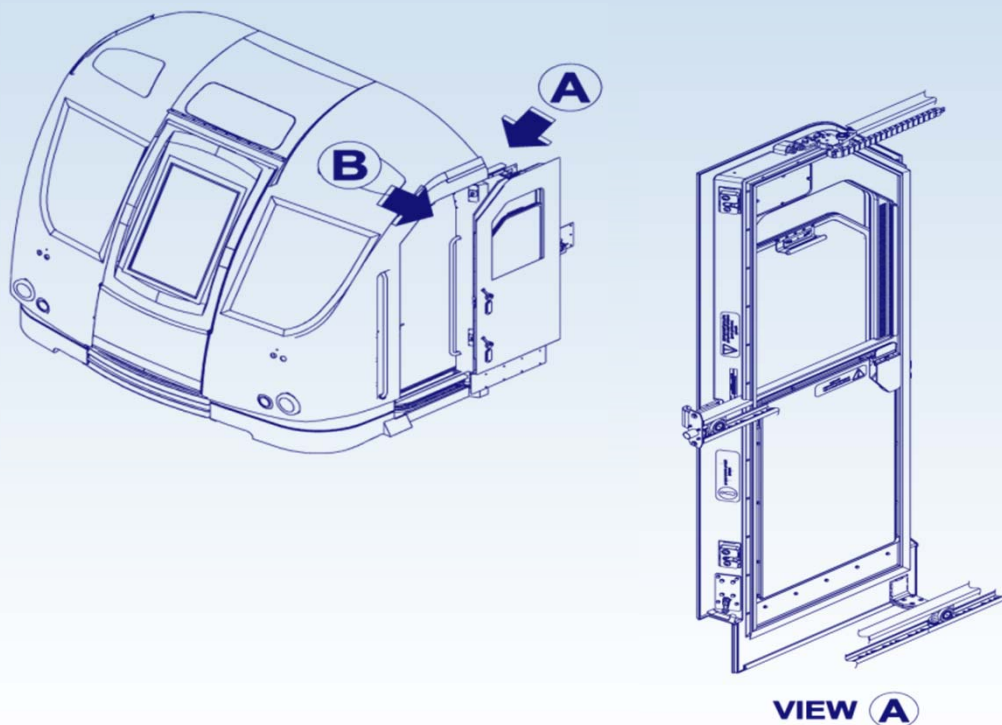
New Cab Configuration and Cab Door Design

- introduced unexpected delays related mechanical latching and electrical door train-line
- Extension of warranty, several design revisions

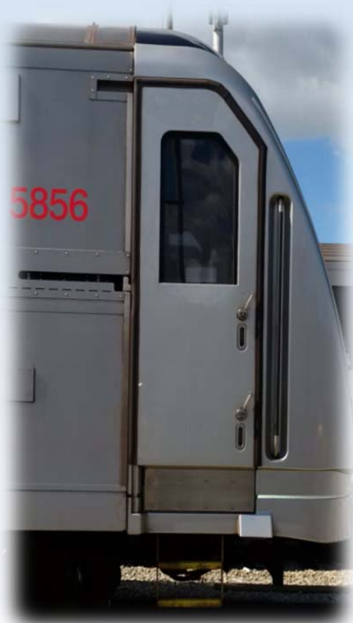
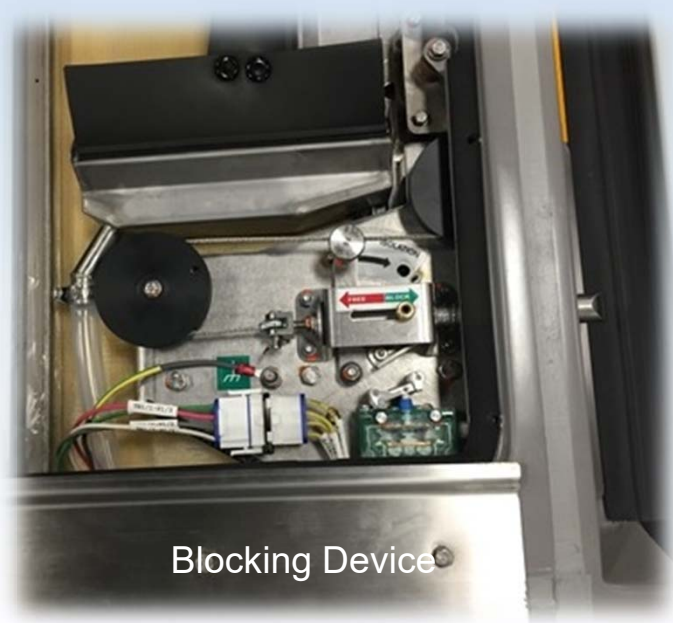
REV. E CAB DOOR

- Manual local isolation device allows trains to stay in service
- Ease of adjustment / maintenance
- Modified external handles to prevent stuck key
- Modified exterior seal & bulb seal to improve air & sound infiltration
- Modified window seal to minimize friction

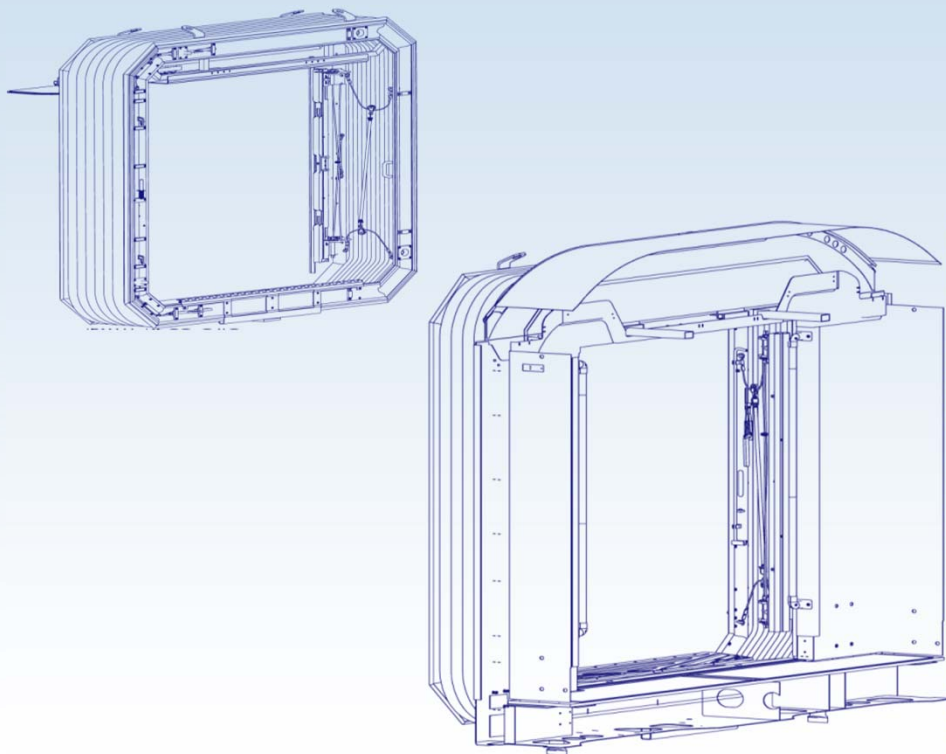
- Interior Gangways require much more attention to detail for maintenance
- Both from a cleanliness and mechanical interface perspective
- Early issues with panels cracking and shifting

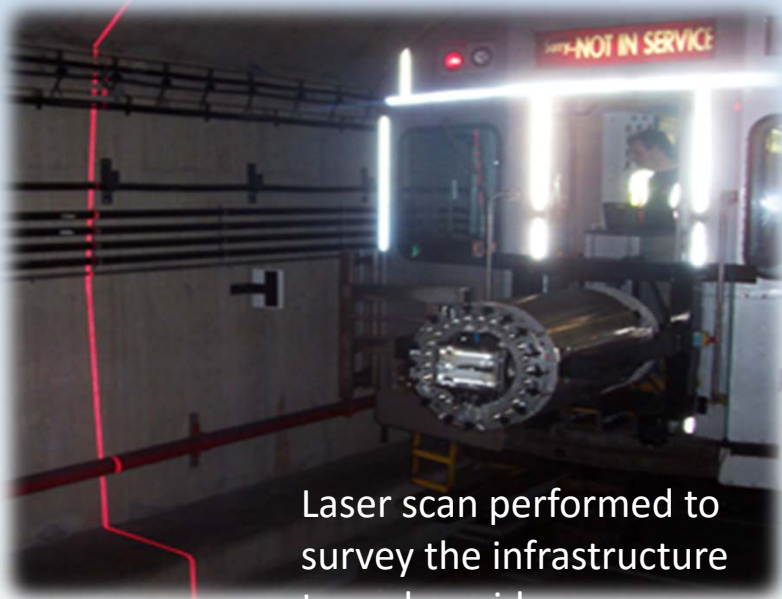
Laser scan performed to survey the infrastructure tunnel corridor

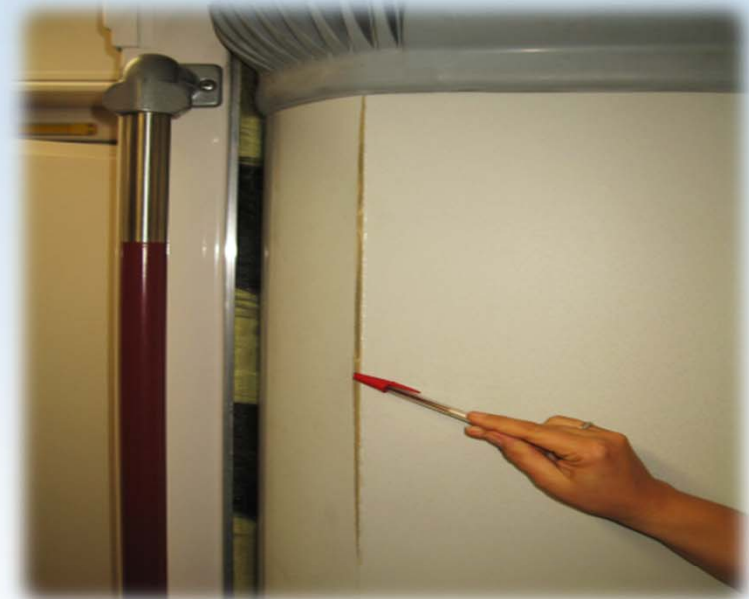
Cracked side wall – Supplier attempted to blame unregistered tight curve but unsupported by the laser scan data obtained during design stage

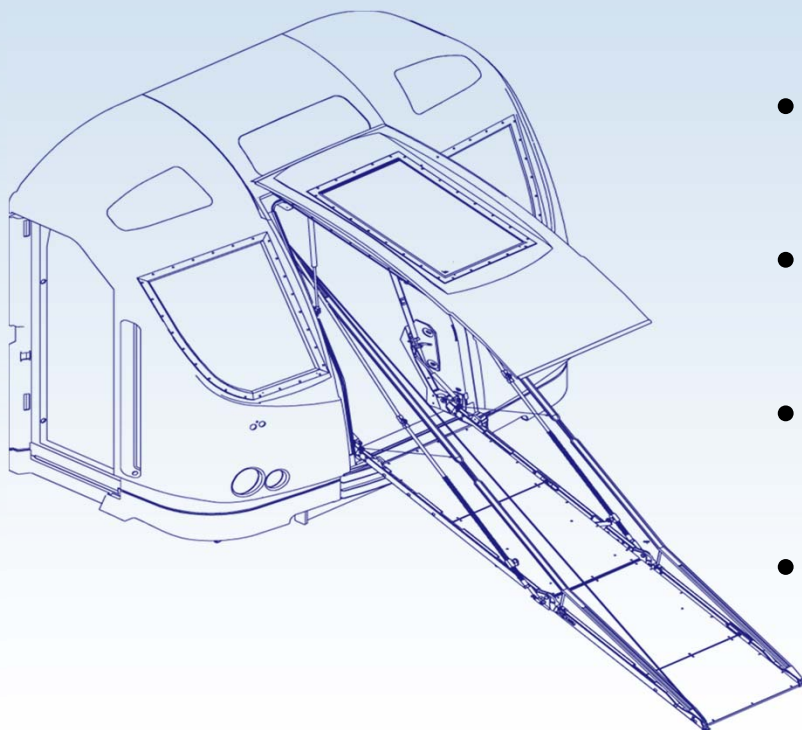
- Early issues with seal retention (water and air ingress) in cab area
- Design issues with door detrainment ramp
- Deploys easy but requires ratcheting tool to recovery ramp
- Long recovery time to restore ramp

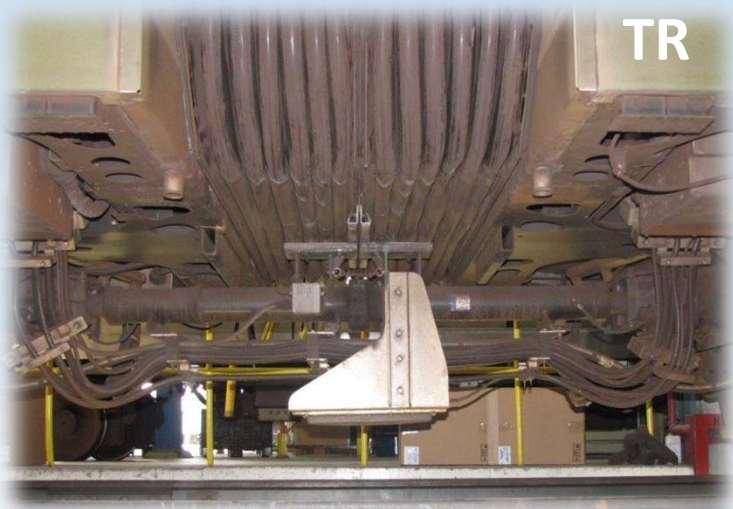
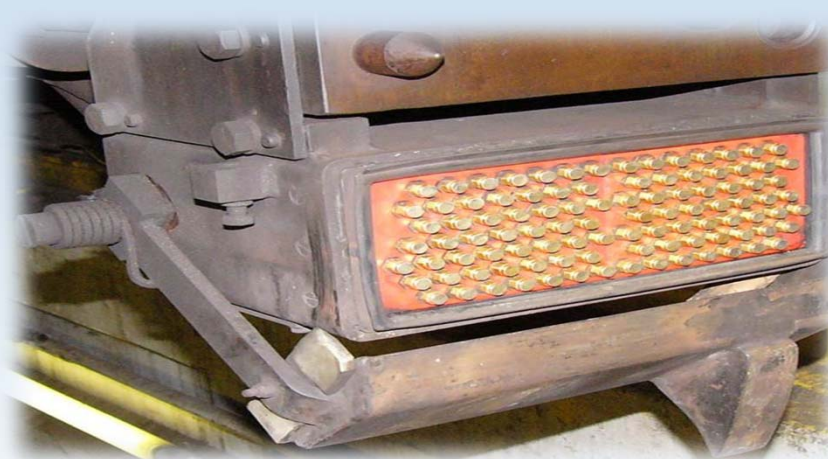
- **Networking Control and Train-lines have less electrical contacts between coupler interface - eliminates Door, EB train-line intermittent type failures and less maintenance.**

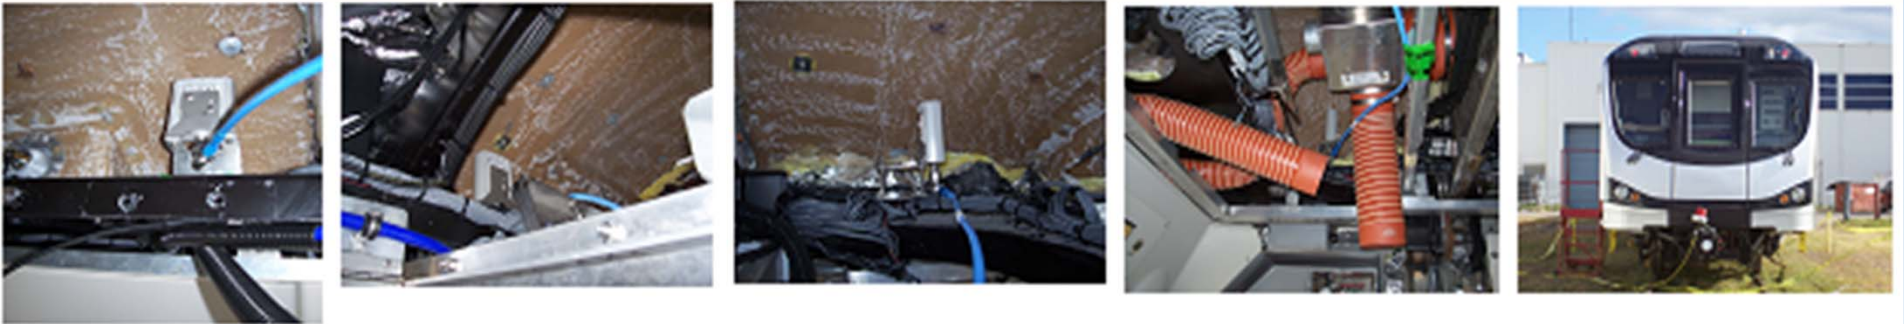
Automatic Train Control (ATC) cut – in

Retrofitting the radio antenna onto the 1st prototype train at Thunder Bay

- Upon “execution” of ATO implementation, 6 to 7 months of software development incurred before proceeding to integration tests of the complete train-borne network exposing high risk to production.

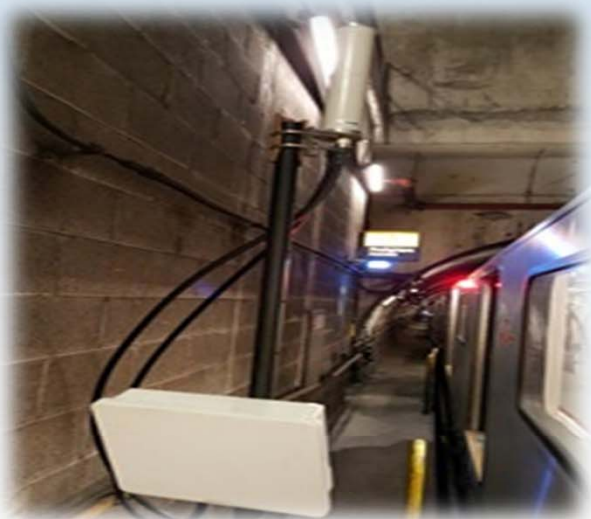
- Train borne wireless receiver & TDM screen
- Cab Console Door Master Switch Panel (CDMSP)

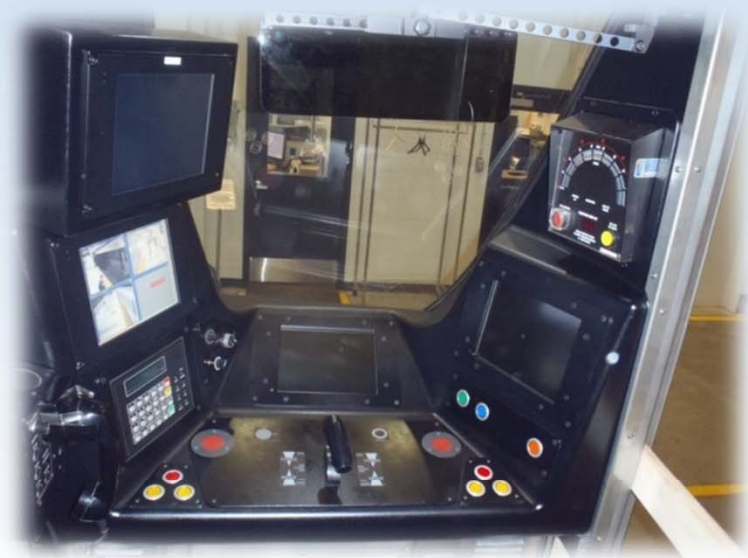
- The main purpose of the TDM system is to display view of passenger train doors in cab console via Way side CCTV camera & wireless transmitter

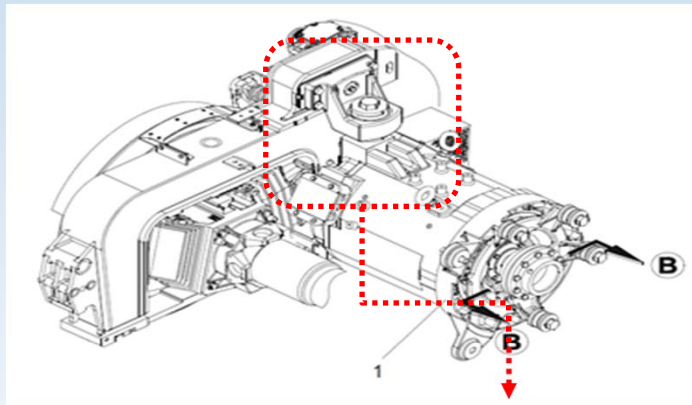
Broken Torque Seal – Loosened
NDE Bolt

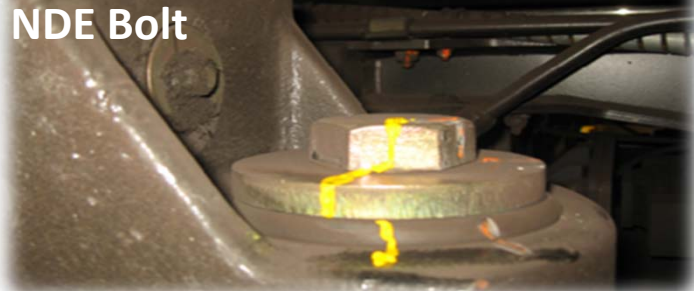
Traction Motor
(Non-Drive End)
Bolt Failures

Rapid Breakage
by Shear Forces

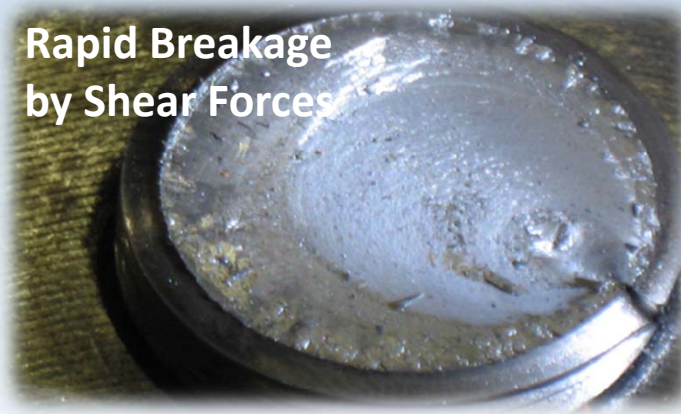
Insufficient Clamp Loads
due to Sub-Quality Blind
Thread Hole of the Motor
Casting Case

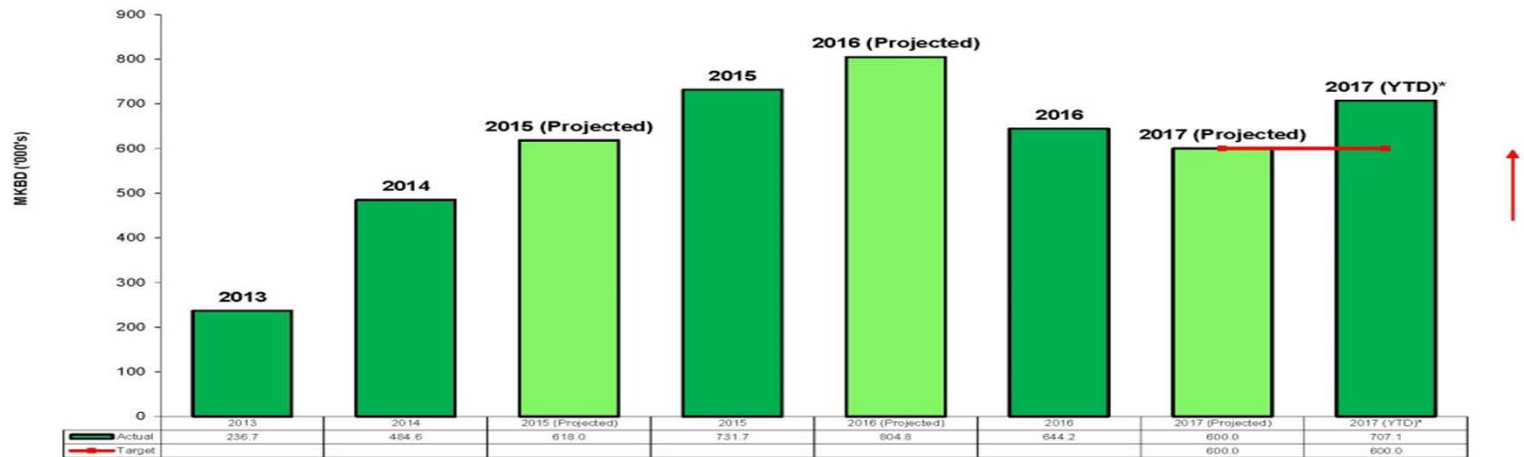
TR MEAN KILOMETRES BETWEEN EQUIPMENT DELAYS (MKBD)
(GREATER THAN OR EQUAL TO FIVE MINUTES)

YEAR END REVIEW 2013 to 2017 (YTD)*

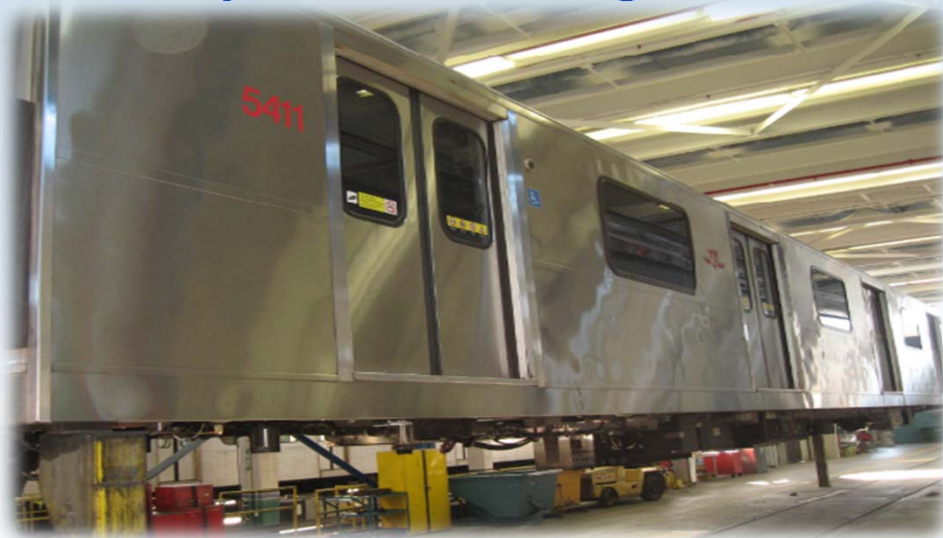
**Single Car Lifting Jack
(for truck replacement)**

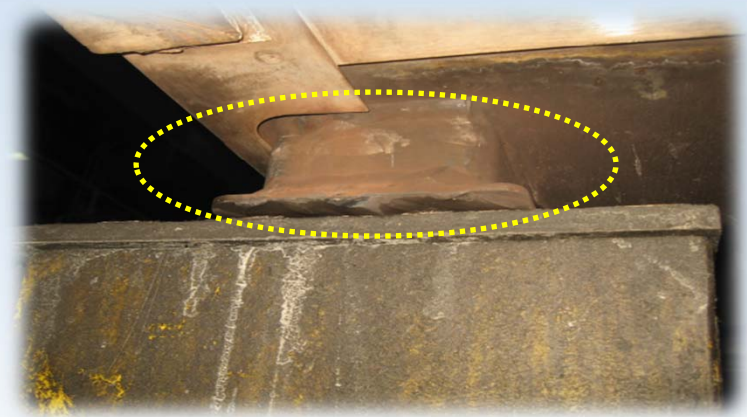
**Partial Seating at the Jacking
Pad (due to different jacking
point locations of older vehicles)**

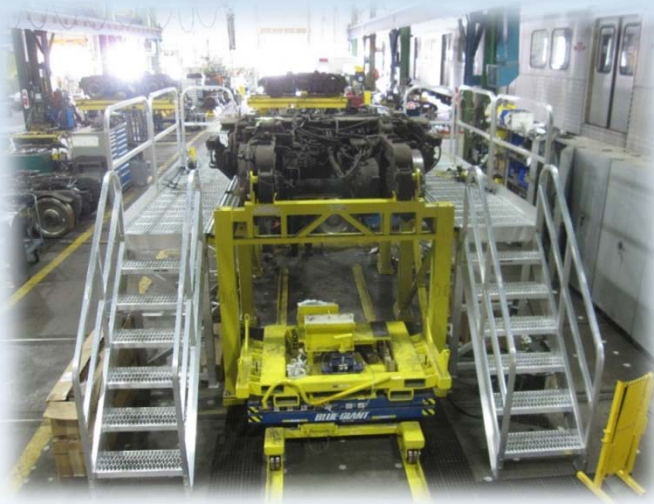
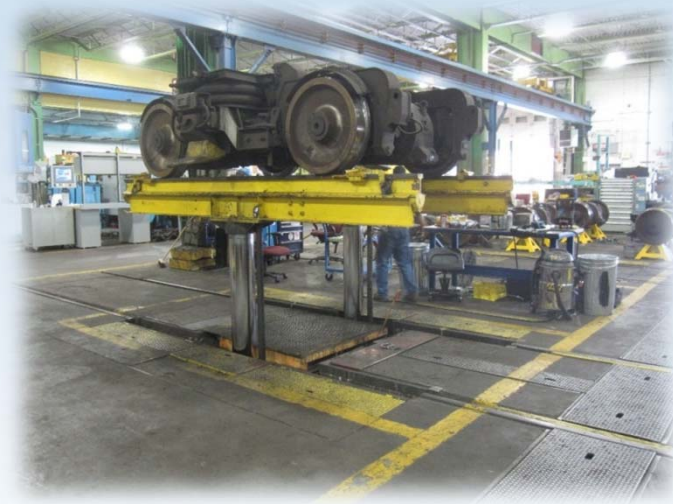
- Ergonomic and functional study
 - Comparing TR Truck Stand and Adjustable Height Hoist
 - Truck Overhaul Maintenance output

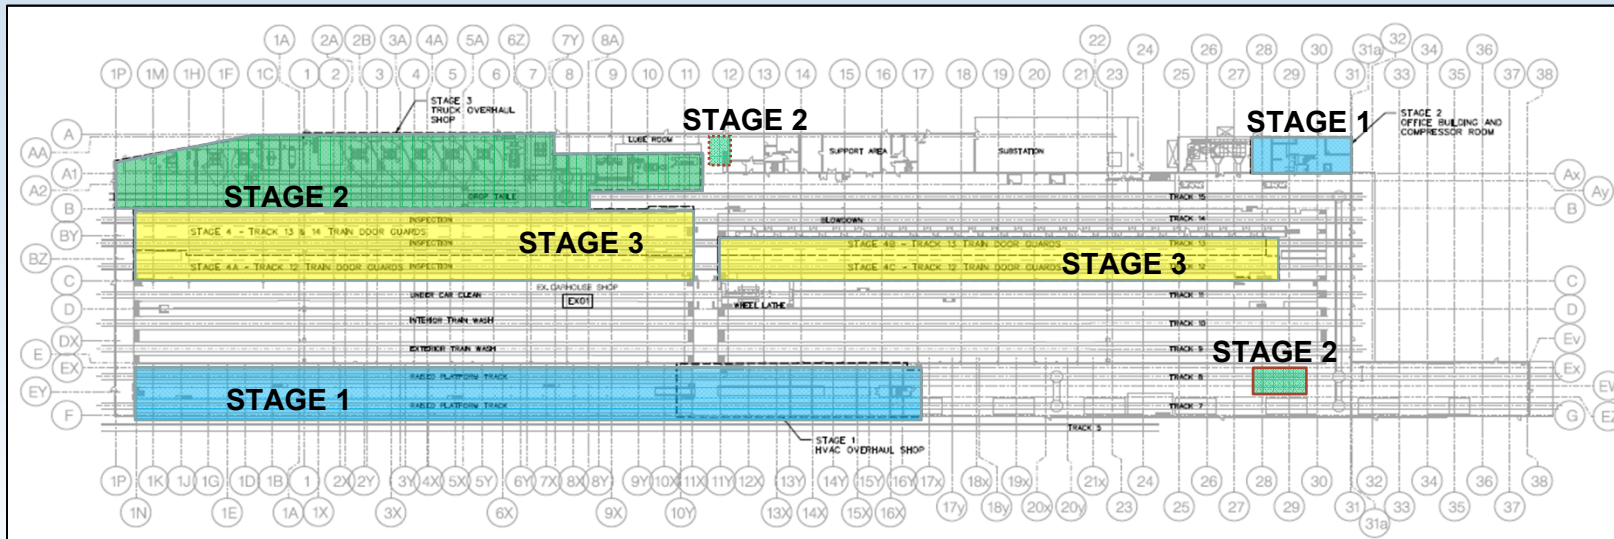
- Stage 1 – Track 7&8 HVAC Overhaul Shop and Mezzanine Ventilation Upgrade and office Building
- Stage 2 – Track 15&16 Truck Overhaul Shop & South Basement Expansion
 - Track Stand Relocation and Additional Track Stand and Crane
- Stage 3 – Train Door Guards and Platforms (Tracks 12, 13 and 14)

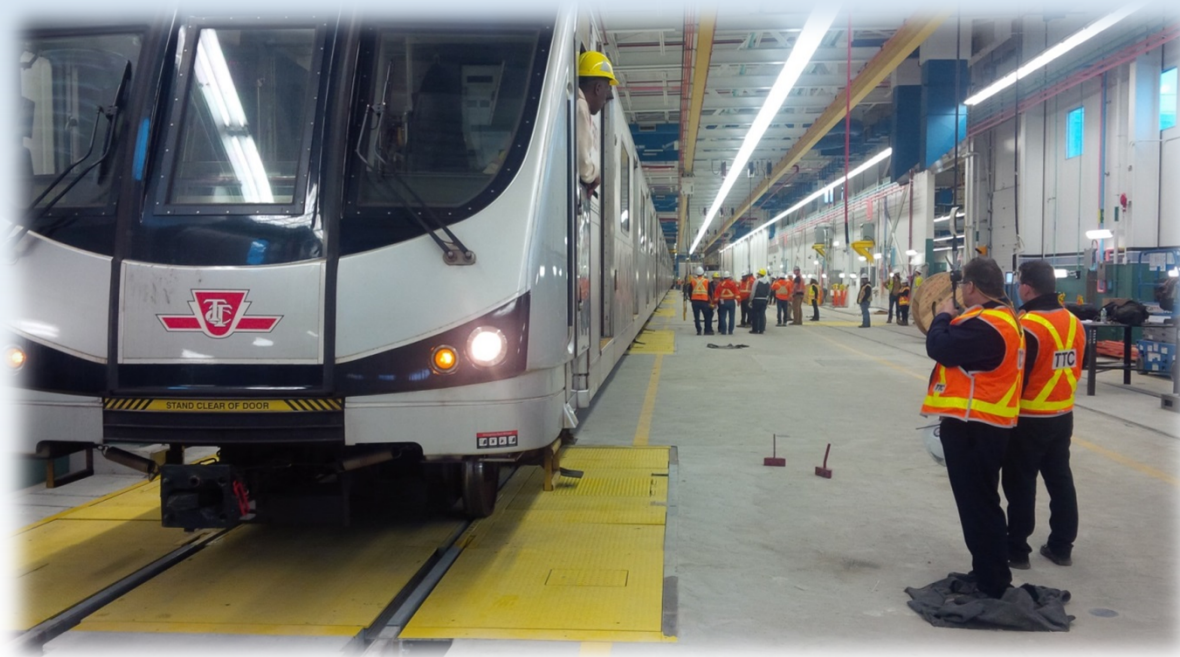
First in North America 6-Car hoist

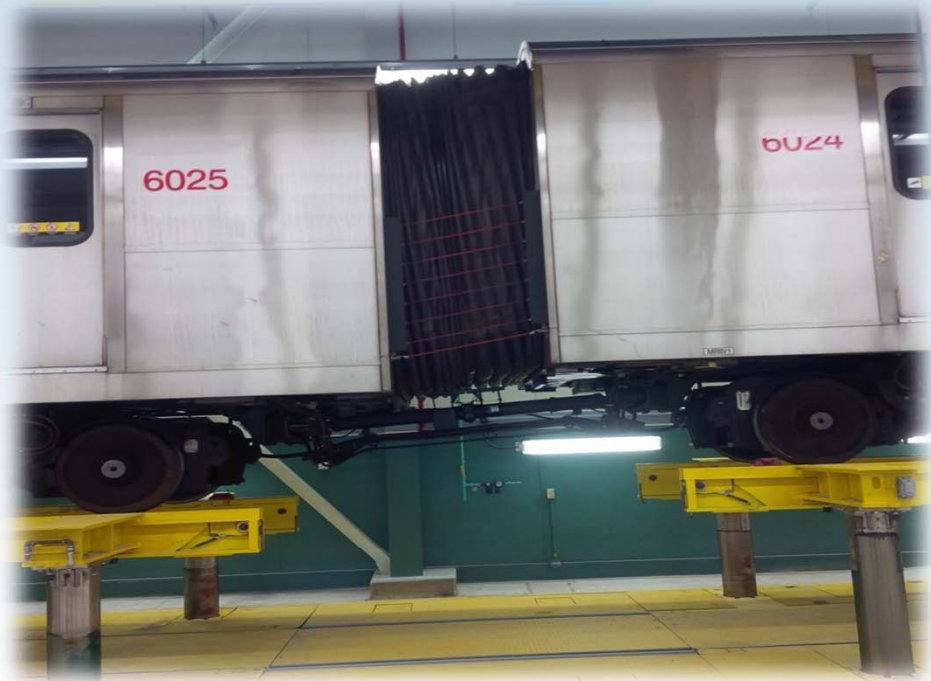
6 Car Hoist Configuration problem

Configuration of control of train position sensors was modified to correct the issue
