# Derailment Case Studies Caused by Poor Management of the Wheel-Rail Interface

Gary Wolf – Wolf Railway Consulting

HEAVY HAUL SEMINAR • MAY 2-3, 2018

# 125 ton Doublestack Derailments

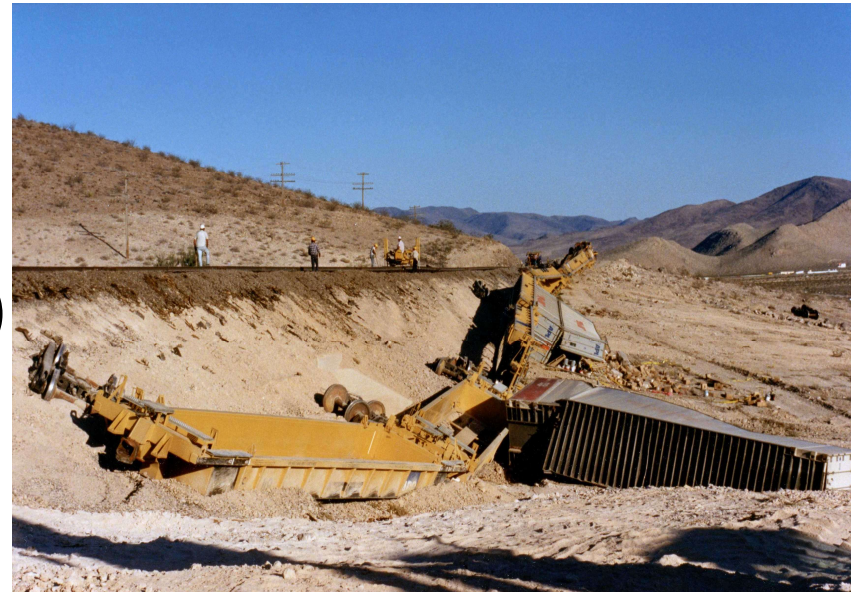
## 25 Unexplained low rail rollover in 1-2 year period

- Low rail rollover
- Wood tie track, cut spikes
- Dry rail conditions
- Moderate curvature (3-7 degree)
- Running under balance speed
- Canted Rail
- Loaded 125 ton DS cars
- Low drawbar force
