# Examining the Role of Wheel/Rail Interaction in a Derailment

HEAVY HAUL SEMINAR • MAY 2-3, 2018

Derailment of 28 hopper cars loaded with frac sand and two DP locomotives at Mile 96.4 Grande Cache Subdivision on 29 October 2016

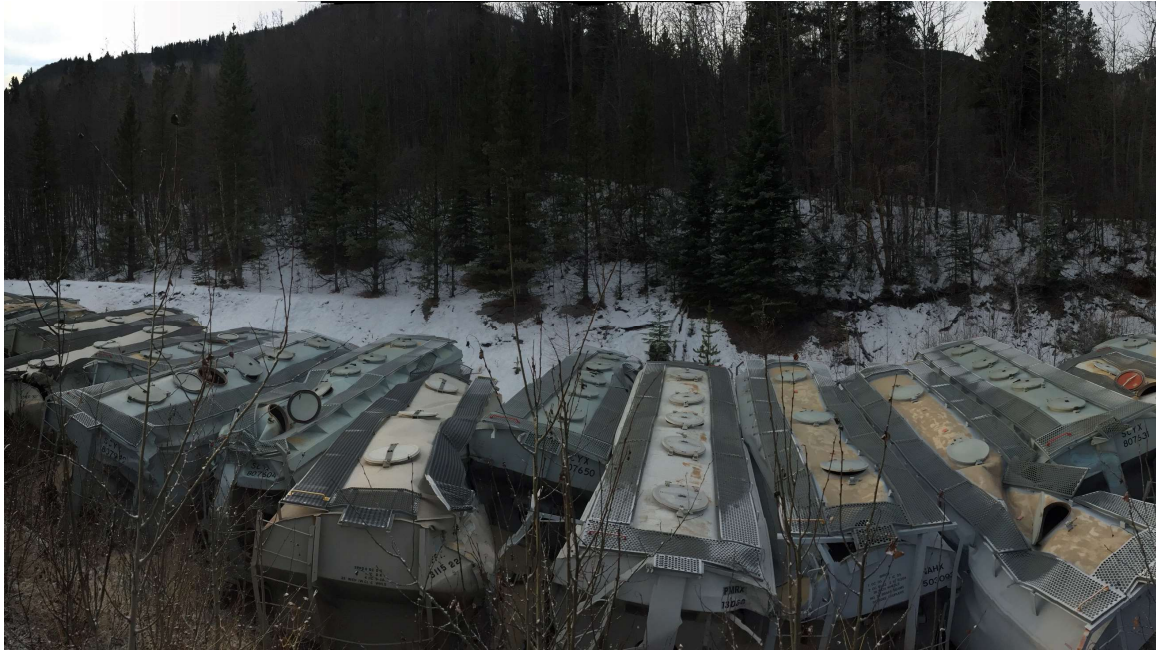
# Emergency

- The train was descending a 1% grade through a 6° RH curve at 27 mph
- DB was in position DB5 on the lead locomotive
- DB was disabled on the 3<sup>rd</sup> head end locomotive
- Train brakes were not applied

- in-train buff force between 85 kips and 115 kips (2 locos at DB5)
- Total lateral forces and L/V ratio = dynamic curving + unbalanced centrifugal + transformed lateral force

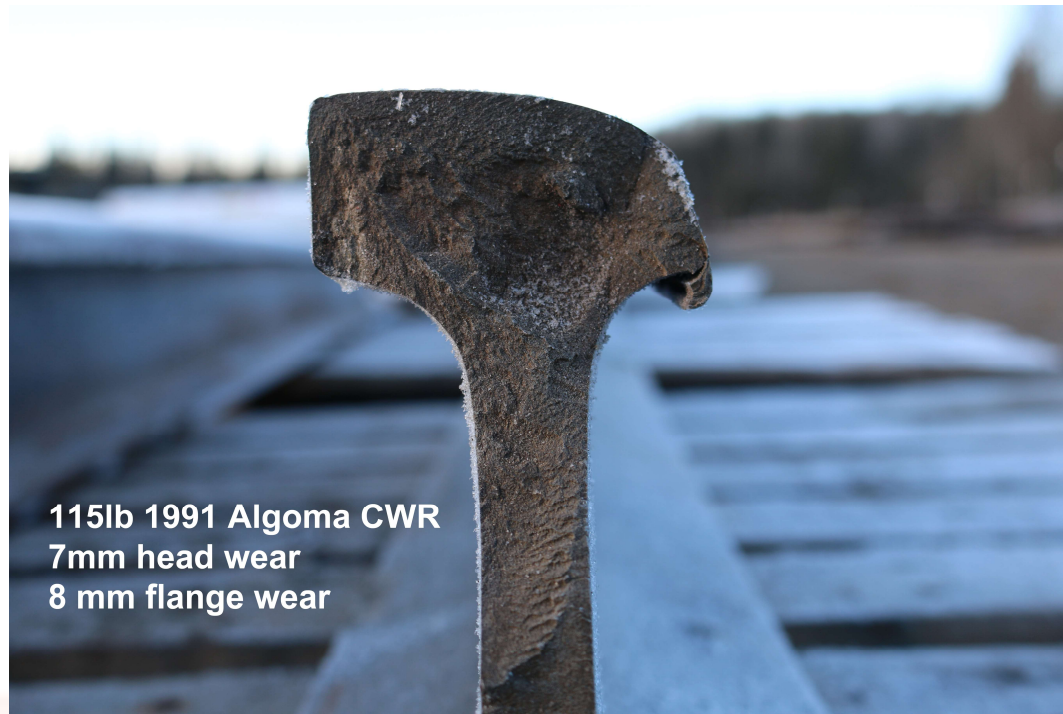
# High Rail

115lb 1991 Algoma CWR  
7mm head wear  
8 mm flange wear

- With the high rail close to its wear limits, wheel/rail contact was closer to the field side of the high rail, resulting in a lower lateral-to-vertical derailment threshold
- High rail likely rolled or canted out sufficiently to allow low rail wheels to drop in

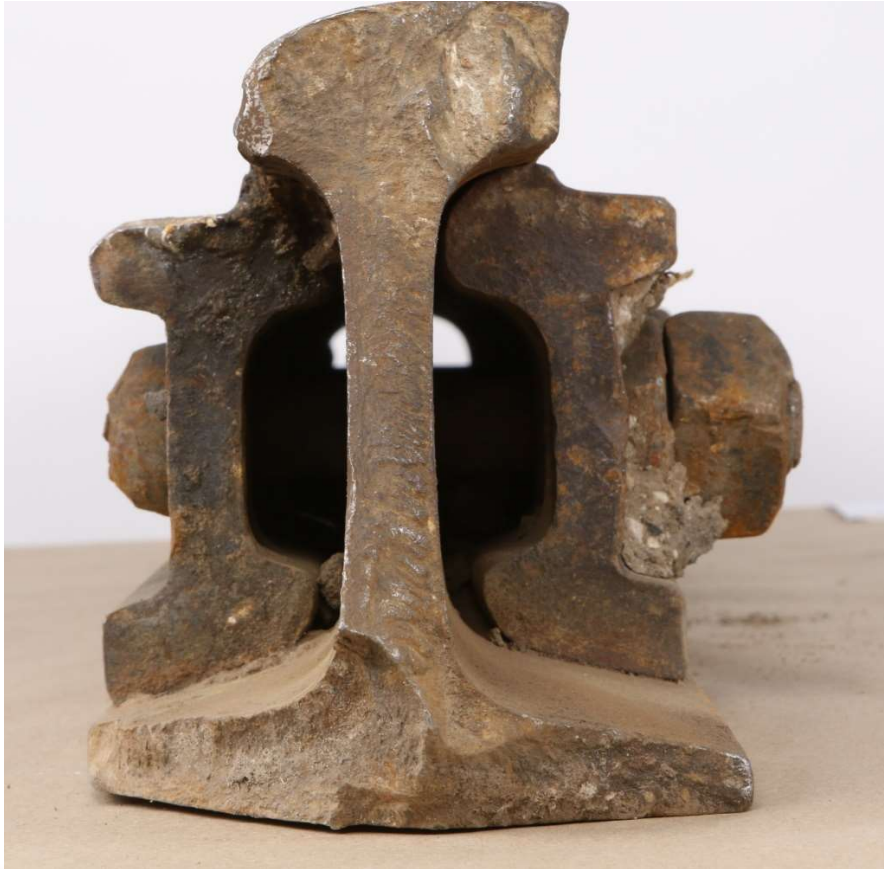
# Plug Rail

- 34' plug rail installed in high rail at POD months previously
- Both joints fully bolted at time of installation
- Both joints recovered intact

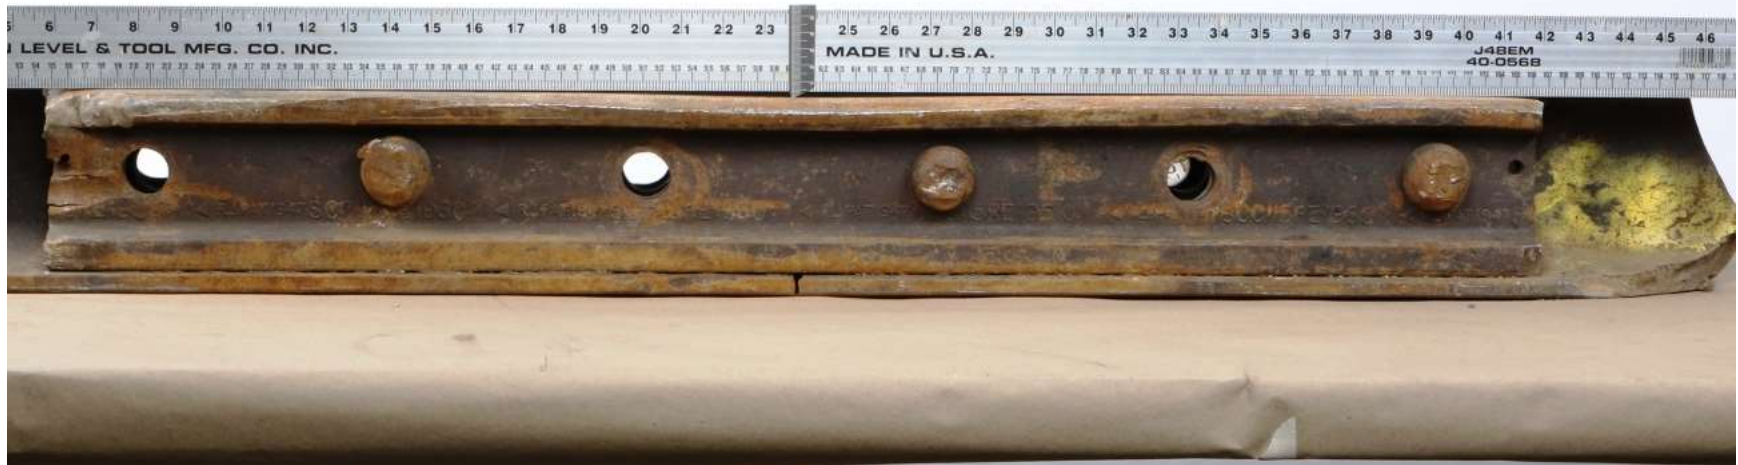
## South plug rail joint

115lb 1991 Algoma Rail. Note missing bolts and wheel flange contact on top of gauge joint bar

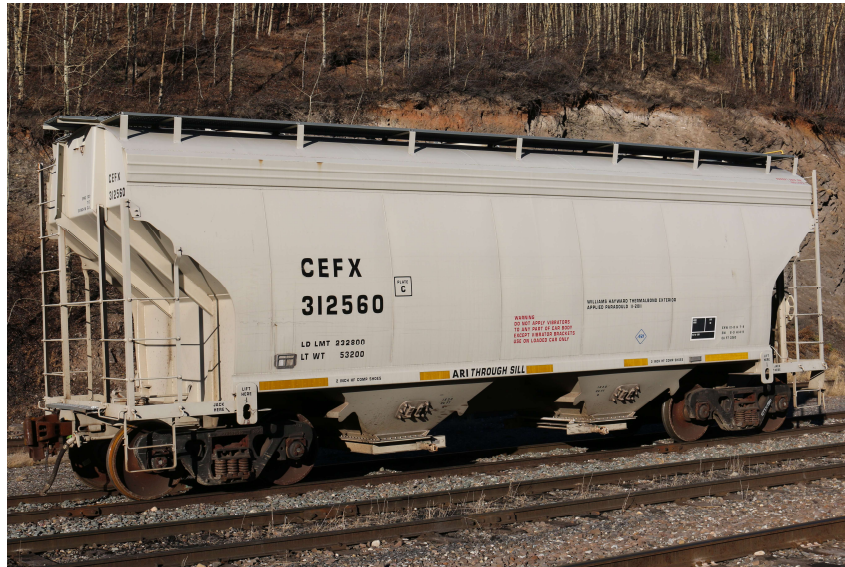
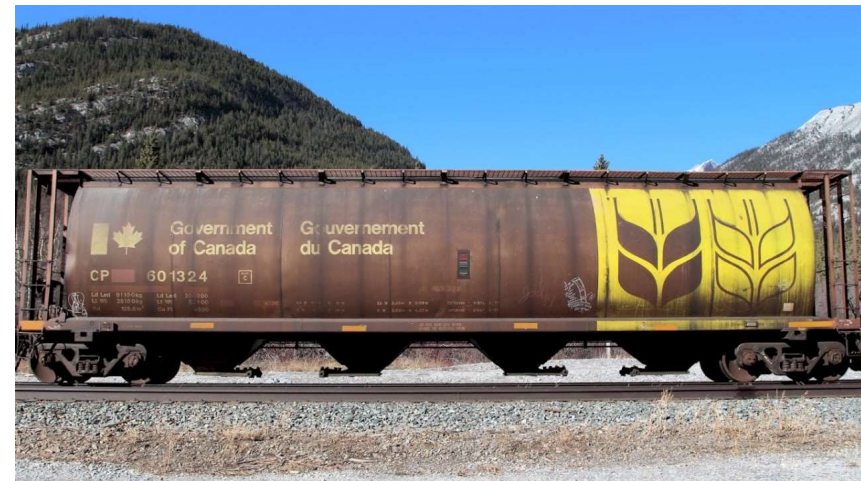
42' Frac Sand Covered Hopper

59' Covered Grain Hopper

For cars of the same weight, in some circumstances, shorter cars can exert higher forces on the rail in curves (i.e., unbalanced centrifugal  $L/V$  and/or transformed lateral forces when the cars are in jackknifed position under buff in-train forces) than longer cars

The shorter distance between sets of trucks in short cars will bring the pressure bulbs produced by each set of trucks closer together and create a larger area of overlapping pressures and lateral forces

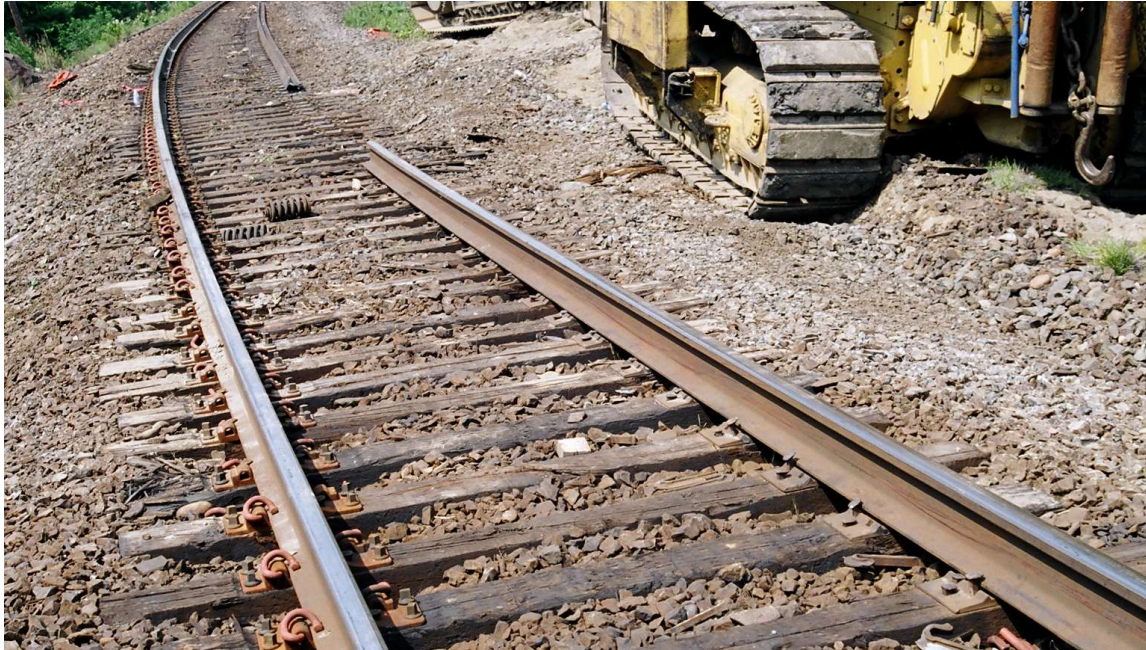
## Elastic Fasteners on high rail, spikes on low

- Uneven fastener resistance between the high and low rail
- reduced superelevation after the low rail was replaced with a new full-height rail

TSB investigation reports R04T0161 and R11T0162, and TSB Railway Occurrence R06T0125

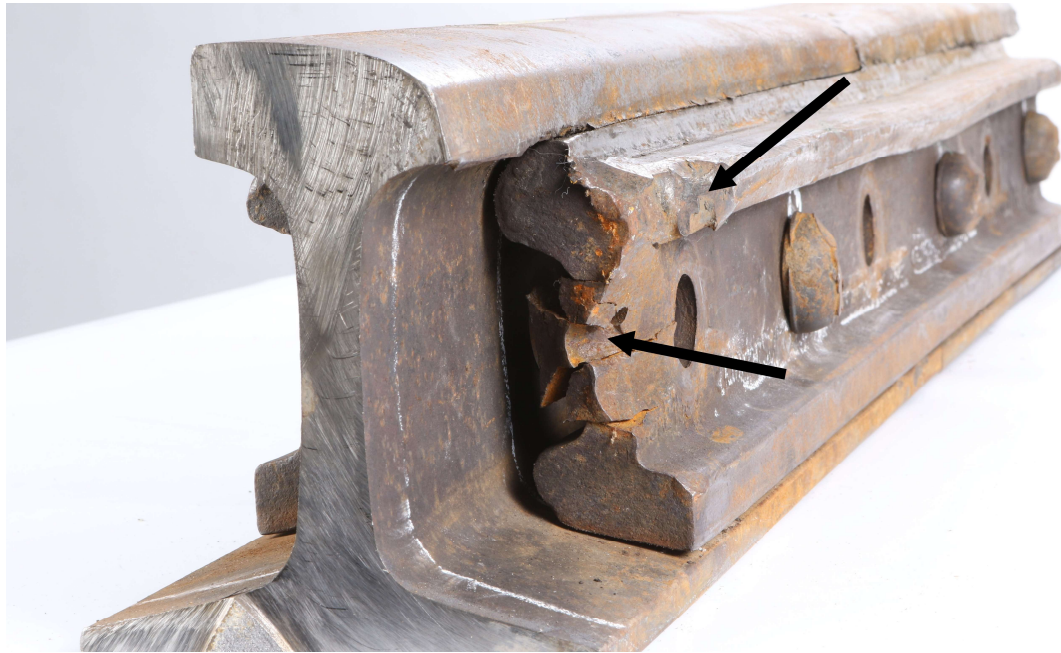
**South plug rail joint bar**

High rail rolled over due to a combination of dynamic brake and train speed on the under-elevated curve, lowered L/V threshold due to 2-point contact on the worn high rail, and uneven high/low rail fastener resistance to dynamic gauge widening

- Gauge restrain measuring
- Review of superelevation standard
- Mandatory use of air in combination with DB
- Increased Engine Service Office presence
- Increased track patrol frequency
