Doublestack Rail Rollover: déjà vu or something new?

*Walter Rosenberger
Research & Tests
Norfolk Southern*

HEAVY HAUL SEMINAR • MAY 2-3, 2018

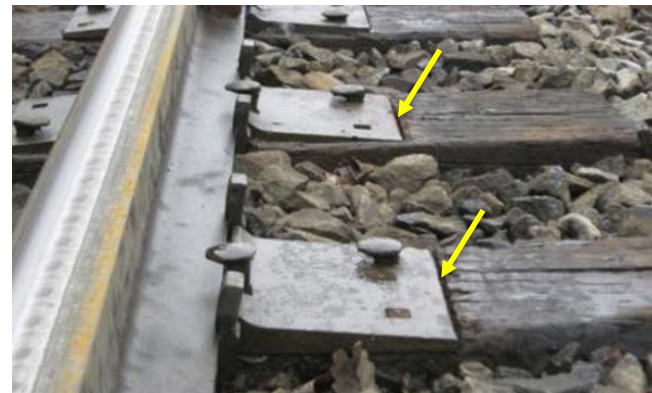
- Conditions
 - 6-9 degree curves
 - Both rails rolled out, one rolled over
 - Under loaded/heavy trains
 - Soon after track maintenance
 - Cut spikes, standard 18" plates

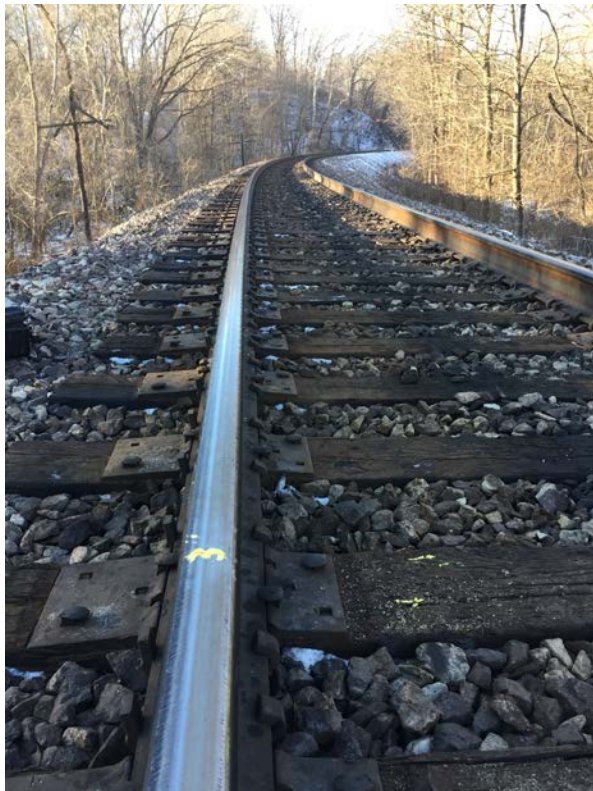
- Excellent track conditions
 - Good geometry
 - No canted rail
 - Minimal plate cutting
 - Optimum GF lube, no TORFM
 - Moderate High Rail wear

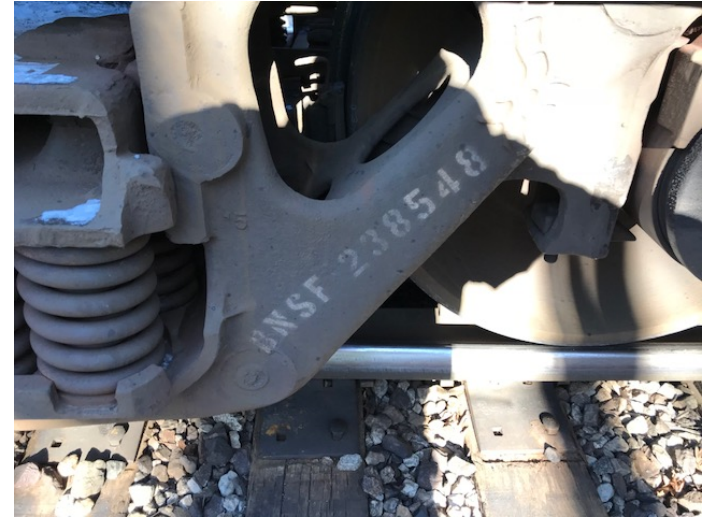
- No equipment problems
 - No sign of truck warp or stiff turning trucks
 - All CCSB's in tolerance (that could be measured)
 - WILD forces nominal
 - Hollow-worn wheels

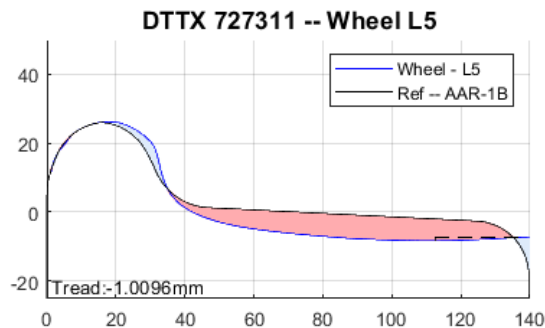
Wheel Profiles

- Hollow wear
- Moderate to near-condemnable
- AAR Rule 41 limit: 4mm on RIP track, 5mm elsewhere

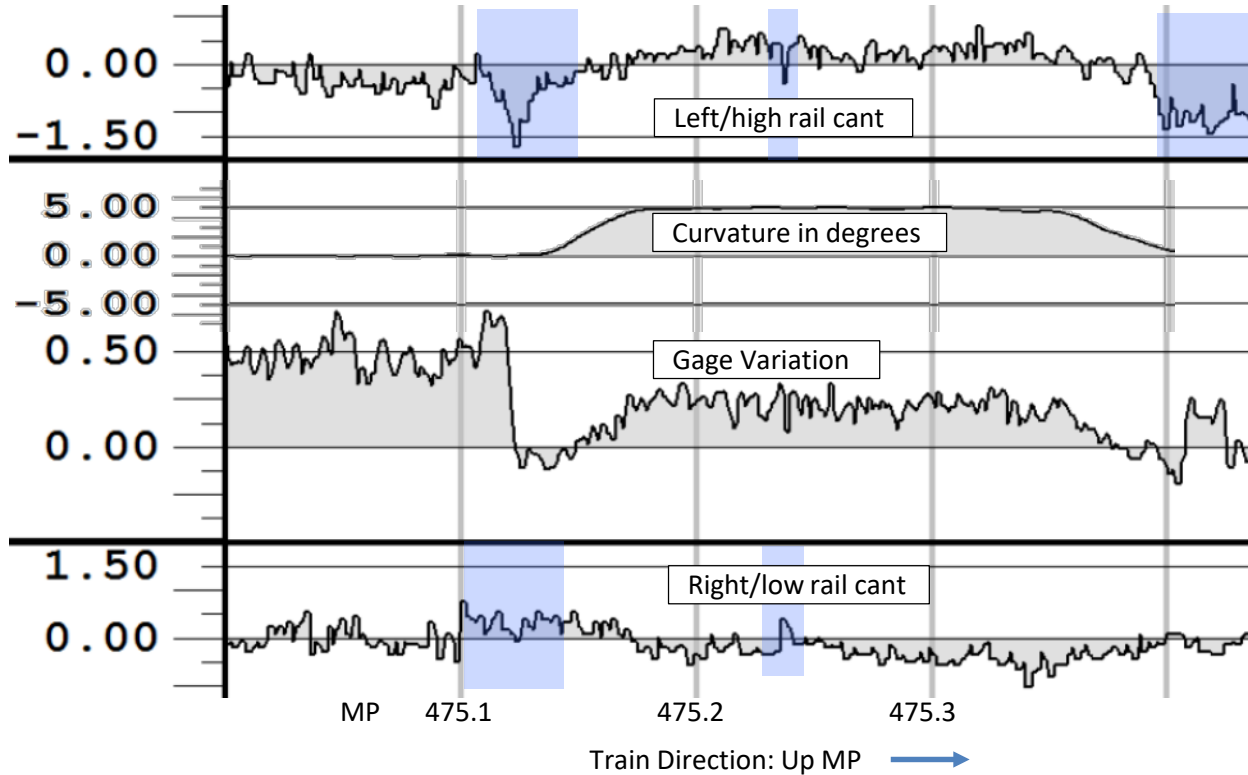
Include rail cant conditions

Inward rail cant

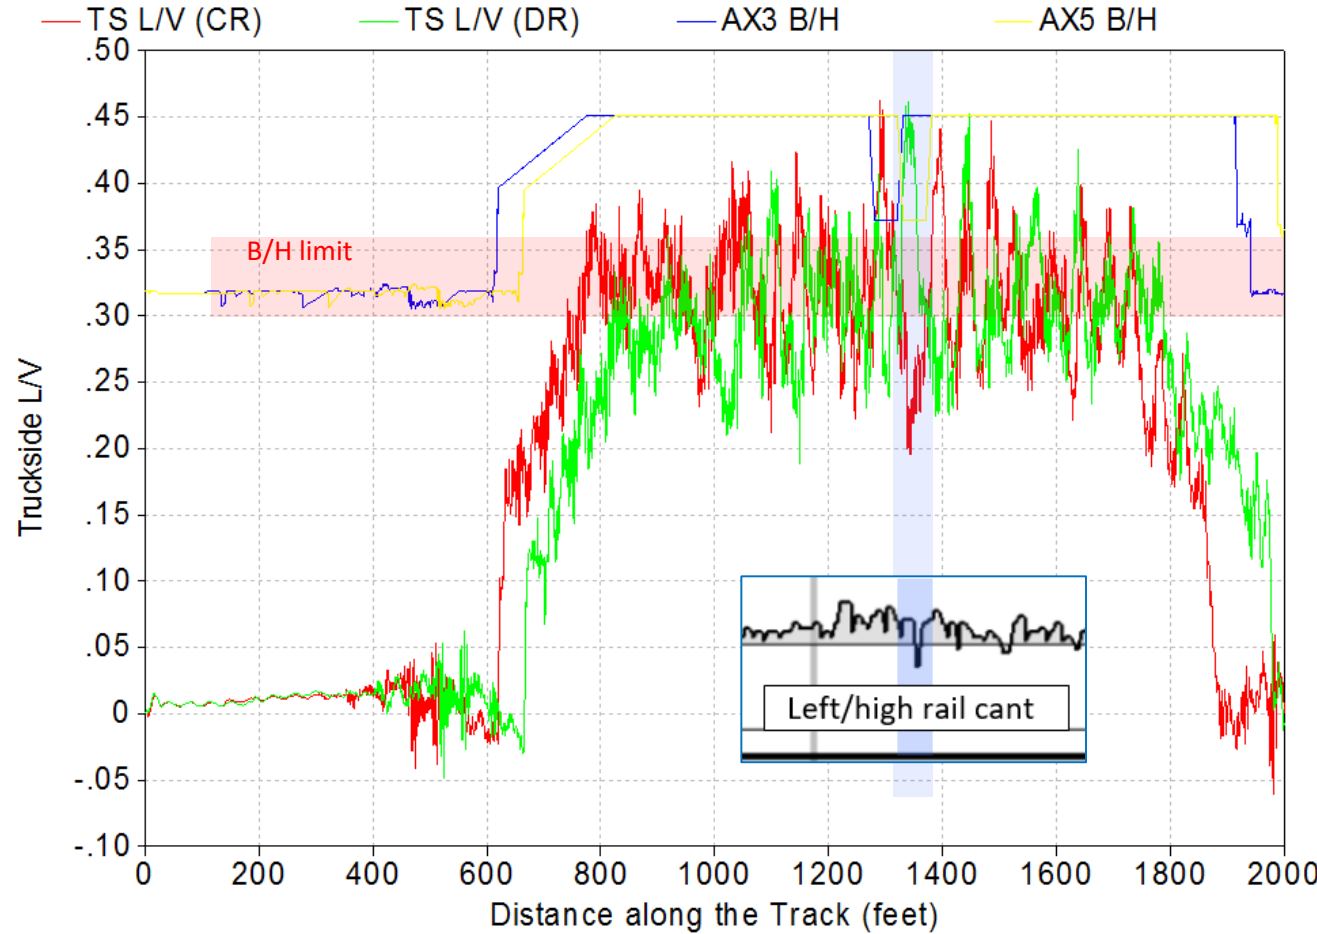
Truckside L/V and B/H, high rail

- R3 profile on all wheels
- Actual rail profiles and cant angles defined per TGC data along distance of simulation

Blue shaded region shows the inward canted area identified in slide 19.

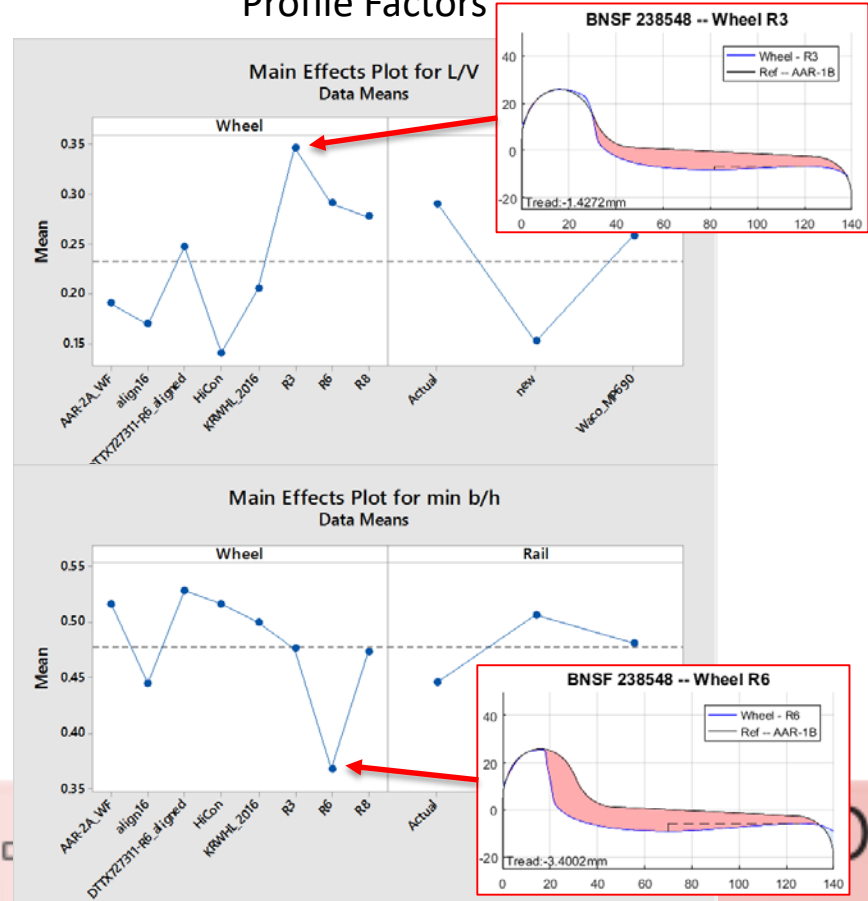
Profile Factors

- Hollow-worn treads
 - Two main effects:
 - Increase truckside L/V
 - Decrease safe B/H
 - Subtle differences between the profiles that cause either one
