# Wheel & Rail Modernization at San Francisco BART

**Charles Franz**  
Vehicle Systems Engineer  
Rolling Stock & Shops

**Gregory Shivy**  
Principal Track Engineer  
Maintenance & Engineering

RAIL TRANSIT SEMINAR • APRIL 30, 2018

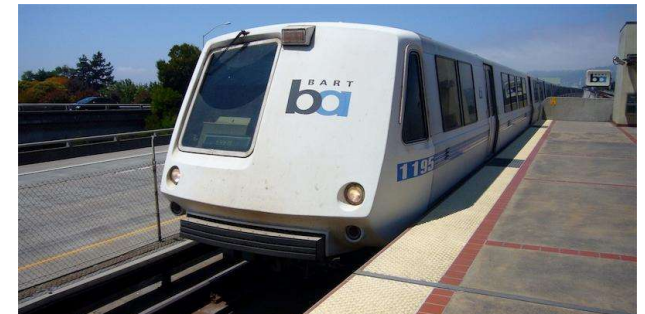
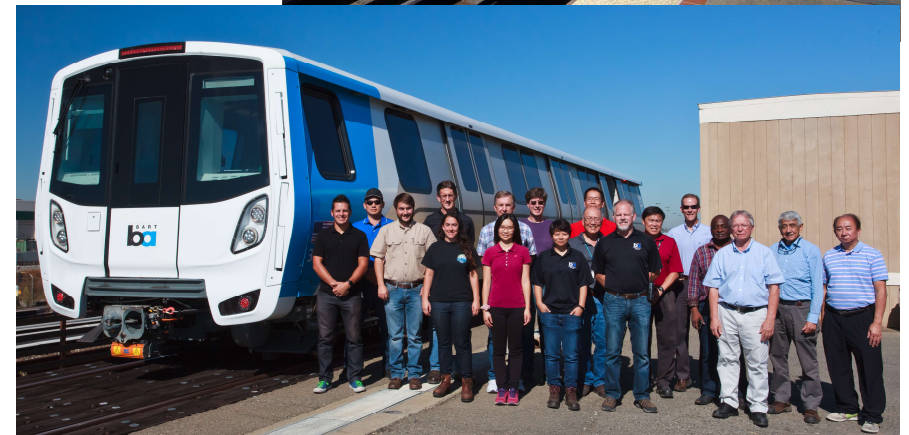
- ❑ 3 Generations of 679 Cars
- ❑ Accepting 775 New Generation Cars Over 10 Years for a 1,048 Target Fleet
- ❑ 80mph Max Speed
- ❑ Full ATO Operation
- ❑ 63,000lbs Empty, 110,000lbs Loaded
- ❑ 5 ½ ft Track Gauge

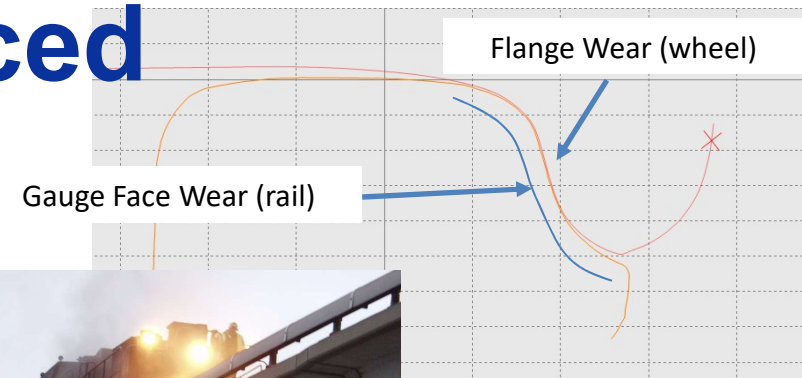
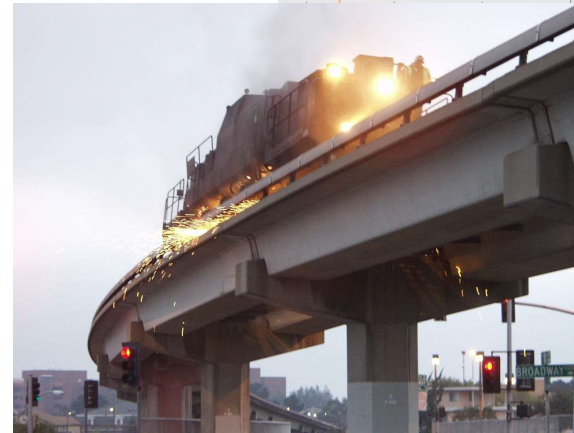
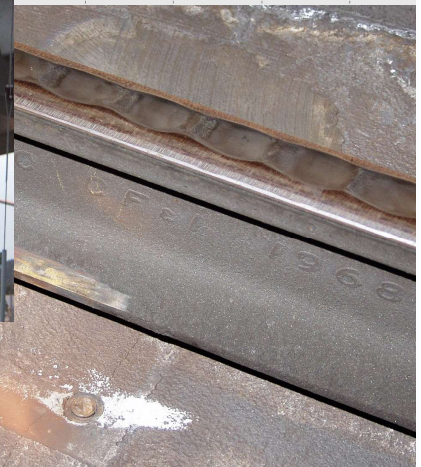
- ❑ Relies on flange to steer
  - ❑ Causes premature flange and gauge face wear
  - ❑ Two point contact
  - ❑ Promotes rail corrugation & noise – corrected by grinding
- = High Maintenance & Material Costs**

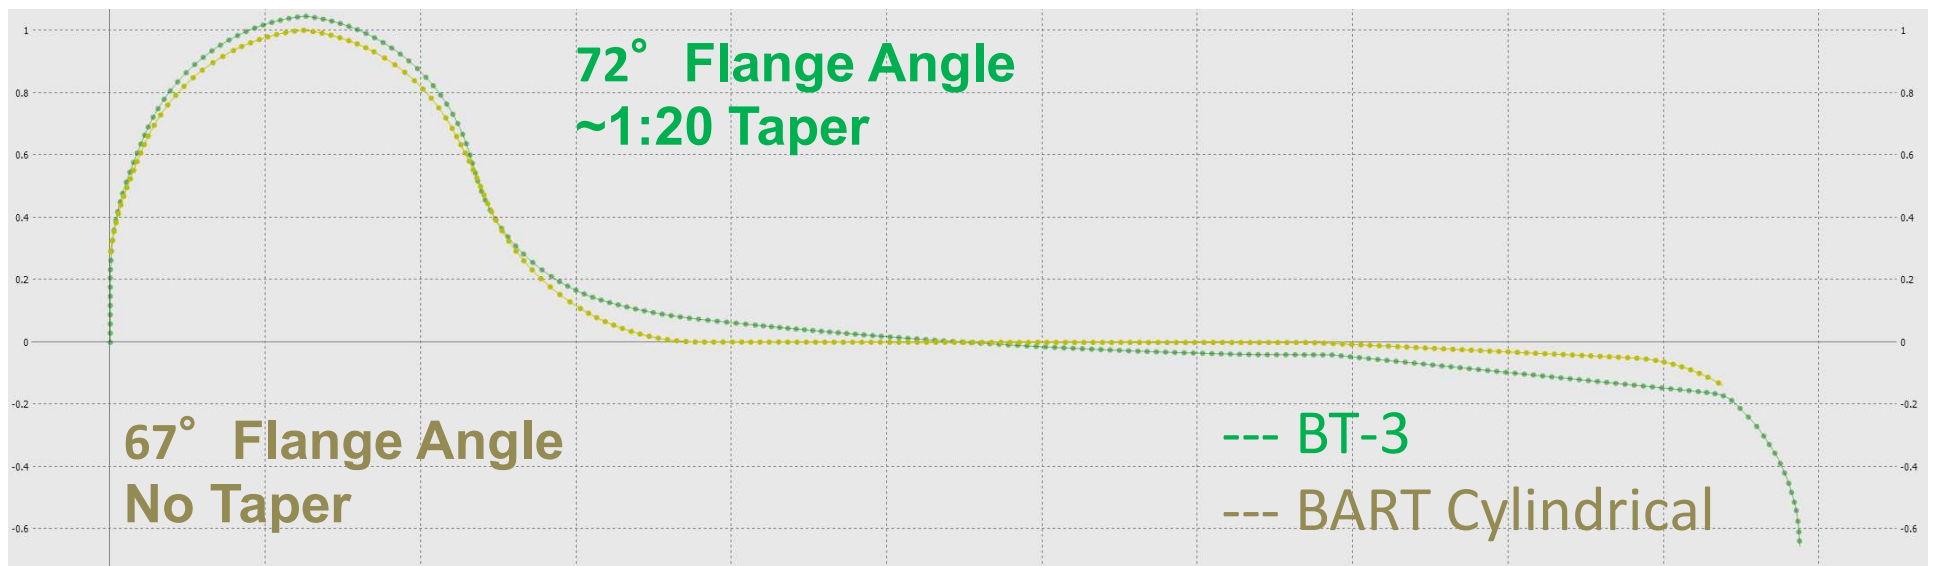
- ❑ Collected profile measurements of BART new and worn wheels and rail
- ❑ Tested ride quality and dynamic characteristics of the network
- ❑ Bombardier confirmed a poor wheel / rail interaction with pervasive two point contact, corrugation, excessive noise, and severe wear
- ❑ Ran simulations to design an optimized wheel profile specific to the BART network
- ❑ Result was the BT-3 modified tapered wheel designed by Bombardier

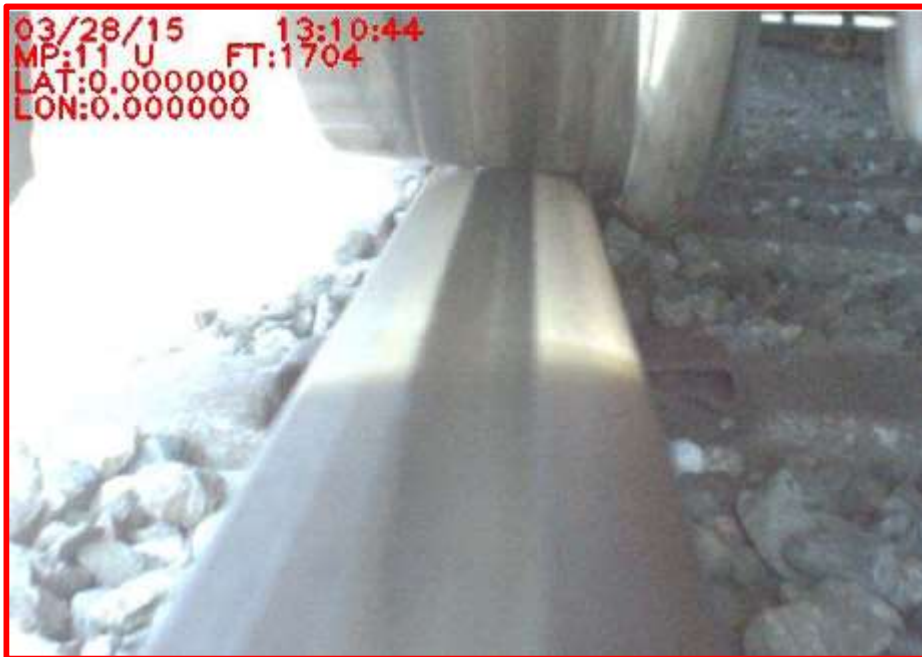
BT-3 profile, tangent track

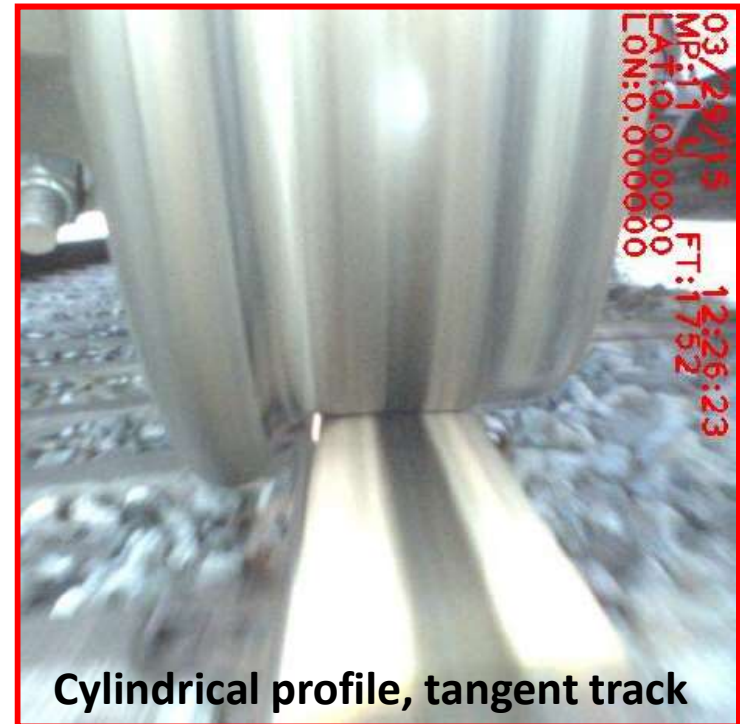
Cylindrical profile, tangent track

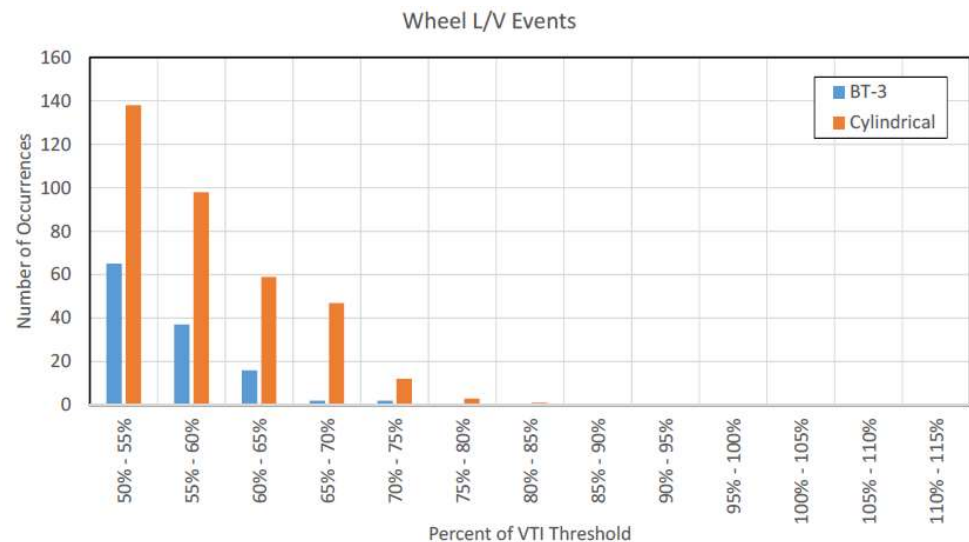
## □ ENSCO and LTK confirmed definite operational improvements

- Safe
- Compatible with special track work
- Good stability and ride quality

## □ Confirmed long term expectations

- Slower corrugation growth
- Reduced wear
- Less noise

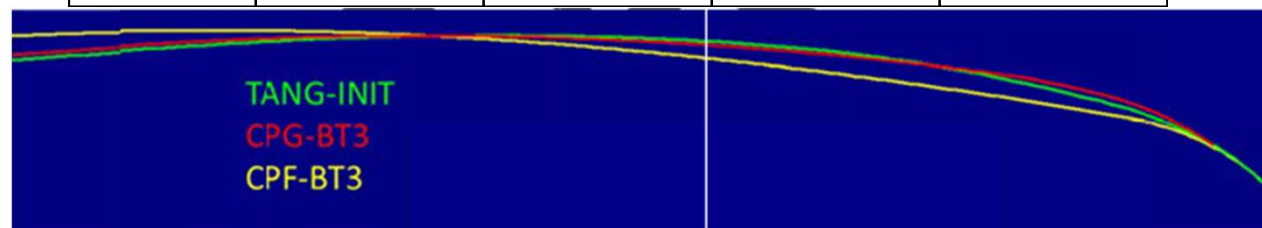
- Grind for new rail profile based on new BT-3 wheel over 6 years.
- Grind in three strategic stages as BT-3 equipped fleet grows to maximize grind time and effectiveness.

High rails	Low rails	T1 tangent	T2 tangent
stage 1	HR_int	LOW_int	TANG-init	TANG-init
stage 2	HR_int	LOW_BT3	CPG_BT3	CPF_int
stage 3	HR_BT3	LOW_BT3	CPG_BT3	CPF_BT3

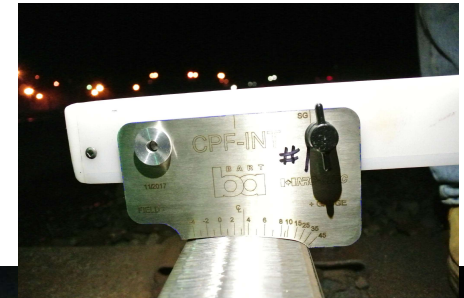
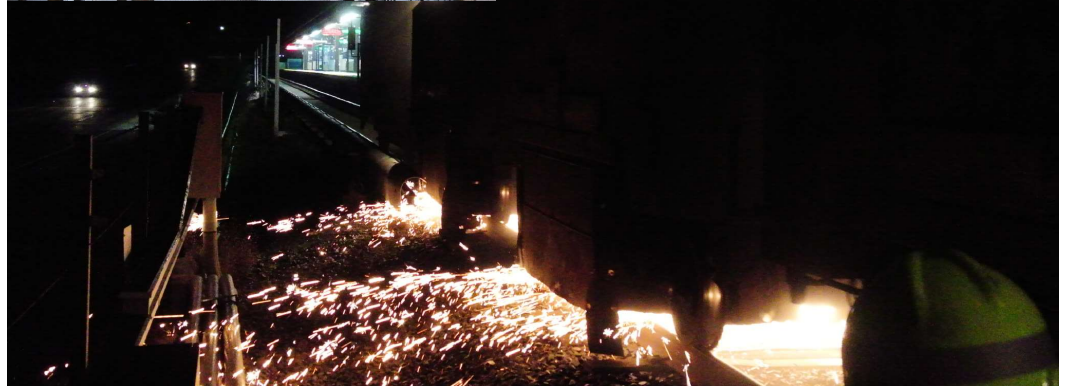
- ❑ Contract with Advanced Rail Management to assist in grinding strategy and operator training.
- ❑ Reassigning grinder operators to line-specific reporting locations to optimize spark time.
- ❑ Grinder availability currently at 30%, contract with Loram to train 6 grinder maintenance personnel.

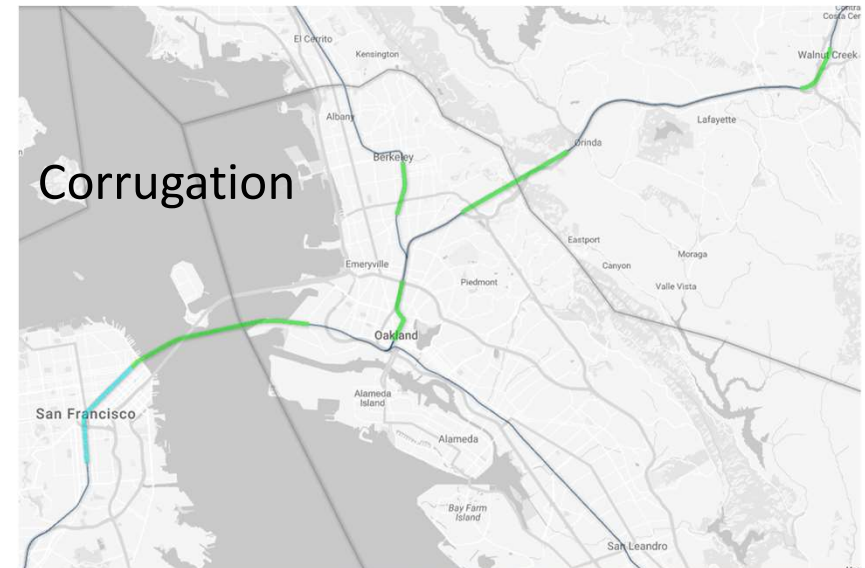
- Pre / post eddy current measurement of RCF – 84 miles since Jan 2018
- Pre / post cat trolley measurement of corrugation – 31 miles since Jan 2018

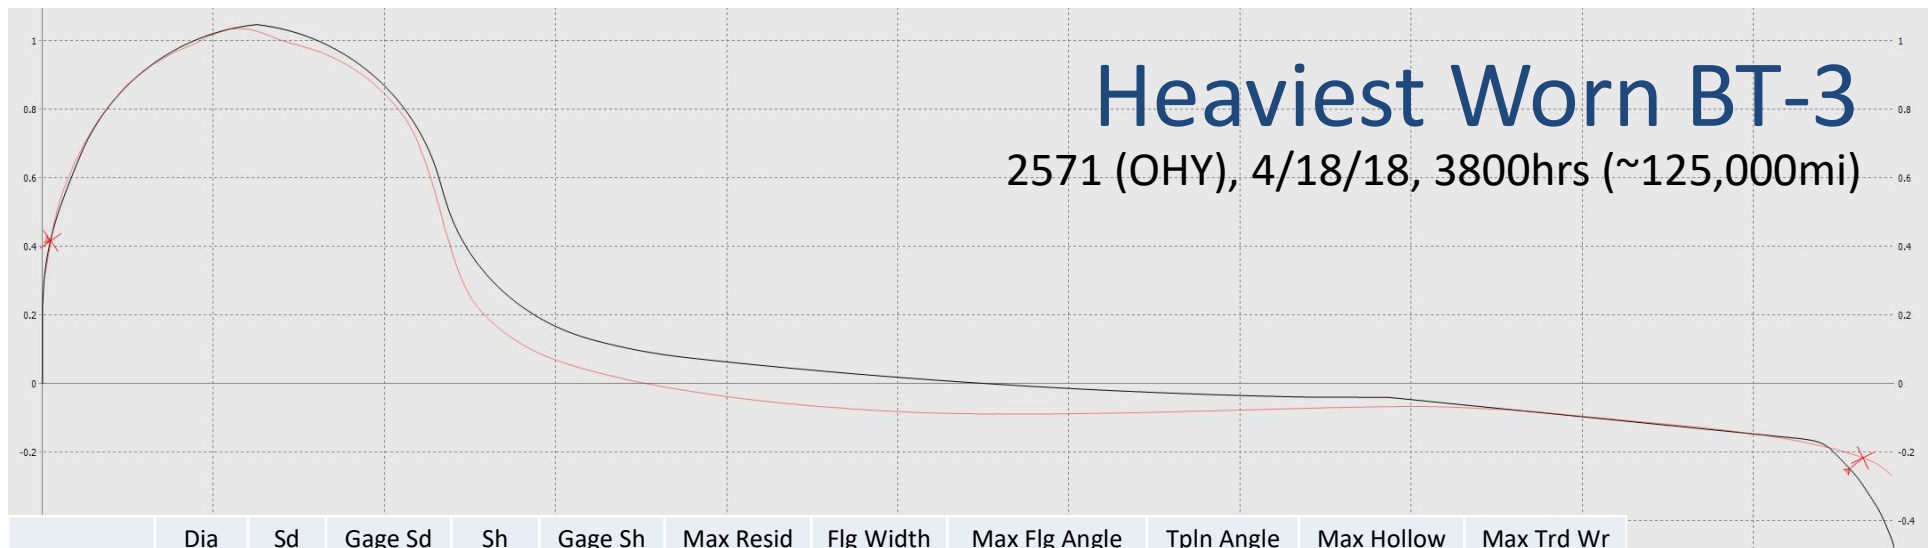
Dia	Sd	Gage Sd	Sh	Gage Sh	Max Resid	Flg Width	Max Flg Angle	TpIn Angle	Max Hollow	Max Trd Wr
Measured	29.420	1.235	0	1.124	18	0.104	1.113	74.25	1.011	0.022	0.104
Reference	30	1.26	0	1.053	17	0	1.132	72.3	3.5	0	0
Difference	0.581	0.025	0	-0.071	-1	-0.104	0.019	-1.950	2.489	-0.022	-0.104

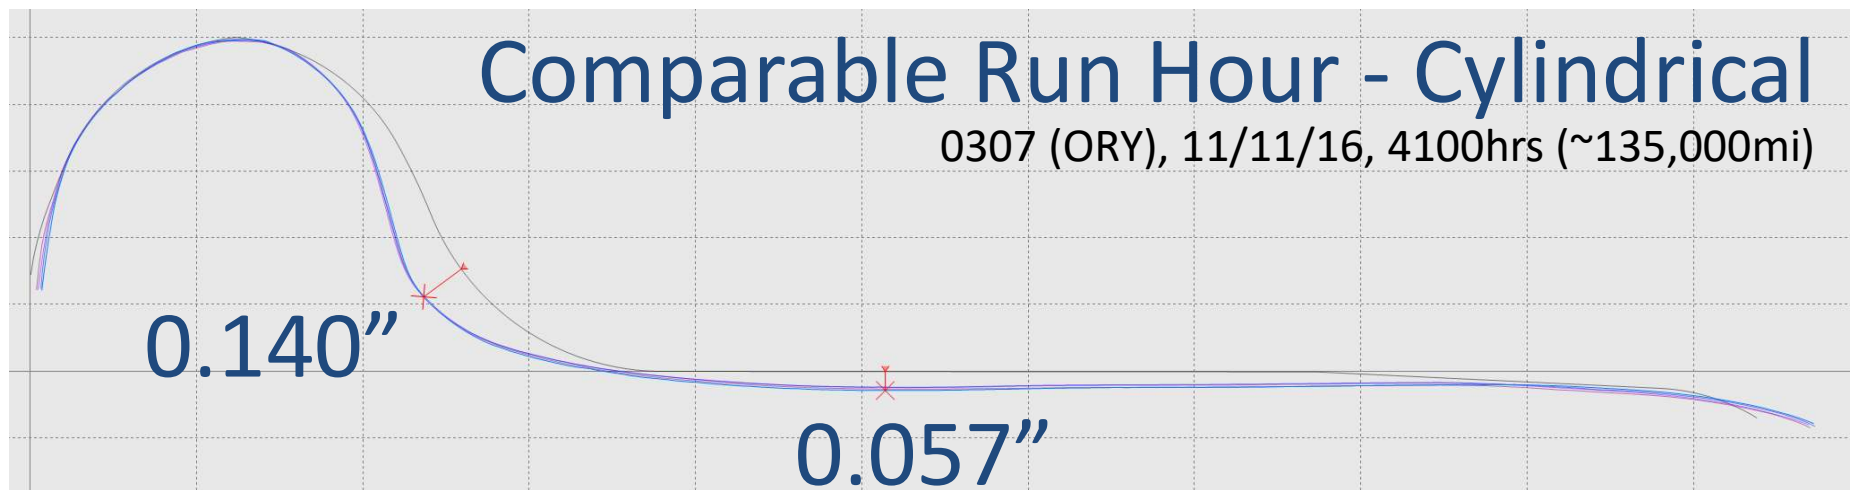
- 533 BT-3 wheels
- 120 CYL wheels
- Assumes 10.45hr run days per 365 days/year
