# Characterizing the Effects of Rail Surface Conditions on Noise and Track Components

**Shankar Rajaram, PhD**

**Sound Transit**

RAIL TRANSIT SEMINAR • APRIL 30, 2018

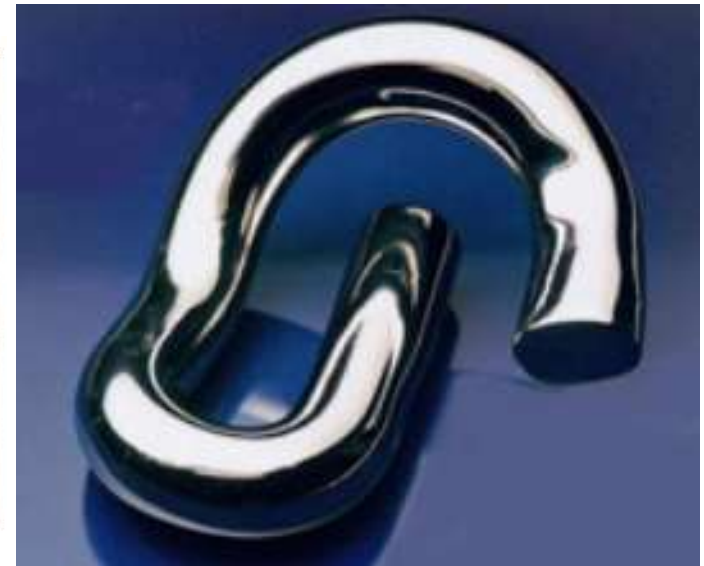
Rail Clip

E-Clip

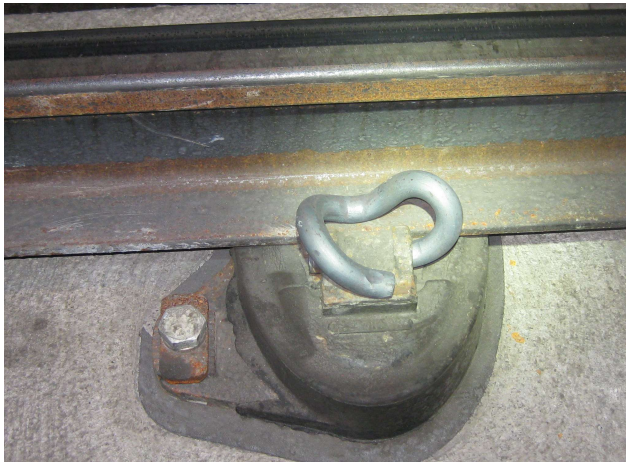
# Use of PR Clips to Arrest Failure Rate

- The PR clip is more robust with higher strain limit
- Clip resonance shifted to ~950 Hz

Use of a bigger clip with higher elasticity and strain capacity can potentially arrest the failure rate

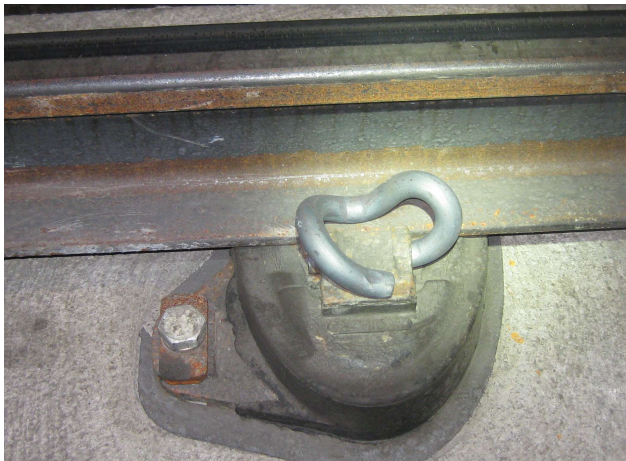
# Trial Section with PR Clips

- About 1000 feet replaced with PR Clips
- No PR Clip failure in 9 months

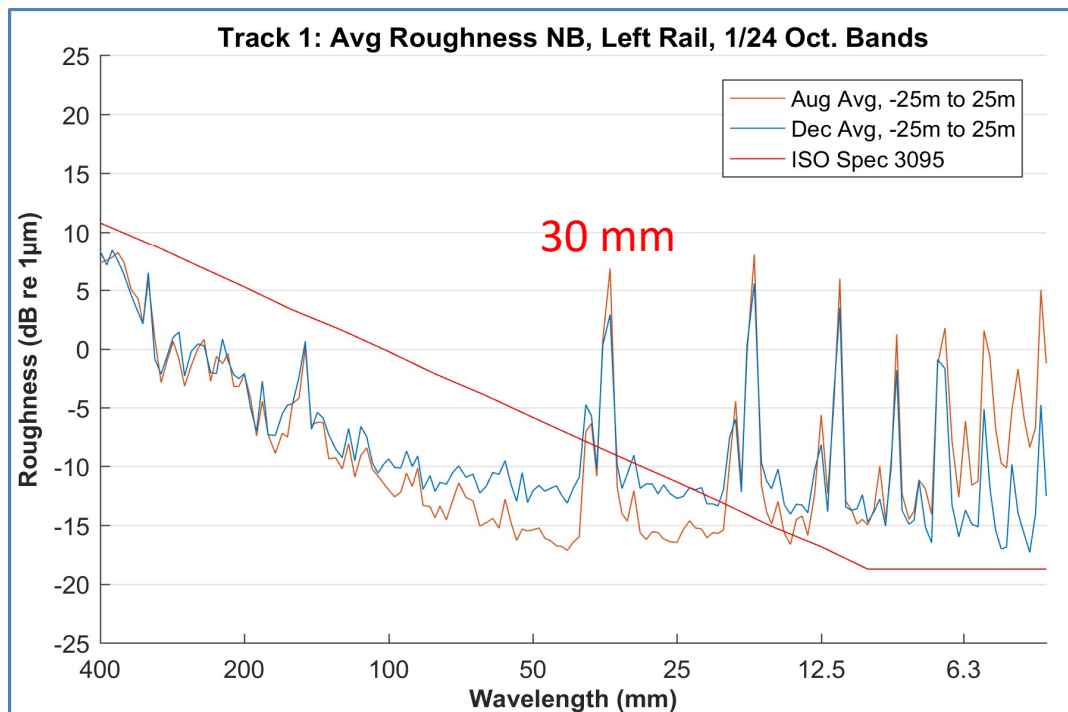
# Recent Rail Grinding Signature of Transit Properties in North America

- Rail roughness wavelength peak at 30 mm
- The peaks are caused by:

*Rail grinder speed— 4 mph*  
*Grinding motor— 3600 rpm*

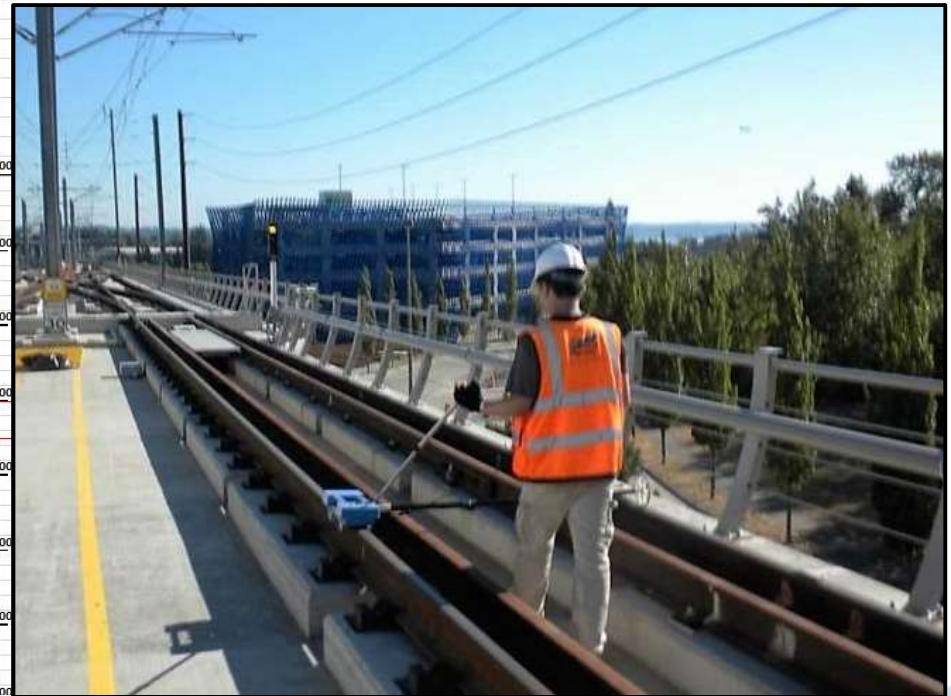
# Rail Roughness Measurements – ATS

## E - CLIPS FAILURE MAP

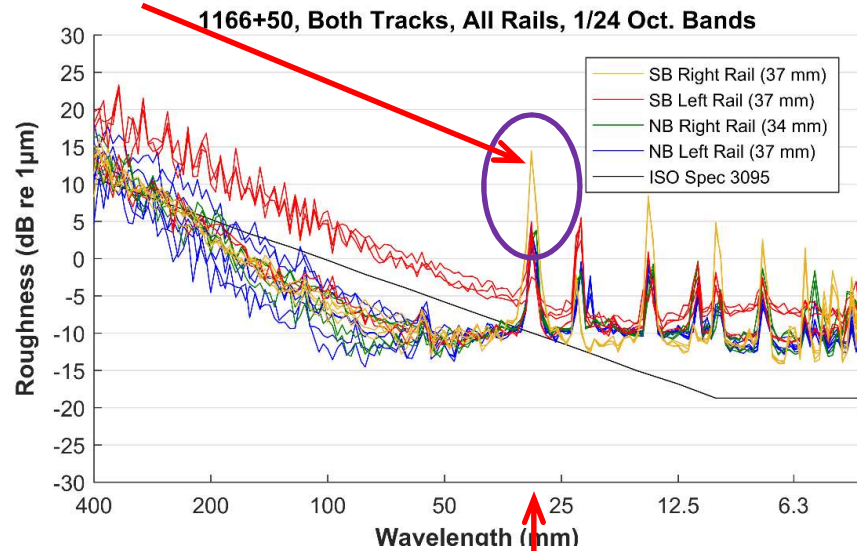
# Rail Roughness Results

SB West Rail = 15 dB

29.8 mm = 890 Hz  
(at 55 mph train speed)

**FOCUS ON THE RAIL GRINDING FINISH !**

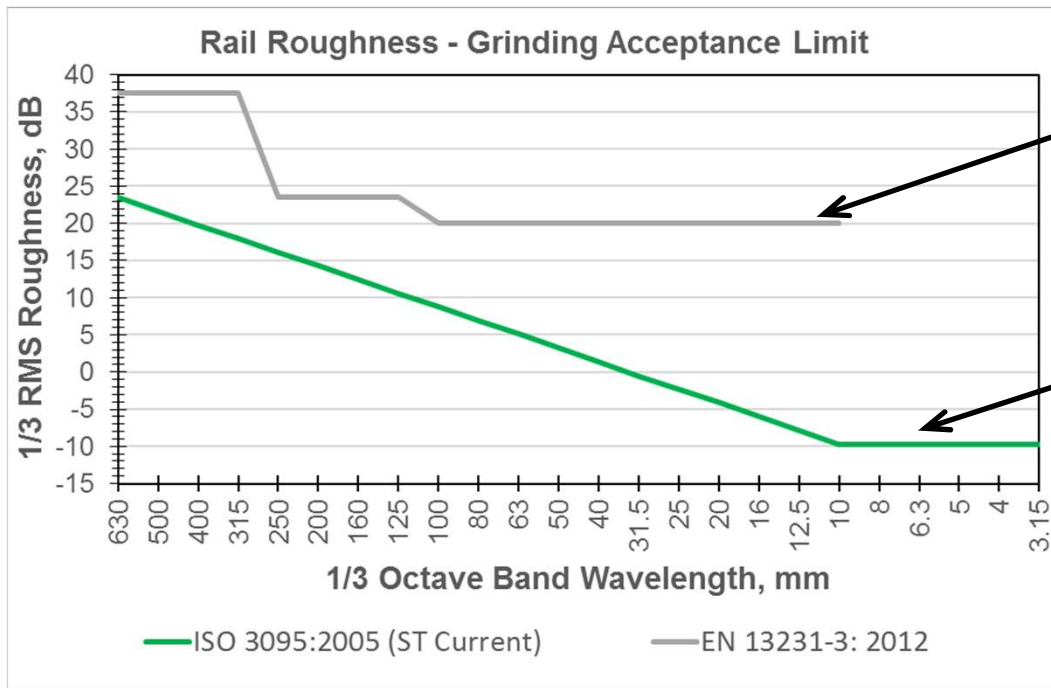
# Transit Rail Grinding – Status Quo

**EN 13231-3:2012**  
Limit Proposed by Rail Grinding Companies

**ISO 2095: 2005**  
ST's Current Rail Grinding Limit
