Understanding Rolling Contact Fatigue: What can be done to lower the risks?

Eric Magel

National Research Council, Canada

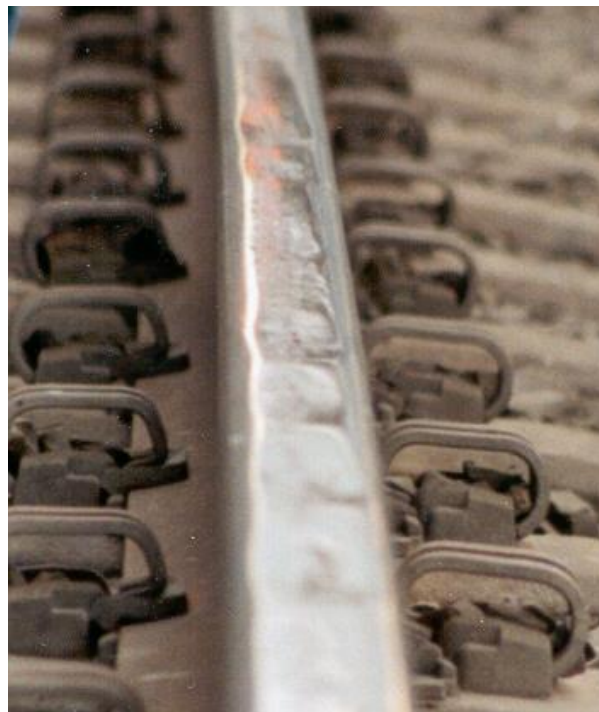
RCF Corrugation

- High dynamic forces
 - degrades ballast
 - noise
- Heavy unit trains
- Consistent speed
- Discrete irregularities
 - welds, joints, crossings
- P2 resonance

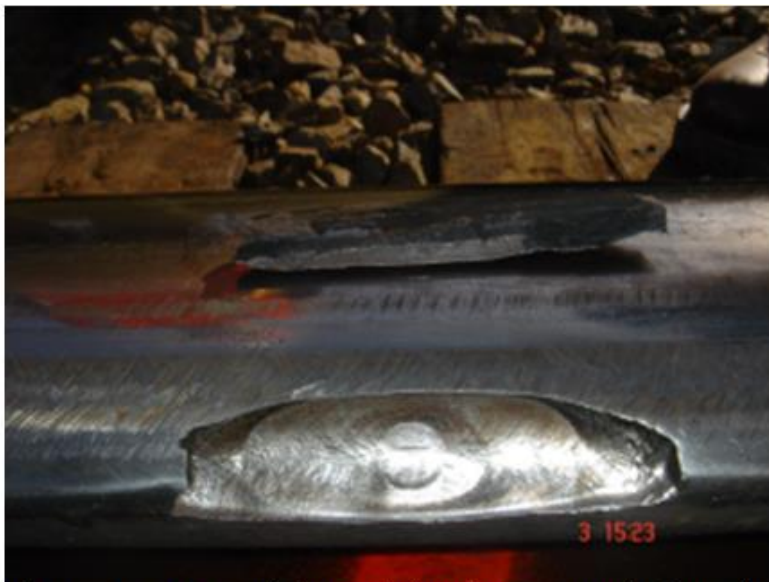
Figure 1a. DSS defect originating 6 mm below the gauge corner was detected by the ultrasonic car.

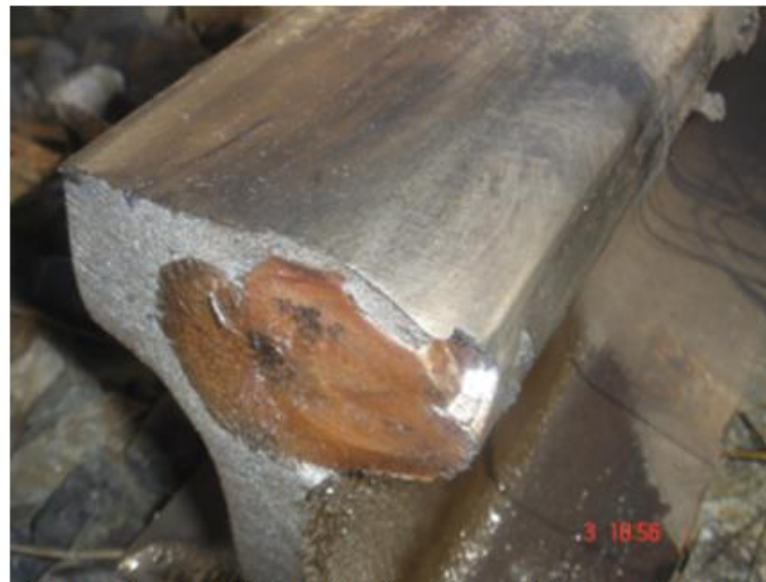
Figure 1b. DSS defect that has turned into a transverse defect and broken the rail under traffic.

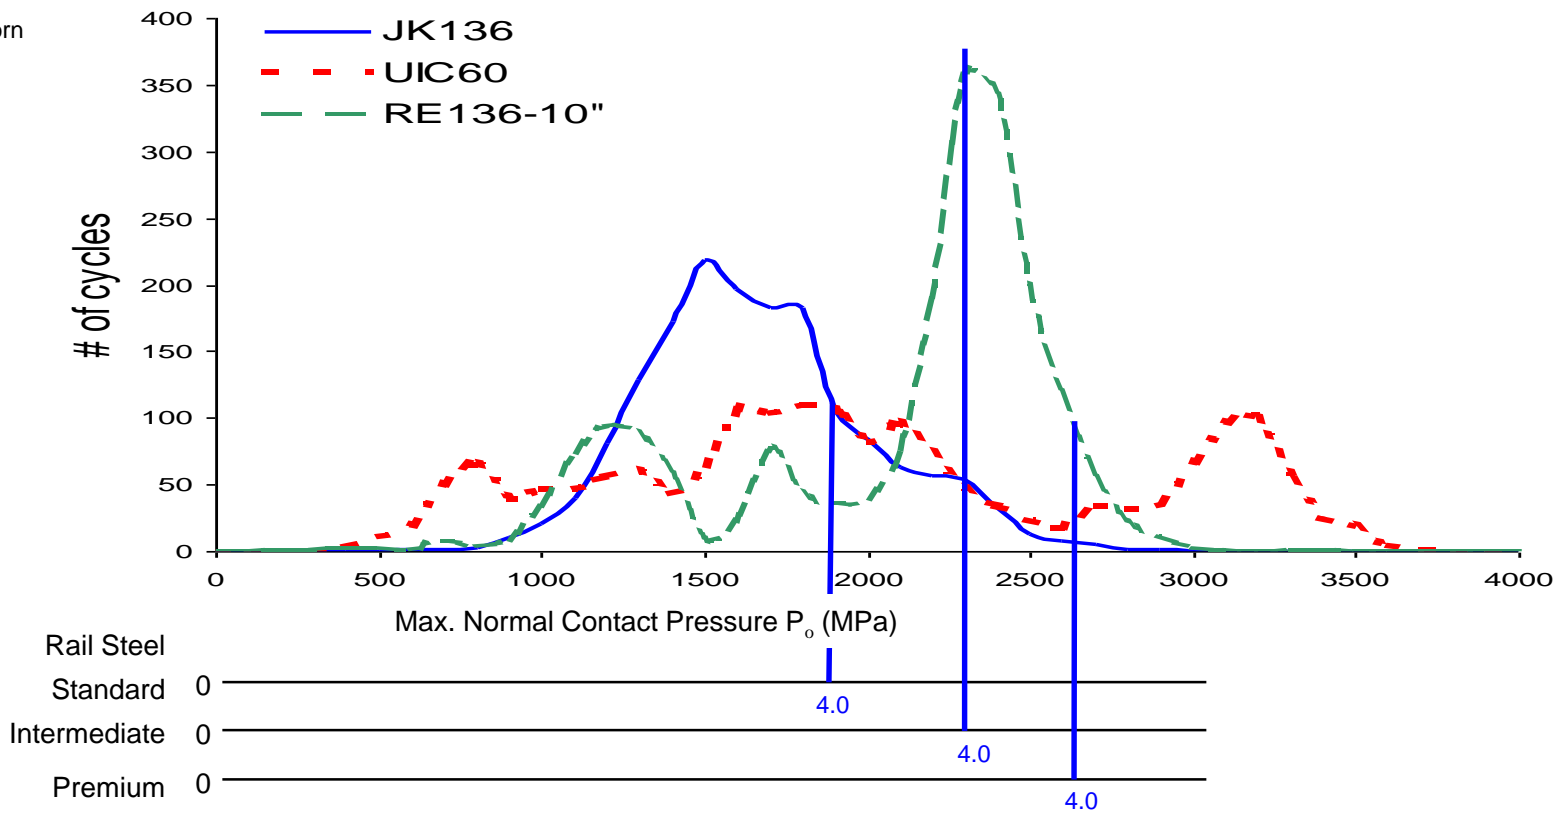
North American
Grain and Coal
2053 new and worn
wheels

Sharp curve,
high rail,
leading and
trailing axles

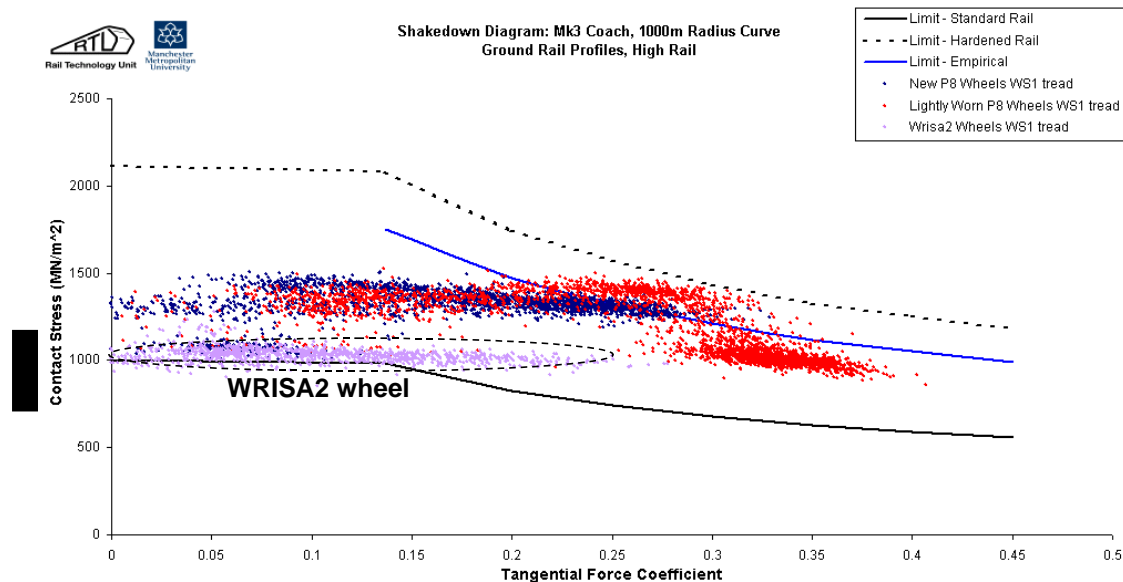
Dynamic Shakedown Plot

Figure 1: Dynamic shakedown plot summarizes the wheel/rail contact conditions for the new P8, lightly worn P8 and WRISA2 wheel profiles running through a (sharp) 1000m radius curve with ground rail profiles. (shakedown limits are solid line – standard rail, dotted line hardened rail, intermediate solid line is 70% of the difference, an empirical value).

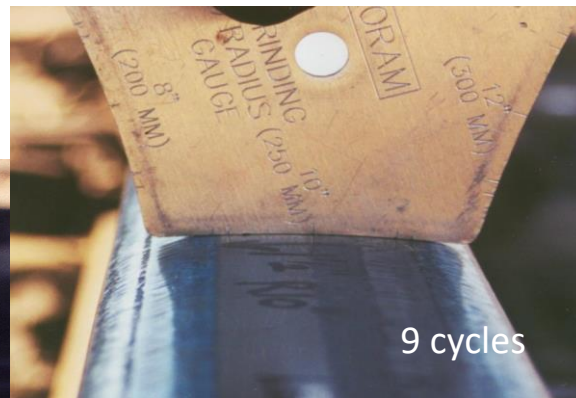
9 cycles

Preventive Gradual

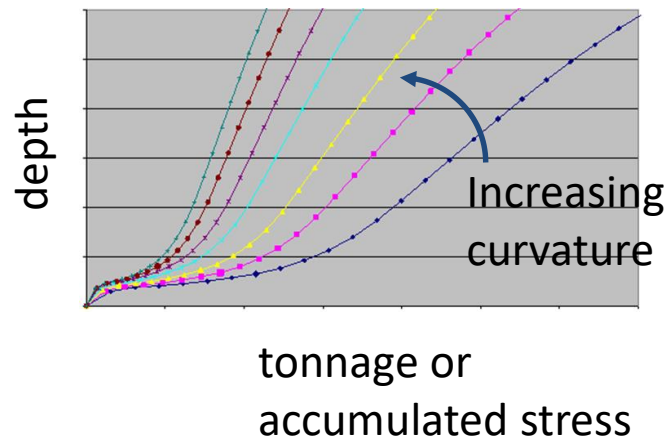
A family of crack growth curves

- probably for different
 - rail steels
 - territories
 - traffic types (e.g. passenger, transit, freight)
 - friction regimes
