Research into the Causes of Visually Undetectable Broken Spikes

A summary of the work by the
University of Illinois Urbana-
Champaign and Norfolk Southern

HEAVY HAUL SEMINAR • OCTOBER 20 - 21, 2021

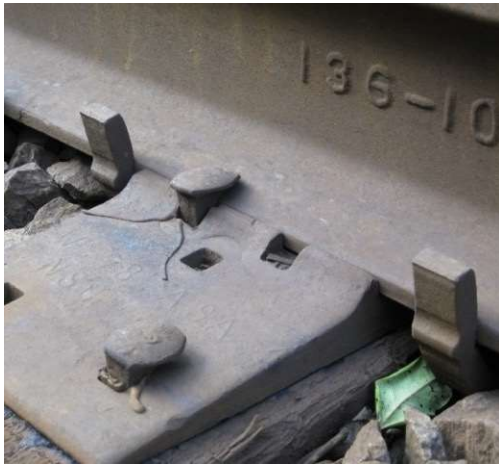
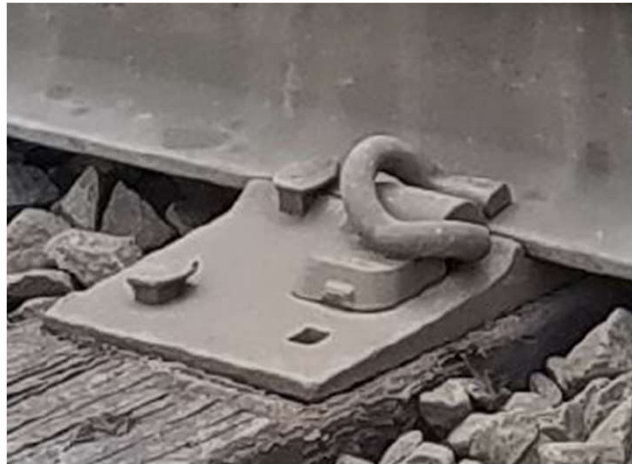
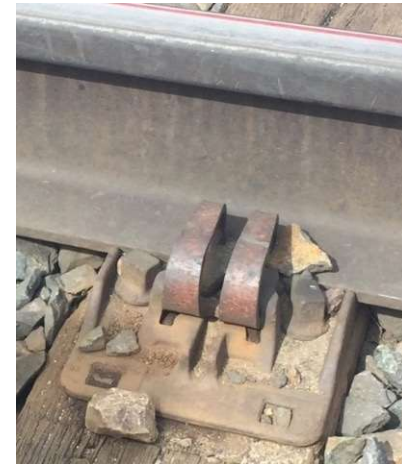
Extent of Spike Fatigue Failure

Magnitude of spike fatigue failure problem based on site visits and industry survey by UIUC (2018):

- Fatigue failures identified on 7 railroads
 - One curve inspected had 23% broken spikes
- 11 derailments identified on 4 railroads
 - Likely more derailments that were identified simply as “wide gauge”
- Failures of both screw spikes and cut spikes

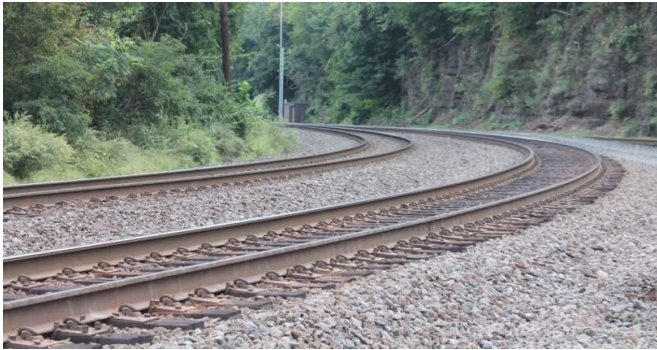
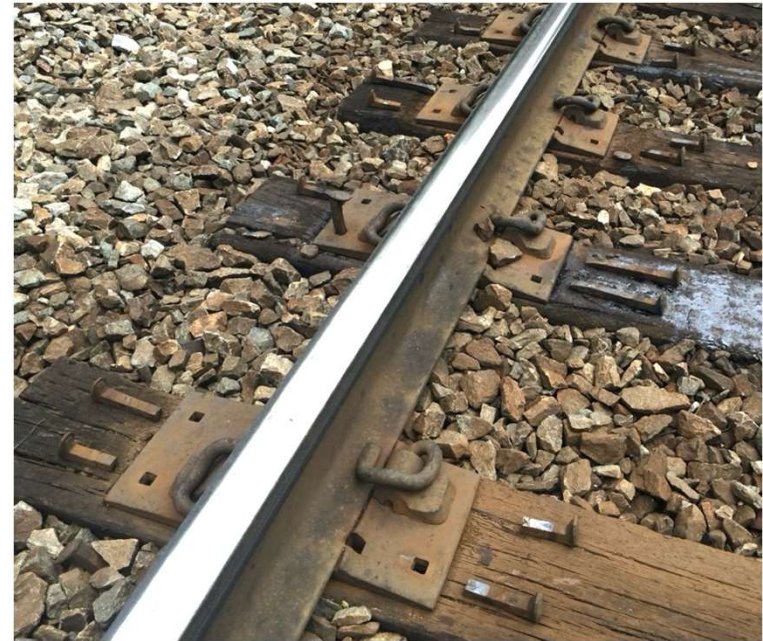
Where are broken spikes found?

- Elastic fastening systems in higher degree curves and special trackwork
- High rails (almost never low rails), in all spike hole positions (gage & field, rail and plate)
- Frequency of broken spikes is higher where there is significant tractive or braking forces
- Tie condition new or very good

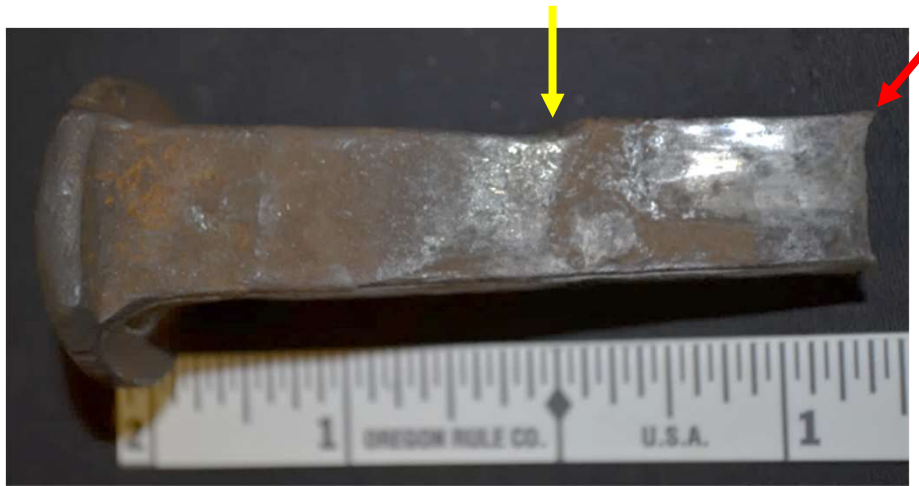
What a broken spike looks like

- Significant plate loading in longitudinal direction indicated by deformation on side of spike shaft (yellow arrow); depth of plate contact indicates a rail spike.
- Fracture is 1-3/8" below top of tie.
- Fracture initiation indicated by red arrow.

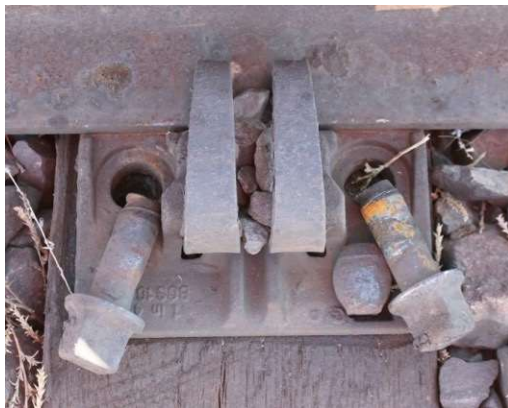
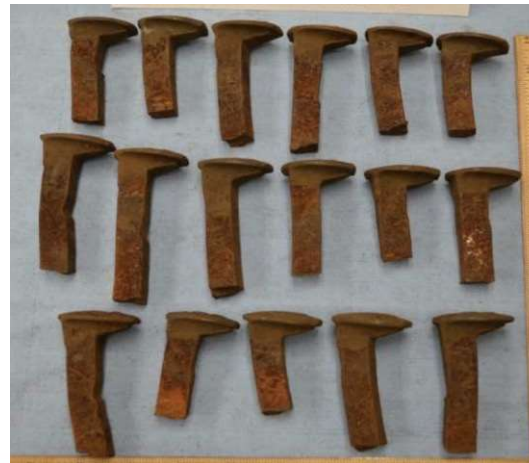
The depth of fracture is remarkably consistent

- Cut spikes tend to fail 1-1/2" below the top of tie. Hole position determines depth: rail spikes fail ~ 3-1/4" below the head, plate spikes ~ 2-1/2".
- Screw spikes tend to fail near their top thread – at the change in cross-section. For the screws below, failure is ~2" below the head.

Left: The longer spikes are rail position, the shorter spikes are plate position

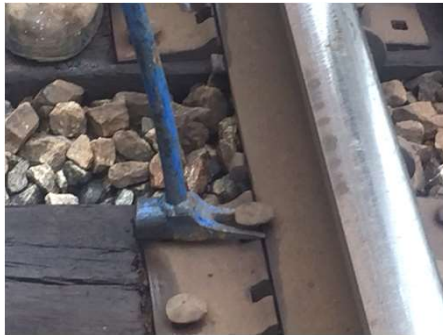
- Single broken spikes are not easy to find.
 - *Visual detection is difficult*
- Because fracture depth is 1-1/2" below top of tie, and the top of spike shaft is often pinched between tie and tie plate, the spike may not be loose.
 - *Broken spikes often must be hit or pulled to be detected*
- A small cluster of broken spikes in one or two ties can produce a "gage spike" during a geometry car inspection.

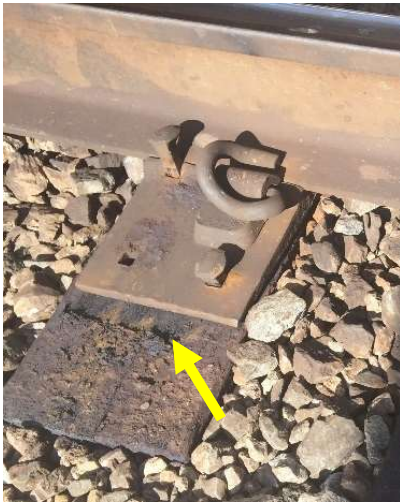
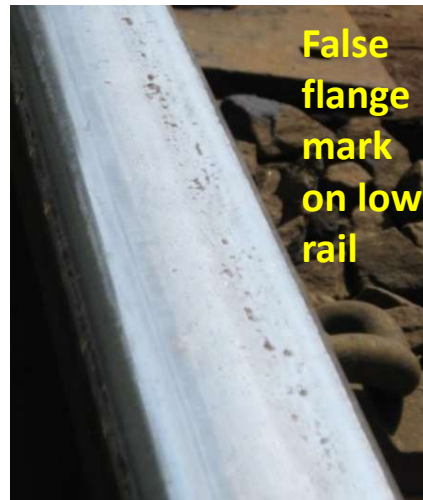
A larger cluster of broken spikes:

- Significant tie plate movement
- Open gage that has existed for some time may show evidence of false flange contact

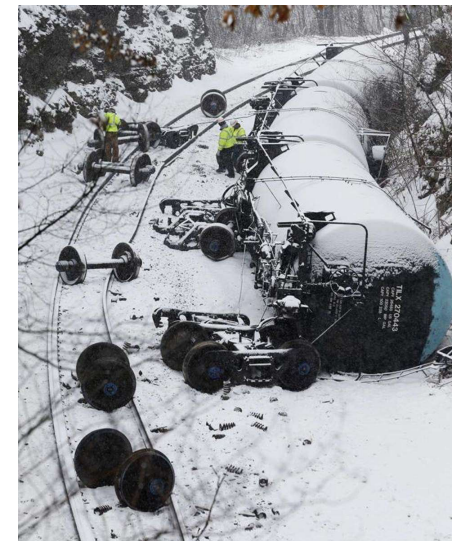
- A still larger cluster of broken spikes can allow enough gage widening to cause a derailment.

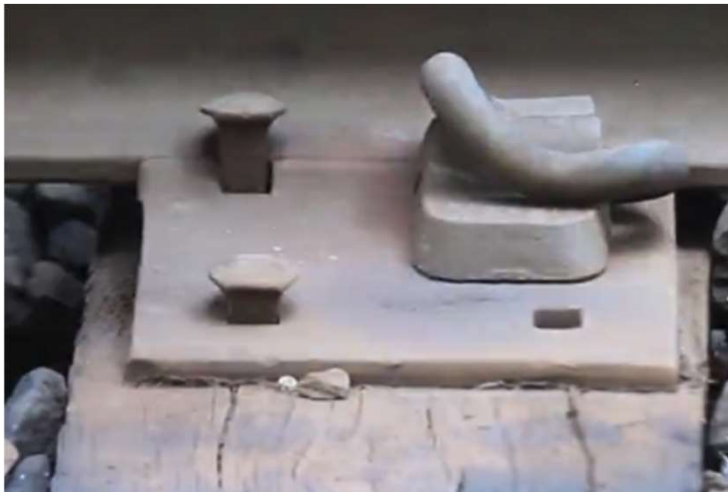
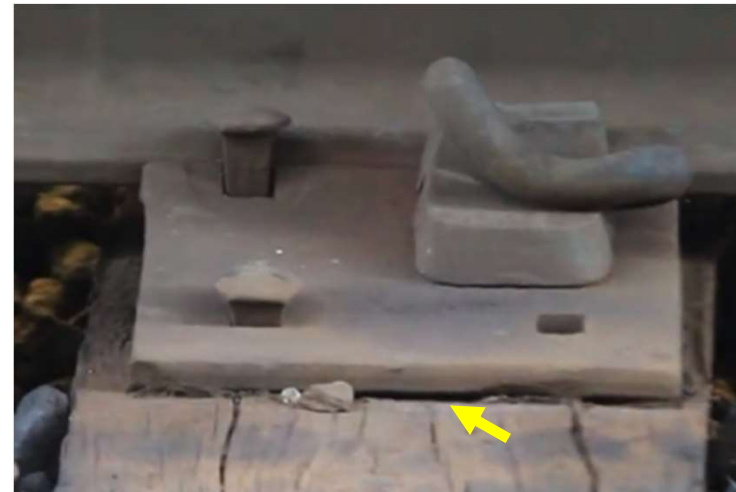
Factor 2: Reduced tie plate friction due to rail uplift

Two screen shots from a video showing tie plate movement under a train.

- Left - plate is bearing on the tie (wheel is directly above plate)
- Right - the impact of rail uplift; the plate lifts ~ 1/8" off the tie (wheel is several ties away)

Wave action of the rail causes plate uplift, eliminating contact (and friction) between plate and tie.

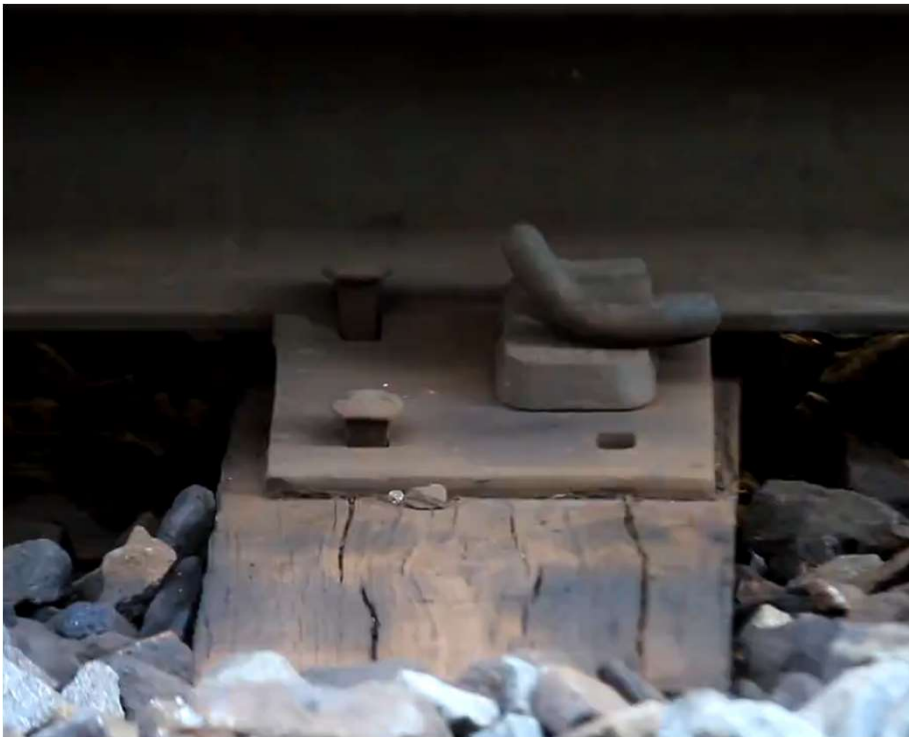
Factor 2: Reduced tie plate friction due to rail uplift - video

- Video shows the field side of a Victor plate under a train.
 - Rail uplift causes the tie plate to move up and down approx. 1/8".
- Loss of plate-to-tie contact means loss of plate/tie friction.
 - Without this friction, lateral and longitudinal wheel loads are transferred directly to the spikes.

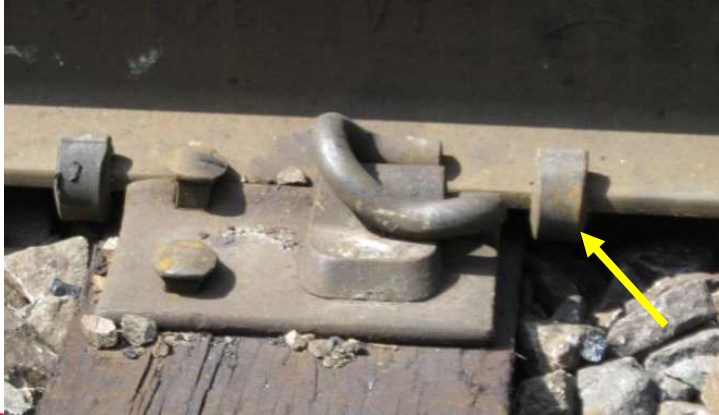
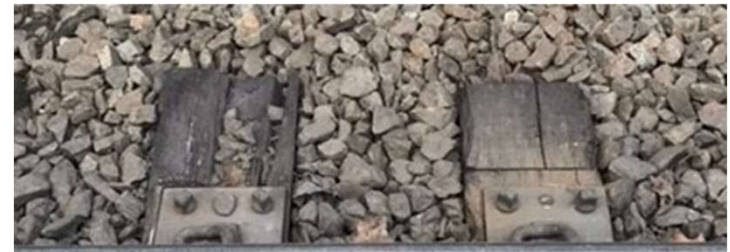
The industry has tried several modifications to the elastic system:

1. Adding rail anchors
2. Replacing square-hole plates and cut spikes with round-hole plates and screw spikes

- Initially, yes.
- Over time, no. Anchors become less effective due to wood deformation & rail movement.
- Any rail movement allowed by a loose anchor will be resisted by the elastic clips and plates, and, ultimately, the spikes.
- Field results on NS showed that initially, anchors eliminated broken spikes. But after several years, broken spikes reappeared.

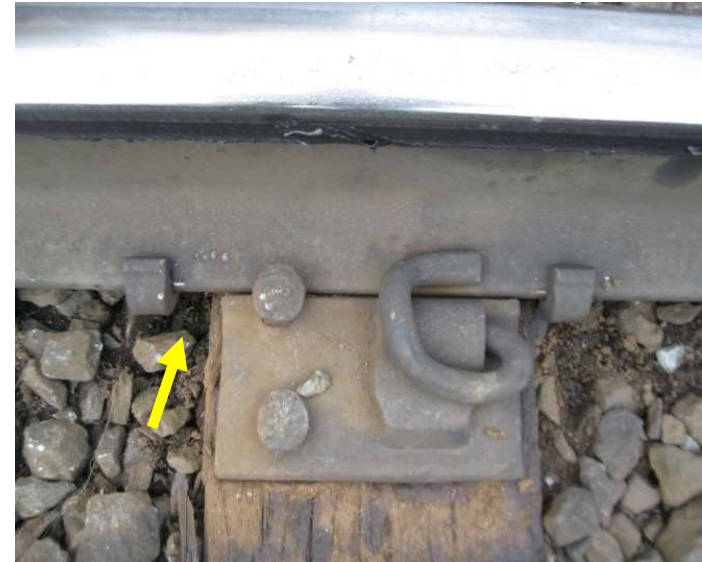
Any space between anchor and tie results in the transfer of the longitudinal load to the spikes.

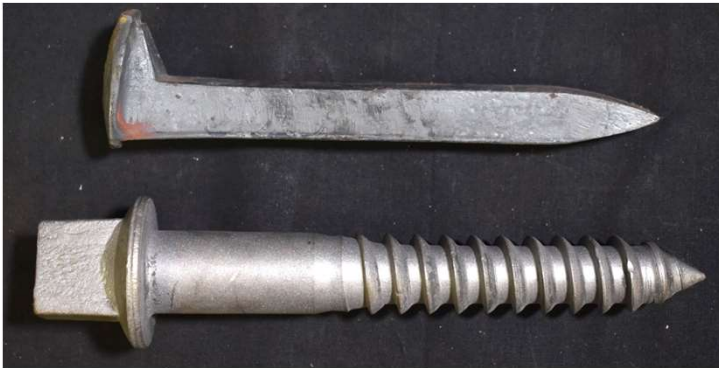
While screw spikes are not stronger in terms of cross section, they do create a plate-to-tie clamping force that produces plate/tie friction, which, in turn, reduces the lateral & longitudinal forces applied to the screws.

Spike (type/location)	Cut	Screw (Upper Shaft)	Screw (Threads)
	0.625"	0.469"	0.344"
Cross Section			
Area Moment of Inertia Formula	$bh^3/12$	$\pi r^4/4$	$\pi r^4/4$
I (in ⁴)	0.0127	0.0380	0.0110
y (in.)	0.3125	0.4690	0.3438
Stress (force/in ²)	24.6 × M*	12.3 × M*	31.3 × M*

Stress (σ) is a function of the moment (M), distance from the neutral axis (y) and area moment of inertia (I)

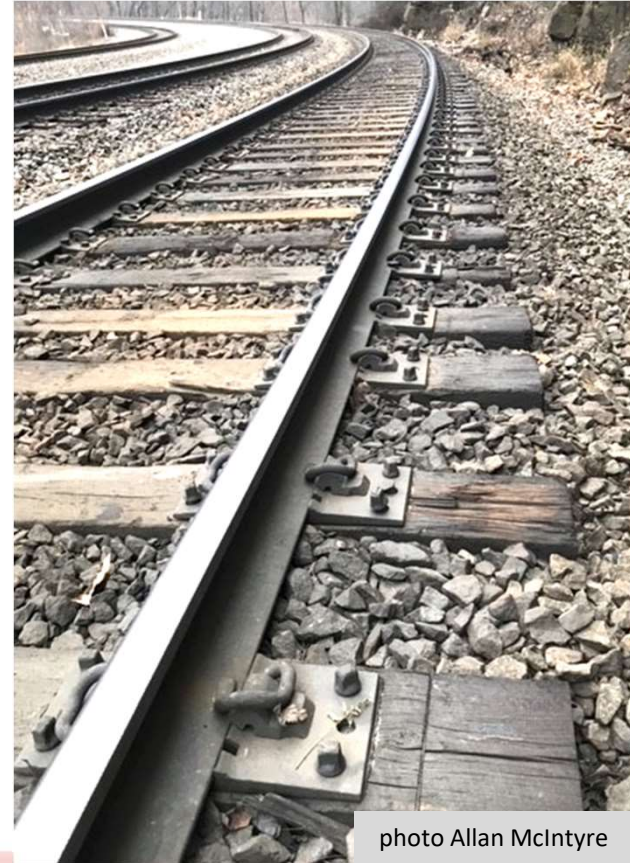
photo Allan McIntyre

Are screw spikes an effective fix?

- Initially, yes. Screw spikes apply a clamping force between plate and tie.
- Over time, these spikes can lose clamping force, due to spike rotation or plate cutting.
- Results from TTCI and one railroad show that screw spikes (without spring washers) can eventually fail.

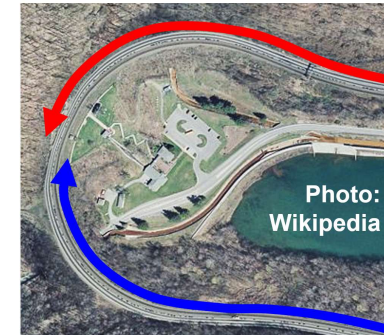
- Load circuits installed in the center of the crib on both high and low rails to quantify:
 - Vertical, lateral, and longitudinal loads

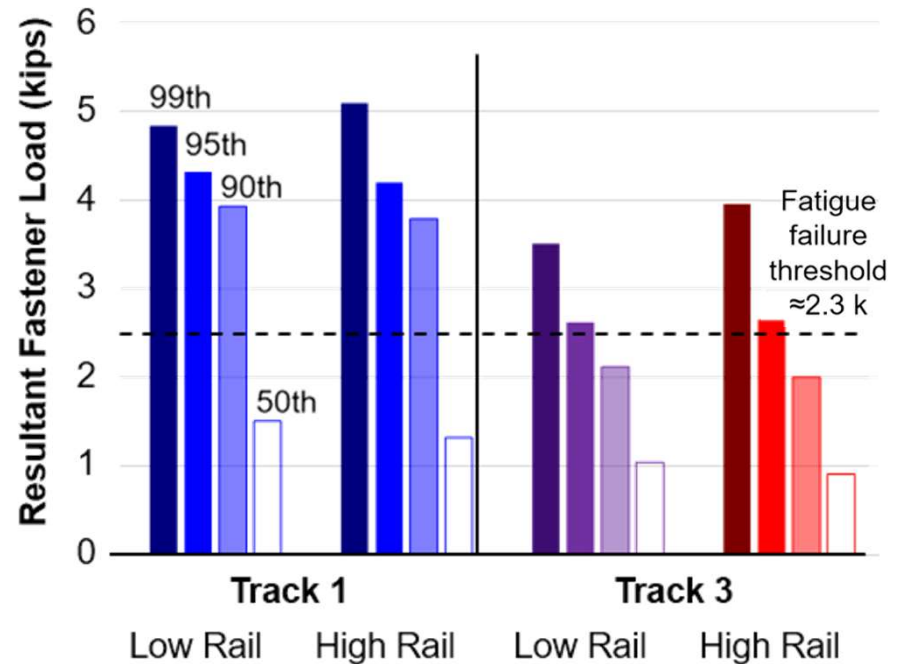
Lateral and Longitudinal Spike Loads

- Lateral fastener loads can exceed 7 kips
- Longitudinal fastener loads can exceed 2.8 kips
- Simplified calculation of total spike load, not considering friction

- Spike fatigue failures would be expected on every rail

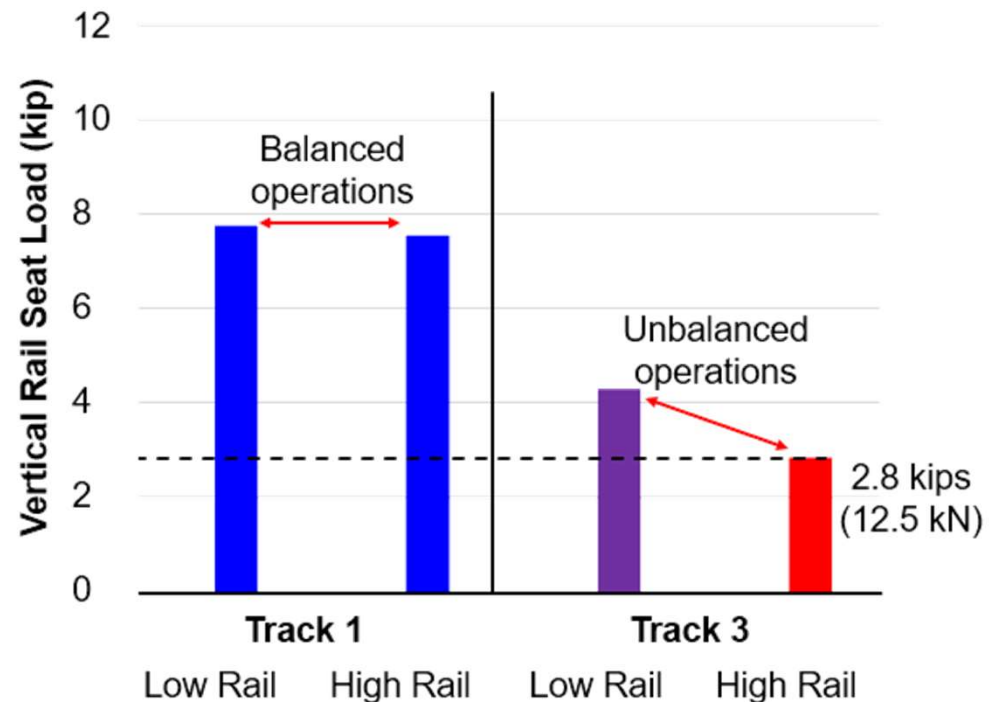
Vertical Rail Seat Loads (50th Percentile)

- Track 1 saw largest magnitude vertical loads
 - 50th percentile \approx 8 kips
- Track 3 subjected to unbalanced operations
 - High rail 50th percentile load \approx 2.8 kips

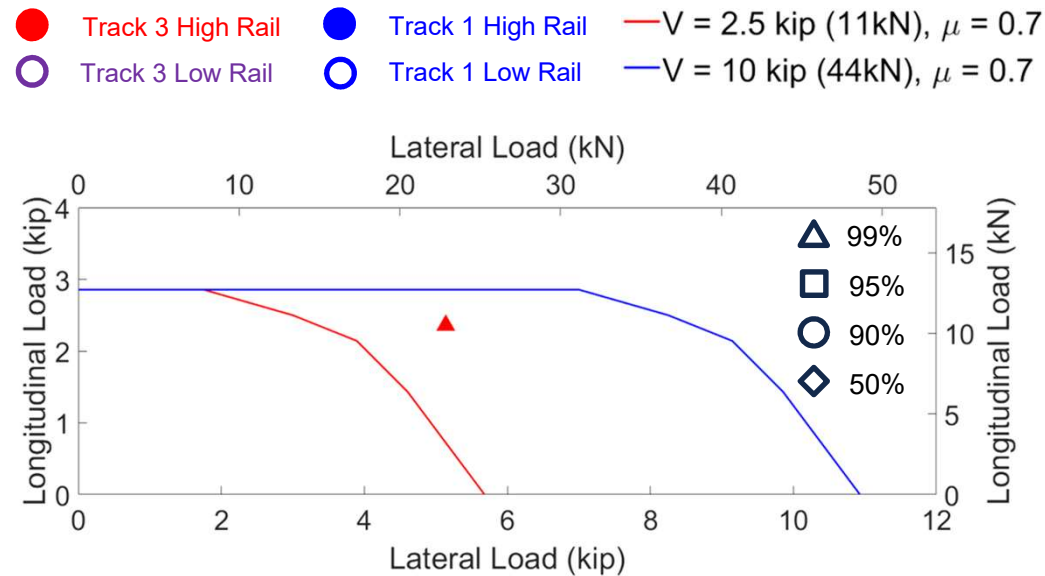
Effect of Friction & Vertical Load

- Vertical load and friction increase the required lateral load to exceed fatigue threshold
- Longitudinal load threshold remains constant given plate uplift
- Track 3 high rail vertical load (2.8 kips (12.5 kN)) leads to lowest failure threshold
- Track 3 high rail lateral and longitudinal loads exceed higher friction thresholds

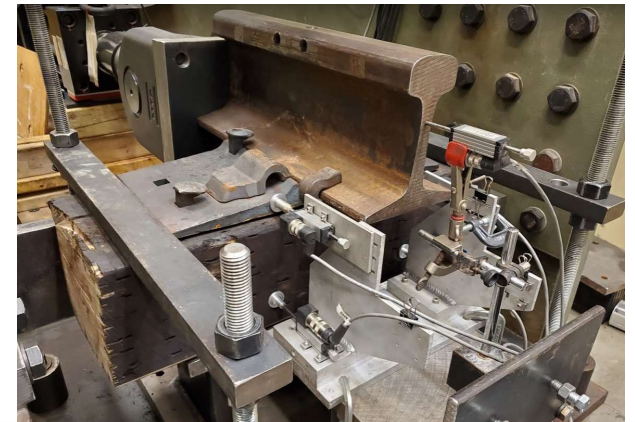
- Timber block, plate and 4 instrumented spikes
- A 2,500 lb. longitudinal load applied to the rail
- Plate hold-down force applied to the rail at three magnitudes:
 - 0 lbs. (control), representing no spring washer
 - 5,000 lbs. total (1,250 lbs./spike)
 - 10,000 lbs. total (2,500 lbs./spike)

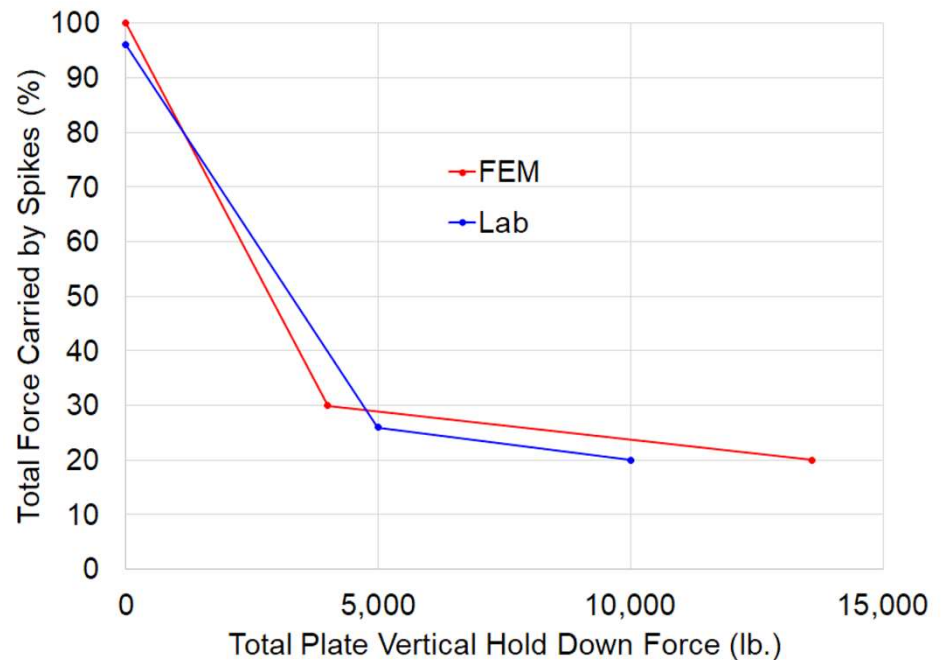
Hold-down force results compared to 0 hold-down force case

- ~70% reduction with reasonably applied load (e.g. ~1,000 lbs./spike)
- ~80% reduction with higher applied load (e.g. ~2,500 lbs./spike)
- Most of the longitudinal force can be resisted by plate-to-tie friction with reasonable vertical hold-down forces
- There is a non-linear benefit from increasing hold-down force; indicating an opportunity for further optimization

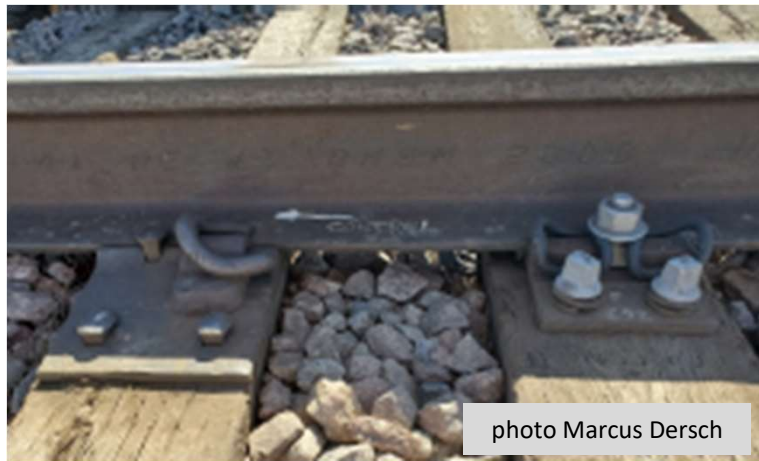
- **Control zone:** 20 ties with 18" Victor plates, e-clips & 5 cut spikes
- **Test zone:** 30 ties with 14" plates, tension clamps & 4 screw spikes with spring washers
- Installed Fall 2019 & accumulated 170 MGT through June 2020

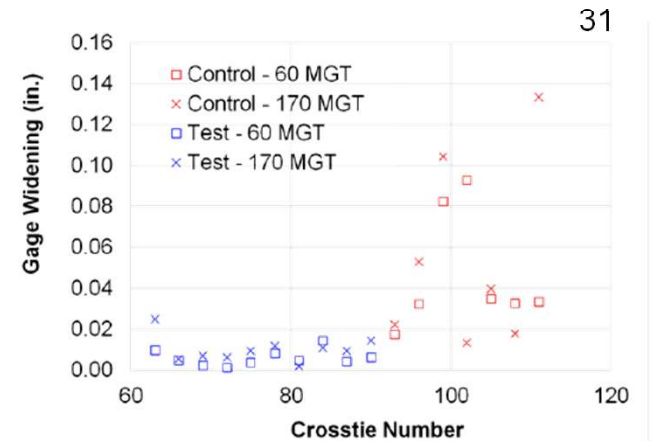
- Test zone 14" plates had less plate cutting than control zone 18" plates
- Test zone screw spike loosening was minimal on 5 rail seats (out of 60) (typically 1/16" spring expansion, *in working range of the spring washer*)
- Control zone had 6 broken spikes
- Test zone had less gage widening than the control zone
- Lab, FEA, and Field work indicate spring washers should provide a benefit

Rail base widening at 9 kips of lateral load using PTLF; measurements every 3rd tie

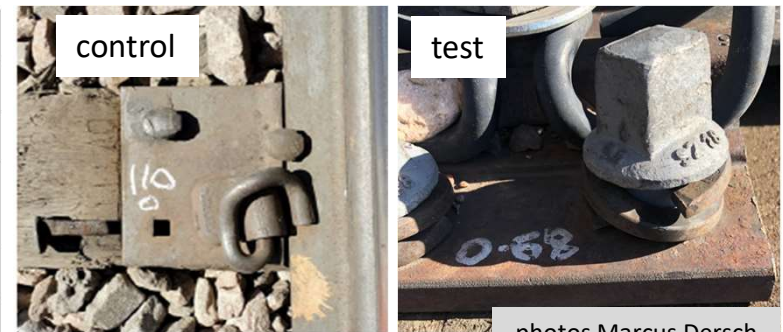
Control Zone	Test Zone
Plate Cutting	Minimal	None
Broken Components	6 broken spikes	None
Loosened Components	Spike uplift	3 spikes at 60 MGT; Additional spikes at 170 MGT
Plate Movement	Some evidence	None
Skewed Crossties	Many ties, significant	2 ties, minimal
