# Making the Best of it: Maintenance<sup>1</sup> Productivity During the Pandemic

**Gregory Shivy**  
Principal Track Engineer  
Maintenance & Engineering

RAIL TRANSIT SEMINAR • OCTOBER 18, 2021

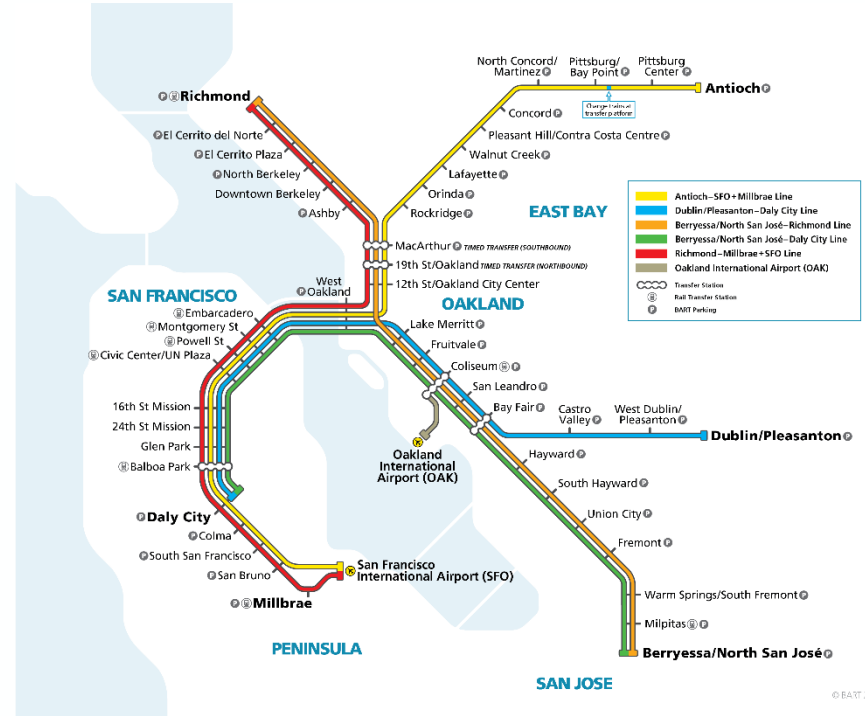
- 126 Route Miles
- 430,000 daily riders (Pre-covid)
- 80mph Max Speed
- Automatic Train Operation
- 66 in. Track Gauge
- 23% Aerial DF, 24% Subway DF
- 53% at Grade Ballasted Concrete Tie

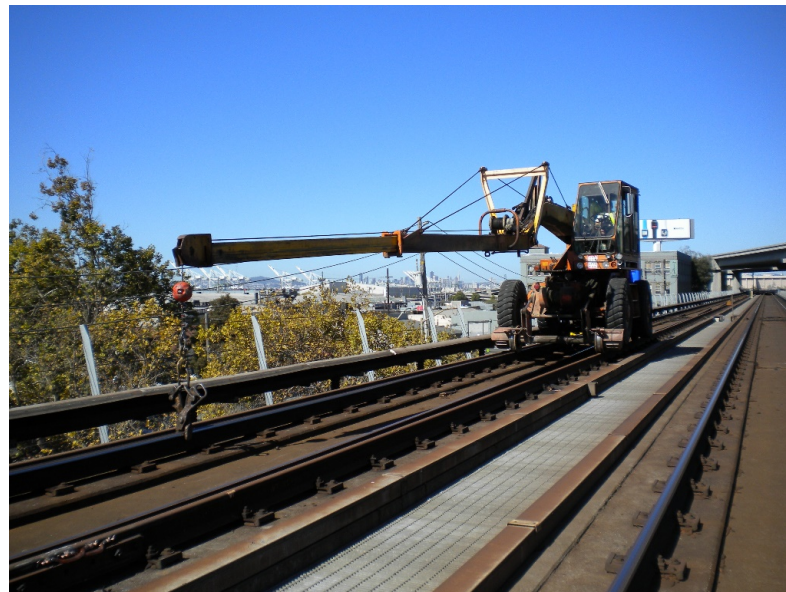
- 50-year-old legacy rail nearing end of useful life
- Predominant wear on high rail
- Short term goal to replace 50 miles

- 13.3 linear miles (15 months)
- 51% increase

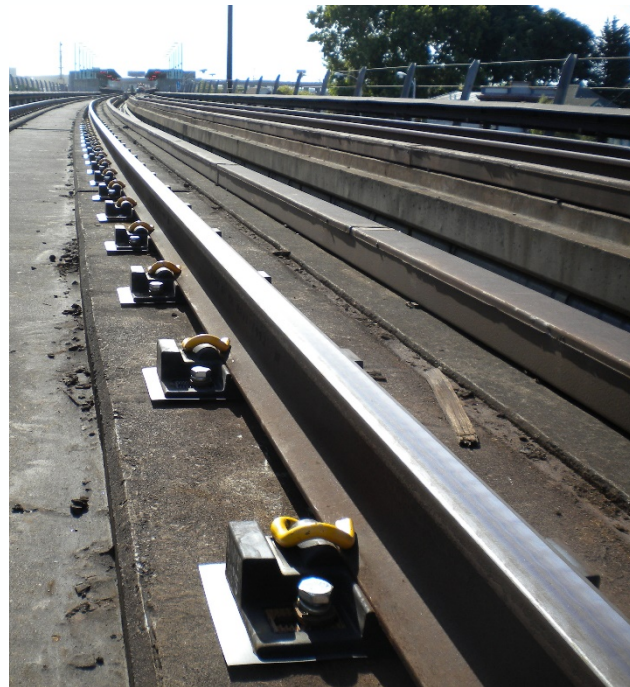
- 50-year-old fasteners nearing end of life
- Replaced legacy threaded fasteners with elastic fasteners
- Replaced 120k out of 345k fasteners

- 20,236 EA (15 months)
- 60% increase

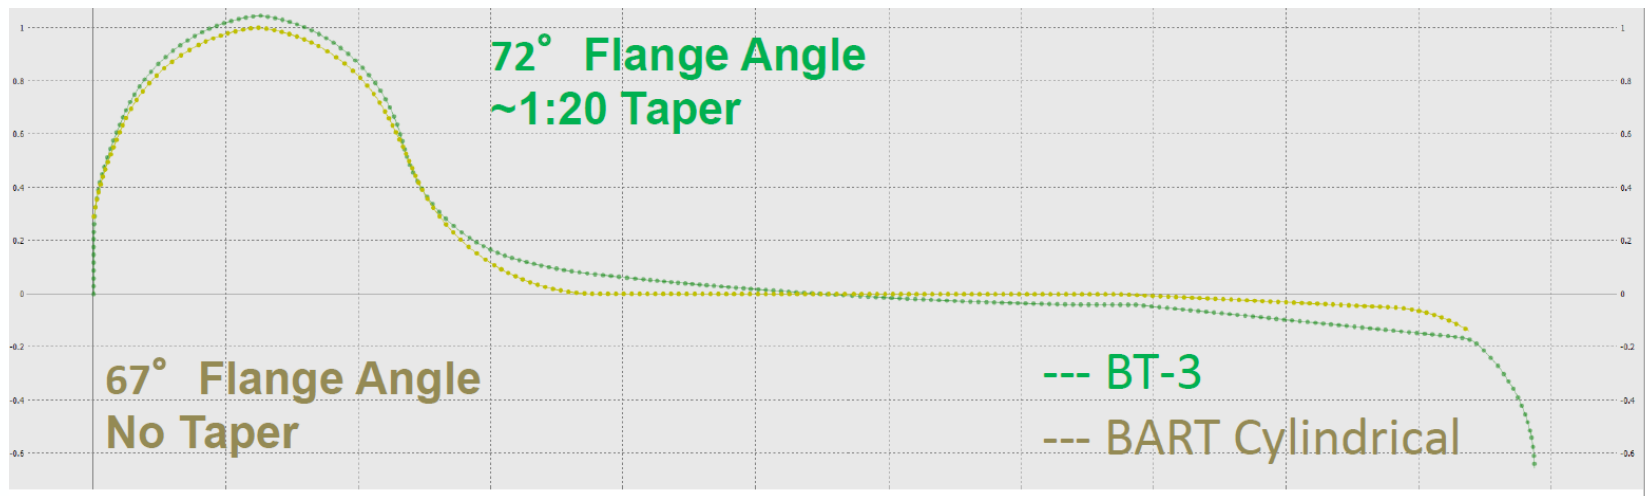
- Transition from cylindrical to conical wheel (BT-3 wheel)
- ARM/NRC designed matching rail templates

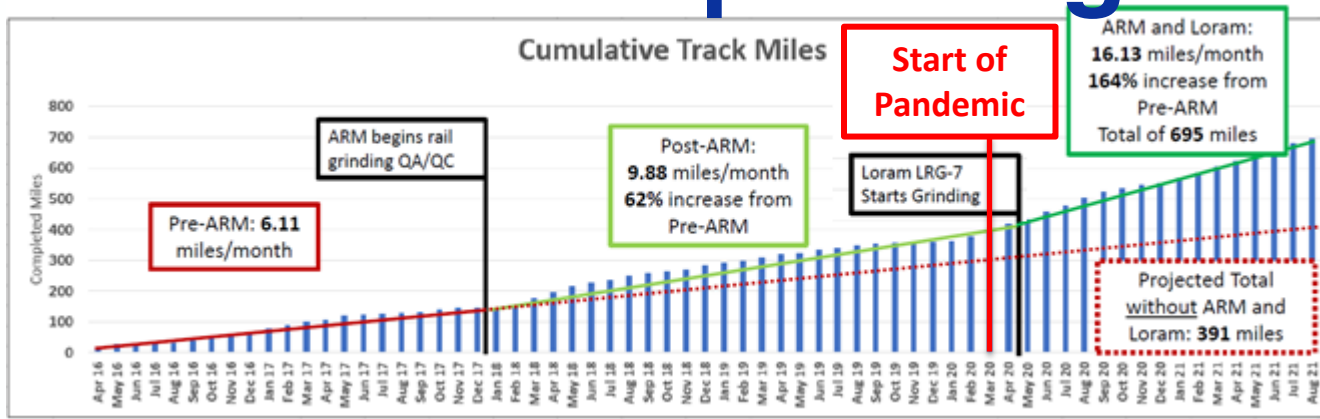
- BT-3 wheel implementation began Jul 2017
- Two-phase rail profile implementation began Jan 2018
- Loram grinder production began Apr 2020
- % complete for phase 1 (93%) and phase 2 (76%)

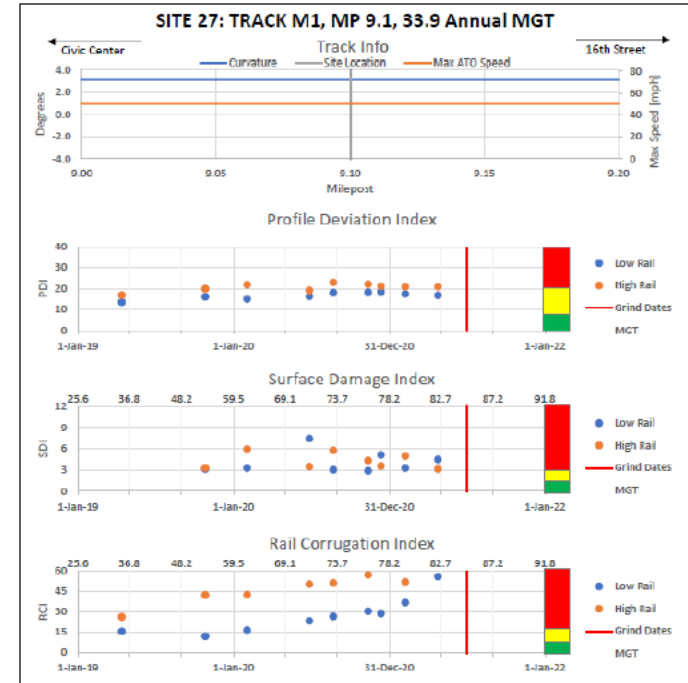
## 50 locations for rail conditions trending

- Based on curvature, speed, traffic volume, grade, etc
- Performed by ARM
- Profile Deviation Index
- Surface Damage Index
- Rail Corrugation Index

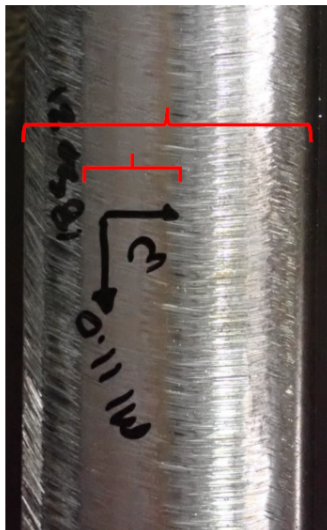
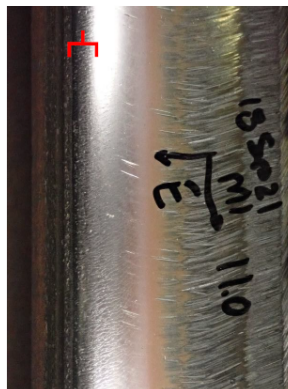
Site 23: M1 11.0, 3.6° curve

Running band looks very good

Ground 23JUN21  
Passes: 4W, 5E  
Light GCC

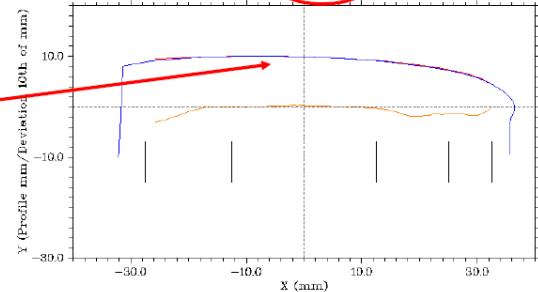
Low-int

BART | LINE M | TRACK M1 | RIGHT RAIL | West Rail | LOW RAIL | TEMPLATE: BART\_LOW\_INT  
CRV M-124 | MP 10.78 TO 11.06 | @ MP 11.000 | RADIUS 1500 FT | GROUND AS SHOWN  
SUPERELEV 0 | MAX ATO SPEED 88 MPH | STRUCTURE ds | Crown = 6.0 inch  
FIELD PQ1 = 16.3 Thou, PQ2 = 3.3, ARMSMA = 100 GAUGE

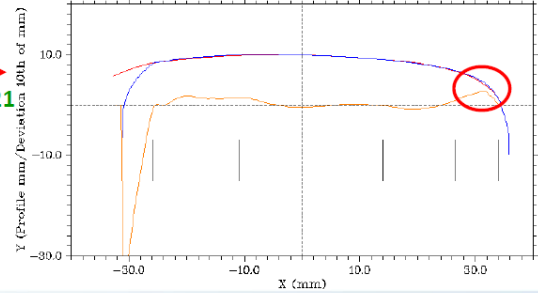
BART | LINE M | TRACK M1 | LEFT RAIL | East Rail | High Rail | TEMPLATE: BART\_HR\_2021\_TPI  
CRV M-124 | MP 10.78 TO 11.06 | @ MP 11.000 | RADIUS 1500 FT | GROUND AS SHOWN  
SUPERELEV 0 | MAX ATO SPEED 88 MPH | STRUCTURE ds | Crown = 12.8 inch  
FIELD PQ1 = 20.1 Thou, PQ2 = 7, ARMSMA = 100 GAUGE

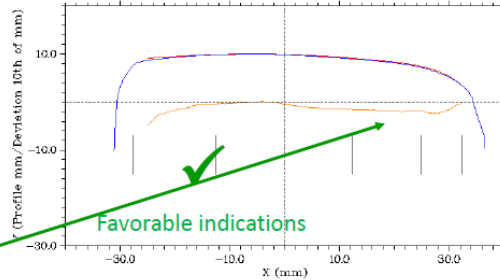
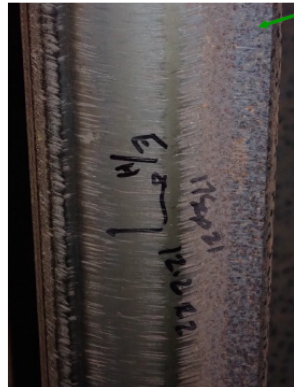
Site 38: R2  
12.2, CPG as  
high rail

BART | LINE R | TRACK R2 | LEFT RAIL | West Rail | High Rail | TEMPLATE: BART\_CPG-45  
CRV R-224 | MP 12.01 TO 12.25 | @ MP 12.200 | RADIUS 2015 FT | GROUND AS MODERATE  
SUPERSEL 0.5 | MAX ATG SPEED na MPH | STRUCTURE: na | Crown = 5.6 inch  
FIELD PQI = 23.6 Thou, PDI = 9, AREMA = 100 GAUGE

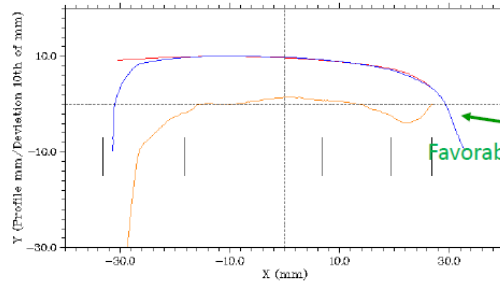
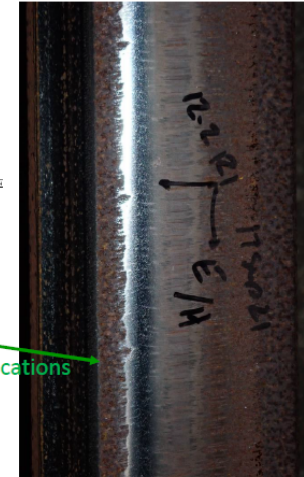
R1 12.2, CPG  
as high rail

BART | LINE R | TRACK R1 | LEFT RAIL | West Rail | High Rail | TEMPLATE: BART\_CPG-45  
CRV R-124 | MP 12.11 TO 12.23 | @ MP 12.200 | RADIUS 3000 FT | GROUND AS MODERATE  
SUPERSEL 0.5 | MAX ATG SPEED na MPH | STRUCTURE: na | Crown = 4.6 inch  
FIELD PQI = 31.0 Thou, PDI = 10, AREMA = 95 GAUGE

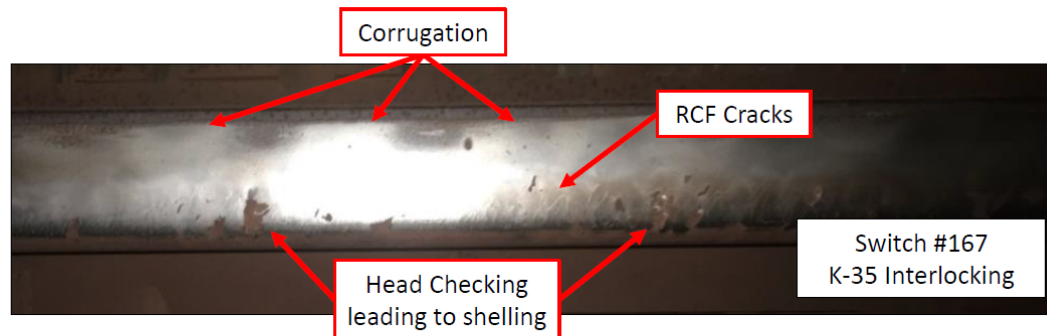
Pre-Grind

- Defect Removal in Switch

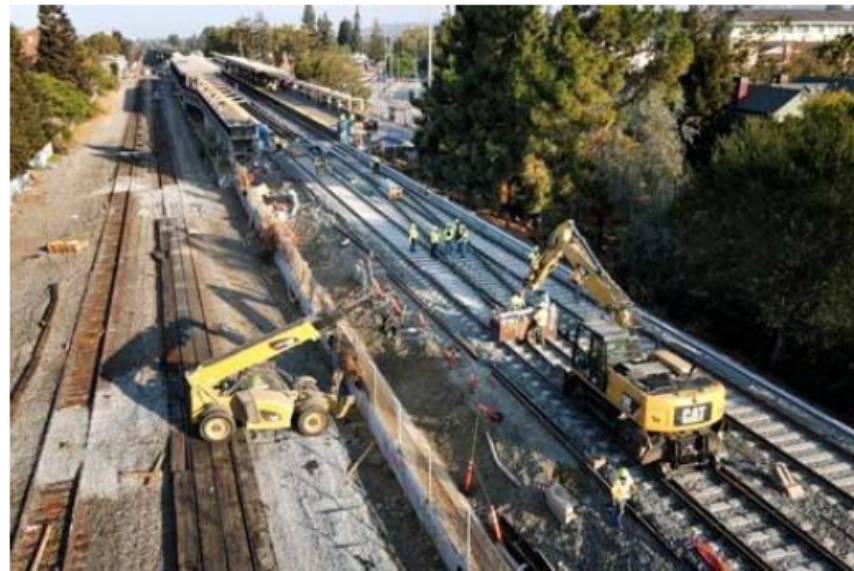
- Hayward Station
- Two No. 10 Concrete Tie Crossovers
- New Traction Power Contact Rail, Coverboard, and Cables

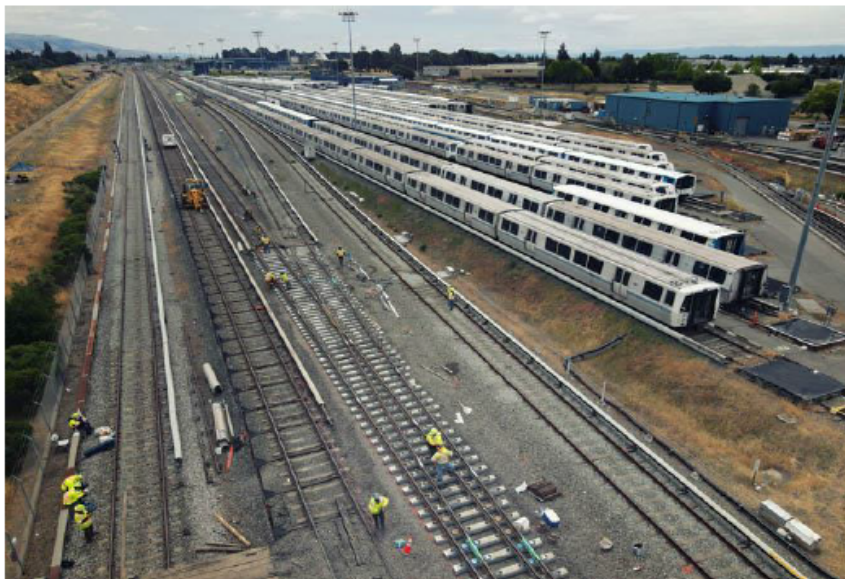
- North Hayward Yard
- One No. 15 Concrete Tie Crossover and Two No. 15 Concrete Tie Turnouts
- New Traction Power Contact Rail, Coverboard, and Cables
