# Vibro-Acoustic Inspection of Vienna's Tram Network

**KAROLINE ALTEN**

RAIL TRANSIT SEMINAR • OCTOBER 18, 2021

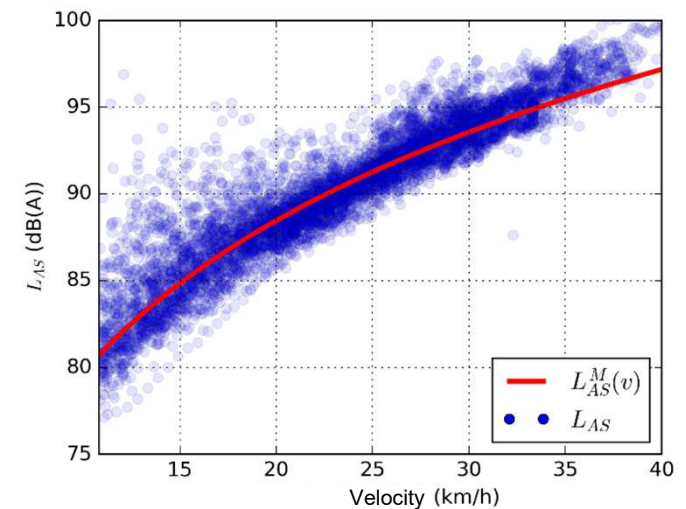
Step 1: Dimensionality reduction

Features selected through logit regression:

- Welch-Periodograms, 20 Hz resolution
- Velocity
- Curvature
- Relative sound level

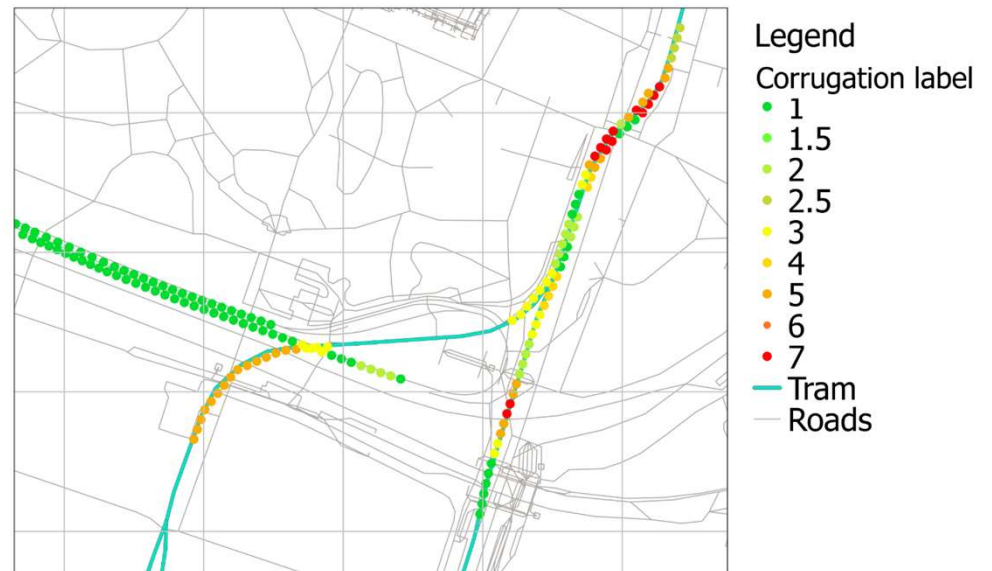
2 approaches investigated:

- Classification algorithms
- Regression models

Problems

- Imbalanced datasets
- Too few independent bins
- Reasonable no. of features?
- Other rail head irregularities hard to differentiate
- Inaccuracies in labelled bin position

Solutions

- Fewer classes
- Exclude redundant sensors
- SV regression

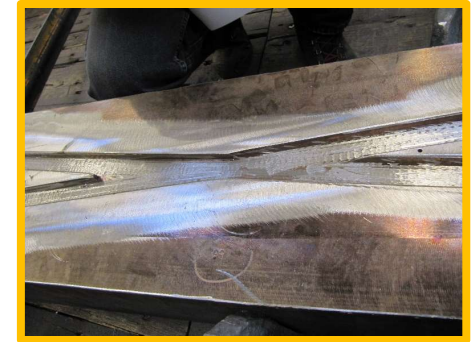
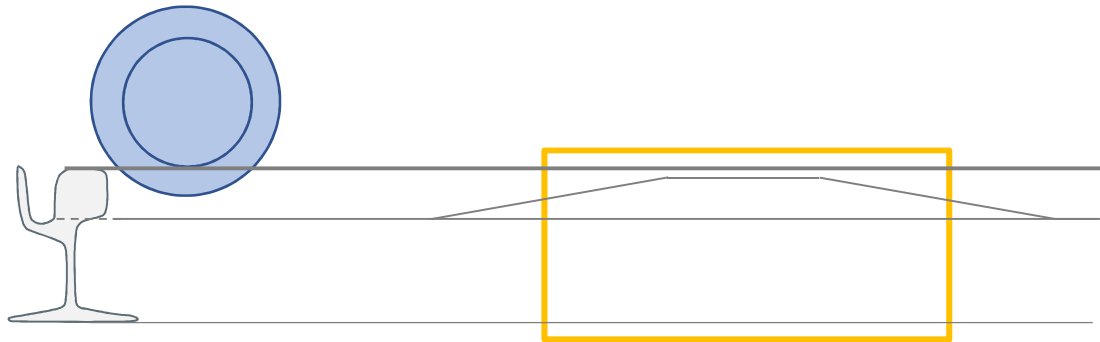
Switch structure on grooved rails

Only regarding mechanical defects in wheel-rail contact area

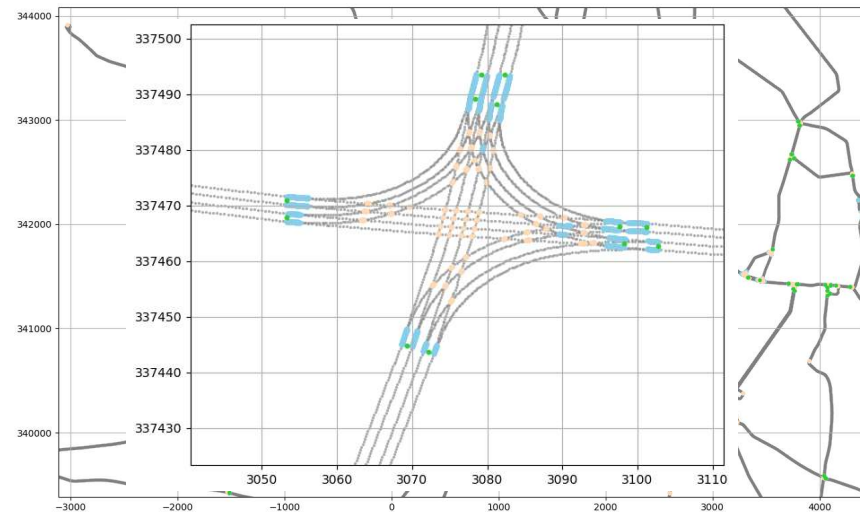
Challenges:

- Ramped crossings
  - Unique geometries
  - Closely spaced crossings
- Define frog clusters
