Conformal frog retrofit to mitigate noise & vibration

By Rashid Dorj, M. Eng, P. Eng. & Harry Skoblenick, P.Eng.

City of Ottawa O-Train System

Field retrofit existing frog to a conformal design

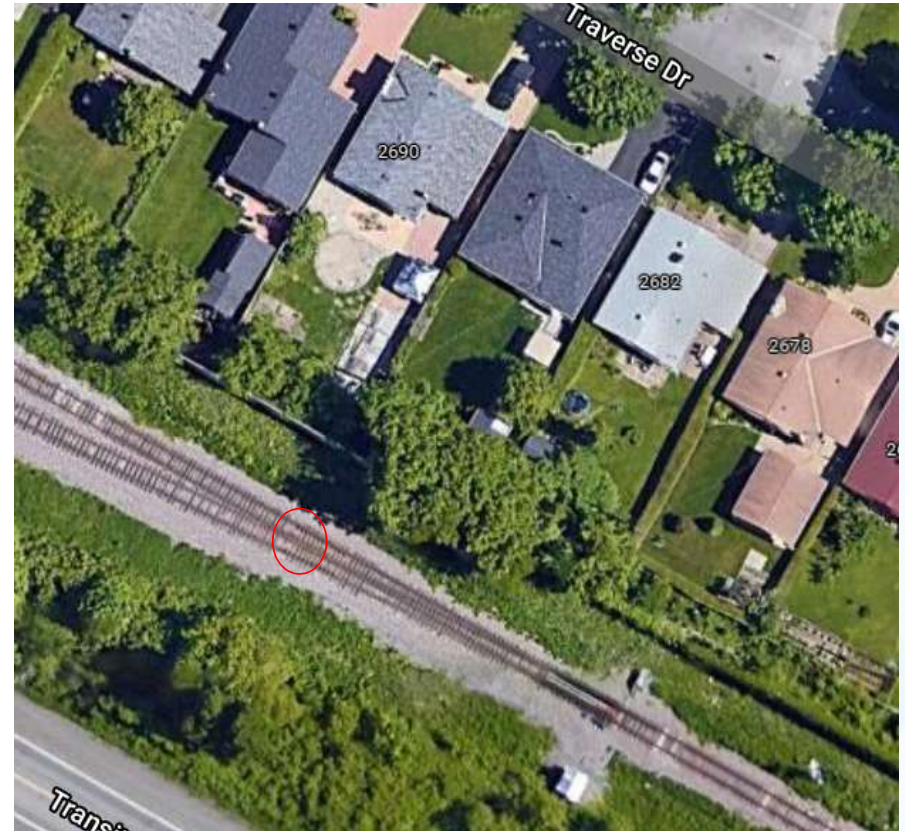
- 2001: pilot project with single siding
- 2015: two new sidings added
- 2016: residents issue formal complaints to City on excessive track noise and vibrations from nearby turnout
- 2016: permanent slow order of 55 kph to mitigate against noise / vibration at one siding
- 2017: added pressure for train operations requires increase transit speed to 85 kph

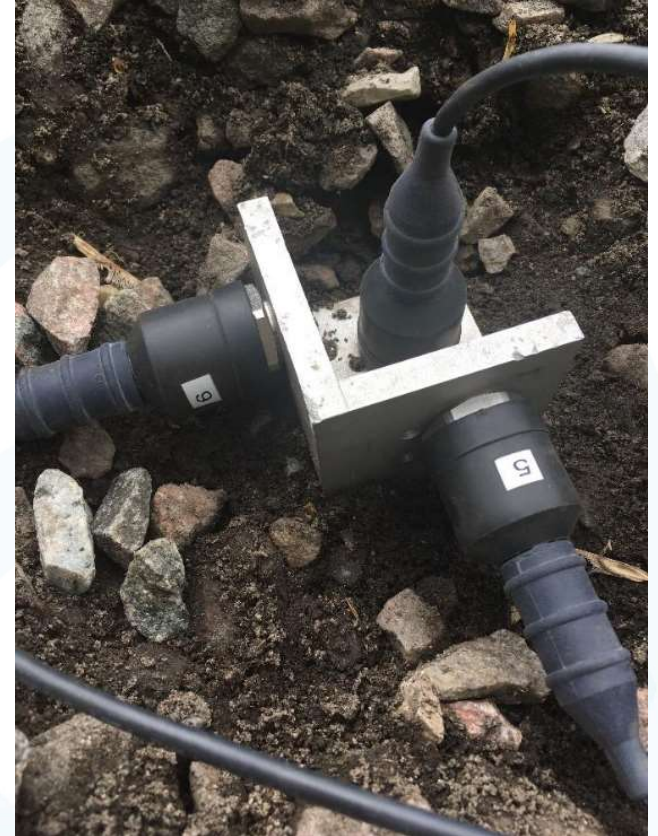
- Four locations: 2m, 8m, 11m and inside residence
- PCB 393A03 accelerometers (8 units)
- Bruel & Kjaer Analyzer Type 2250 Sound Meter

- Average maximum = 47 dBA \pm 1 dB
- Average equivalent sound (1 hour) = 36 dBA

- Vertical: 16 $\mu\text{m/s}$ to 37 $\mu\text{m/s}$
- Perpendicular: 10 $\mu\text{m/s}$ to 15 $\mu\text{m/s}$
- Parallel: 13 $\mu\text{m/s}$ to 17 $\mu\text{m/s}$

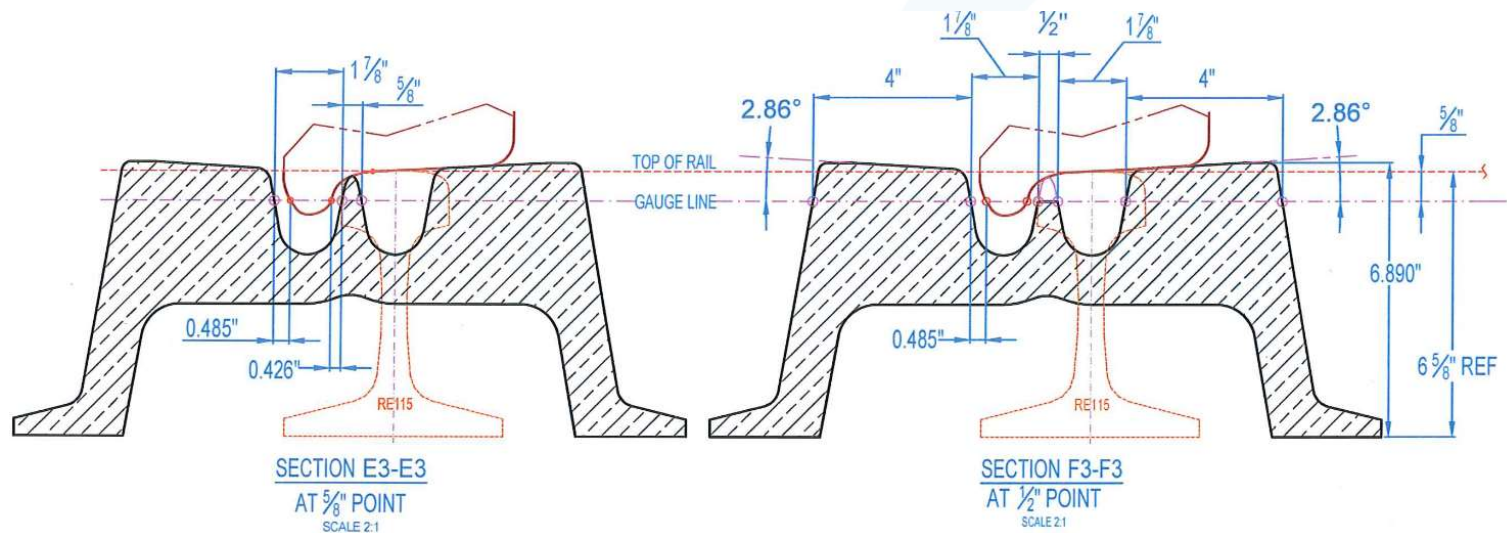
APTA 220 Wheel Profile – Frog Transition Requirement

B.5 APTA 220 Wheel Profile

Based on AAR-1B (AAR S-669), 1:20 taper, modified for 5.5 inch wheel width.

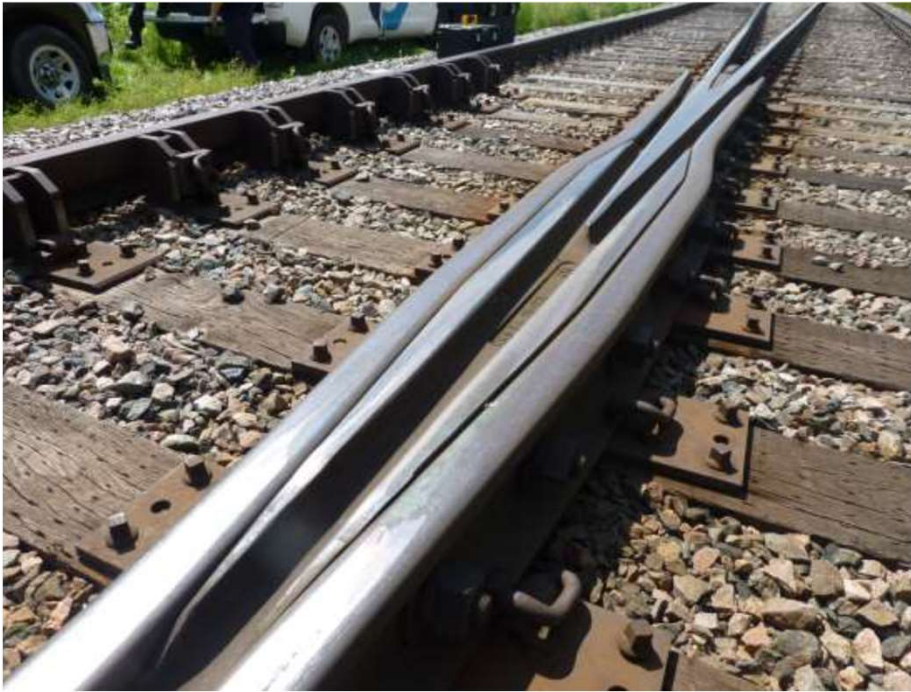
Brookfield - No. 15 Crossover Frog (July 15, 2019)

1. For smooth trackwork crossings, contact transitions should be shared and at least 50mm long
2. Sudden transitions and noticeable wear at Point and Throat indicating high wheel/rail impacts

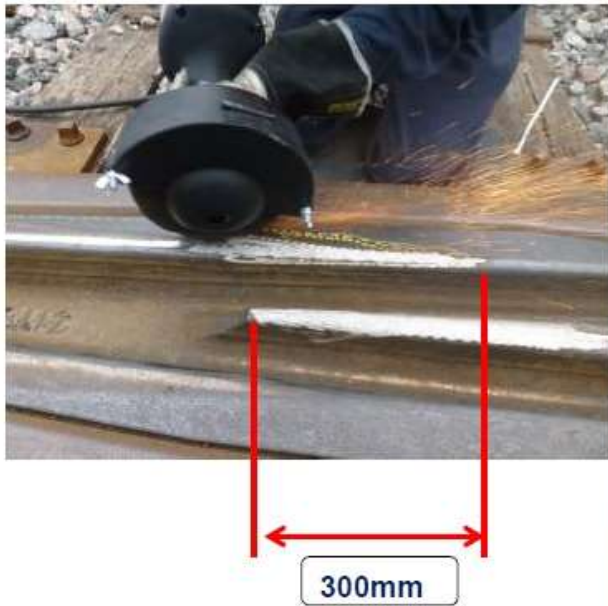
Repair Process- pre-grinding

Apply straight hand grinder to remove surface hardness and defects including minor cracks – target measured hardness 300HB (+/- 30).
