Rail Damage Functions Associated with Automatic Train Operation

Andy Vickerstaff

Transport for London Engineering

RAIL TRANSIT SEMINAR • JUNE 21

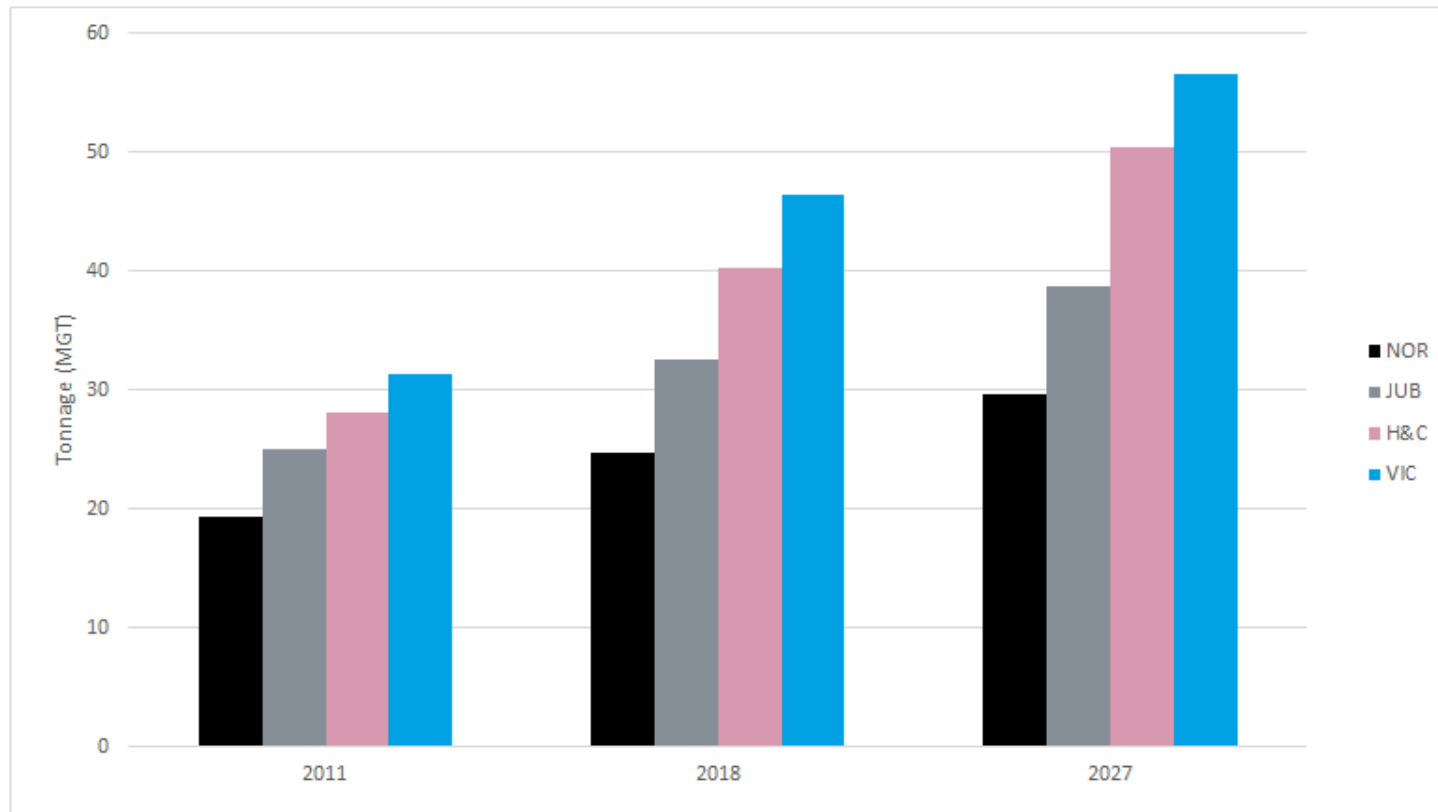
ATO = Tonnage Increase

- How can't we increase capacity?
 - Bigger Trains: Need bigger tunnels
 - Longer Trains: Need new platforms in tunnels
 - Faster Trains: A bit faster....but inherent geometry limiting
- How can we increase capacity?
 - Run more trains, closer together
 - Inter station lengths short, acceleration and braking more important
 - More trains = Greater Tonnages

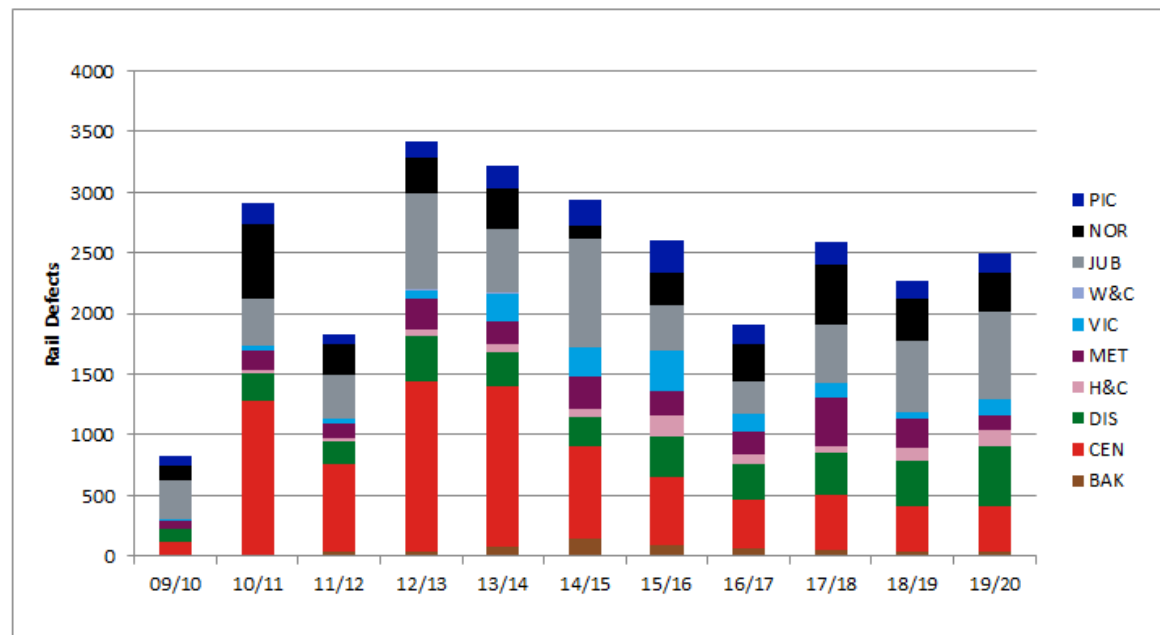
Squat Type Defects

- Open sections
- AC Traction Systems
- Concentrated in areas of congestion, rarely in platforms
- Martensitic layer present above cracks
- Explosion in numbers found post ATO commissioning

- Not the same as conventional squats¹
- Need low adhesion conditions on railhead, rarely found in tunnels²
- Low speed slip recovery in 'damp' conditions, not 'contaminated' adhesion conditions²
- Simulations show capable of producing $T\gamma$ in excess of 2200J/m, capable of producing temperatures greater than 727°C to produce martensite²
- Manual driving much better at coping with low adhesion, not necessarily at maintaining timetables hence ATO.
- Best option is to re-design Wheel Slip Protection (S-Stock), however not a quick fix.....

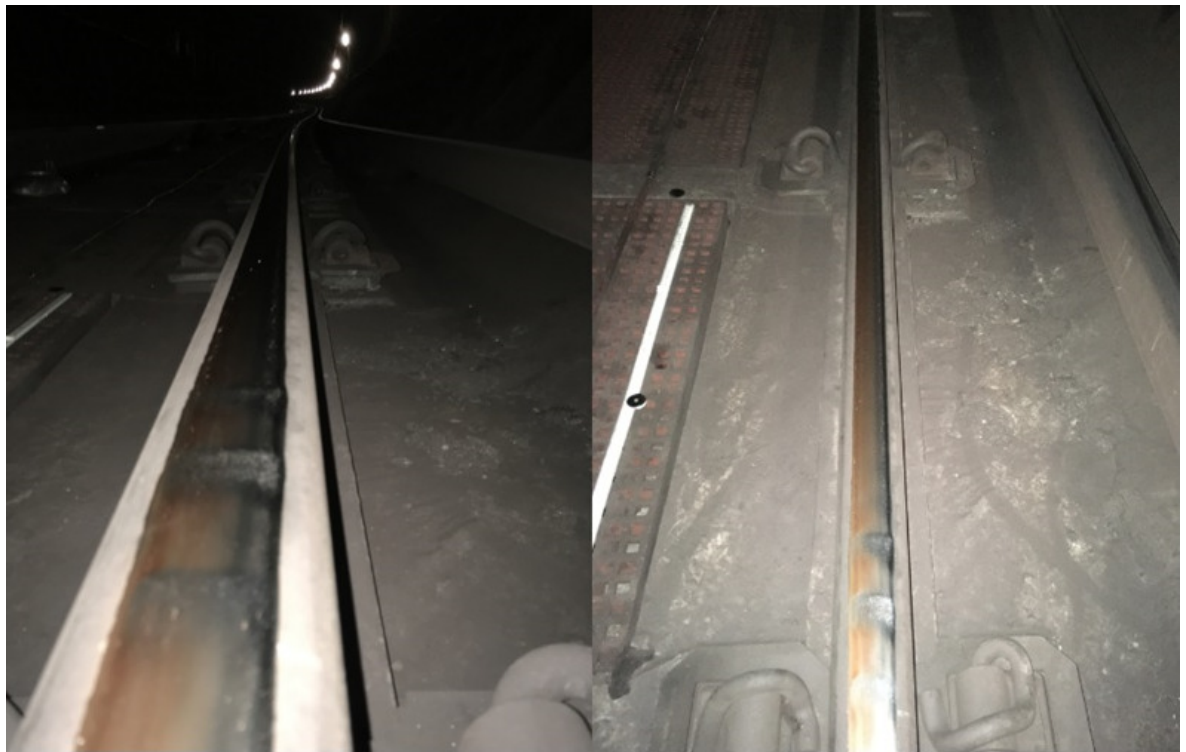
P2 Resonance

Pinned-Pinned

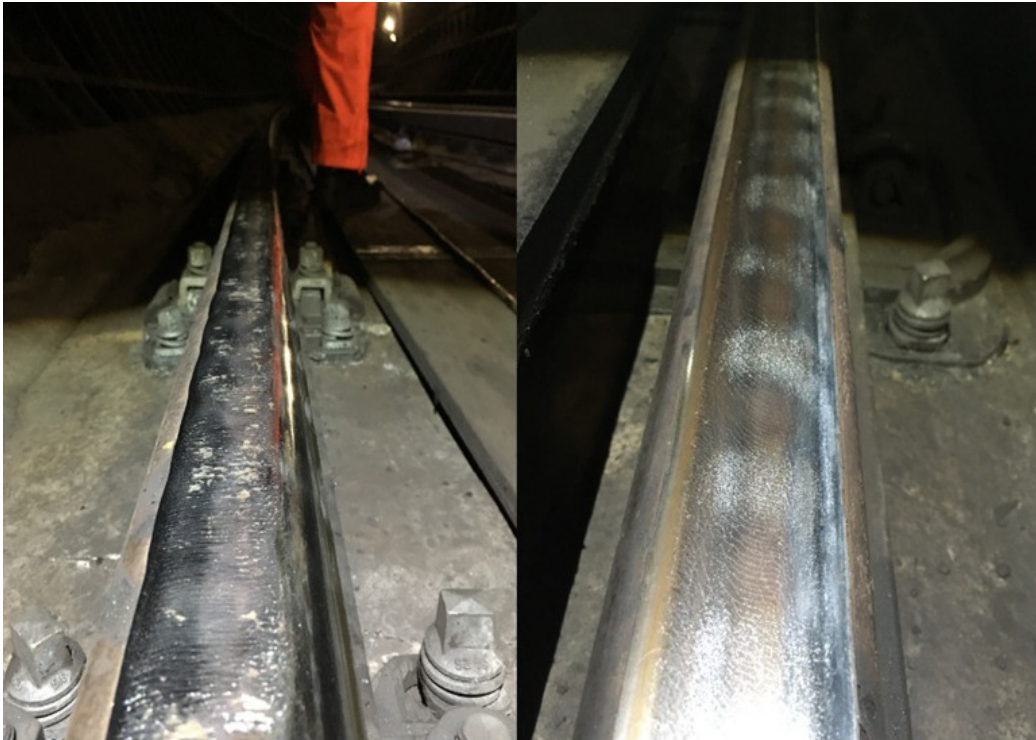
Corrugation

Rutting

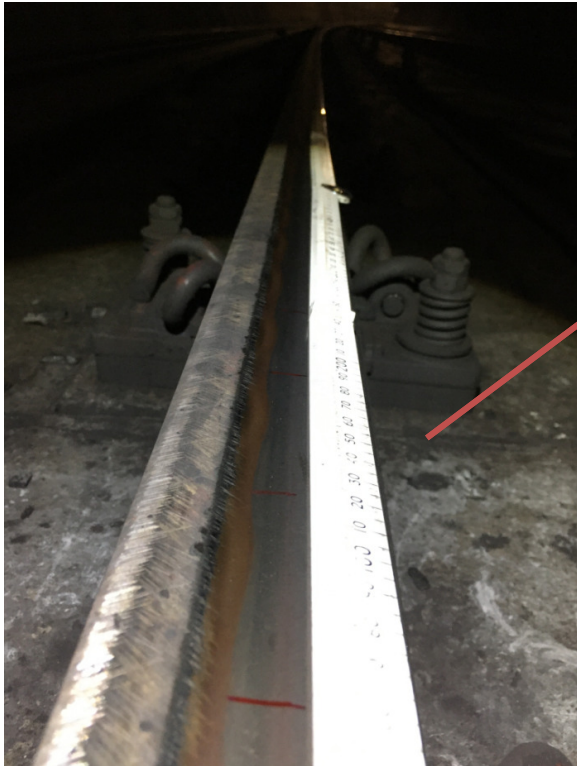
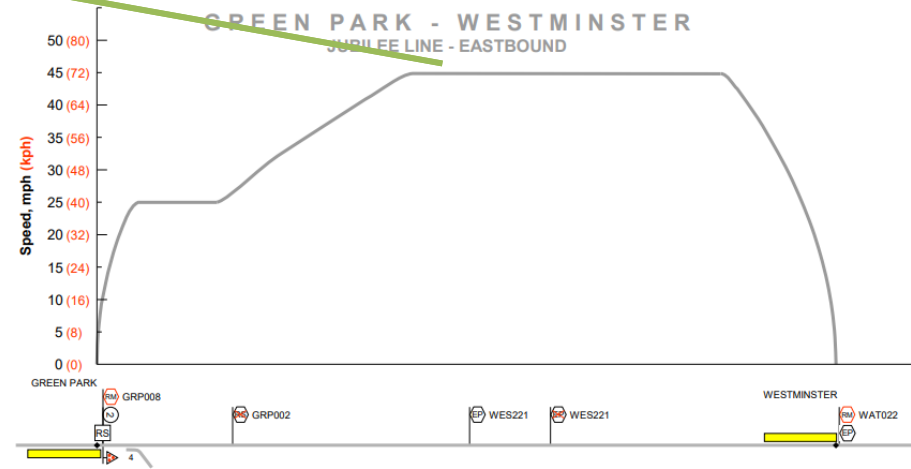
A Constant Frequency Phenomena ¹⁷

$$\lambda = \frac{v}{f}$$
$$f = \frac{v}{\lambda}$$

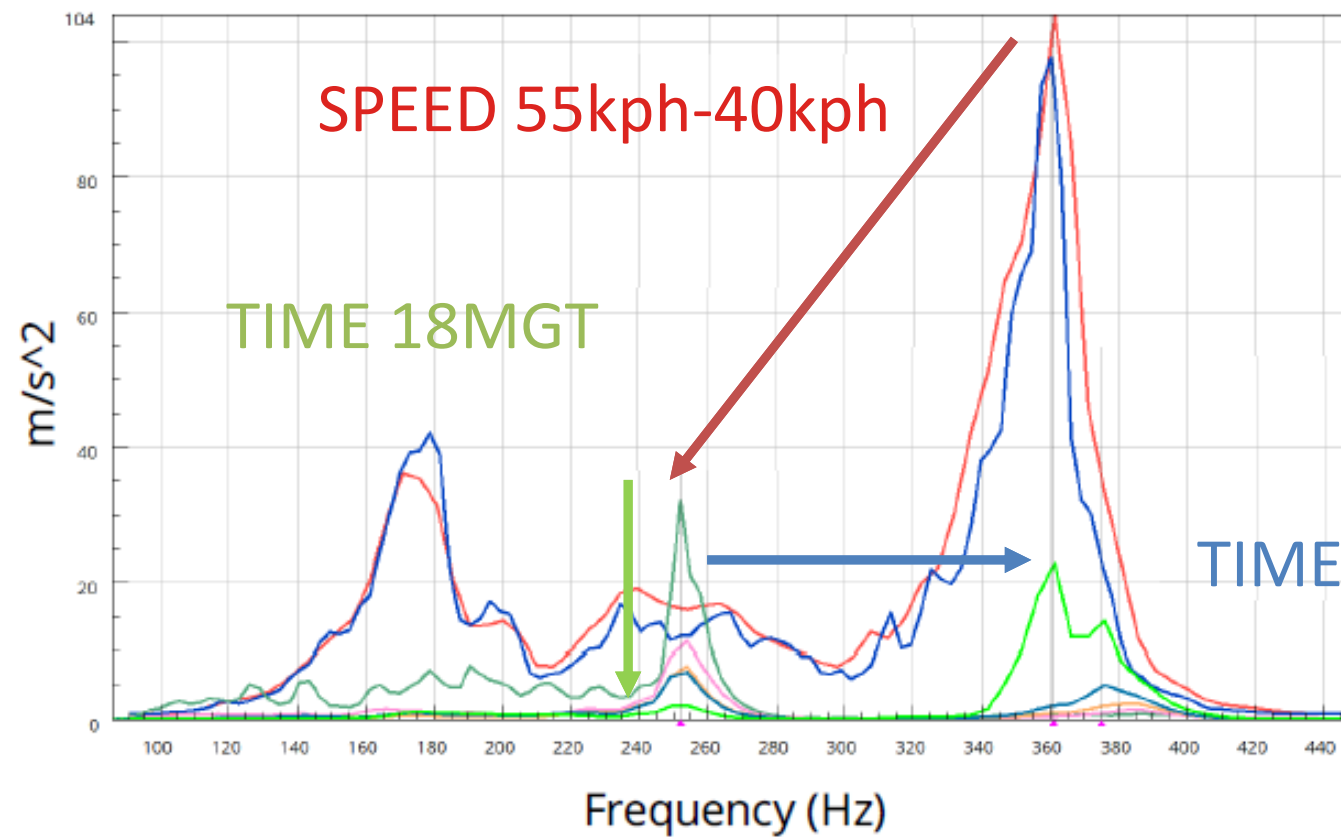
Wearing out λ with Δv

Marker	Title
—	2020-02-05_1hr_All_in1 Ch
—	2020-05-14_1hr_Full Speed
—	2020-05-14_1hr_40 kph_All
—	2020-09-02_40KPH_1hr_All
—	2020-11-10_40KPH_1hr_All
—	2021-01-05_40kph_1hr_All
—	2021-06-03_40kph_1hr_All

55kph@42mm = 360Hz
 40kph@42mm= 265Hz
 360Hz@40kph= 31.5mm

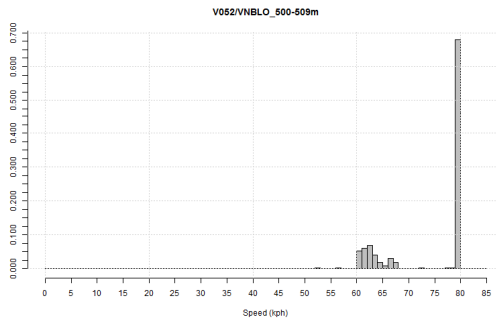
70% reach 80kph

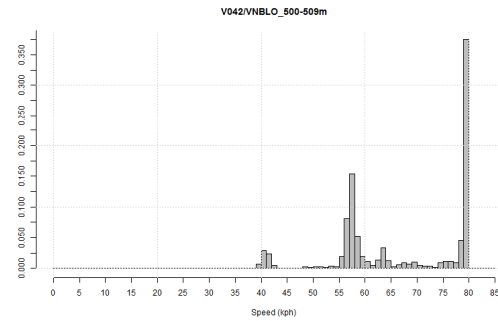
35% reach 80kph

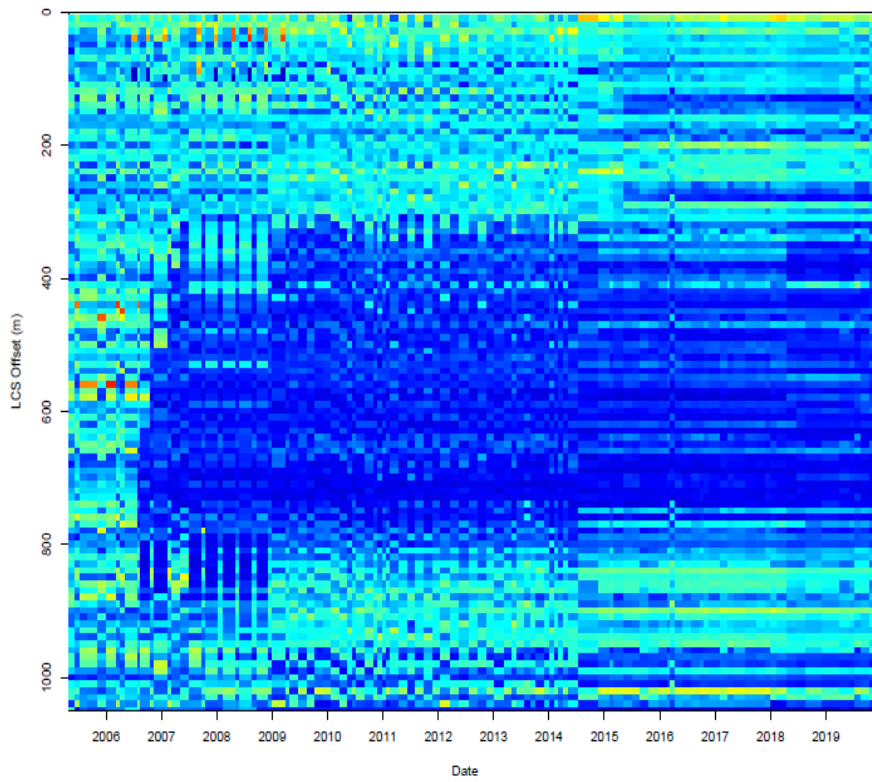
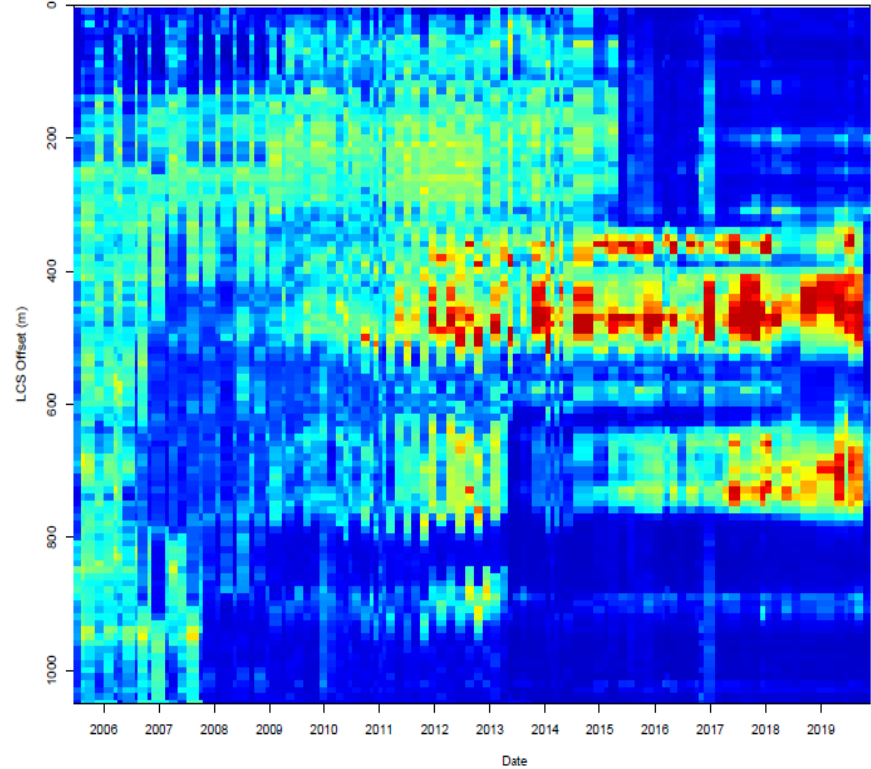
Long Term Trends

N086/NNBFA - PLT3 CAMDEN TOWN TO PLT1 KENTISH TOWN
