Aiming for a State of Good Repair: Moving from Reactive to Preventative Rail Maintenance

Peeter Vesik – Asset Integration Project Manager
Guideway(Track), Equipment, and Maintenance Infrastructure

RAIL TRANSIT SEMINAR • JUNE 21

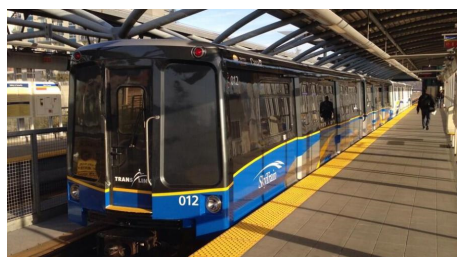
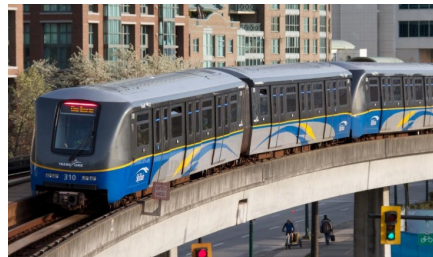
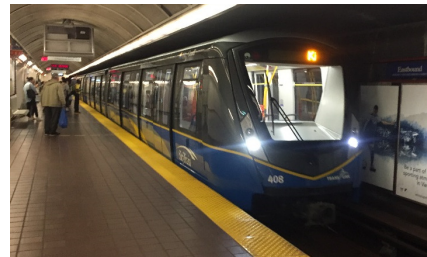
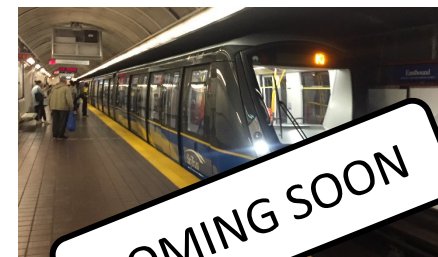
Mark I: 2-car units
UTDC
150 cars
12.7 m long

Mark II: 2-car units
Bombardier
108 cars
16.7 m long

Mark III: 4-car units
Bombardier
84 cars
17 m long (avg.)

Mark IV: 5-car units
Alstom
205 cars
17 m long (avg.)

- LIM propulsion
- Steerable bogies
- Fully automated train control (driverless)

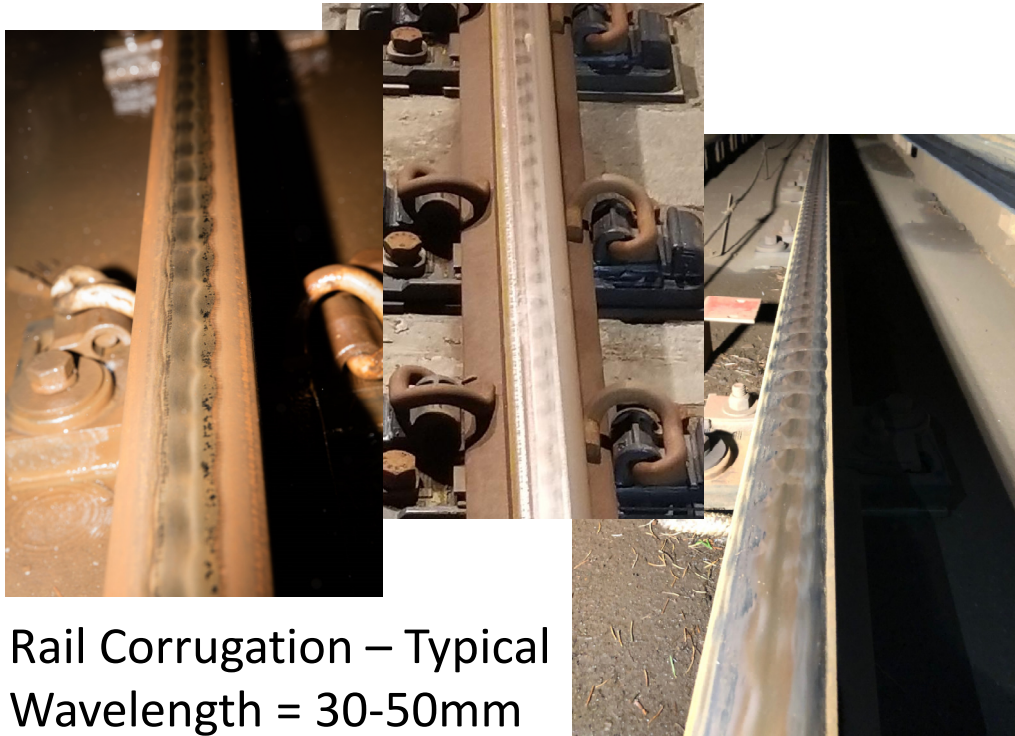
Rail Corrugation – Typical Wavelength = 30-50mm

- Removed by Rail Grinding

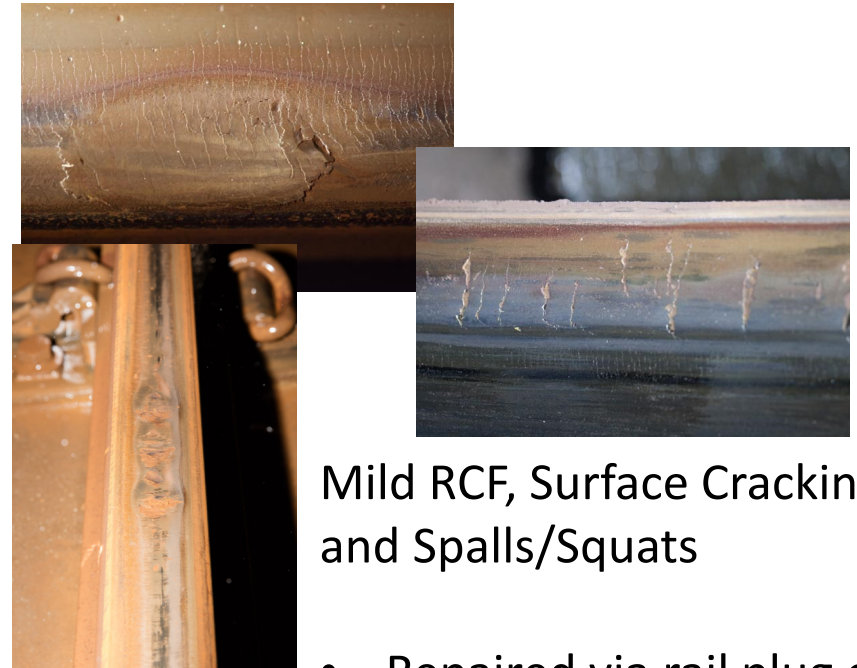
Mild RCF, Surface Cracking, and Spalls/Squats

- Repaired via rail plug or weld
- Maintained by regular grinding and monitoring

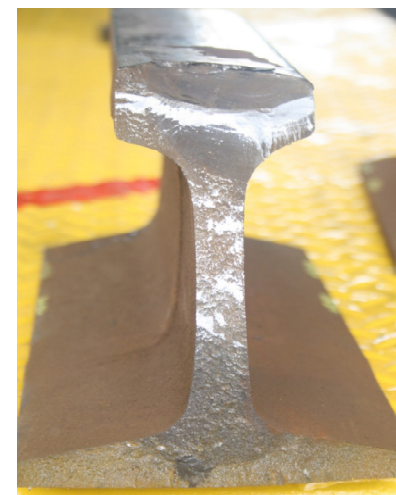
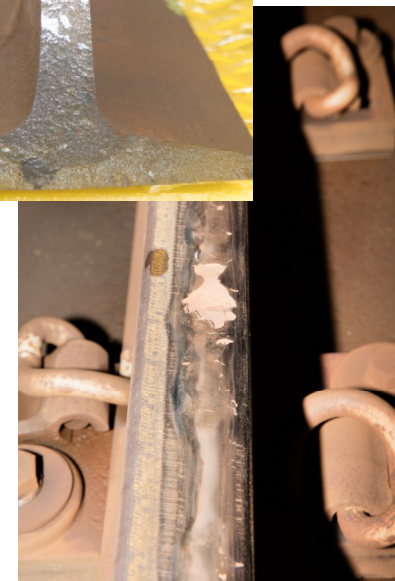
Track Maintenance History: 2010-2015

- Increased service levels from 2010 Olympics not aligned with maintenance practices
- BCRTC track maintenance department stretched thin
 - Keeping system safe and operable
 - Not setup for long-term sustainability
 - In-house rail grinder working, but at limited capacity
- NRC report in 2015 contained 557 defects
- If no intervention, significant re-railing would be required immediately (est. \$50M+)

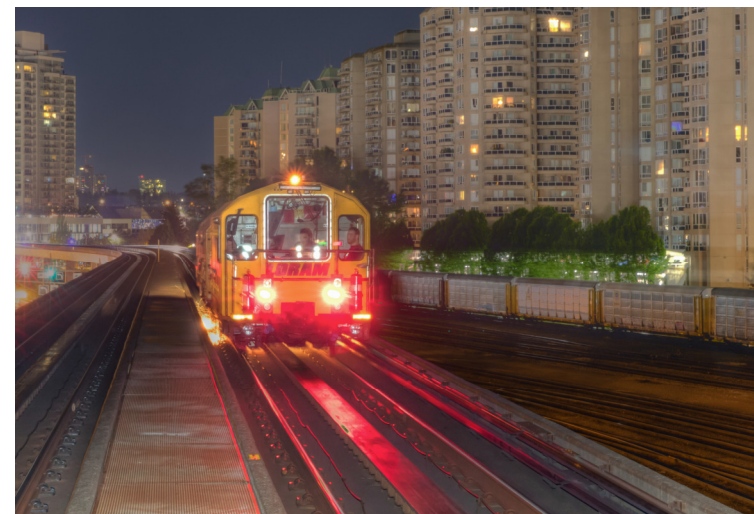
Today's Grinding Strategy

Key focus of Grinding at SkyTrain:

- Transitioning from Corrective to Preventative Grinding
- Focus on minor damage, corrugation, and profile
- Make use of in-house and contract grinding equipment
- Other maintenance inputs and projects such as rail replacements, ultrasonic/geometry results used to constantly inform grinding program
- Grinding Schedule currently on 24-month cycle
 - Highest Frequency is Quarterly
 - Lowest Frequency is Bi-annual
 - 125km ground per year (Average)

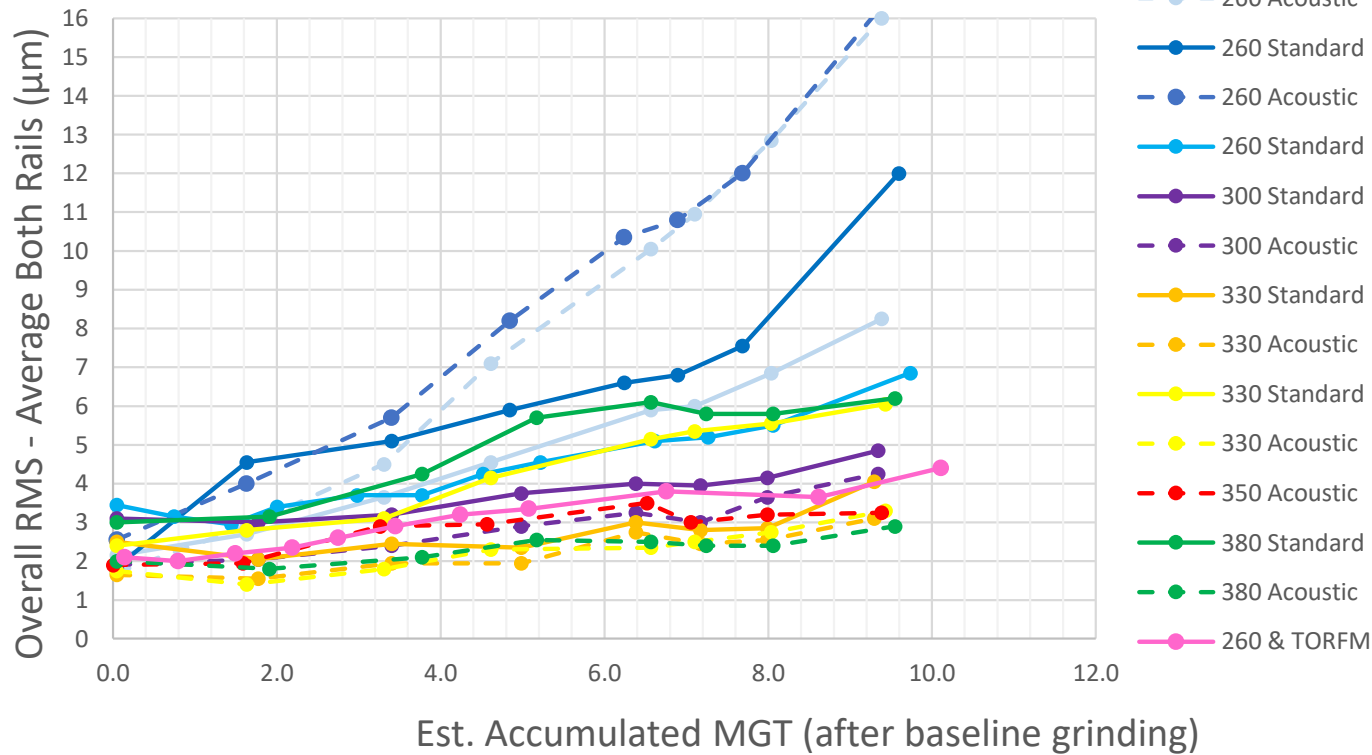
Rail Roughness Growth - Rail Hardness vs. Accumulated MGT (post-grind)

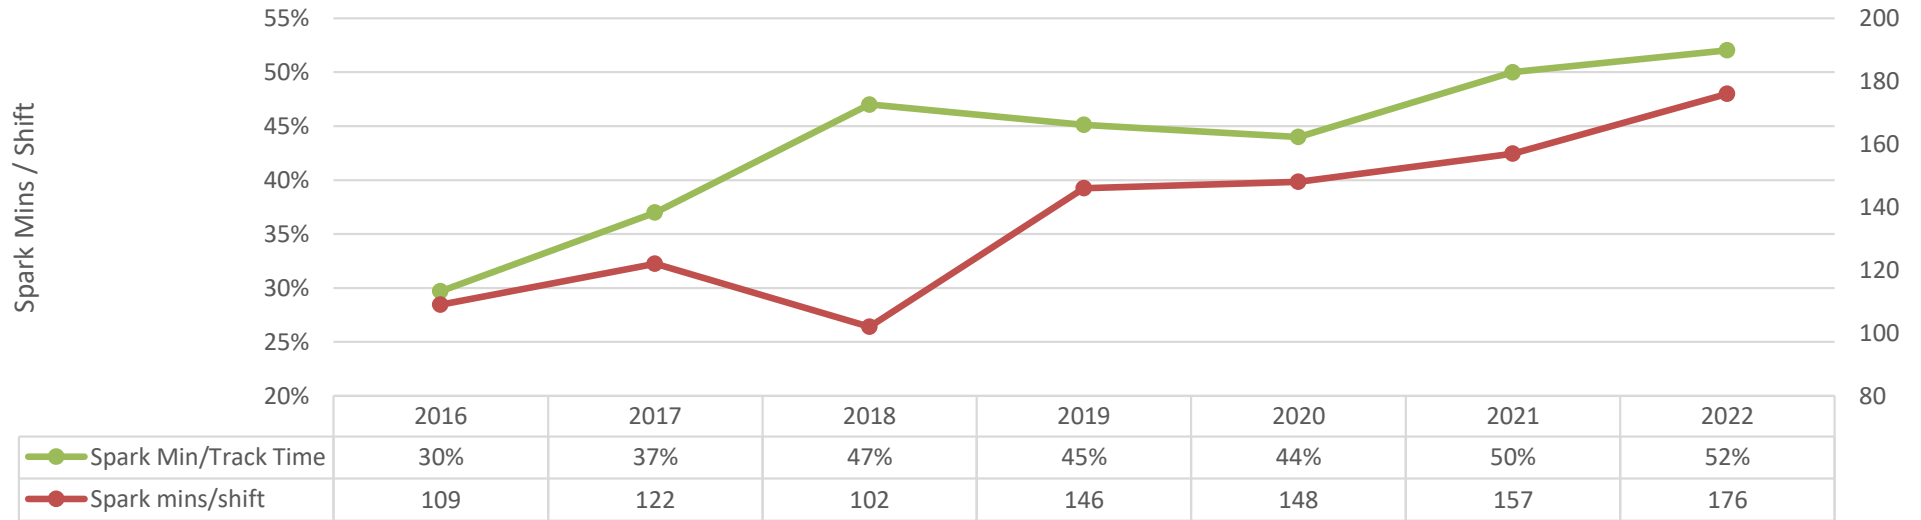
Tracking & Quantifying Grinding Effectiveness

- Increased usage of single tracking (reduces % of time on travel)
- Strategically staging and tying-up equipment in locations which maximize track time (use pockets and sidings to limit travel time)
- Ensuring stone changes and re-fueling is completed during maintenance hours as often as possible

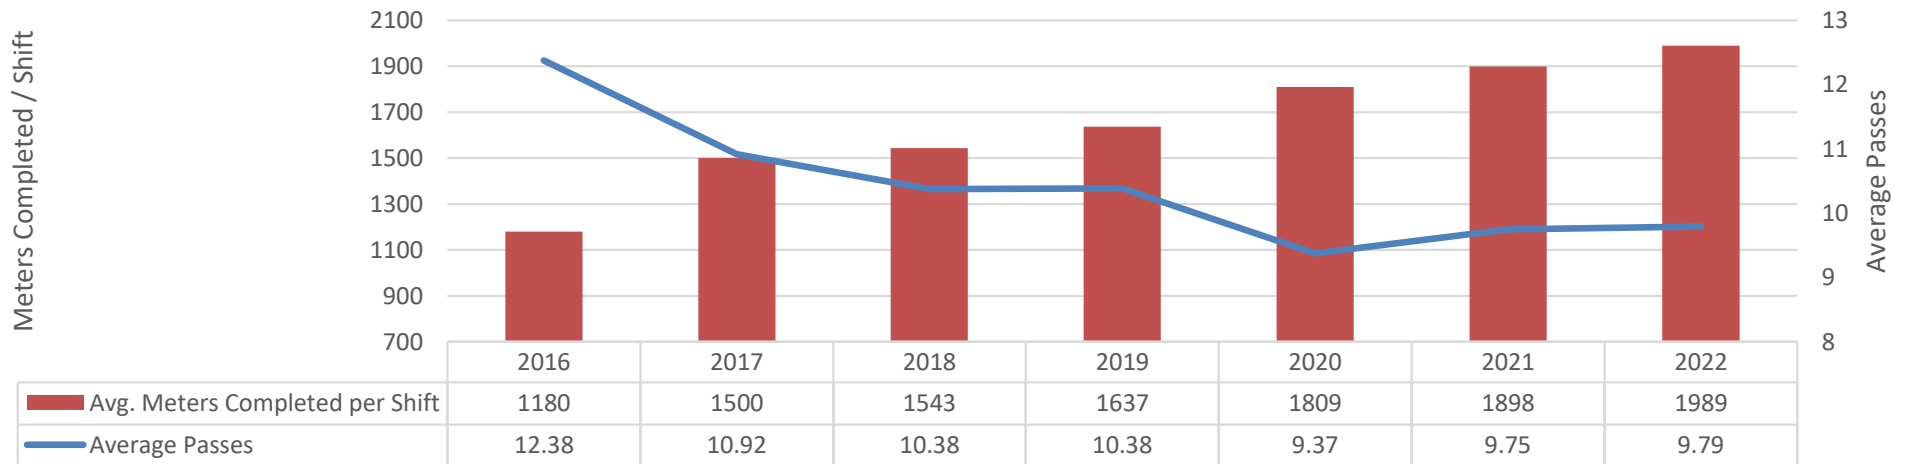
Tracking & Quantifying Grinding Effectiveness

- Each year is requiring less passes than the year before
 - This is a testament to performing regular preventative grinding
- Less passes, combined with increased track time efficiency, means more track meters are being completed per shift
- Due to fixed annual grinding budget, improving conditions and increasing spark time means more track can be covered under the same amount of shifts

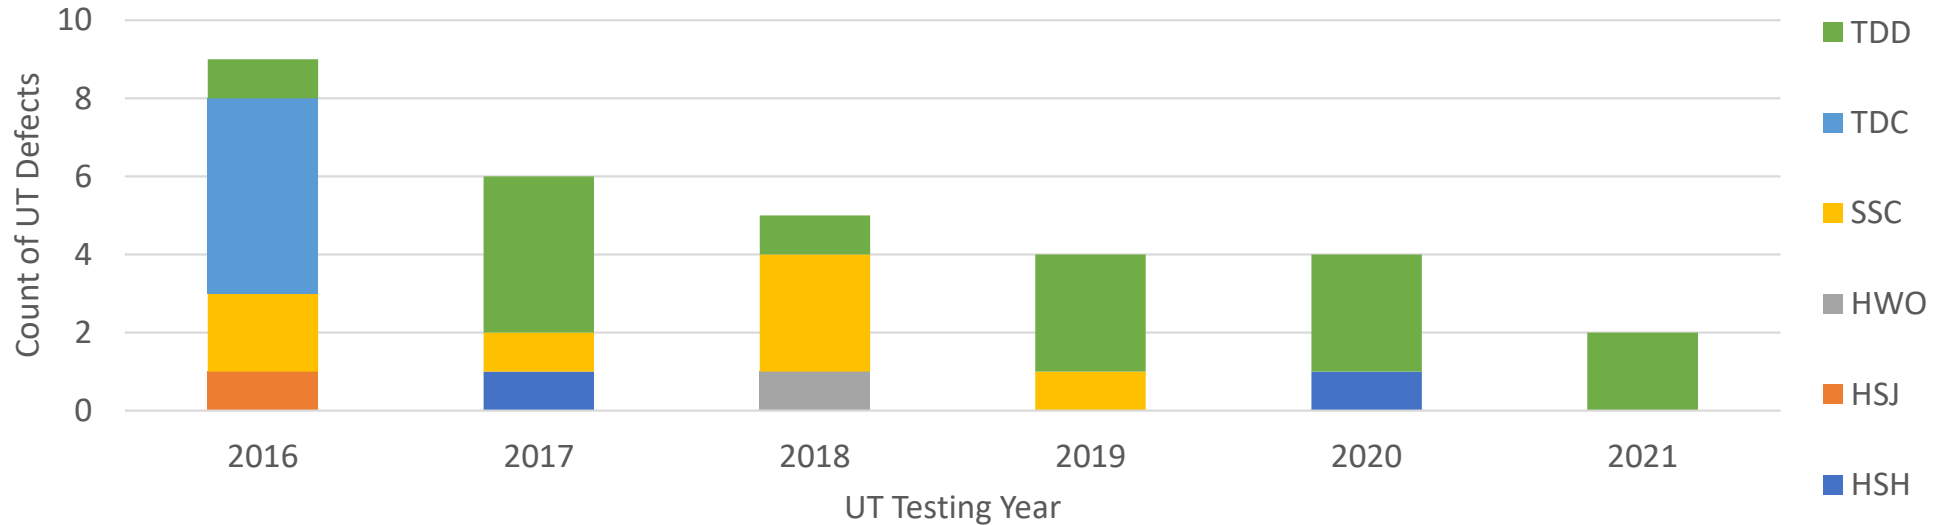
UT Defect Occurrence History - Mainline Track

- Removing defects via grinding and rail replacements reduces impacts and vibration
- UT defect reduction aligns very well with moving to Preventative Rail maint. strategy
- More “severe” types of Defects no longer appearing
- Clearer reporting: Reduction in SSC defects for example

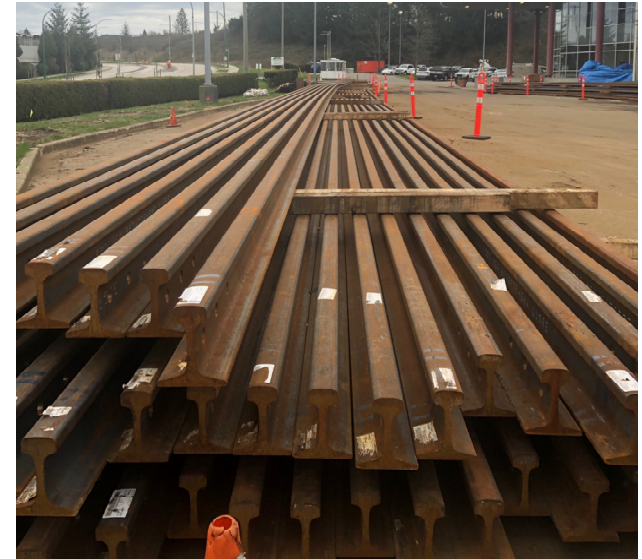
What's Next?

- Procurement of 2x (16) stone rail grinders to have optimized/distributed annual grinding capacity, and keeping capacity on hand for upcoming extensions
- Continue Running Rail and Fastener Replacement Program
 - 2.5-3km of track per year, replacing 260HB rail with 350-370HB

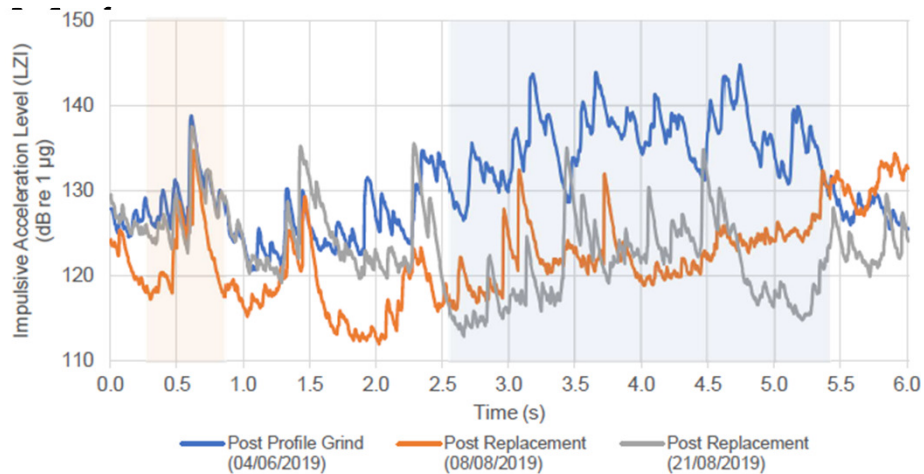
Turnouts: Noise/Vibration Monitoring to Drive

- Old/Damaged switches difficult to remediate
- Replacing worn switch can result in up to 10dBA wayside noise reduction
- Must replace old/worn switches, but key is to preventatively maintain with switch grinding program

Switch (Typical Train Speed)	Condition	Broadband Wayside Sound Level [dBA]	Broadband Equivalent Vibration Level [dB re 10 ⁻⁶ g]	Reduction ¹	
				Sound Level	Vibration Level
DC09 (50 km/h)	Post Replacement	82	135	-	-
	Post Profile Grind	82	129	0	5
DC10 (48 km/h)	Post Profile Grind ²	90	137	-	-
	Post Replacement	80	123	10	14
DC11 (49 km/h)	Post Profile Grind	86	133	-	-
DC12 (46 km/h)	As-Found	85	134	-	-
	Post Profile Grind	86	135	0	-3
	Post Replacement	78	125	7	7
DC30 (75 km/h)	As-Found	90	128	-	-
	Post Profile Grind	90	131	0	-3
DC40 (75 km/h)	As-Found	88	135	-	-
	Post Profile and Rotary Grind	84	129	4	6
