Energy and Forces within a Train Consist

Two Derailment Case Studies

Two derailments illustrate the power of in-train forces

- 1) Train 18N, Altoona, PA, 2014
- 2) Train 22Q, Pell City, AL, 2018

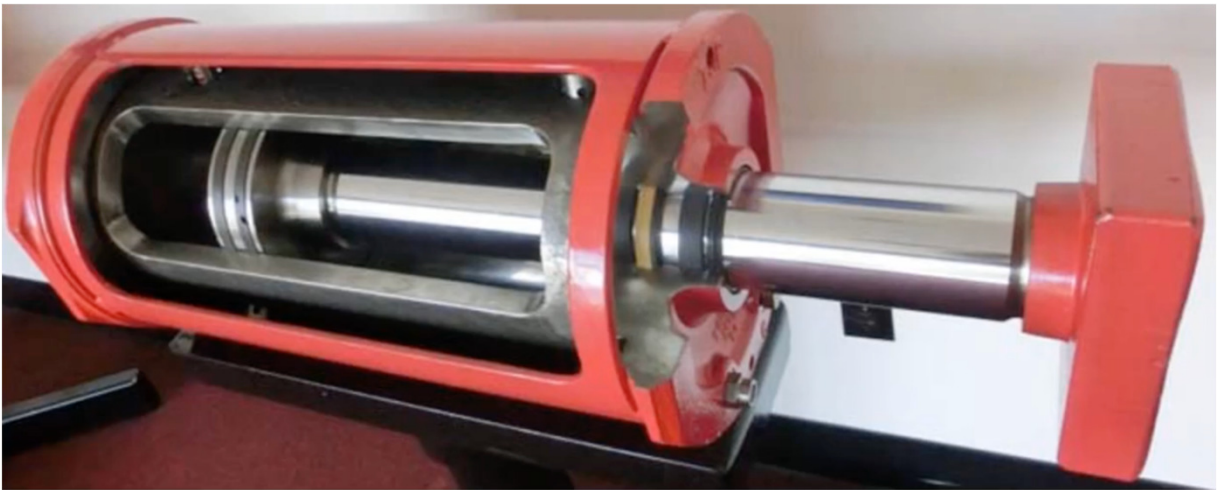
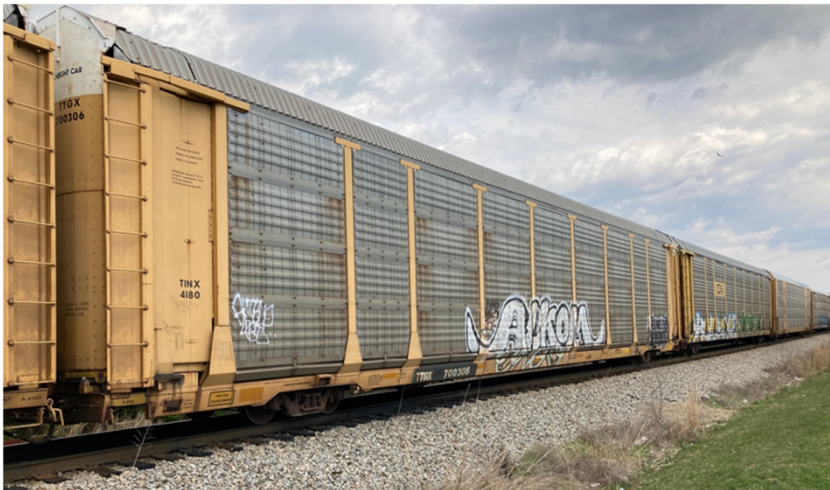
Hydraulic End-Of-Car Cushion Units

An EOCC unit absorbs energy by compressing a hydraulic piston. Car type determines stroke and preload.

Equipped car types include multi-level, coil steel, auto parts box, and center beam & bulkhead flats (where impact could shift or damage lading)

Auto	Other
Preload	50,000 lbs	100,000 lbs
Stroke	10"	15"

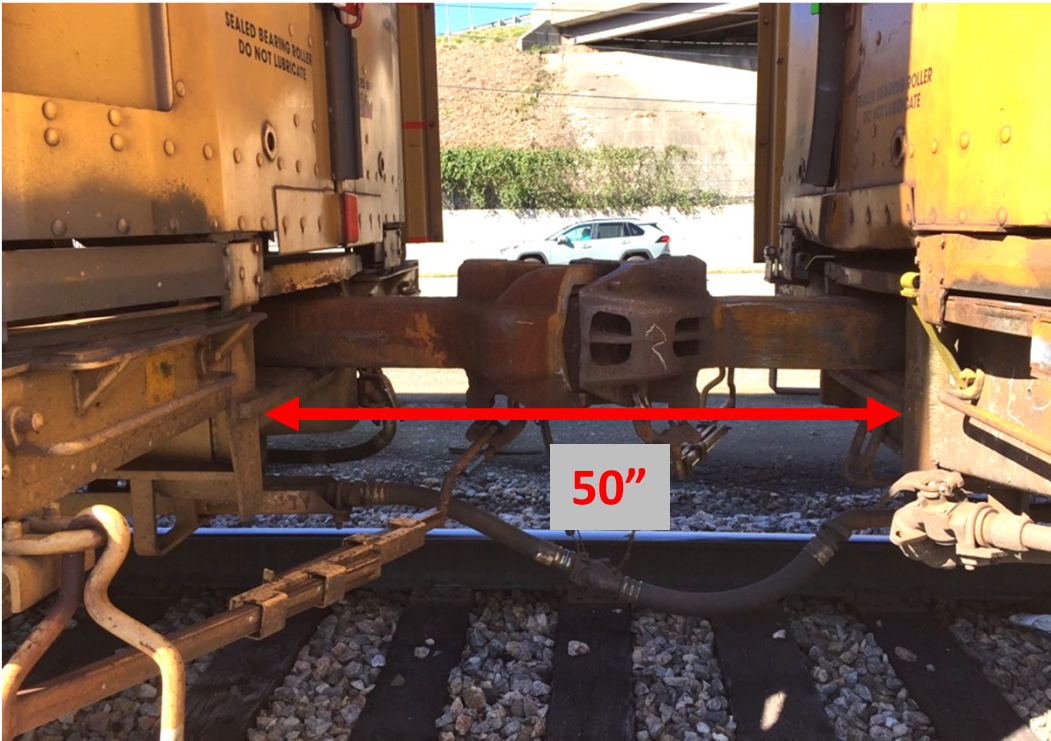
EOCC units on multi-levels, unloaded & compressed

Unloaded EOCCs
50'' car separation

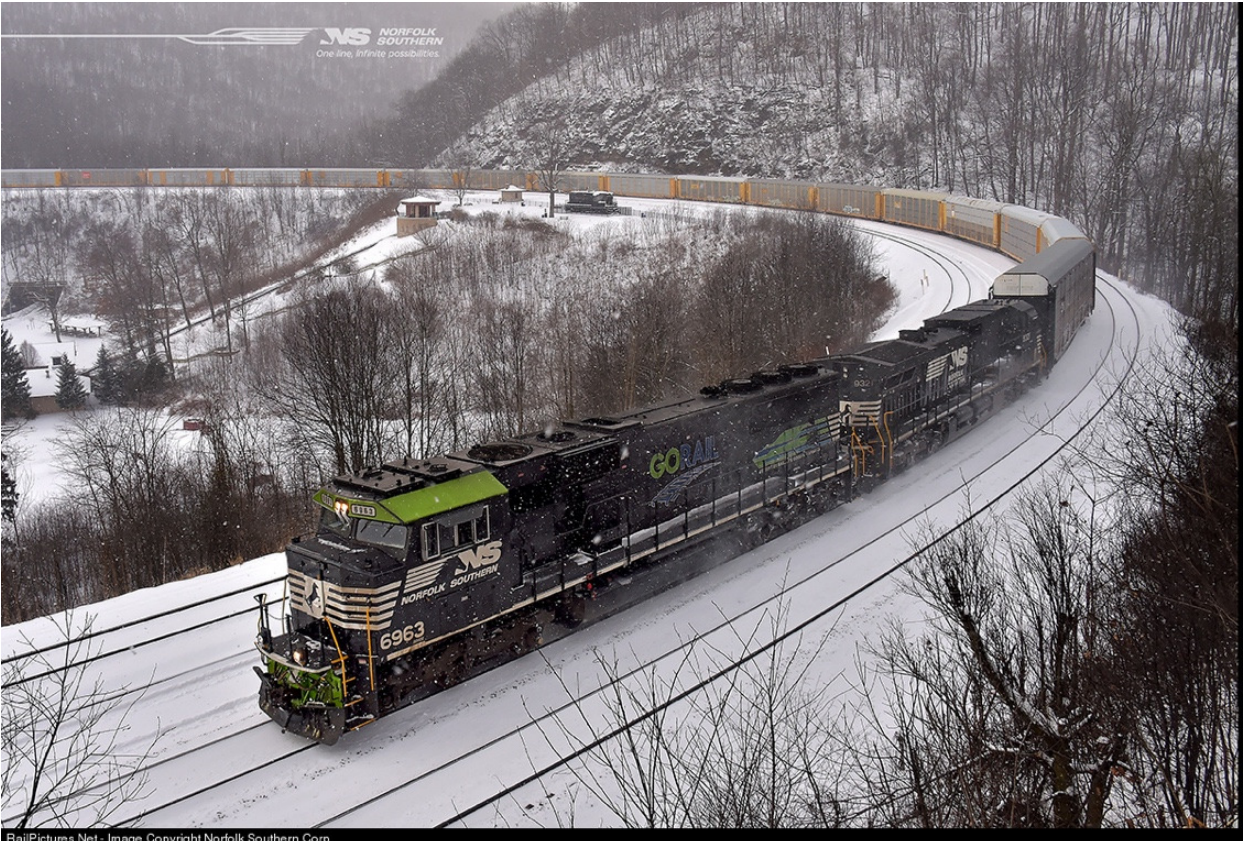
1) Train 18N descending the East Slope into Altoona, PA

Train 18N – 107 multi-levels
(similar to train in photo)
Descending grade 1.5% - 2%

Cause: Improper release of the air brakes on a descending grade allowing the stretched train to run in.

The solution – delay the air brake release

Delay release of air brakes until half the train is off the descending grade

For a two-mile long train, release brakes when the head end reaches MP 236

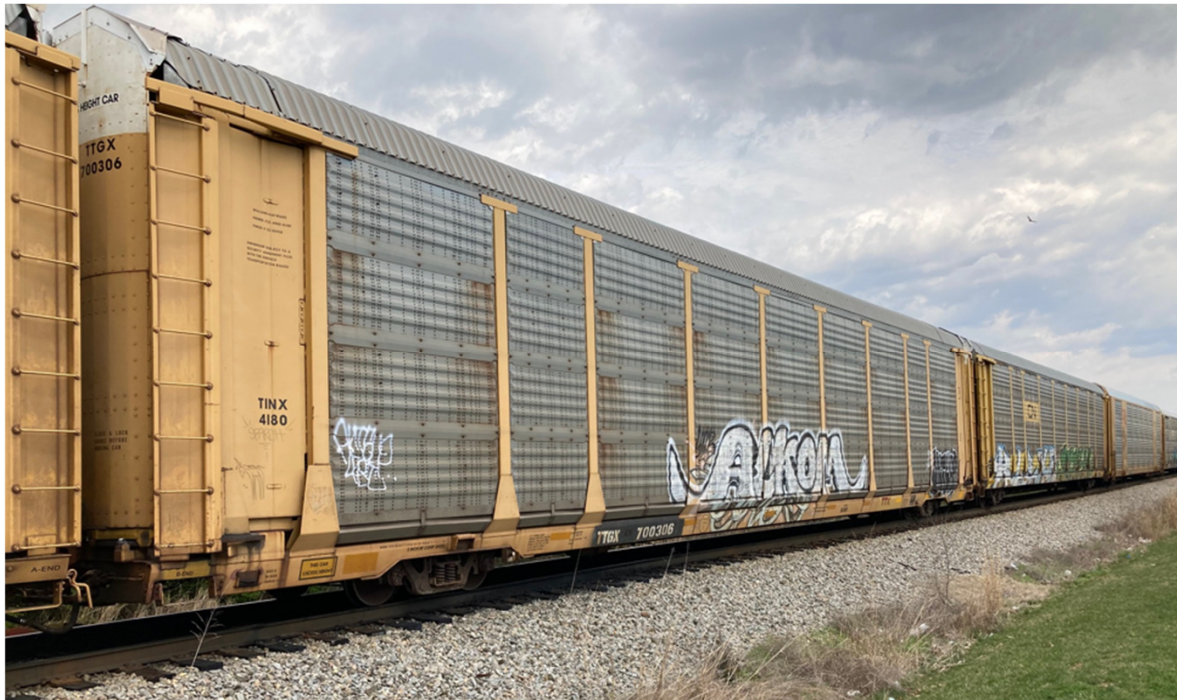
Train 18N consist details

107 multi-levels equipped with EOCCs

Length - 10,331 feet

Weight - 7866 tons

Slack - 10" per EOCC unit

Total EOCC slack - $107 \times 20'' = 178$ feet

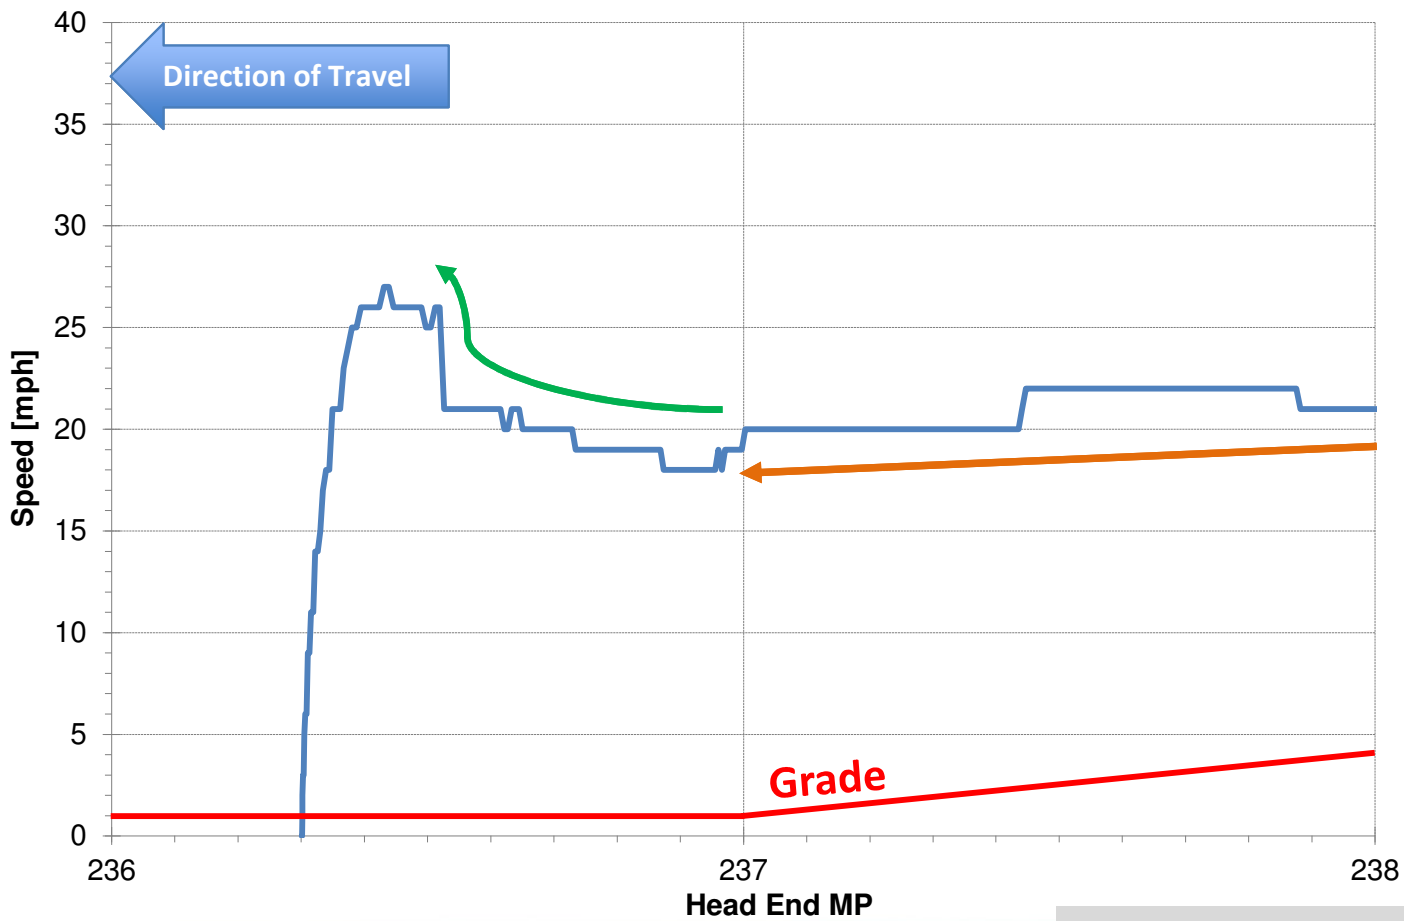
Speed, lead locomotive, at bottom of grade

— NS 9912 Speed

Speed is displayed in full mph increments

MP 237 - bottom of 1.8% grade

Between MP 238 & 237, speed changes from 21 to 22 to 20 mph

Beyond MP 237, speed drops to 18 mph, increases gradually to 21 mph, then spikes suddenly to 26 mph

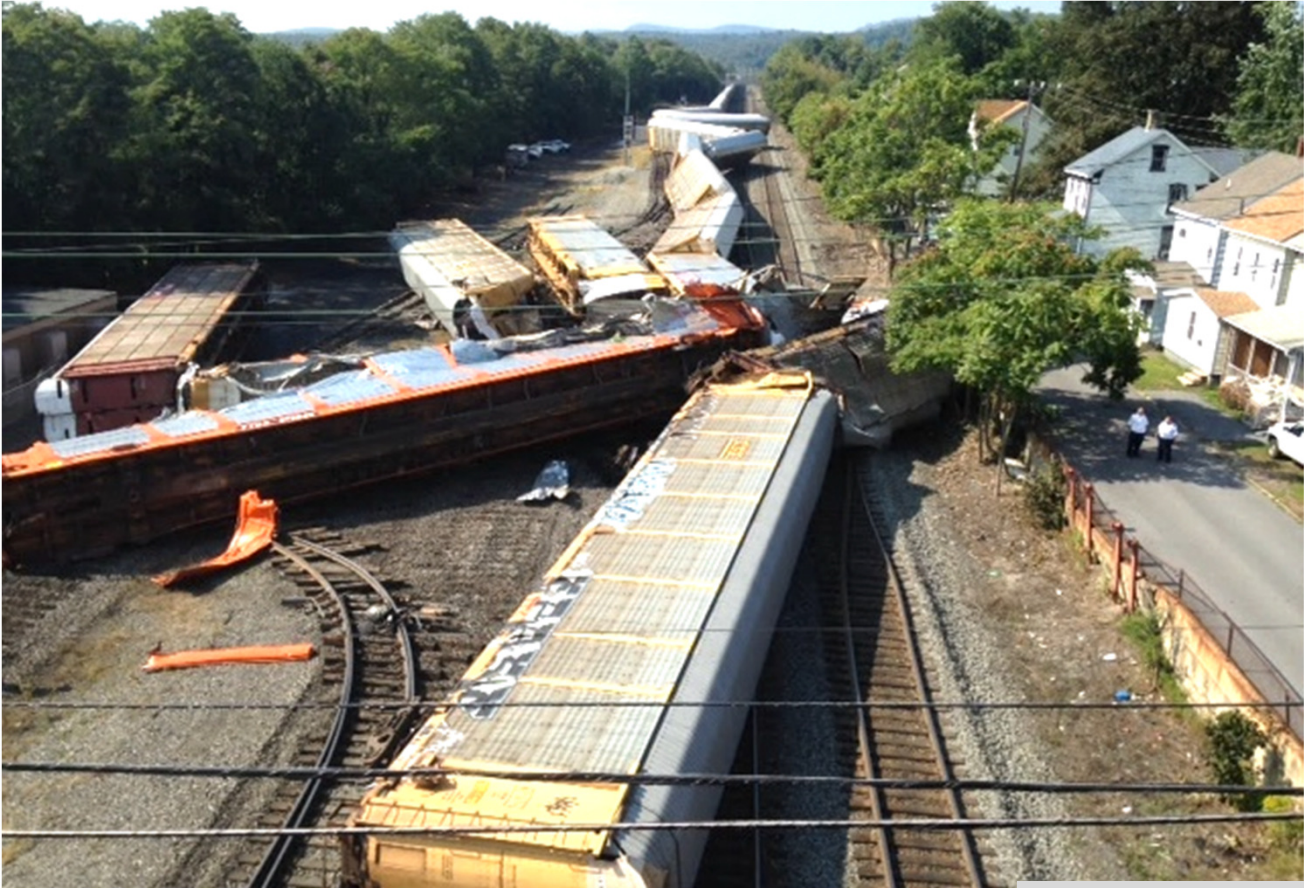
And quite the run-in it was!

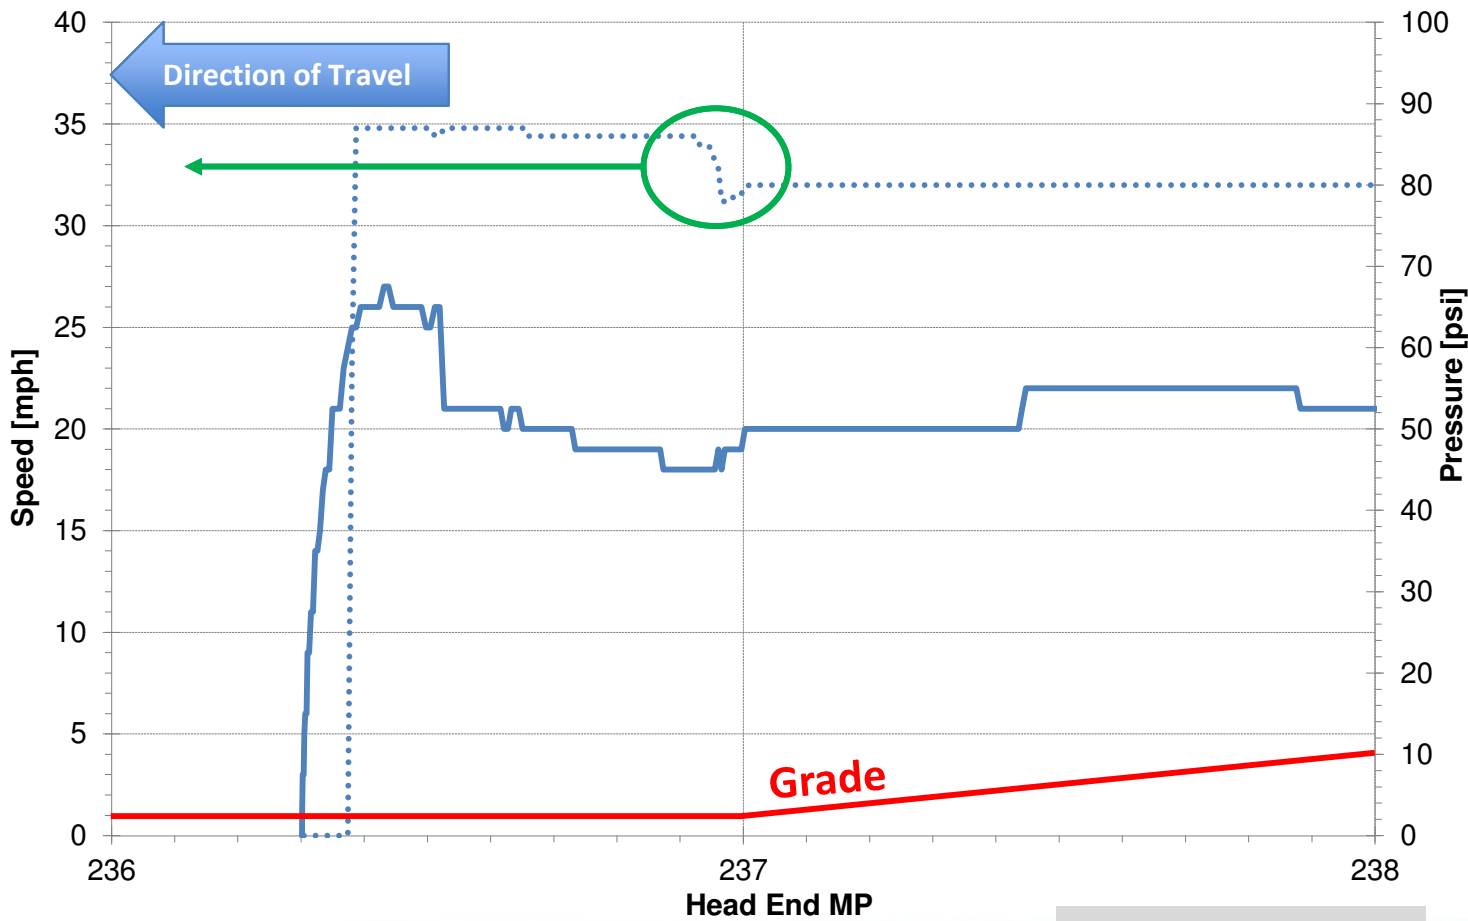
— NS 9912 Speed
 NS 9912 ABRK

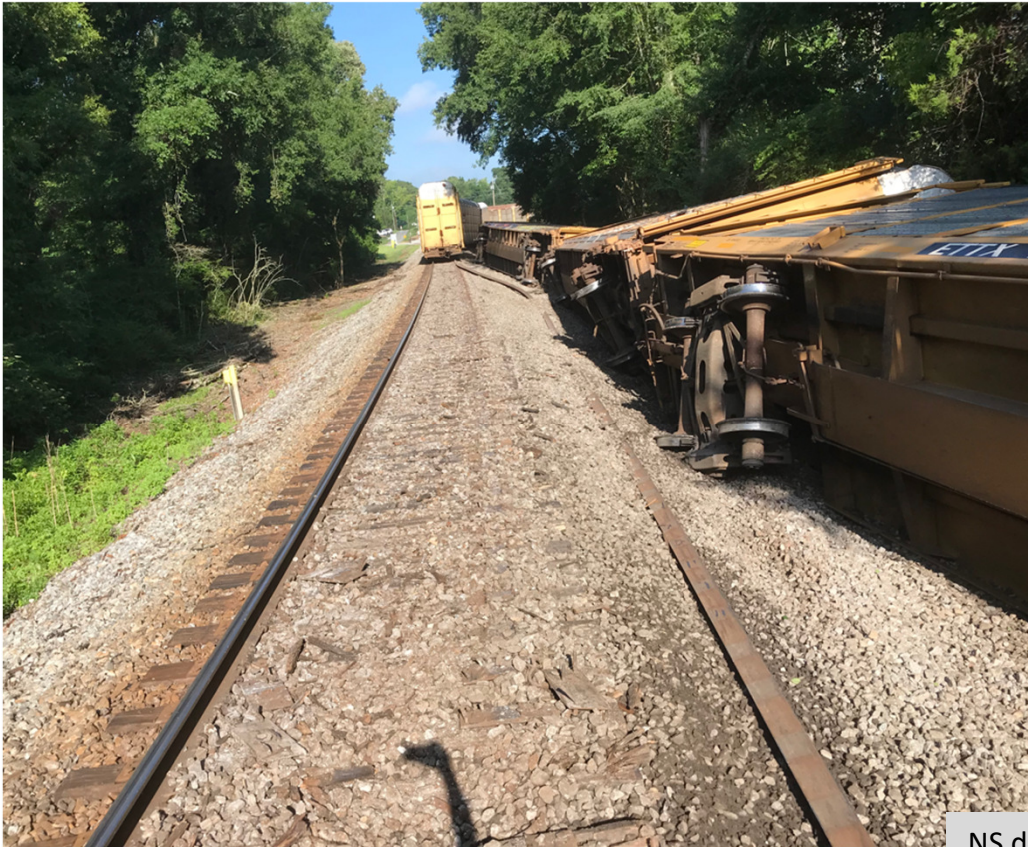
2) Train 22Q, Pell City, AL on an undulating grade

NS derailment file P-7728

Consist details

3 locos on head end

70 cars - a combination of loaded double-stacks and loaded & empty multi-levels

8631 tons, 10,194 feet

Description: When the rear doublestack block, weight 3347 tons, crested, it caused a run-in force of -315 kips compressing the slack in 41 EOCC-equipped multi-levels and rupturing gage under the 39th-43rd head cars.

Cause: Train makeup

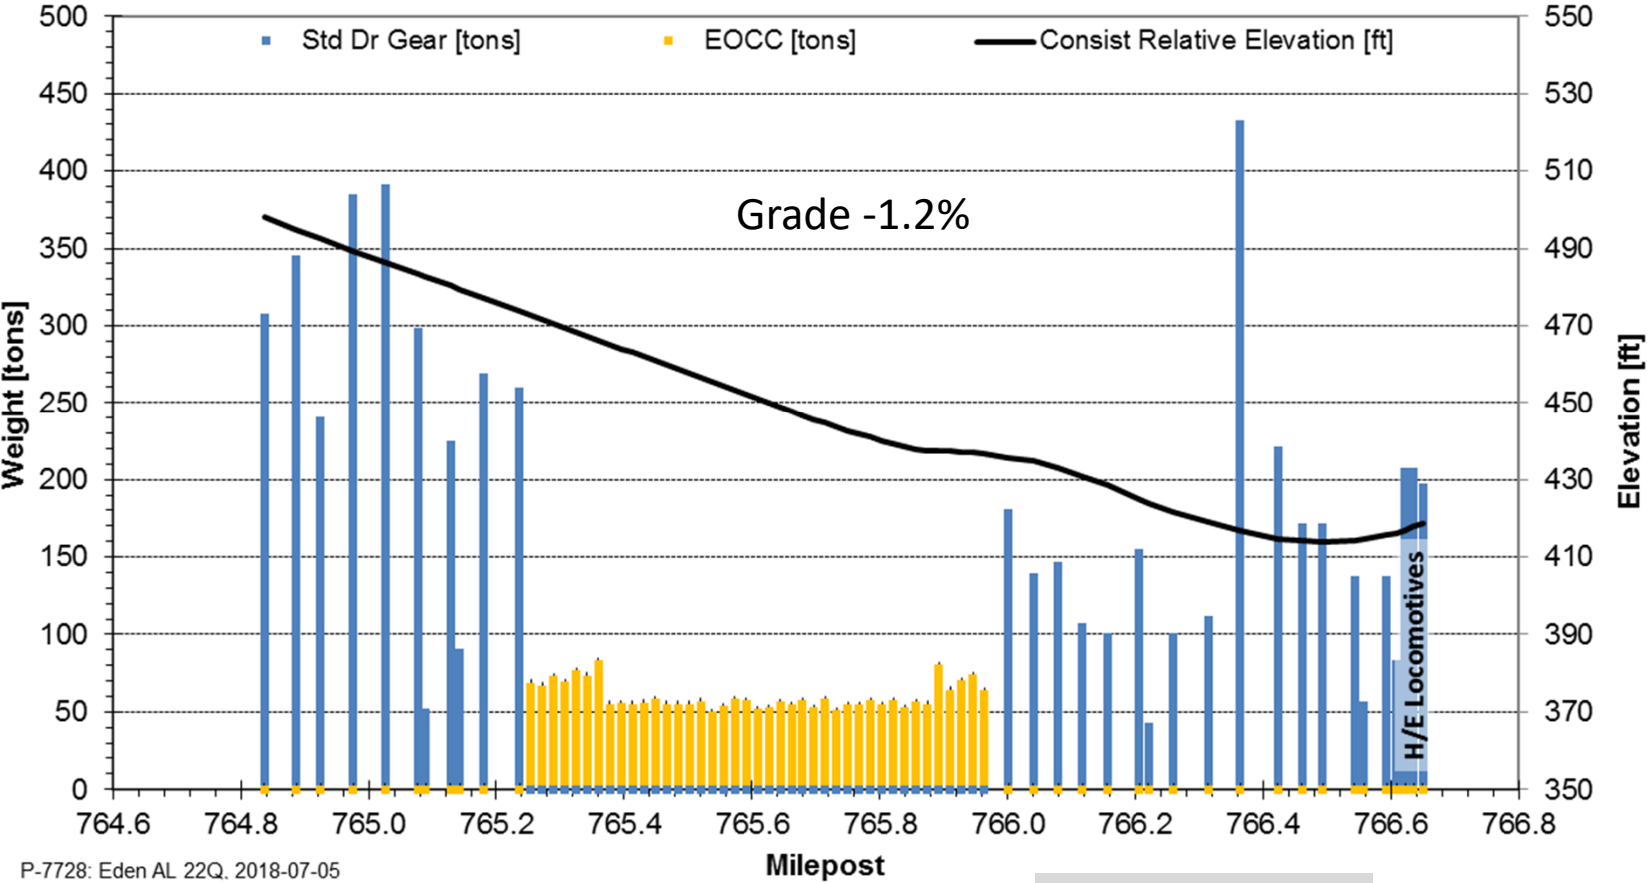
Tonnage & Grade Profile scaled by Length

17 doublestacks
(55 platforms)
2527 tons

41 multi-levels
2357 tons
68 ft EOCC slack

12 doublestacks
(46 platforms)
3347 tons

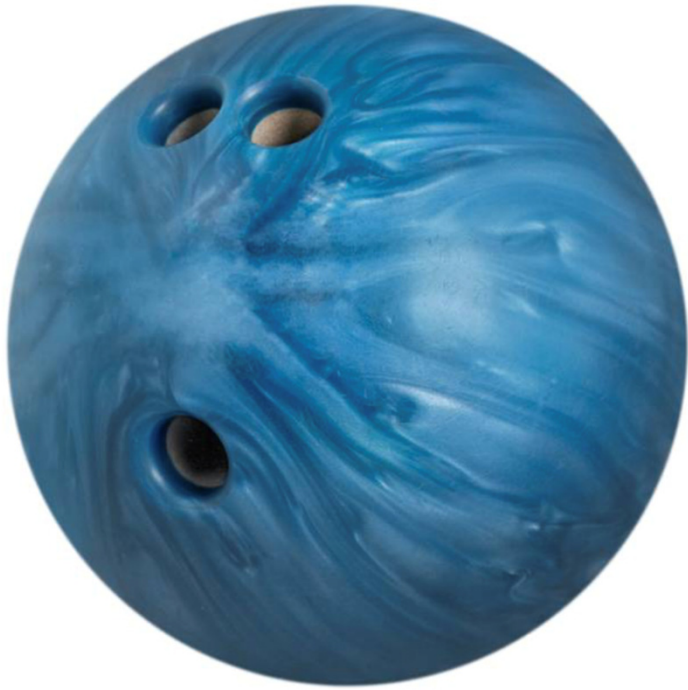
This analogy has been used for multi-levels & doublestacks

Q: Which is the more controllable arrangement:
a slinky pulling the bowling ball, or the bowling
ball pulling the slinky?

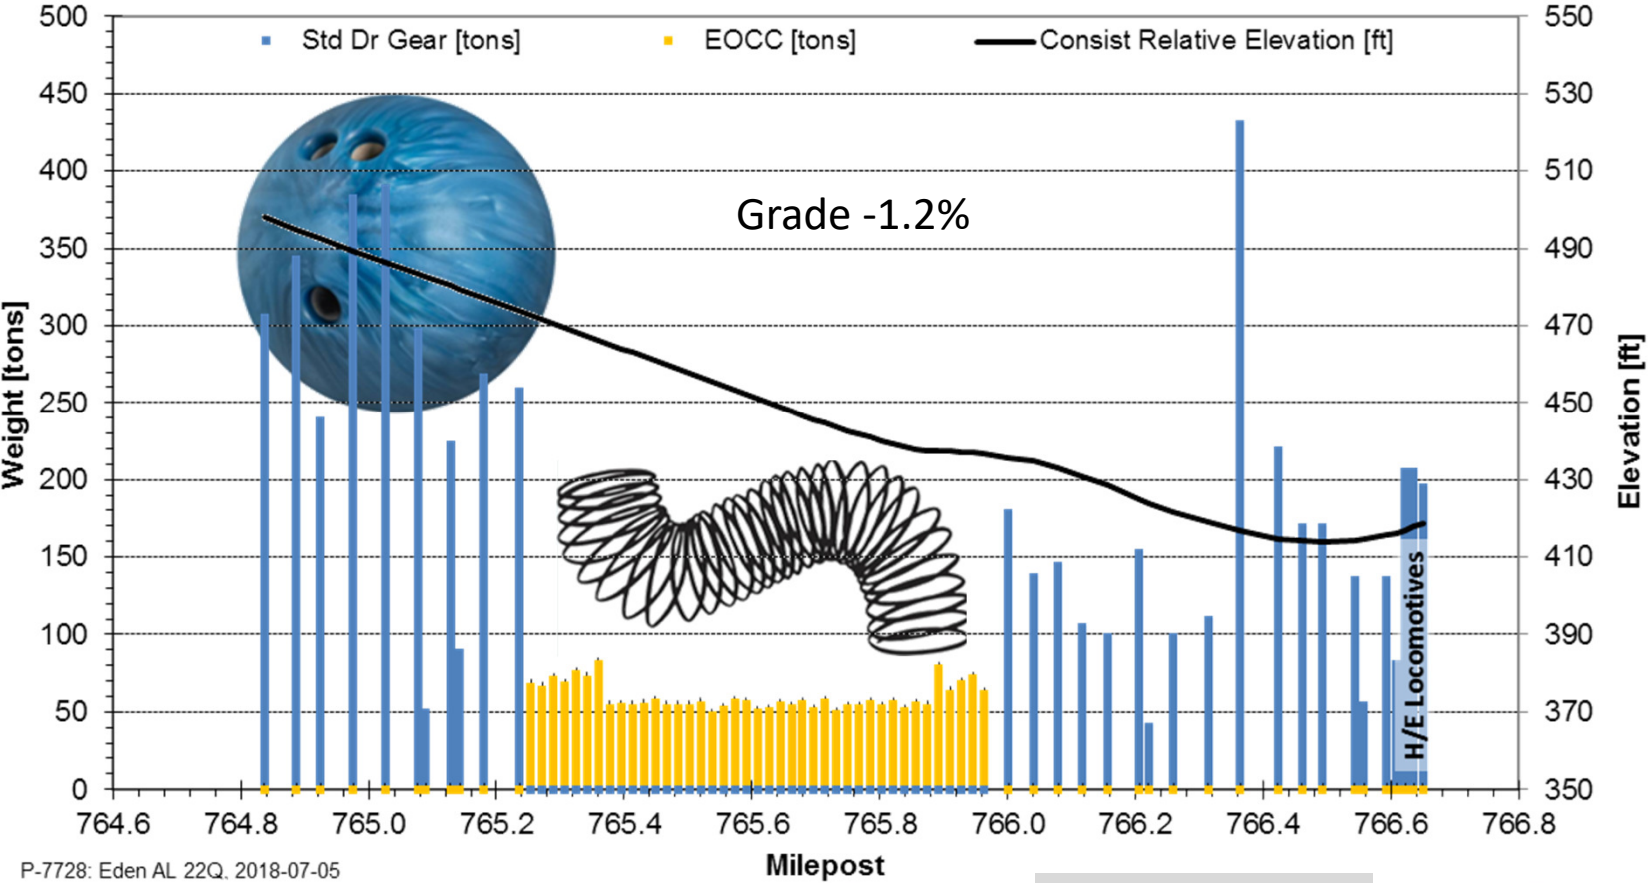
Tonnage & Grade Profile scaled by Length

17 doublestacks
(55 platforms)
2527 tons

41 multi-levels
2357 tons
68 ft EOCC slack

12 doublestacks
(46 platforms)
3347 tons

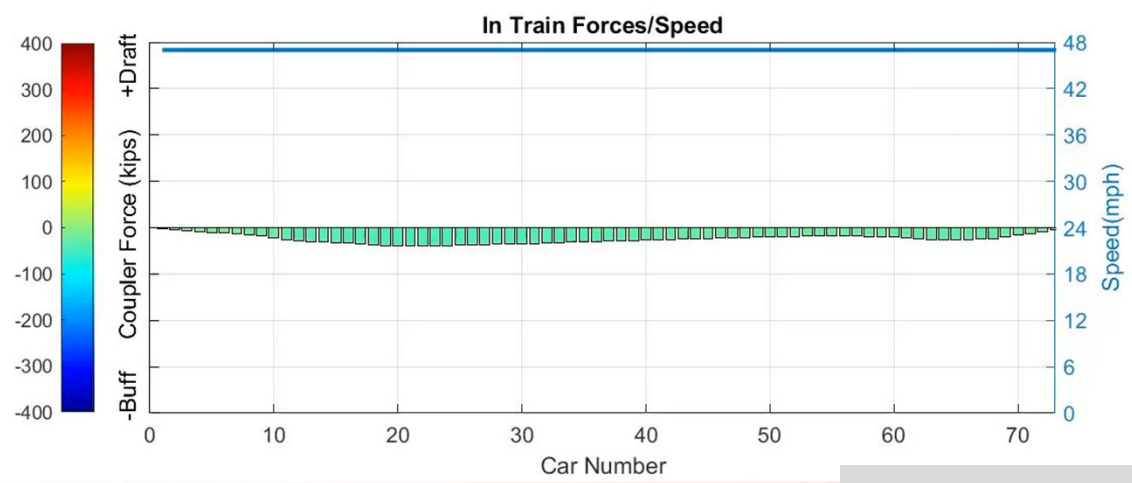
TOES simulation displayed in video format

Bar graph – coupler force, left margin (+ draft, - compression)

Blue line – vehicle speed, right margin

Engineer was in DB-4 at bottom of grade

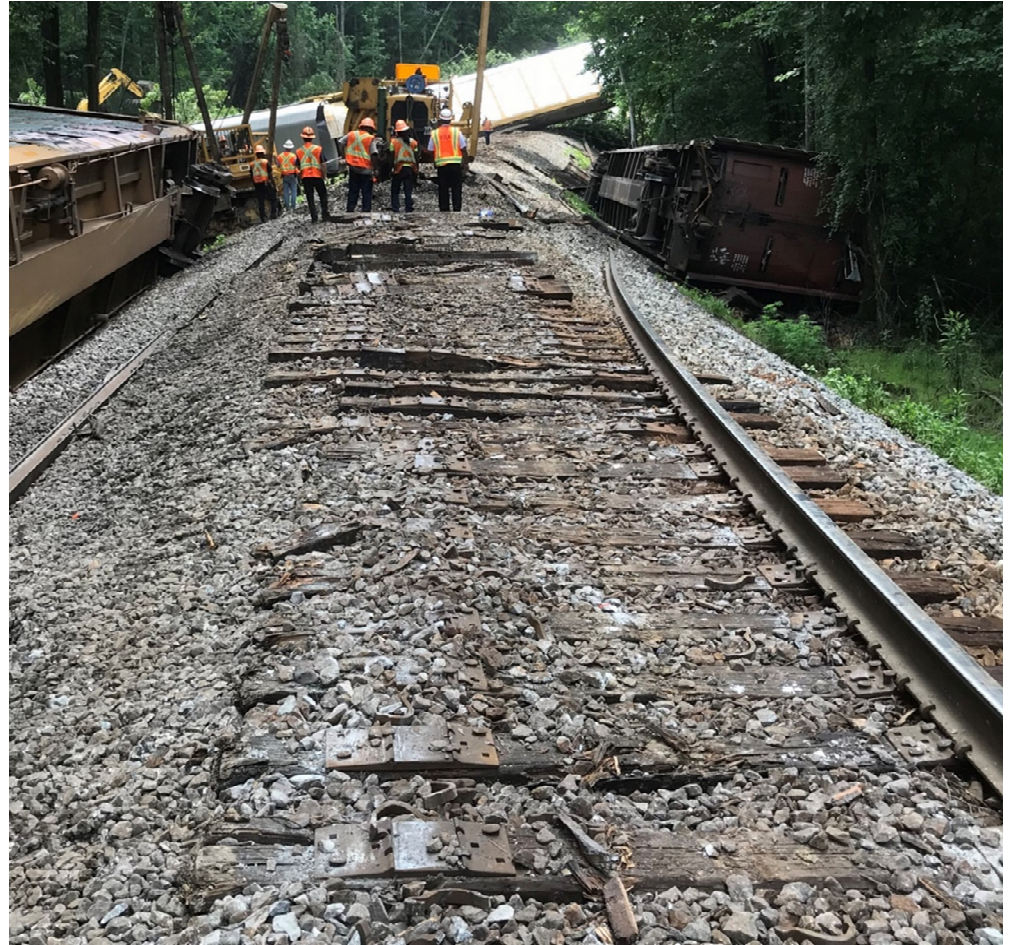
Destined to derail

TOES modeling showed that no train handling that complied with the rules and generally acceptable train handling practices could have prevented a causative level run-in.

Train make-up: things to consider

1. EOCC-equipped cars – number and placement
2. Tonnage trailing a block of EOCC-equipped cars
3. Grade
4. Use of air & dynamic brakes
5. Tonnage trailing empty cars
6. Distributed power placement & operation
