Challenges Handling Multilevels and Other Long/Cushion Equipped Cars

*Walter Rosenberger
Norfolk Southern
- Research & Tests*

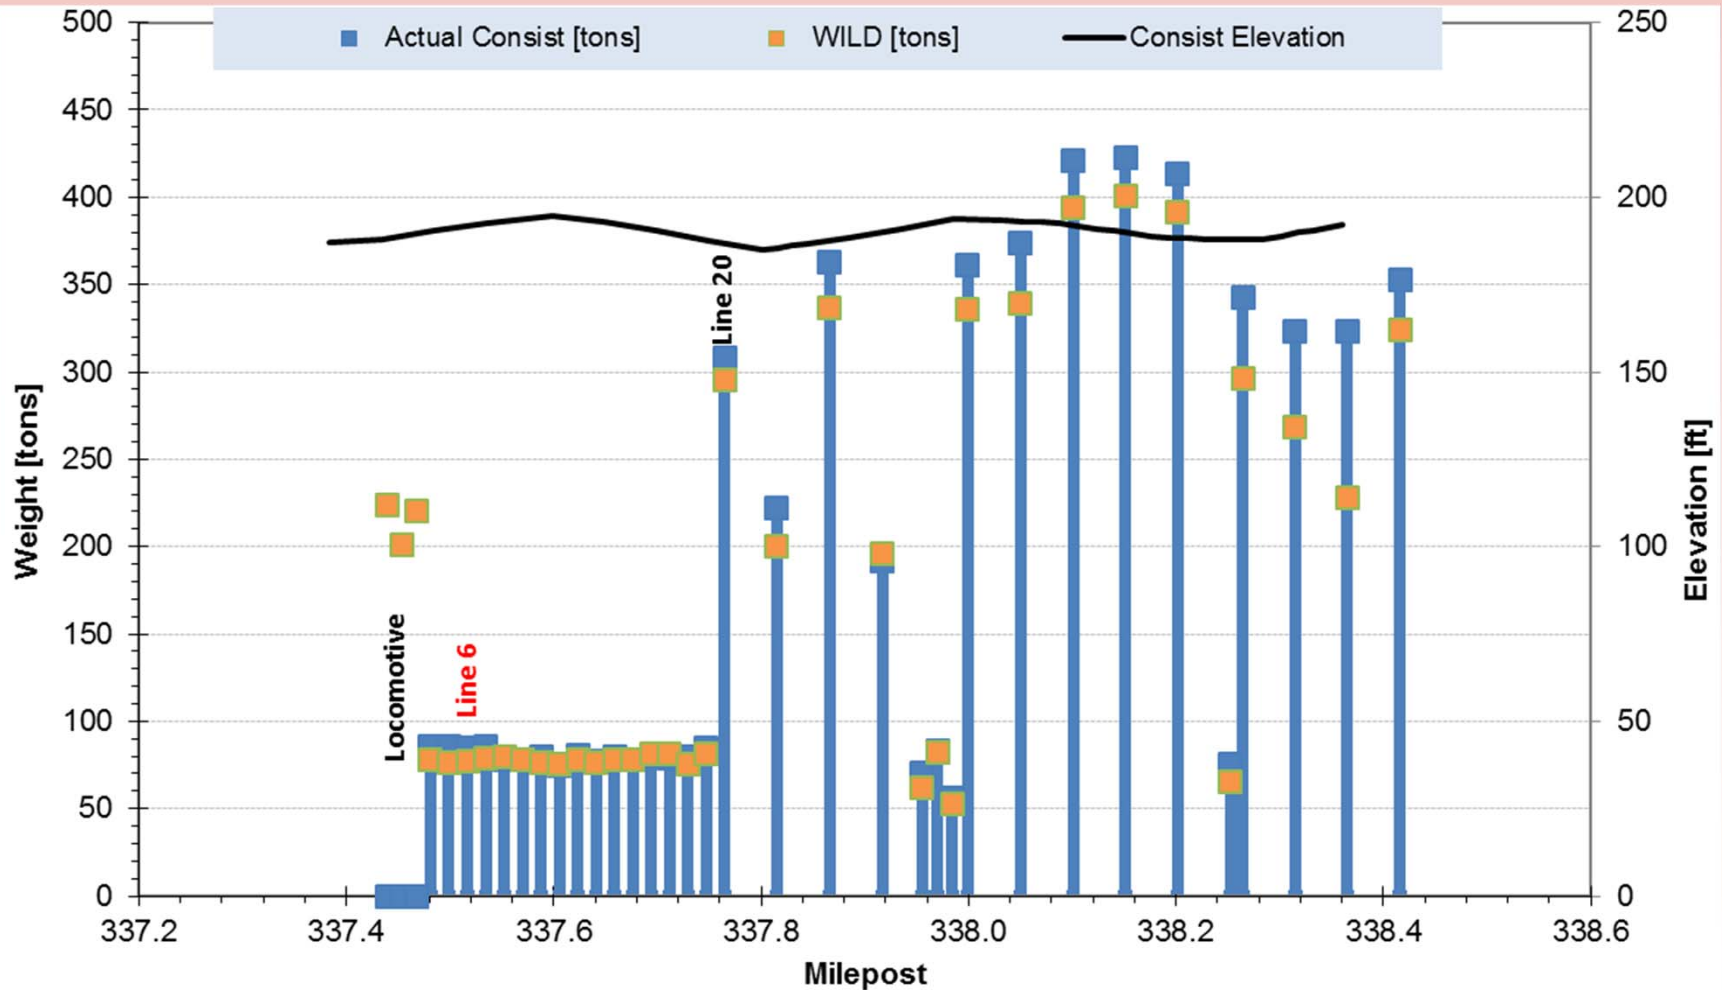
Wytheville 23G: tonnage profile

- 3x0, 16 loaded multilevels, 17 loaded doublestacks, 5996 tons and 5421 feet
- 36 mph with 12 Klbs in Dynamic 5
- Derailed 16 cars (lines 6-21)
- Normally operates 2x1 DP

- “Trail end 3rd head car/head end 4th head car (both 89 ft multilevels) jackknifed in entry spiral of 4.1° curve account aggressive dynamic braking of a train incorrectly built without DP to mitigate in-train forces of doublestacks trailing multilevels.”
- FRA Cause Code: **H519 Dynamic brake, too rapid adjustment**

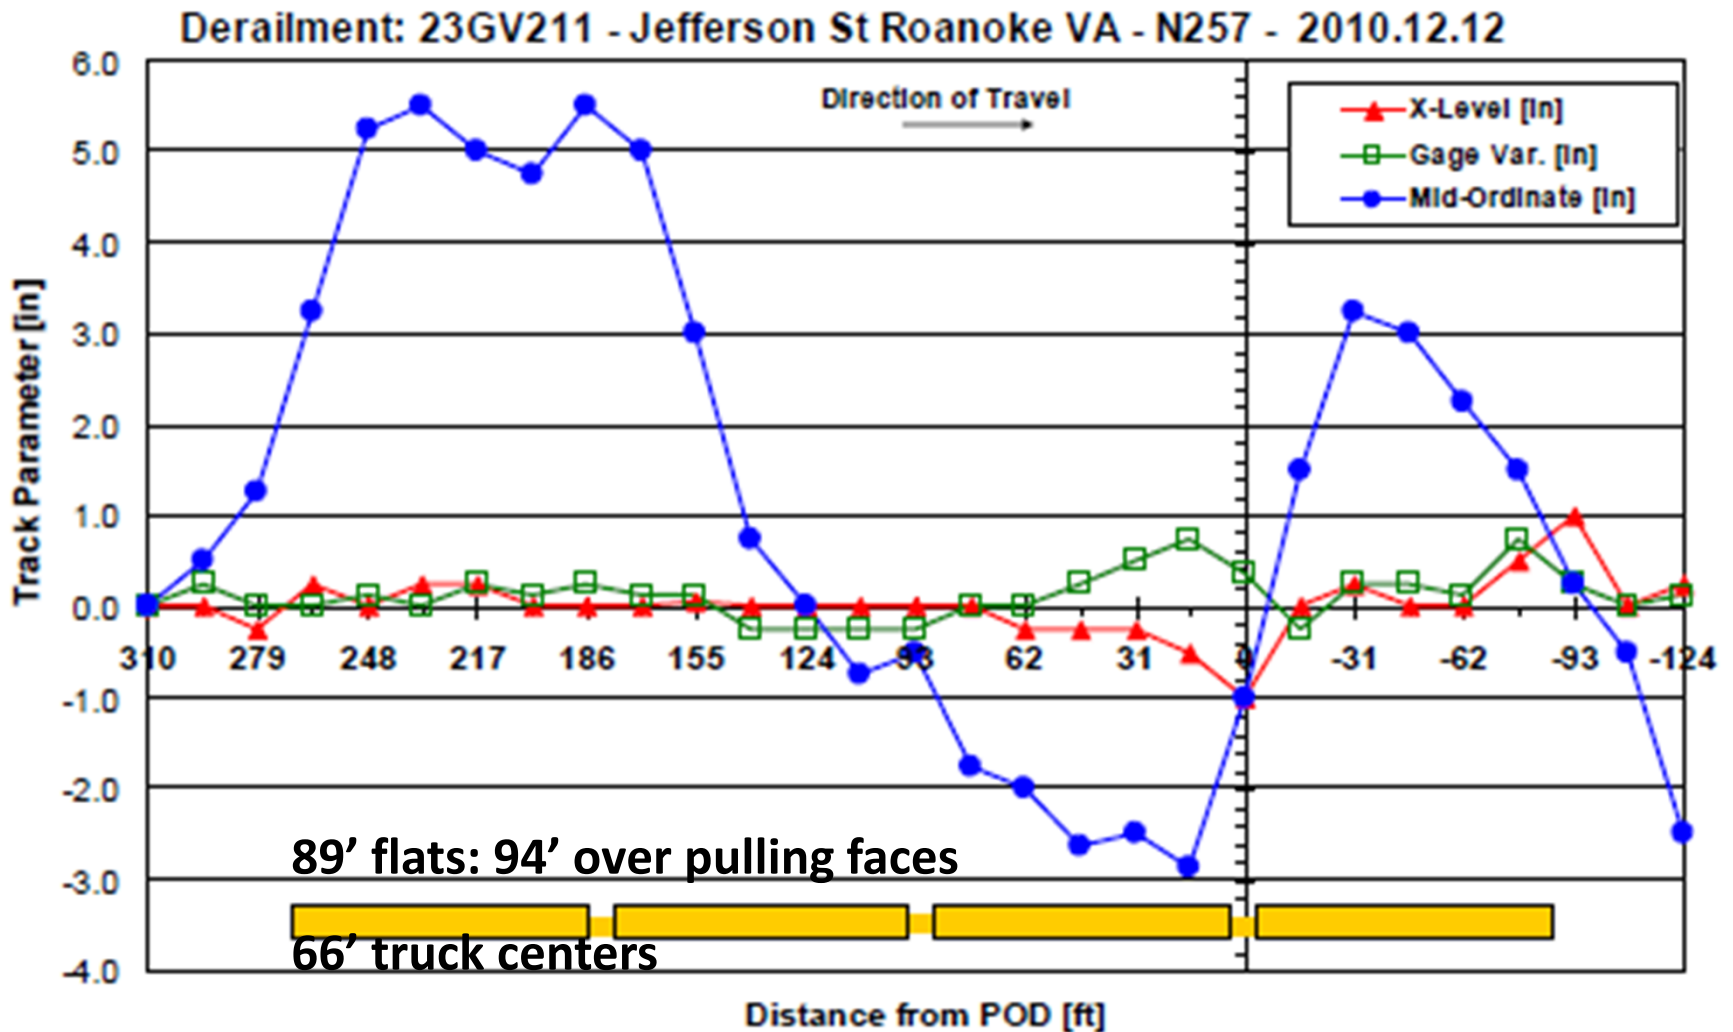
Roanoke 23G: cars on curves

- Long car
- Long coupler overhang
- Long shank couplers
- High degree of coupler angularity

- “Lead wheels, lead truck of 20th head car (loaded multilevel CN 710905) partially rolled north rail and passed behind switch point account resultant lateral forces associated with improper train makeup.”
- FRA Cause Code: **H501 Improper train make-up at initial terminal**

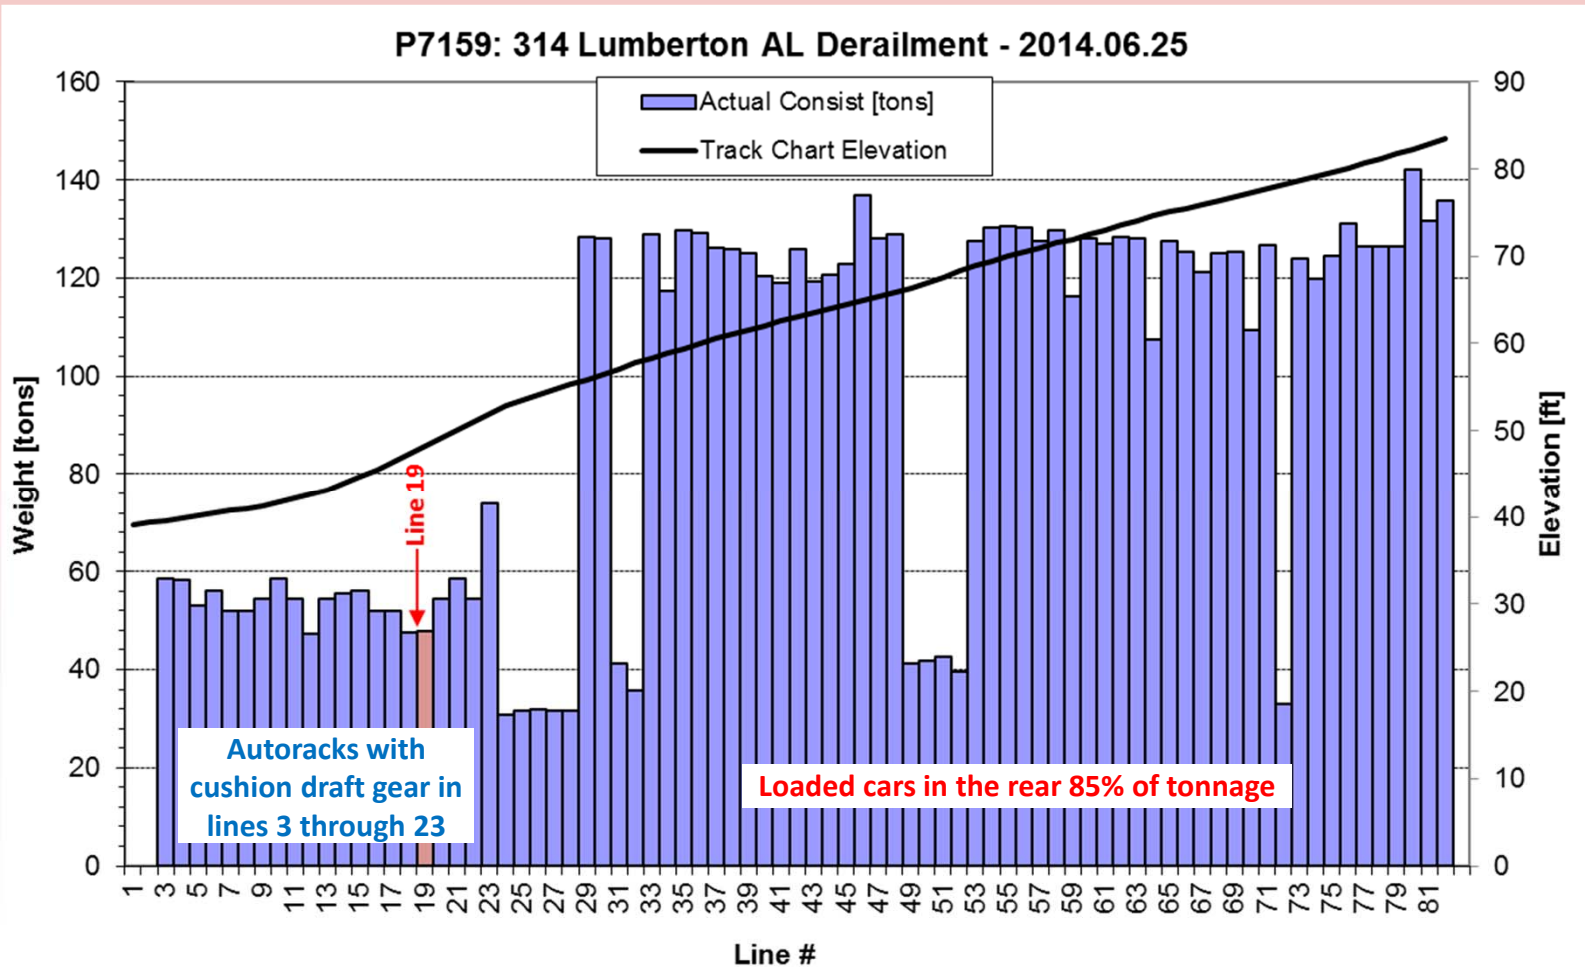
Lumberton 314: tonnage profile

- 2x0, 48 loads, 32 empties, 7513 tons; 5533 ft
- 21 M/L's ahead of 6354 tons
- Derailed trail truck of 17th head car, empty 89' multilevel
- 15 mph in full dynamic brake
- POD: point of switch, #10 turnout
- Near bottom of a 2-mile 0.9-1.0% descending grade

- “Trail truck of 17th head car, in a block of 21 autoracks trailed by 6323 tons, picked the switch point at 15 mph in full dynamic braking, account lateral force due to long car coupler angle sufficient to deflect stock rail.”
- FRA Cause Code: **H506 Lateral drawbar force on curve excessive, train make-up**

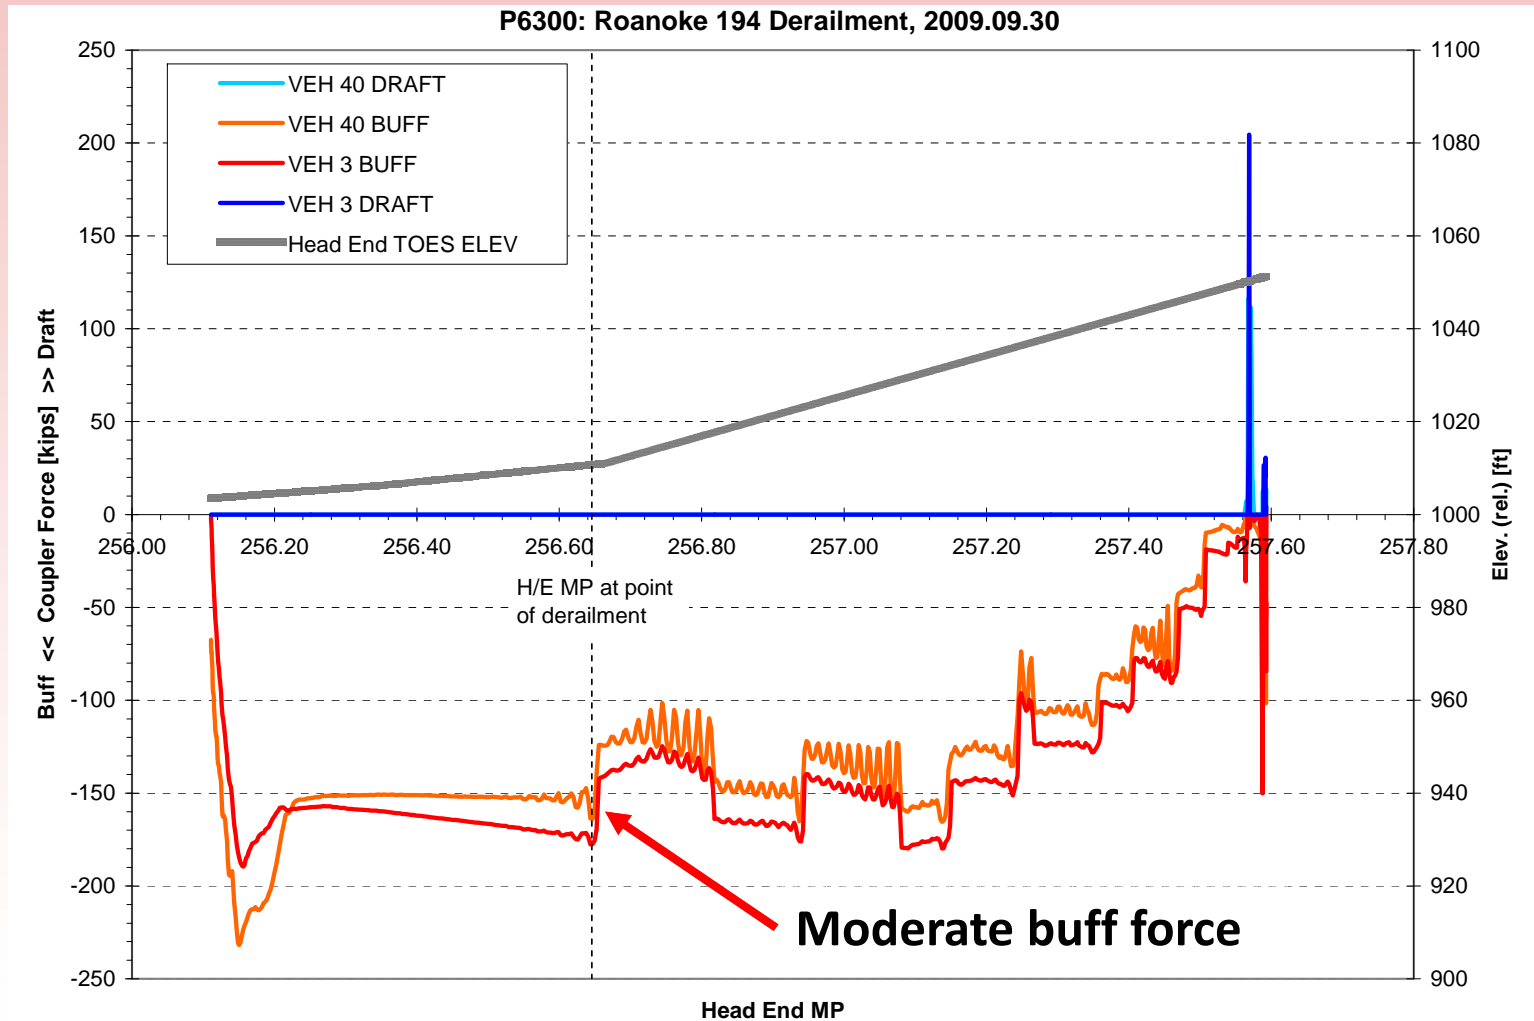
Roanoke 192: TOES buff forces

- 3x0 (1 isolated), 12,653 tons, 9120 ft
- 9 mph in DB-8, 670 Amps
- Derailed trail truck of 39th H/C, empty 89' flat
- Car ahead was an empty 73' bulkhead flat, car behind was another empty 89' flat; ahead of 83% of train's tonnage
- Climbed guard rail of #10 frog in crossover
- Near bottom of a 2-mile 0.82% descending grade

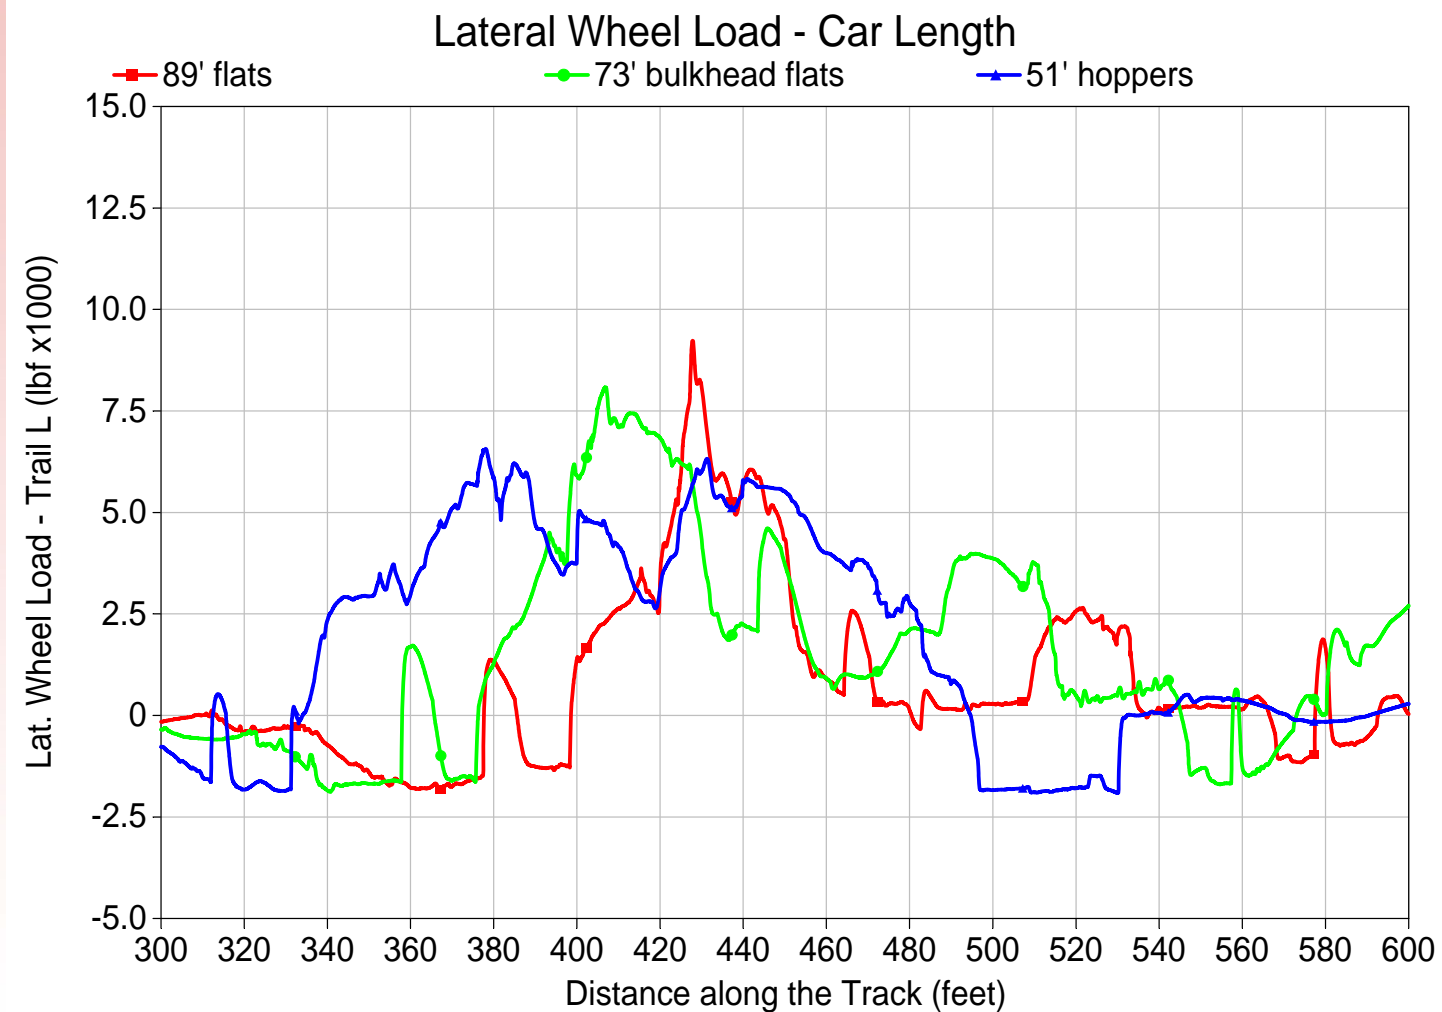
Lateral force in turnouts – car length

This situation can become critical where there is less than one car length of track in between the lead curves of the switches in a crossover. It becomes more severe for the sharper turnouts (#10 and less). The problem is caused by the long overhang on these long cars. Consideration should be given in yards for this train make-up by limiting the routes traversed to areas where the above mentioned problem is minimized.
