Using Wheel Rail Interface Analysis to Evaluate Rail Transit Maintenance Priorities:

A Case Study on Los Angeles Metro BLUE Line

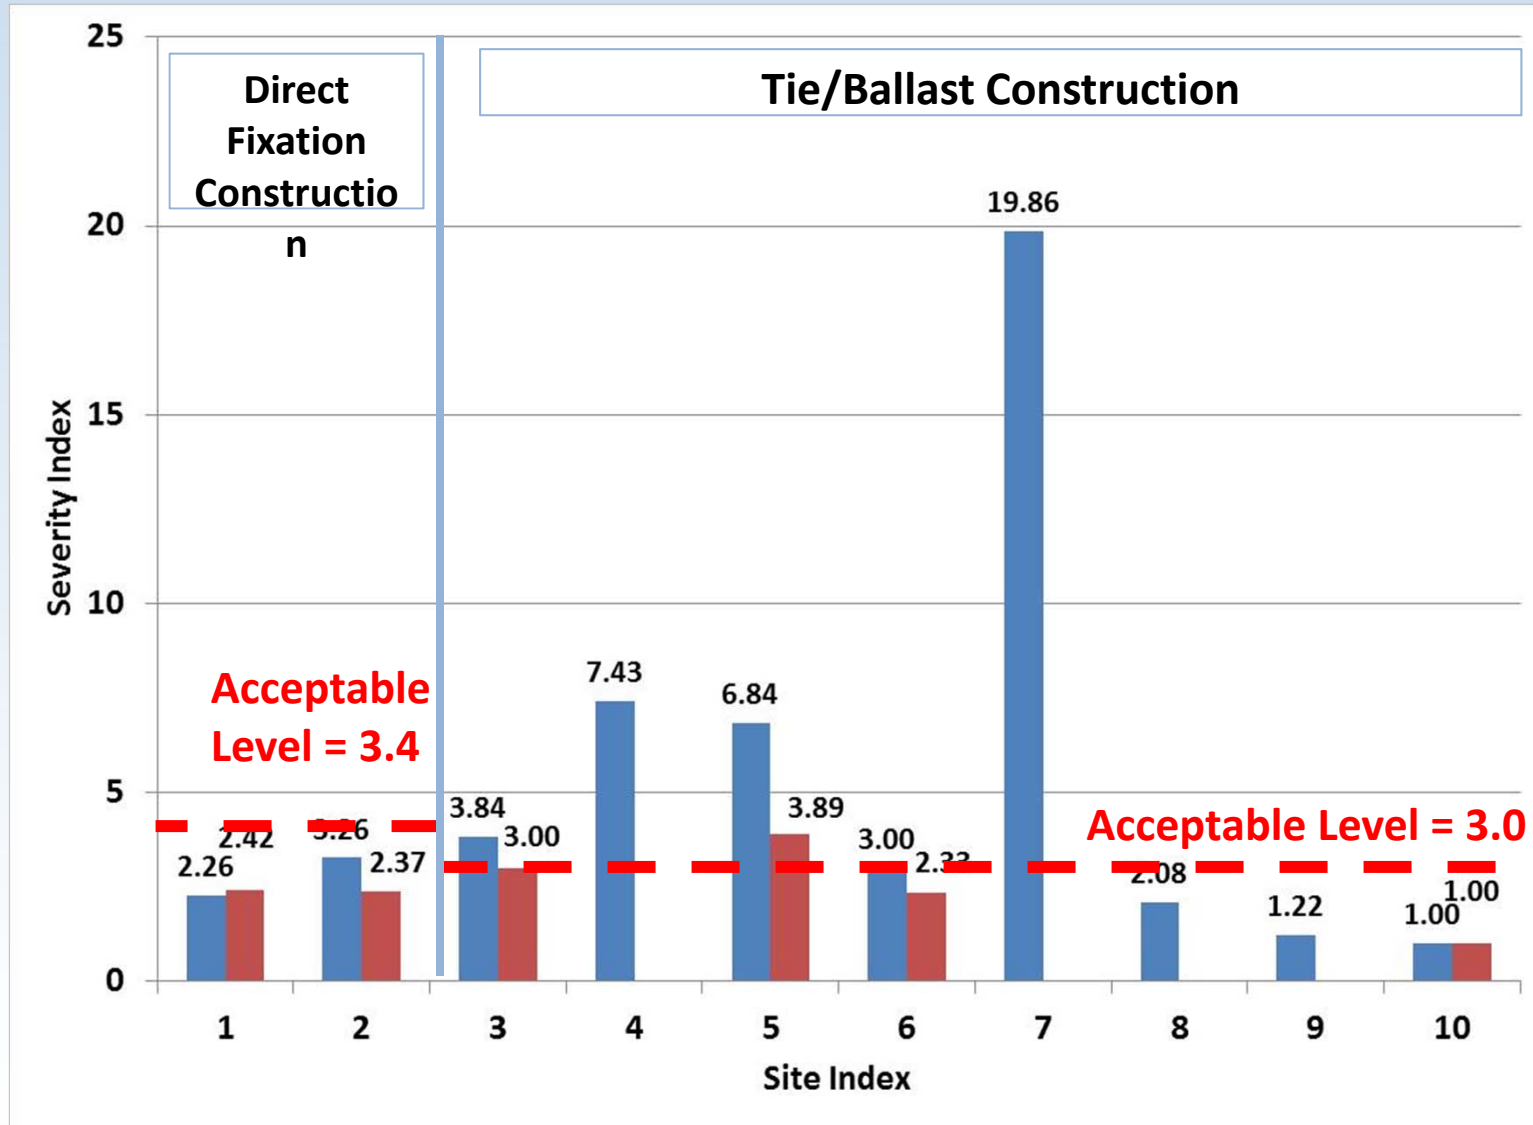
Metro Site 7

- The #10 Crossovers & Turnout North-Bound into Division 11 Yard from Trk #1 to Trk #2 and into the Yard from LA River Bridge into the Yard on our end of test runs from Willow Pocket
- Severity Index of **18.96** (P-865)
- This area was noted by LA Metro as having rotten ties and in the process of tie replacement
