When Wheels and Rails don't Interact in a Good Way

Transportation
Safety Board
of Canada

**MAIN-TRACK DERAILMENT
CANADIAN NATIONAL
FREIGHT TRAIN G84042-09
MILE 73.6, FORT FRANCES SUBDIVISION
NICKEL LAKE, ONTARIO
10 NOVEMBER 2013**

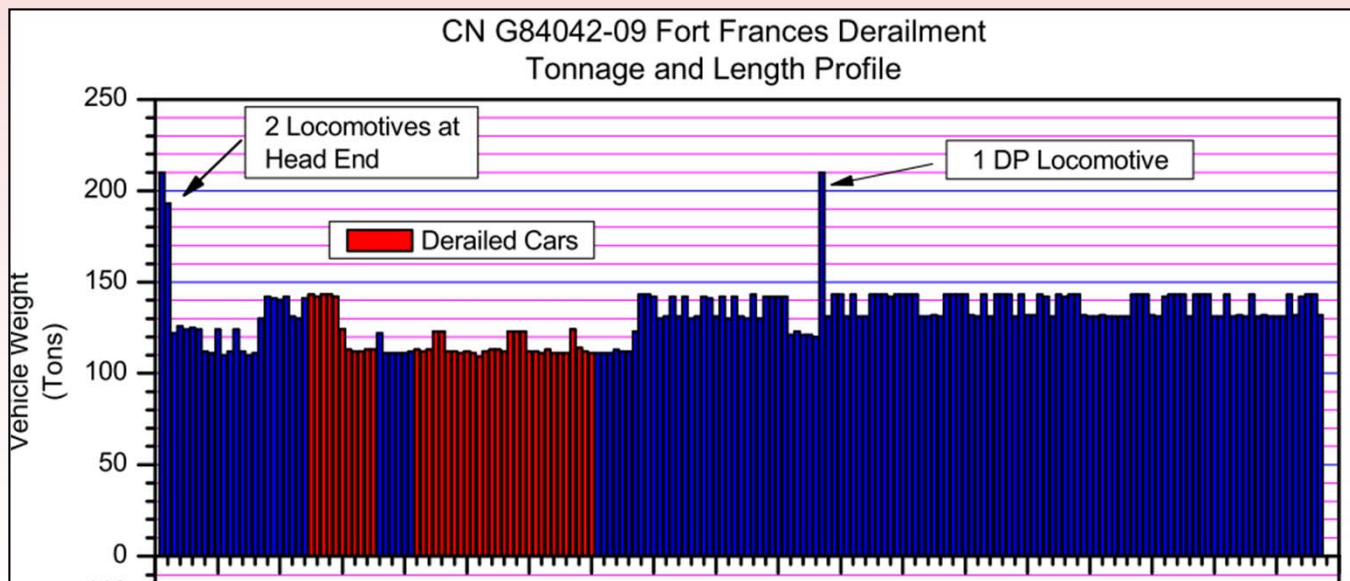
Train Tonnage & Length Profile

- DP train pulled by 2 head-end locomotives and 1 remote locomotive positioned between the 104th and the 105th car
- 184 loaded covered hopper cars, 24,432 tons and 11,058 feet long

- Train marshalled with 12 828 tons ahead of and 10 990 tons behind the remote locomotive
- train had been configured with 4108 tons more behind the remote locomotive than the guideline stipulated

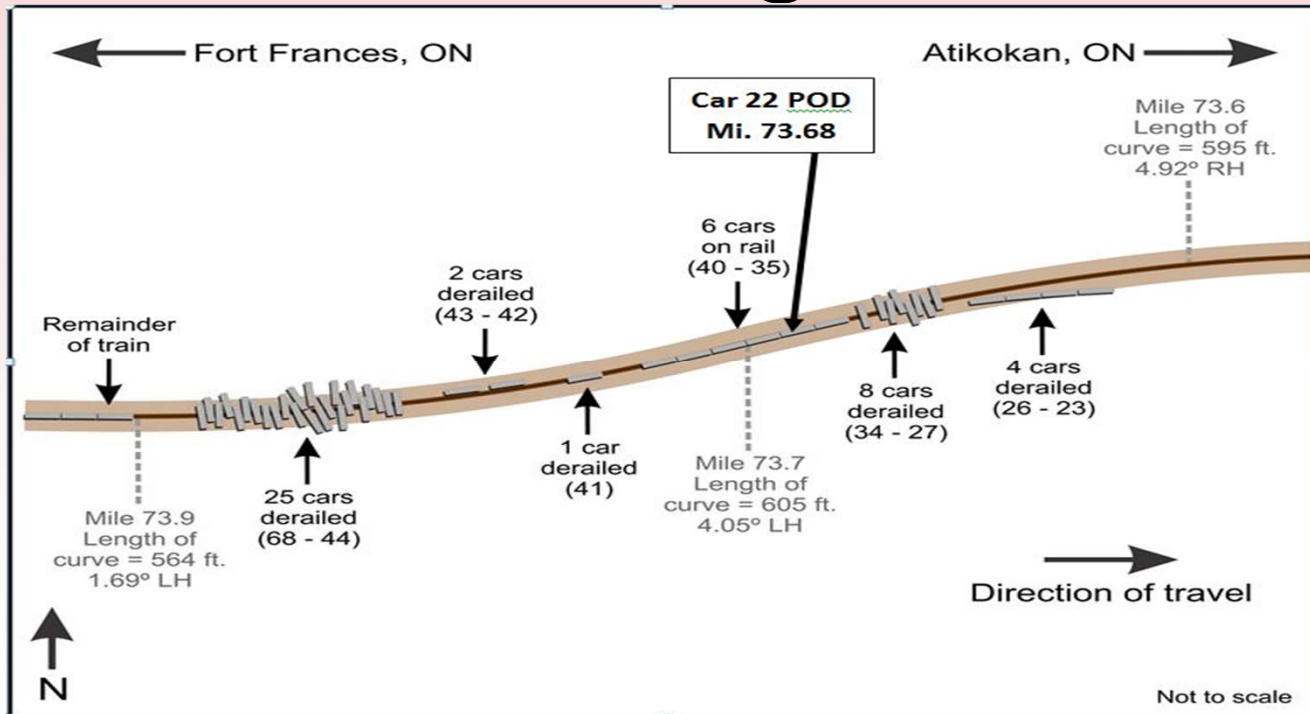
Site Diagram

- Mile 73.68, between reversing 4.05° LH and a 4.92° RH curves 182' apart
- Cars 22 and 23 separated
- 40 cars derailed in two main groups

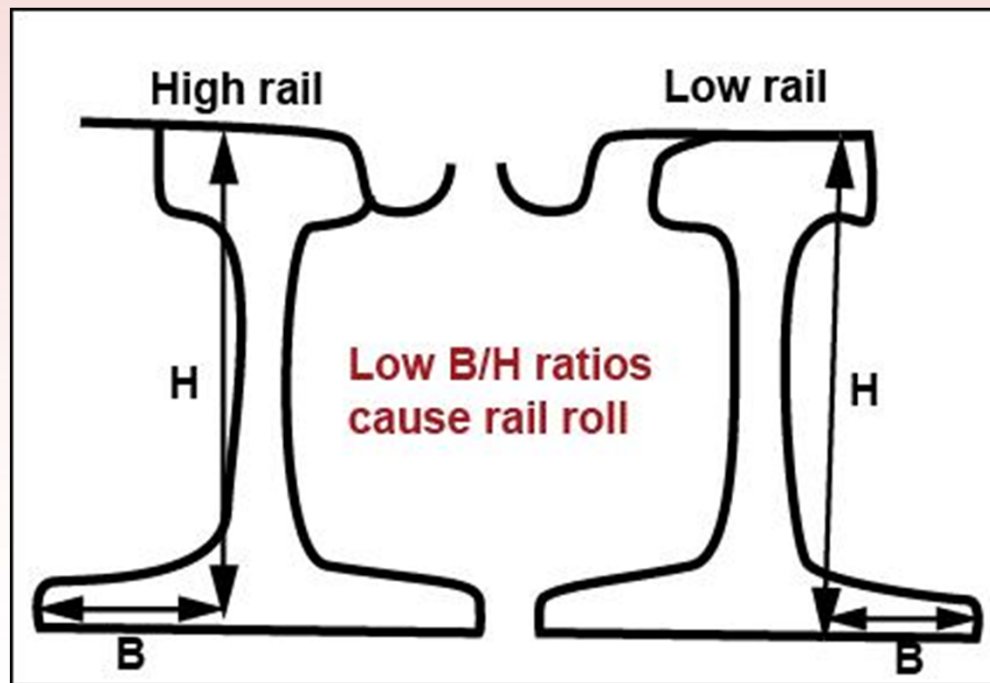
Rail base/rail height ratio

- With the high rail close to its wear limits, wheel/rail contact was closer to the field side of the high rail, resulting in a lower lateral-to-vertical derailment threshold
- High rail likely rolled or canted out sufficiently to allow low rail wheels to drop in
