A Derailment Investigation and Broken Spikes

*Brad Kerchof
Research & Tests*

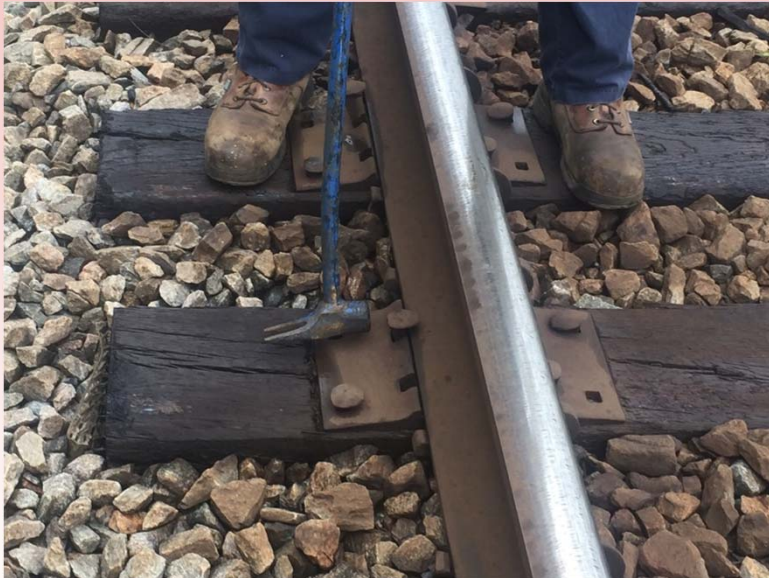
Step 1: Hit the heel of the spike to see if it is loose or makes an unusual sound.

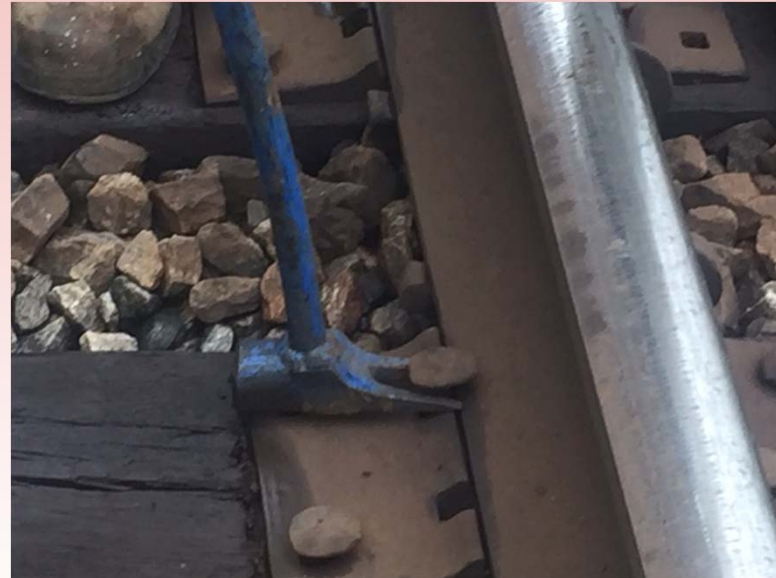
Step 2: Attempt to pry the spike up. If it is broken, the top half will pull out.
