# Hunting at Vale EFC

**Case study of bogie hunting at Vale EFC between 2009 to 2017, and the inter-relationship between track and rollingstock**

**Paul Bladon, Denis D'Aoust, Pedro Freire**

HEAVY HAUL SEMINAR \* JUNE 7-8, 2017

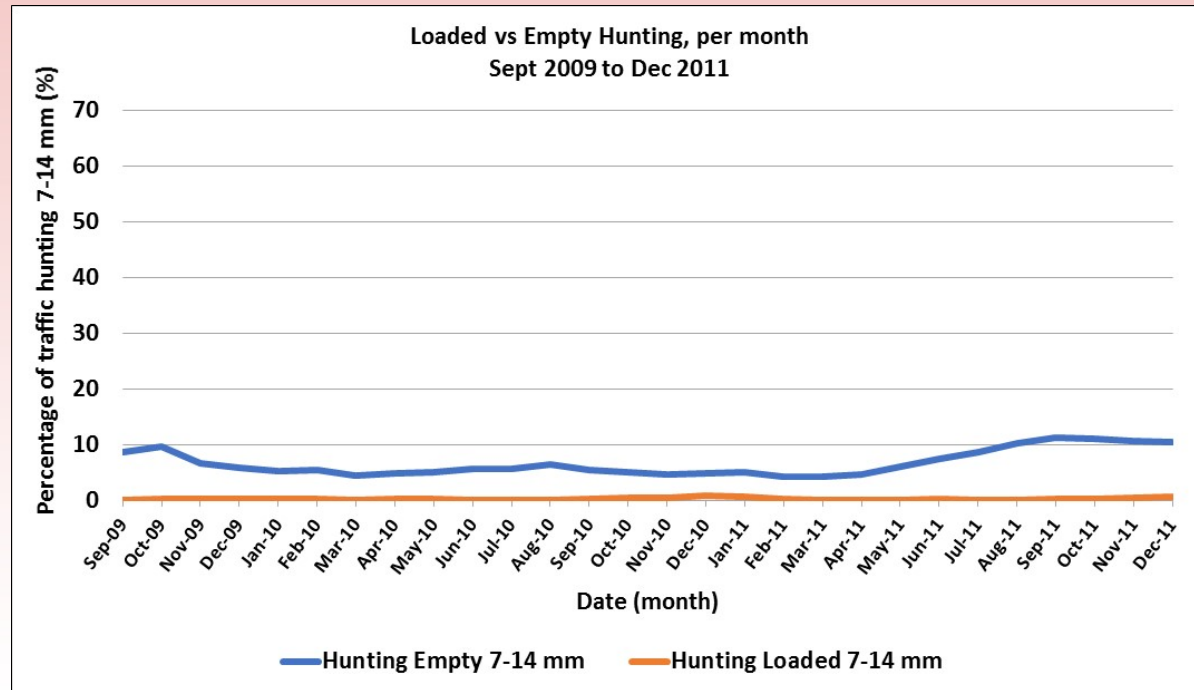
# 2009 - 2011

Pre-2010 rail replaced with rail that had shorter life and was prone to vibration

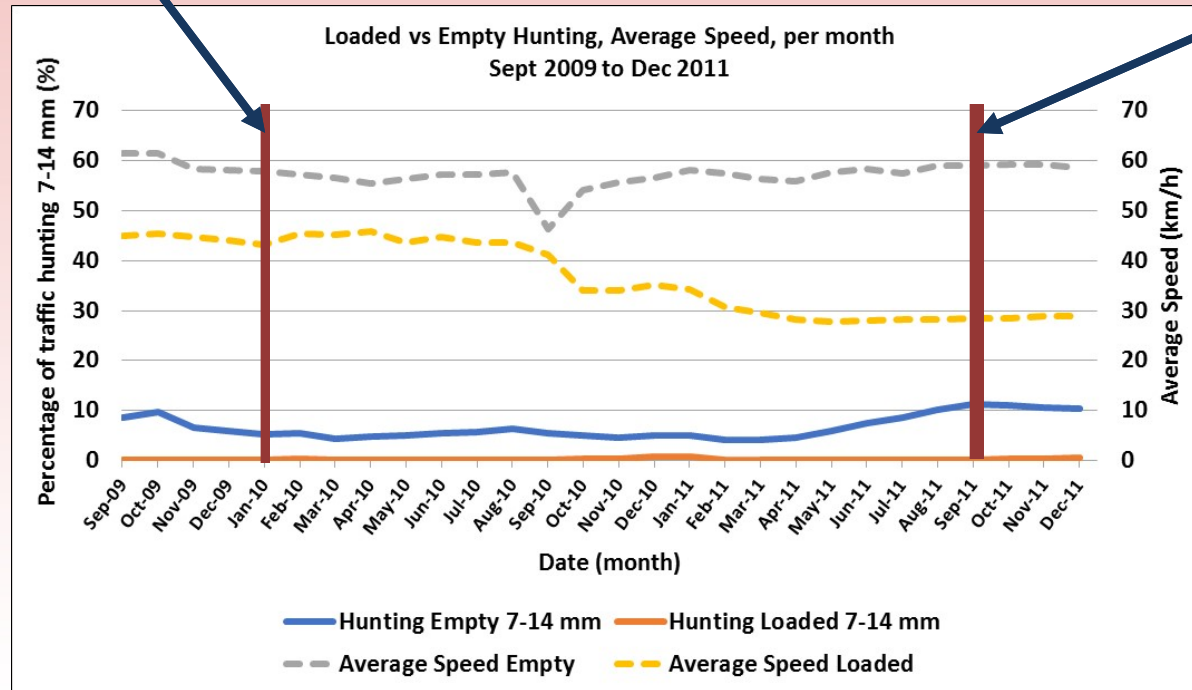
GDU bogies began entering the fleet

Pre-2010 rail replaced with rail that had shorter life and was prone to vibration

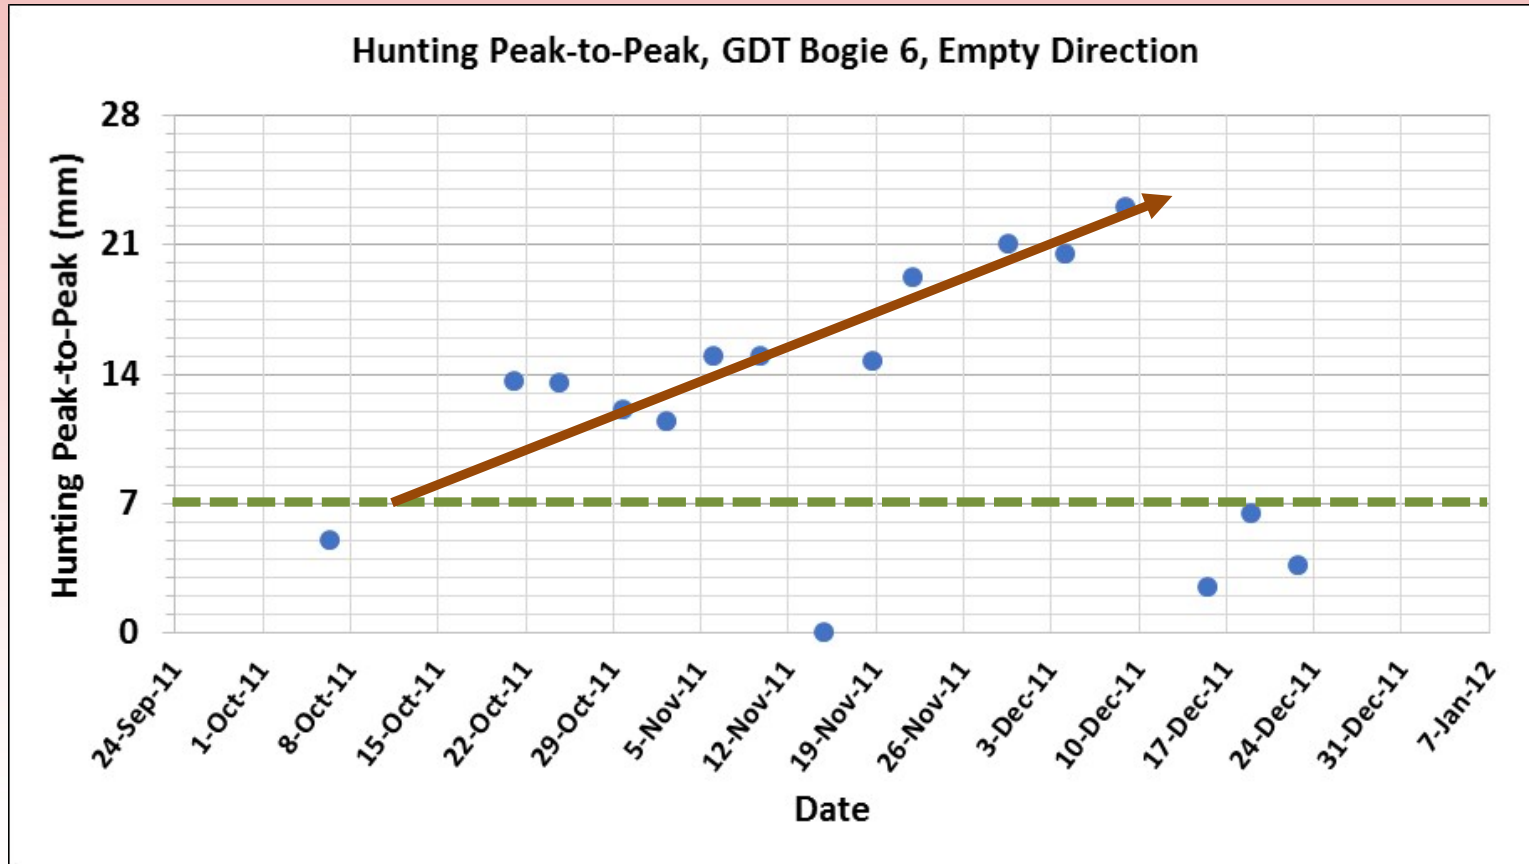
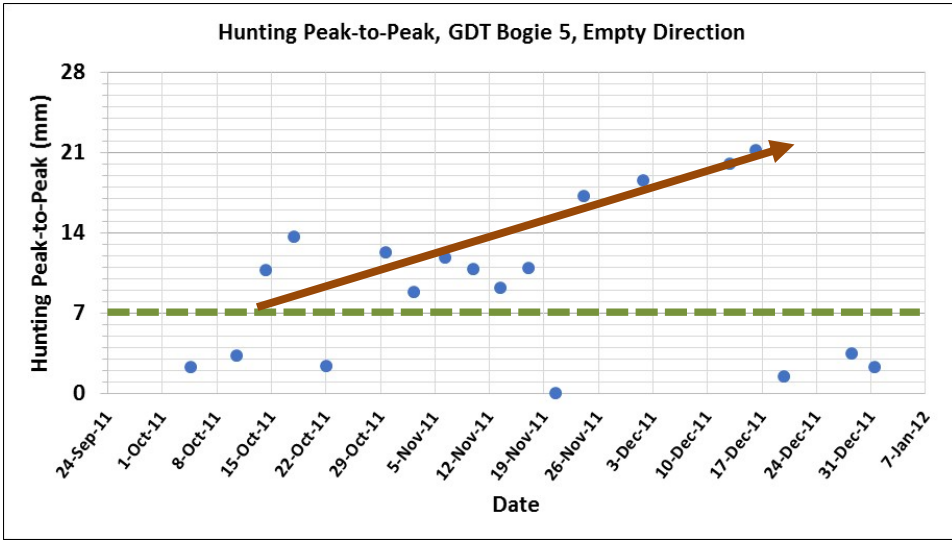
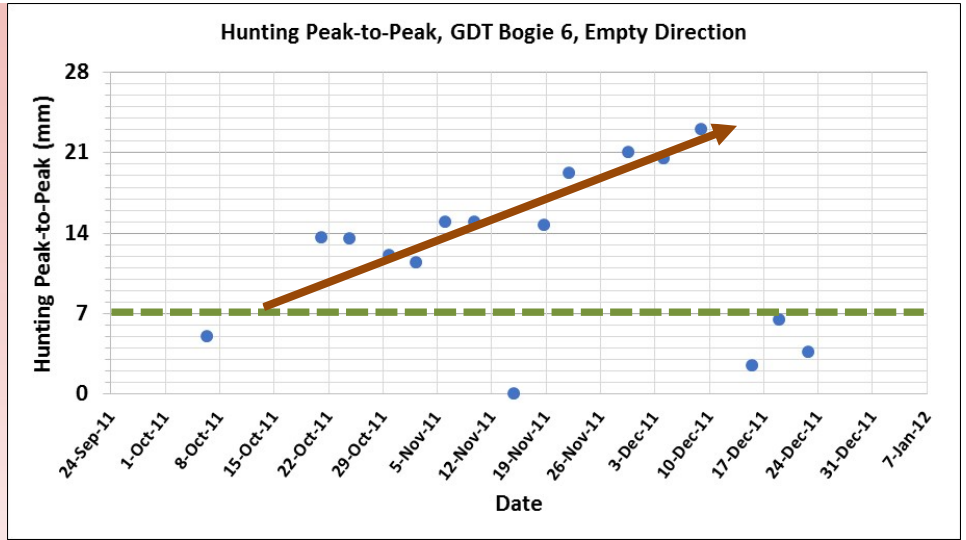
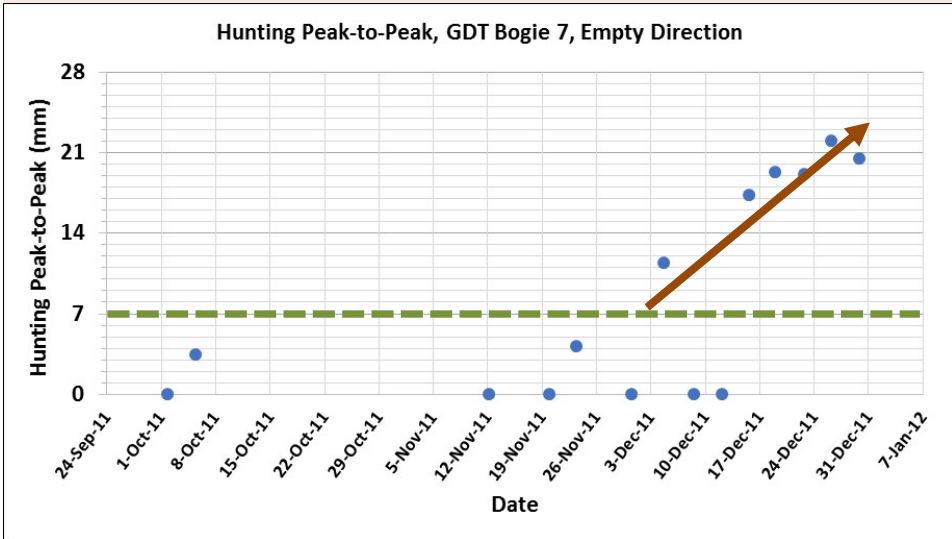
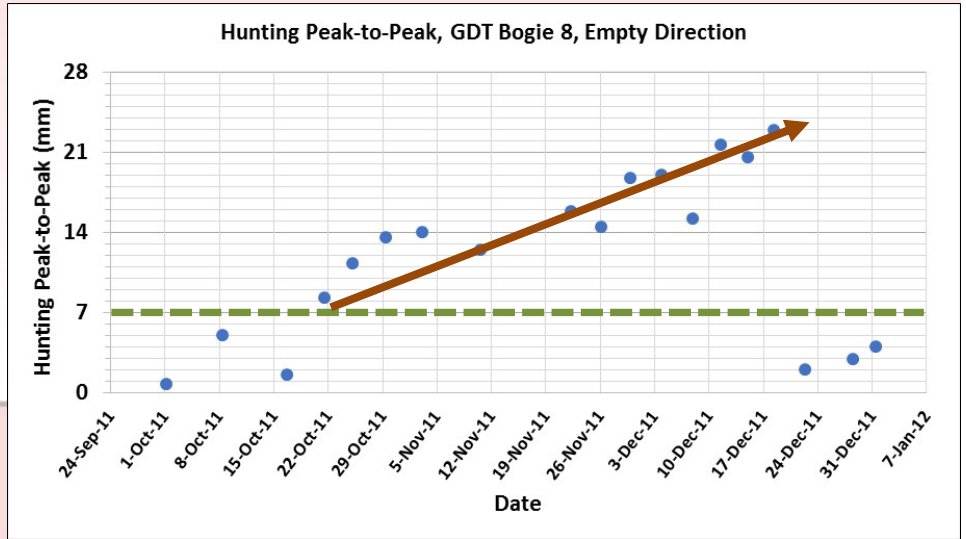
1. Average degradation rate for hunting defects was 14 months
2. Degradation trends typically not steep, were manageable by rolling stock maintenance
3. There were still some steep trends - degradation within 1 month - that required quicker intervention
4. Hunting degradation predominantly manifesting when cars empty, which is normal for heavy-haul

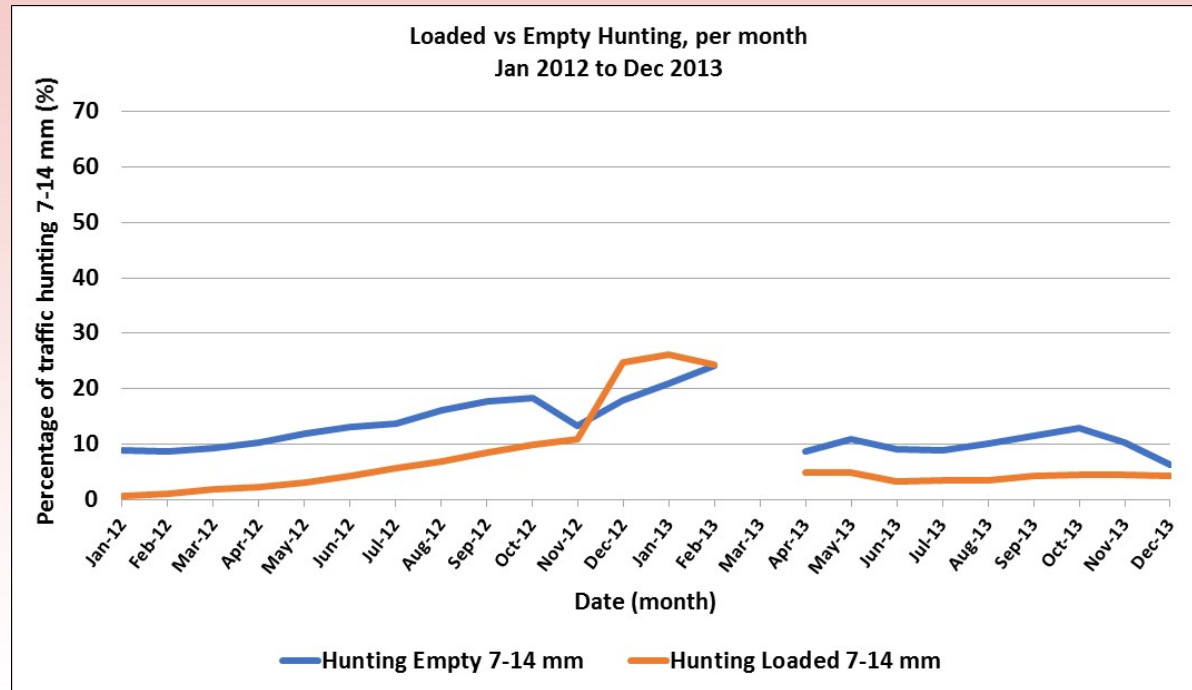
# 2012 - 2013

Manual grinding/tamping,  
and sleeper leveling

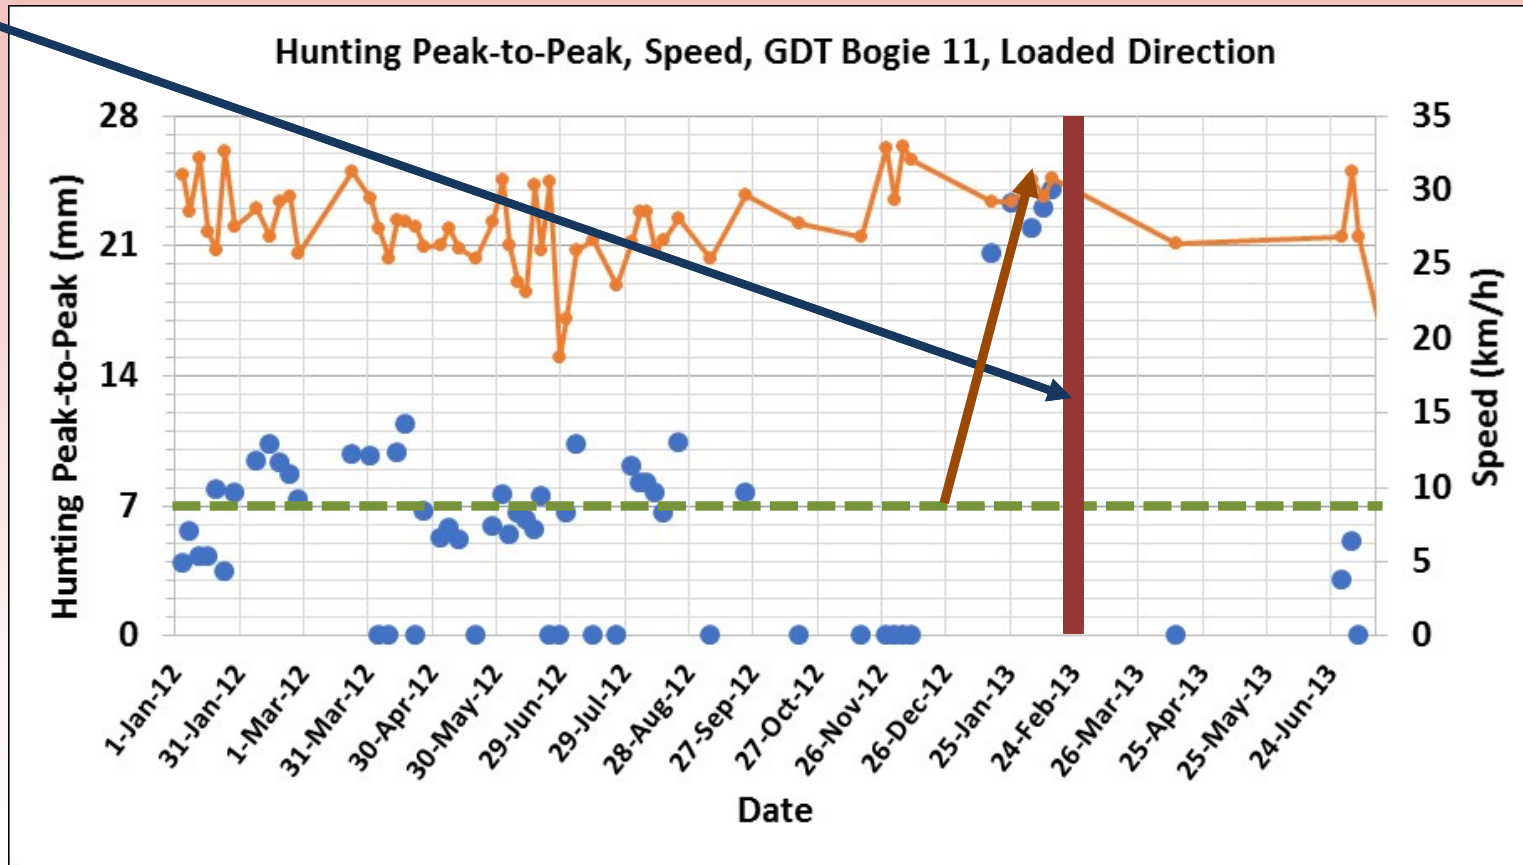
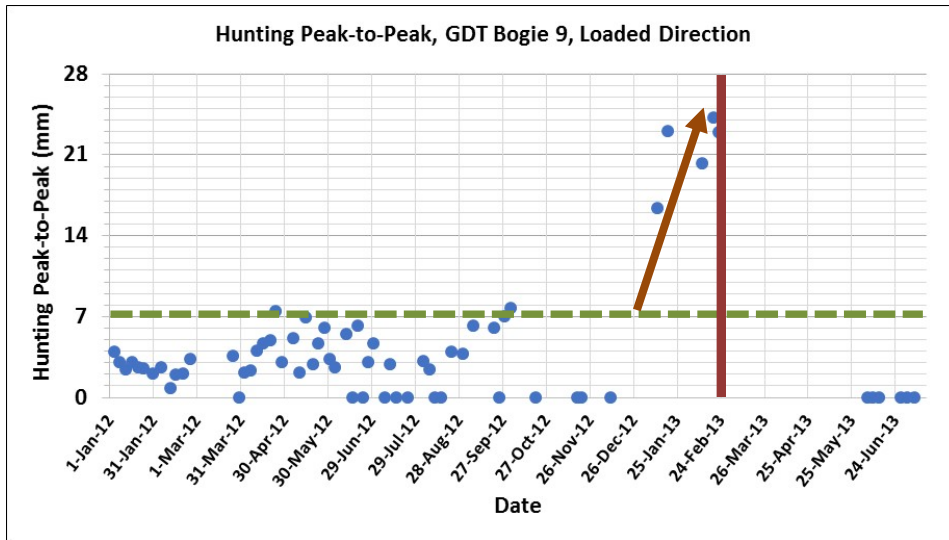
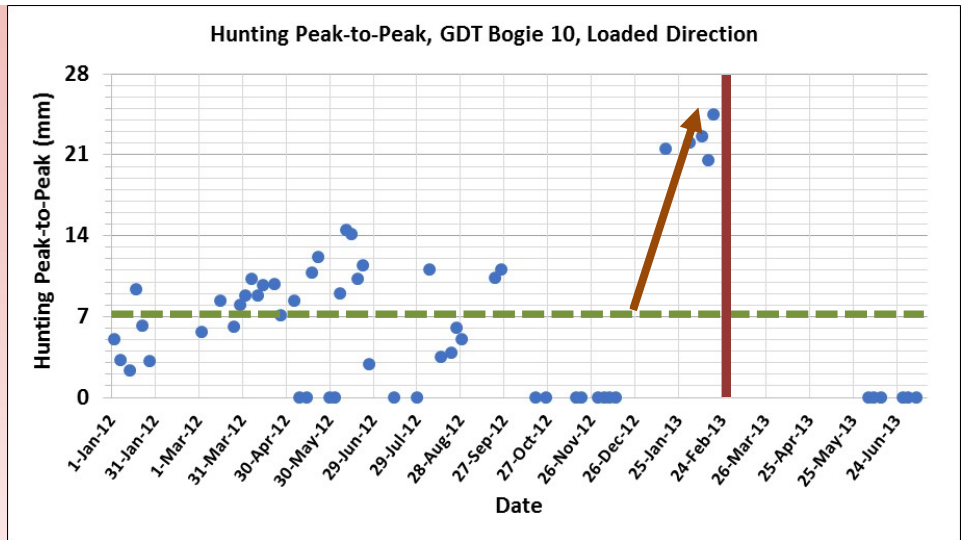
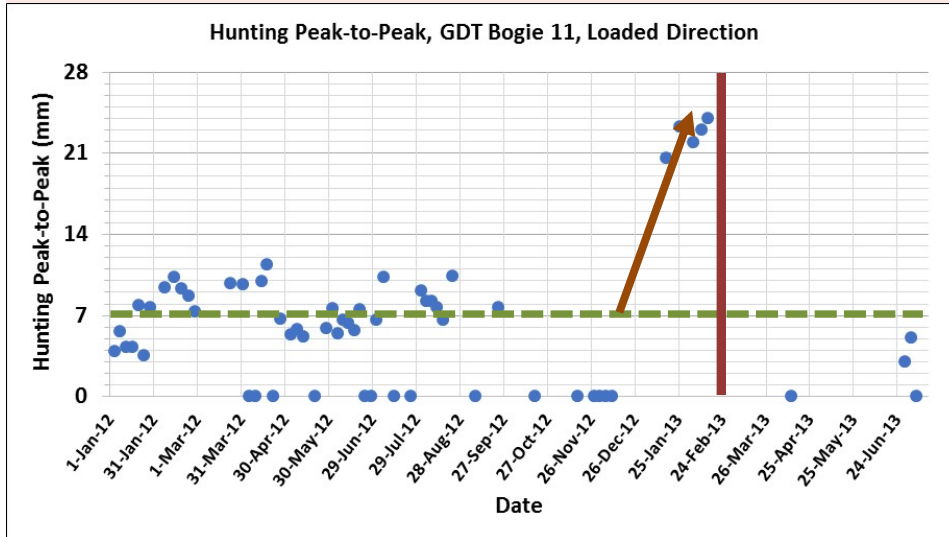
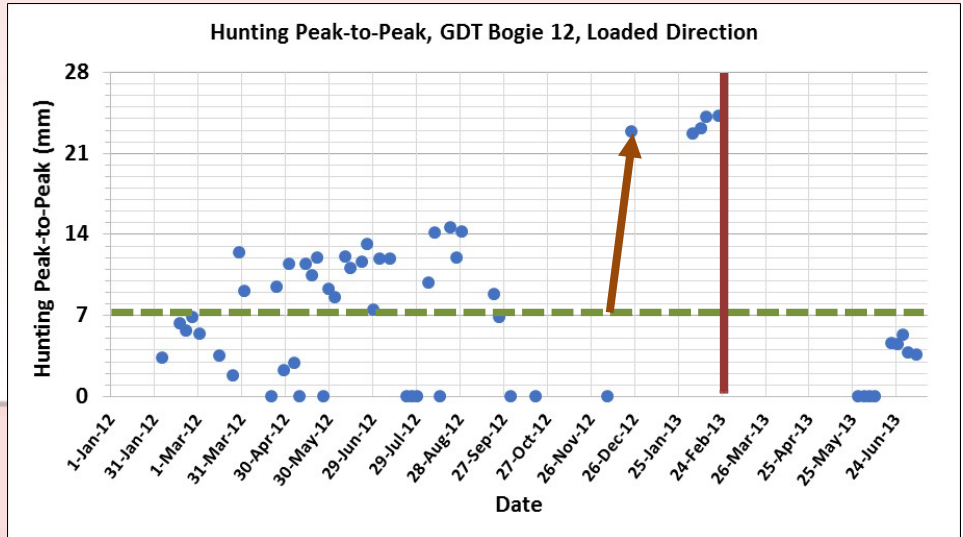
# Rail replacement with better quality rail

1. Predominantly GDT bogies that experienced repeat hunting
2. Degradation time for gradual-onset defects reduced from average of 14 months to average of 7 months
3. Bogies that experienced sudden-onset loaded hunting were different bogies to those that experienced gradual-onset empty hunting
4. Sudden-onset and gradual-onset hunting defects continued degrading without significant changes in speed (per bogie)

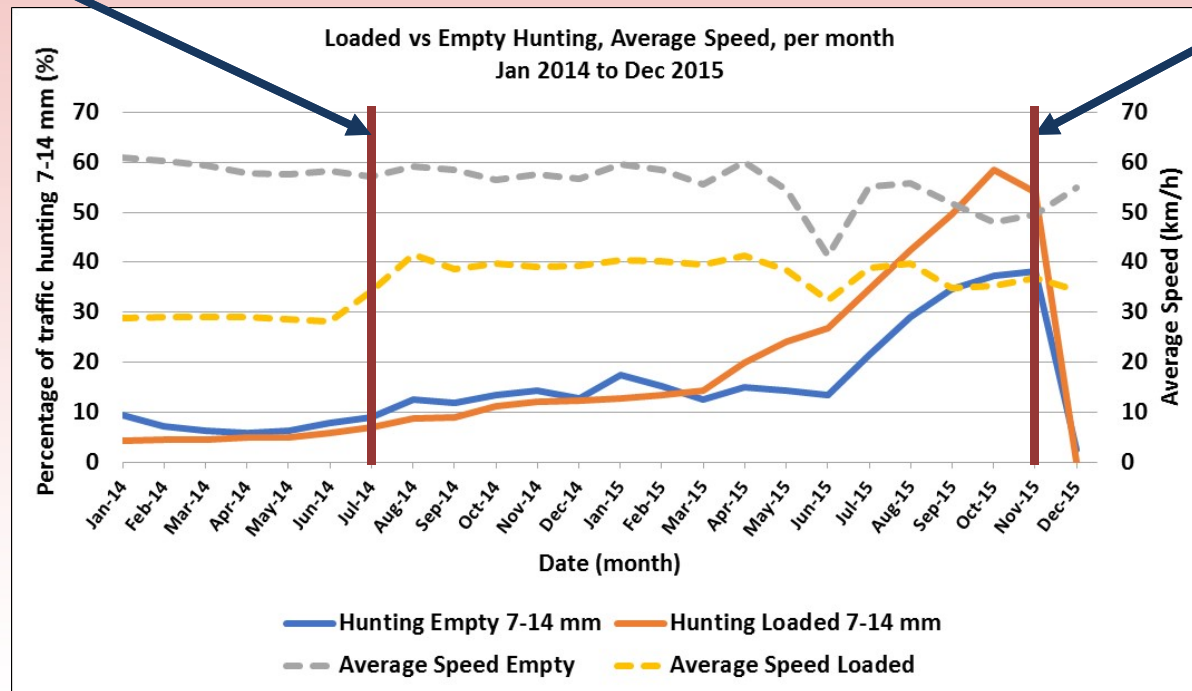
# 2014 - 2015

1. Still predominantly GDT bogies experiencing repeat hunting
2. Vale noticed frame braces starting to break in 2014, and significant increase in twisted/broken frame braces in 2015. Also marked increase in asymmetrical wear in wheelsets.
3. Hunting bogies divided into three main types:
  - a) Gradual-onset defects when empty
  - b) Gradual-onset defects when loaded
  - c) Sudden-onset defects when loaded

Major track overhaul:  
Replaced rail, ballast  
cleaning/renewal,  
mechanical tamping  
and leveling

Plus a bogie  
maintenance  
regime focused  
on the extreme  
defects

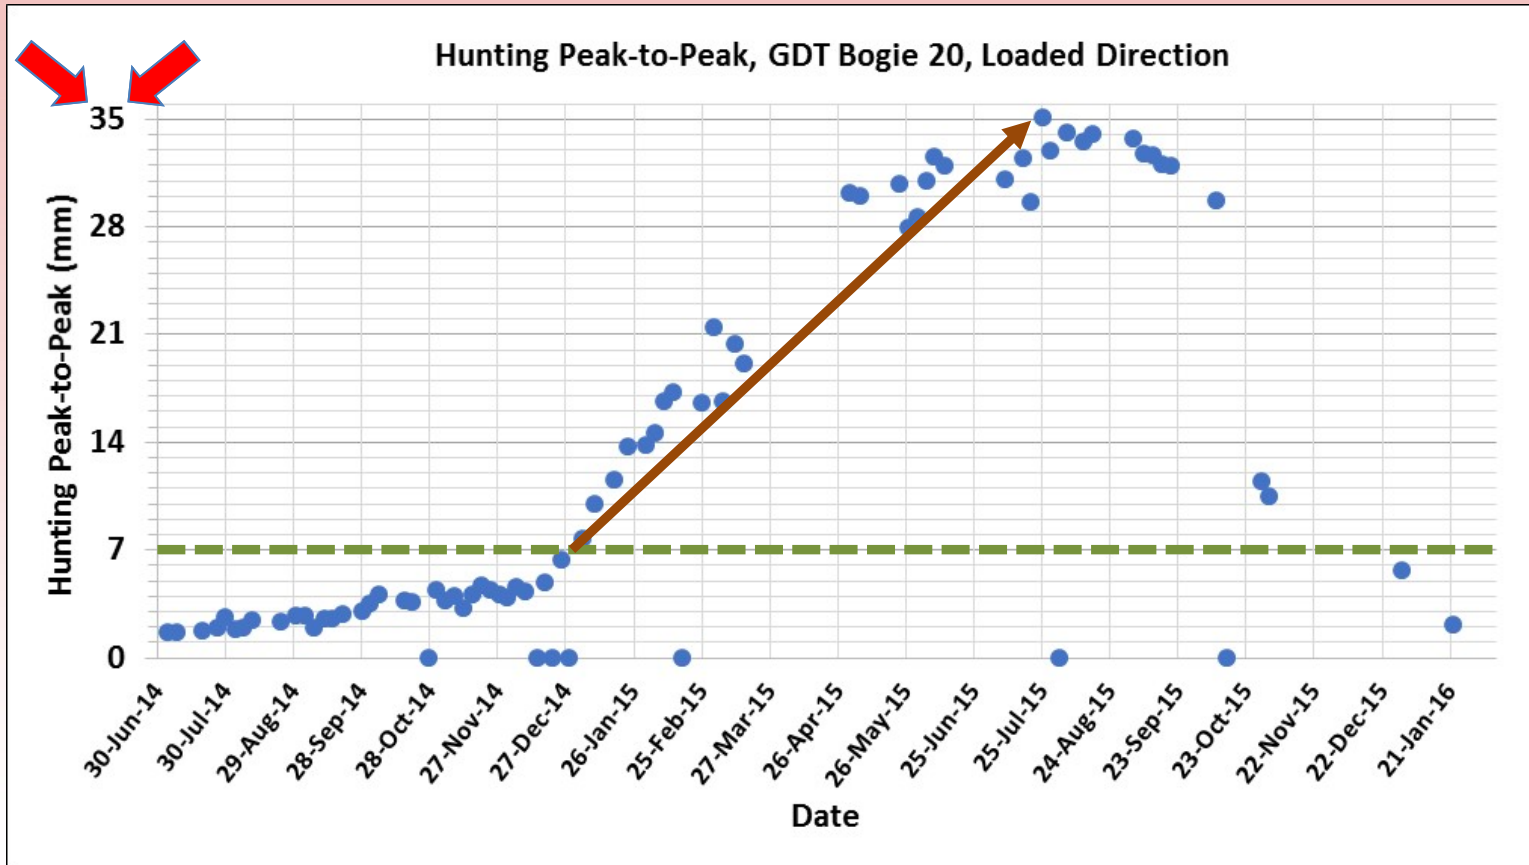
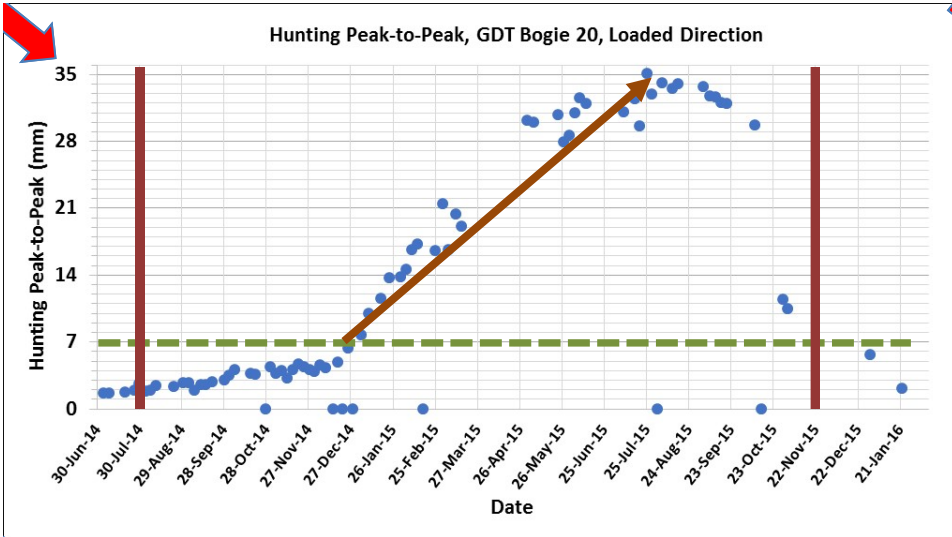
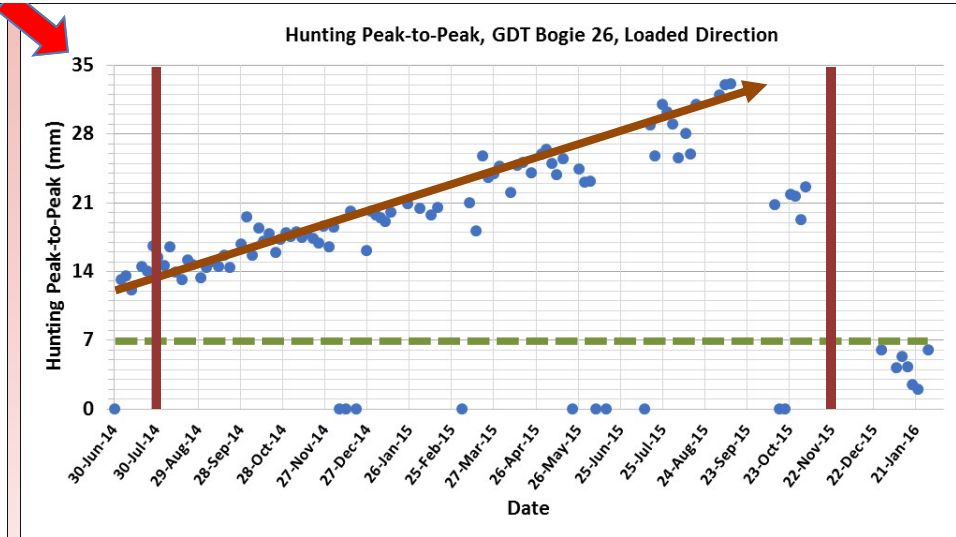
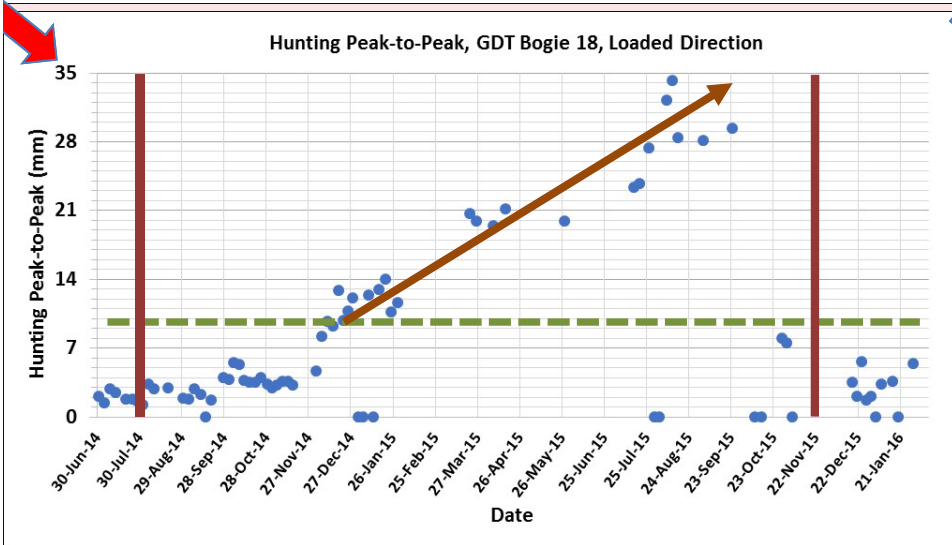
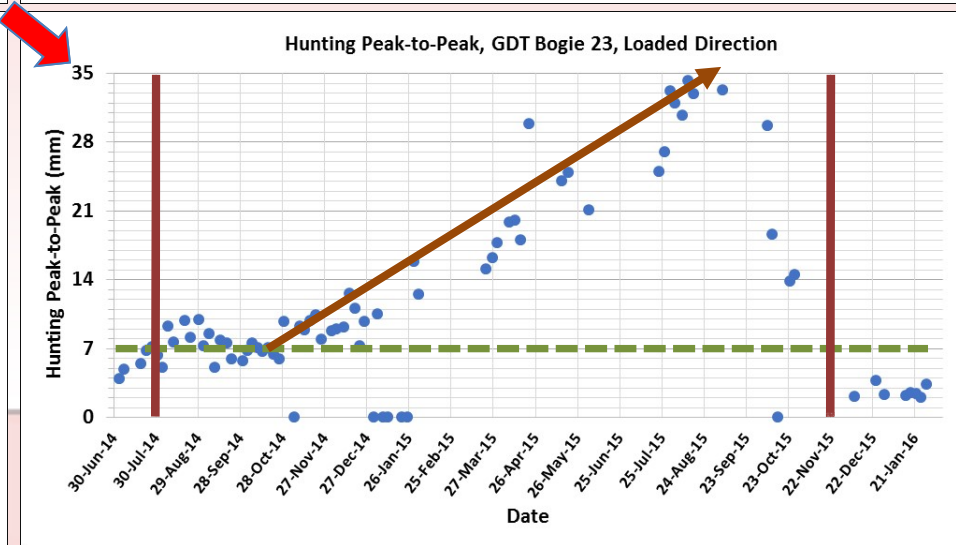
## Type (b): Gradual-onset defects when loaded

- **Almost always, a bogie that develops a gradual-onset hunting will do so in either empty, or loaded condition, but not in both**
- **Sudden-onset hunting developed in loaded condition**
- **Gradual-onset defects typically reached significantly higher severity levels than sudden-onset defects:**
  - **Gradual-onset defects continued upwards toward and beyond 35 mm**
  - **Sudden-onset defects were typically asymptotic to ~21-28 mm**

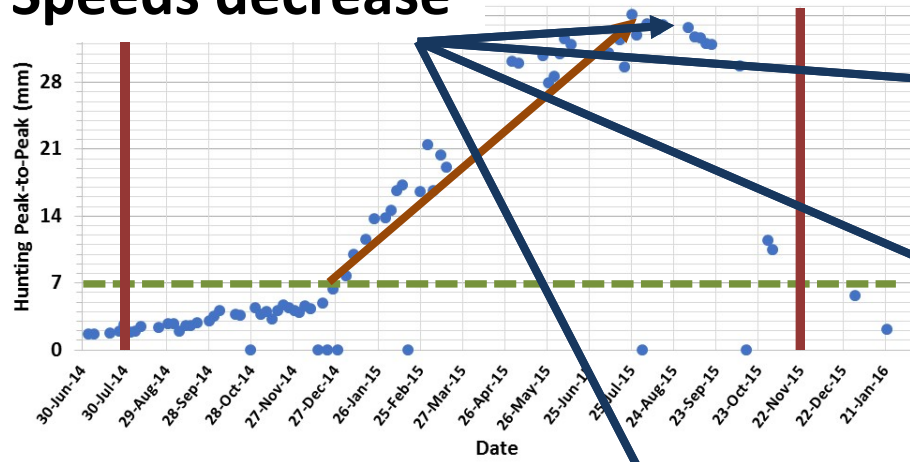
IT Bogie 20, Loaded Direction

# Speeds decrease

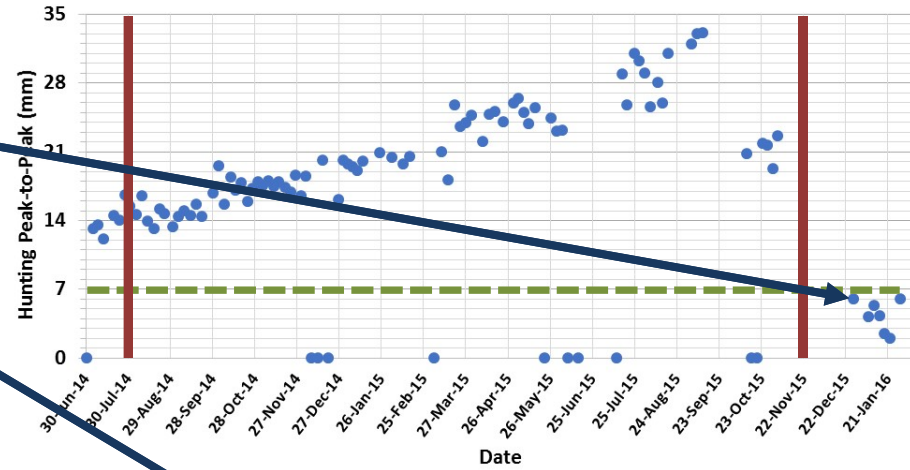
Hunting Peak-to-Peak, GDT Bogie 26, Loaded Direction

# Speeds increase

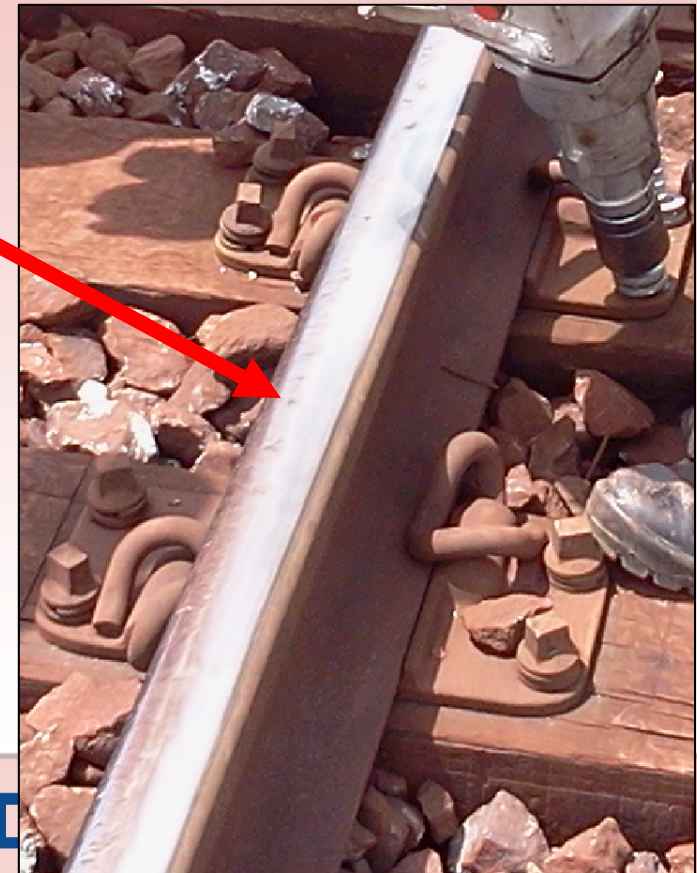
- The main wear on the rail prior to Nov-Dec 2015 was surface shelling - experienced much more RCF than wear
- Rail replaced in Mar 2013 and Nov-Dec 2015 - difference in 2015 was that also sleeper and fixings renewal, ballast maintenance, renewal, and levelling

**Was the rail change in Nov-Dec 2015 the panacea it appears to be?**

**Yes and no: it was only part of the solution**

**During the same window of time, Vale repaired a lot of the trucks with extreme hunting**

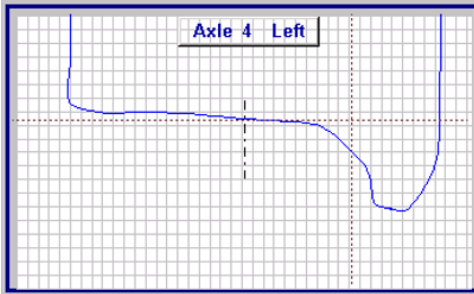
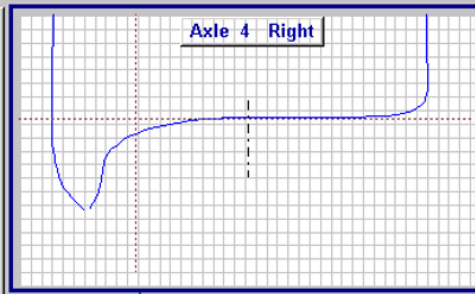
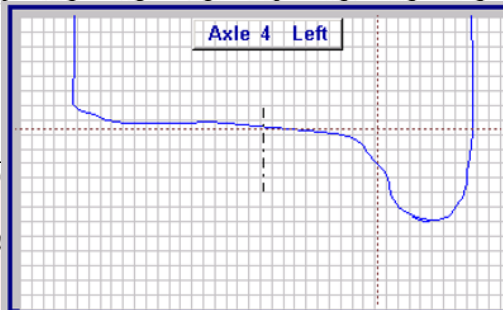
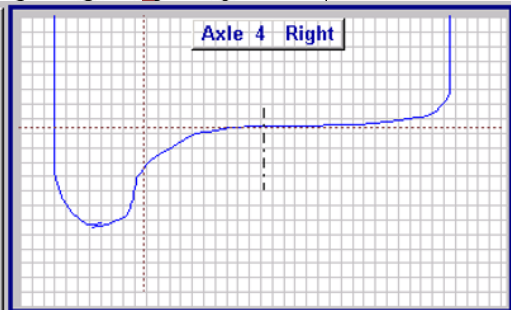
### Hunting Peak-to-Peak, GDT Bogie 20, Loaded Direction

0	Diameter	0	mm
27.0	Flange height	27.1	
30.2	Flange thickness	20.5	
10.36	Flange gradient	6.07	
28.9	Thin Flange	18.7	
65.15	Flange angle	68.98	degree
4.69	Vertical Flange	1.45	
46.4	Rim Thickness	41.1	
0.41	Tread Hollow		
2.01	Tread Taper	0.51	
	Grooved Tread

0	Diameter	0	mm
25.8	Flange height	27.2	
32.3	Flange thickness	30.7	
11.96	Flange gradient	8.94	
30.6	Thin Flange	29.1	
51.40	Flange angle	64.27	degree
4.60	Vertical Flange	5.44	
58.7	Rim Thickness	60.7	
	Tread Hollow		
1.93	Tread Taper	1.92	
	Grooved Tread

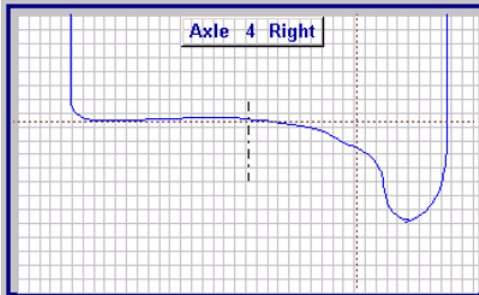
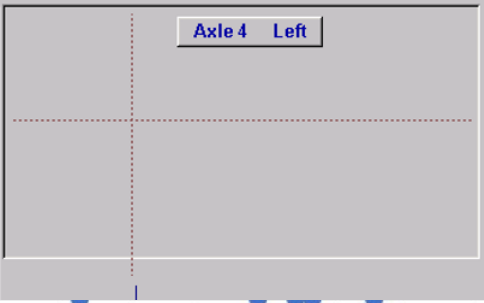
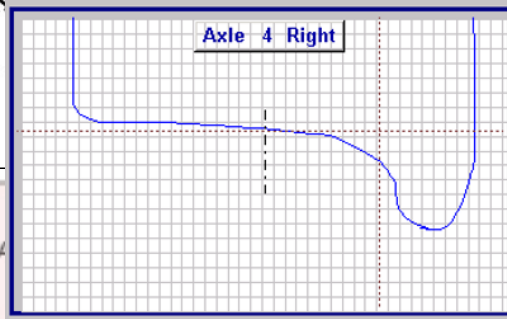
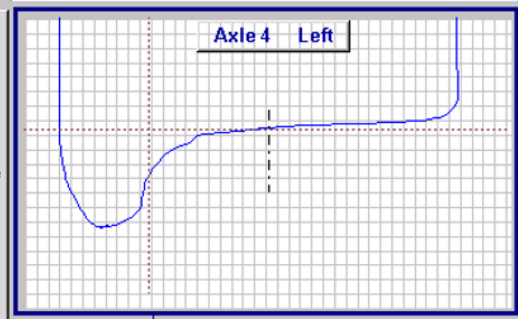
### Hunting Peak-to-Peak, GDT Bogie 26, Loaded Direction

962	Diameter	0	mm
28.7	Flange height		
28.0	Flange thickness		
10.39	Flange gradient		
23.6	Thin Flange		
66.25	Flange angle		degree
2.90	Vertical Flange		
55.1	Rim Thickness		
0.83	Tread Hollow		
0.67	Tread Taper		
	Grooved Tread

0	Diameter	0	mm
27.6	Flange height	27.3	
29.7	Flange thickness	30.4	
10.19	Flange gradient	10.06	
27.5	Thin Flange	28.6	
61.27	Flange angle	60.92	degree
4.63	Vertical Flange	5.47	
54.0	Rim Thickness	55.7	
	Tread Hollow		
2.21	Tread Taper	2.32	
	Grooved Tread

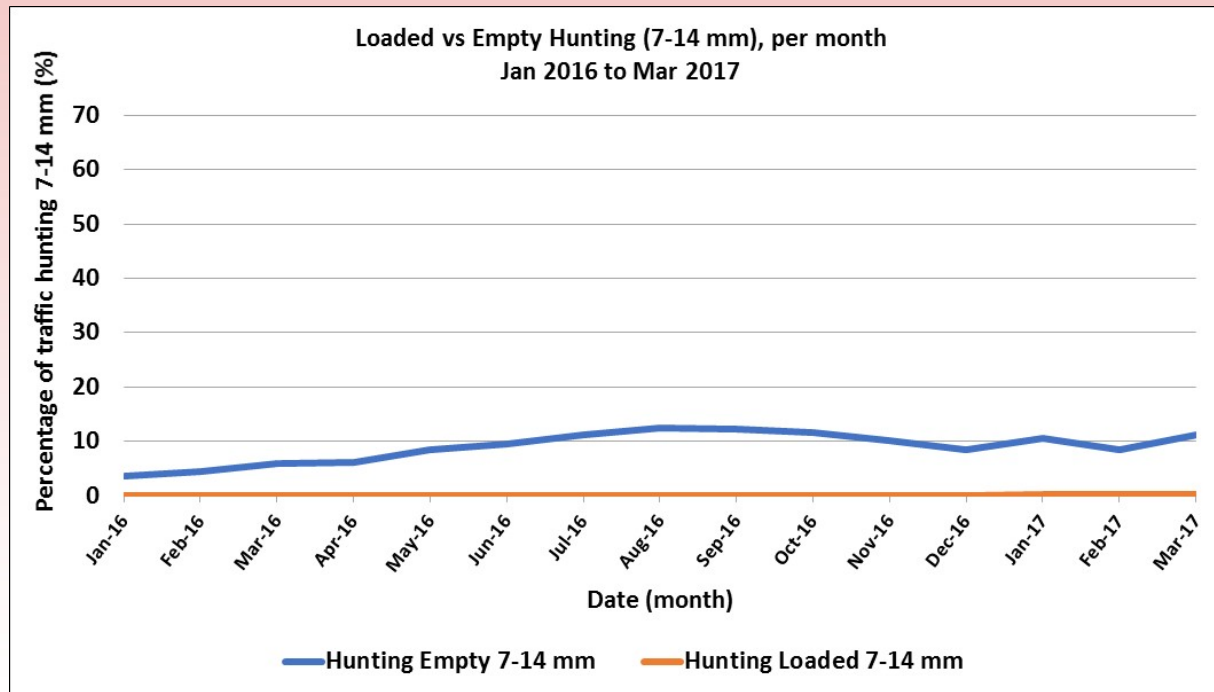
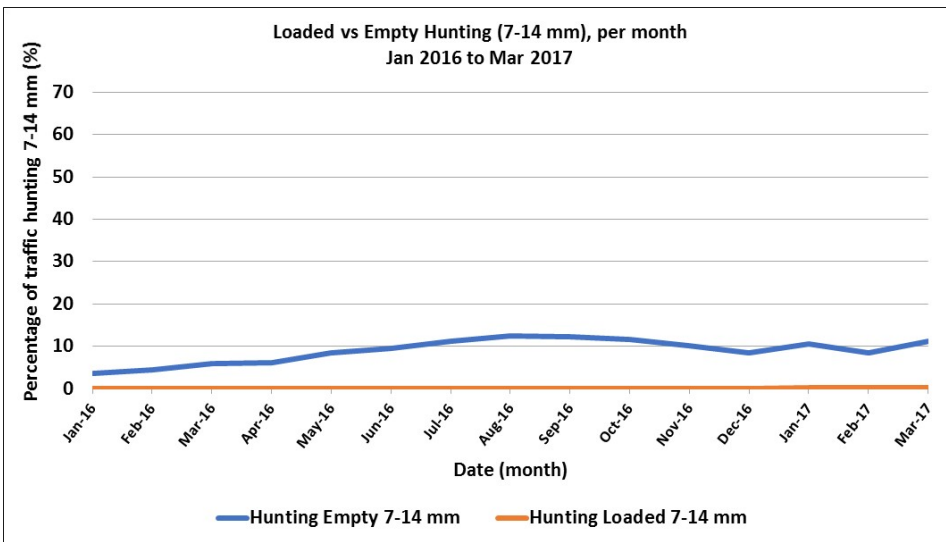
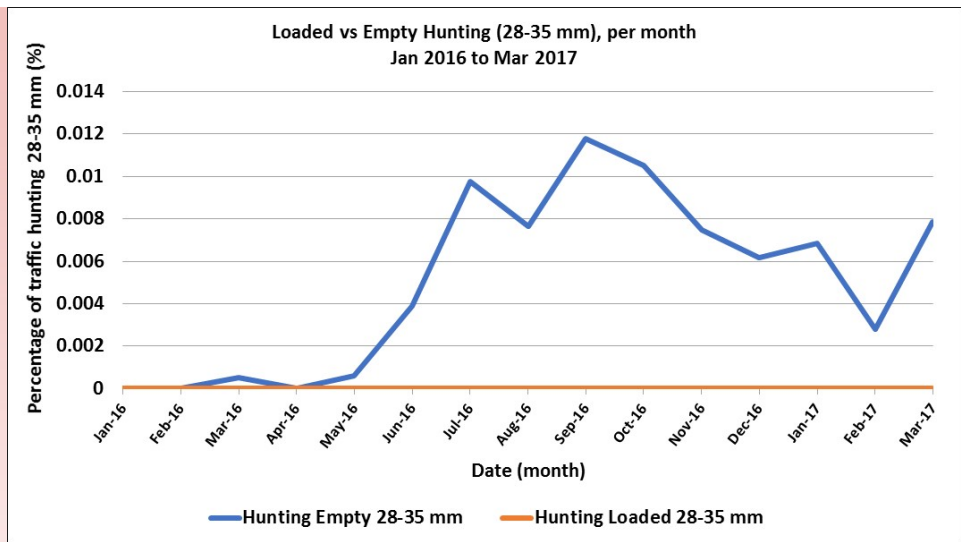
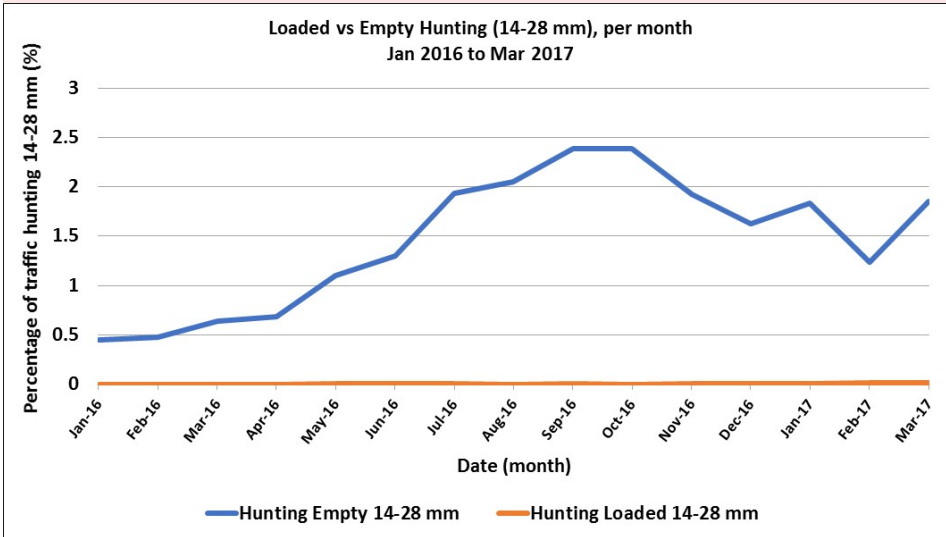
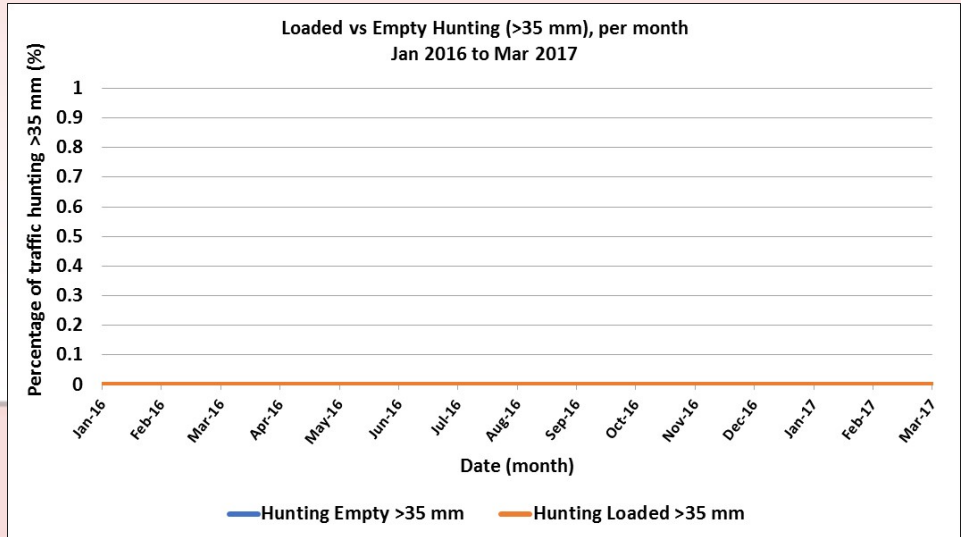
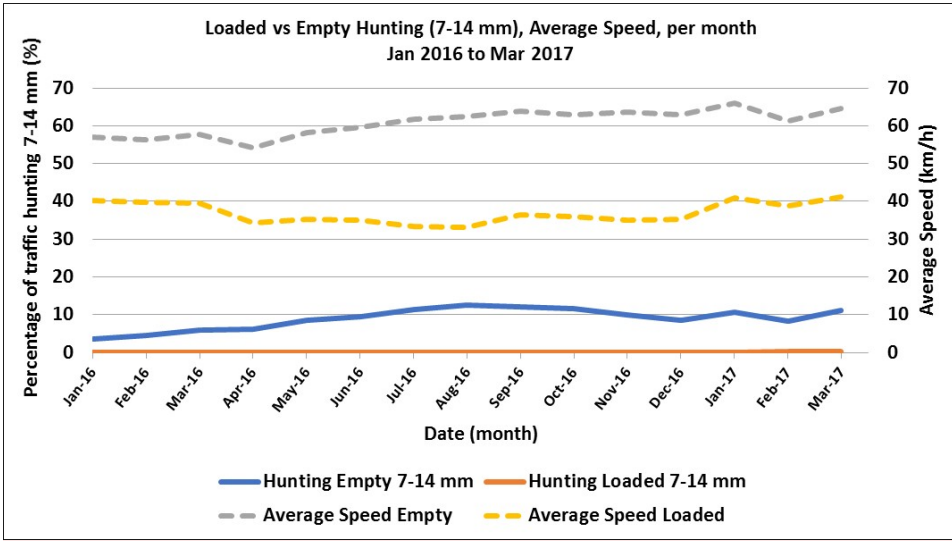
# 2016 - 2017

- **Loaded hunting: back to normal with specific trucks degrading, and no longer an indication of a population-level issue**
- **Empty hunting: back to normal with specific trucks degrading, but indication that a subset of trucks are hunting badly at higher speeds**
- **Empty hunting severity is non-linear in response to speed: a small increase in speed can correspond to a much greater increase in hunting severity (if a bogie is already unstable)**
