How Wayside Detector Data Can Drive Forensic Analysis of Derailments

G Walter Rosenberger
Norfolk Southern –
Research & Tests

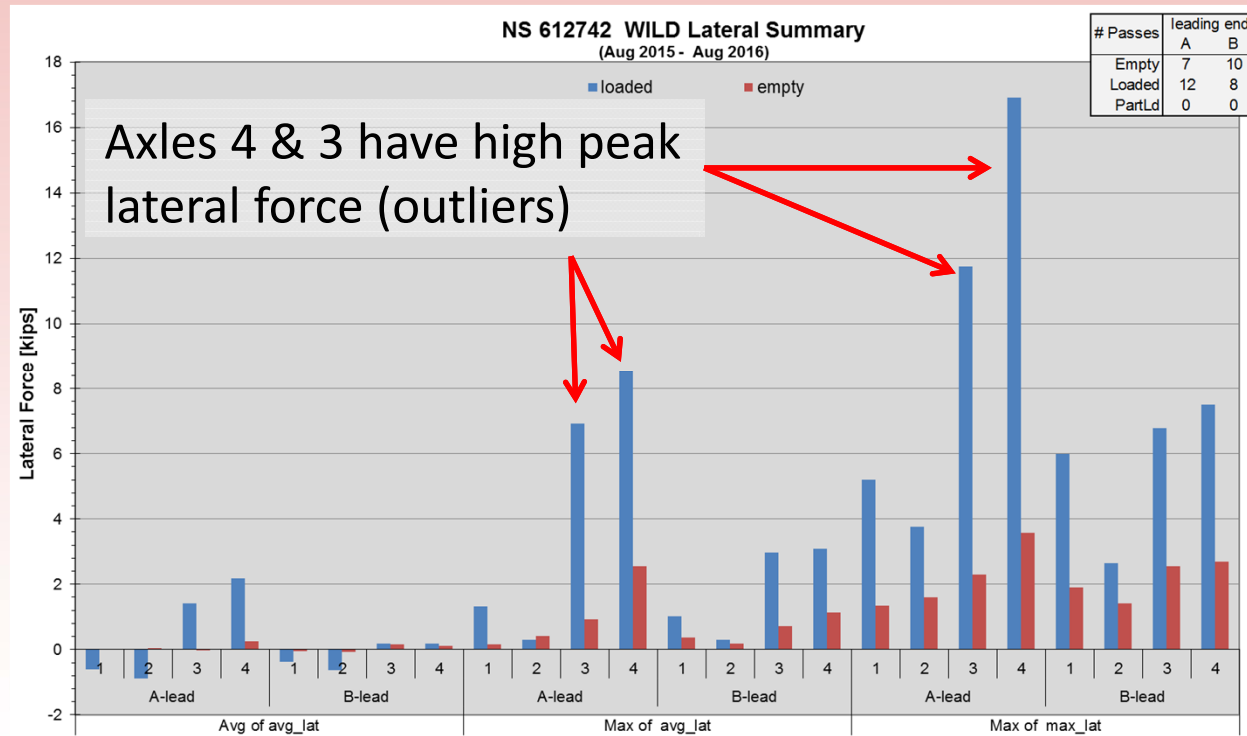
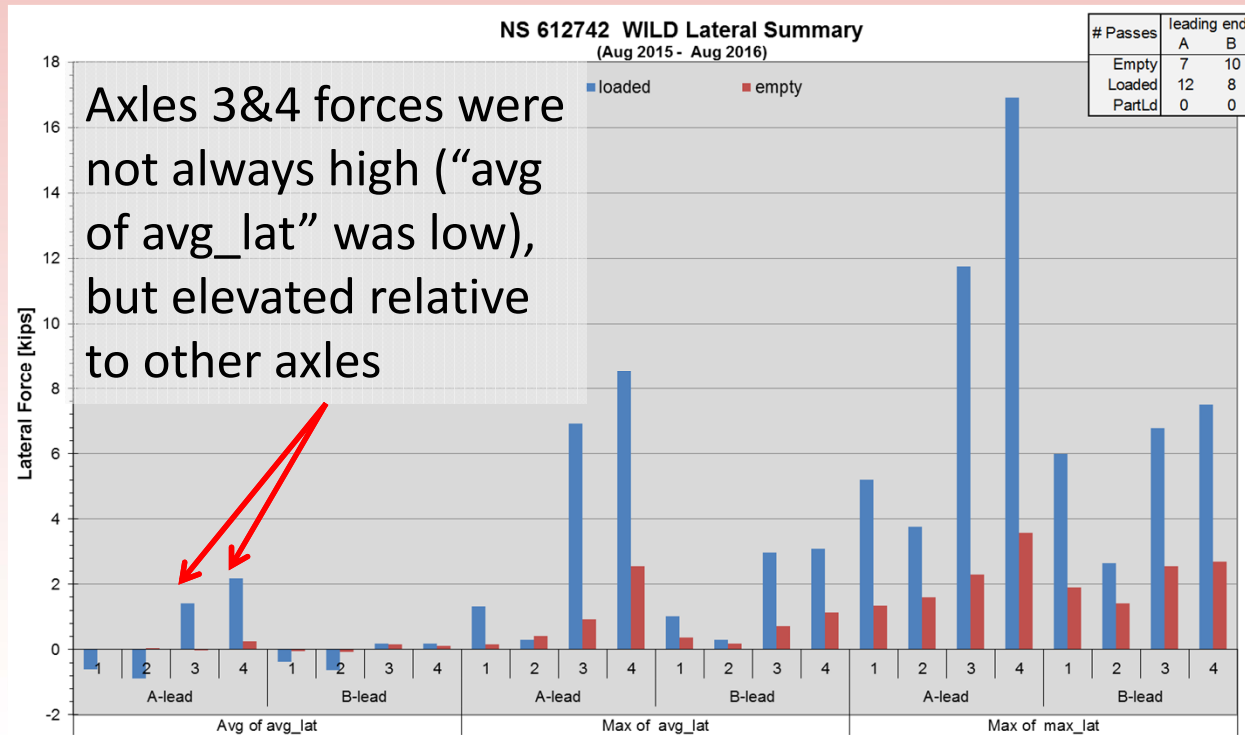
- Excessive wedge rise + asymmetric wheel wear
- Was there any correlation to wayside forces?
- Next slide shows lateral force data from 37 WILD passes over the previous 12 months.

- Lateral forces higher when loaded
- Lateral forces higher with A-end leading
- These same conditions existed at the derailment: Loaded, A-end leading

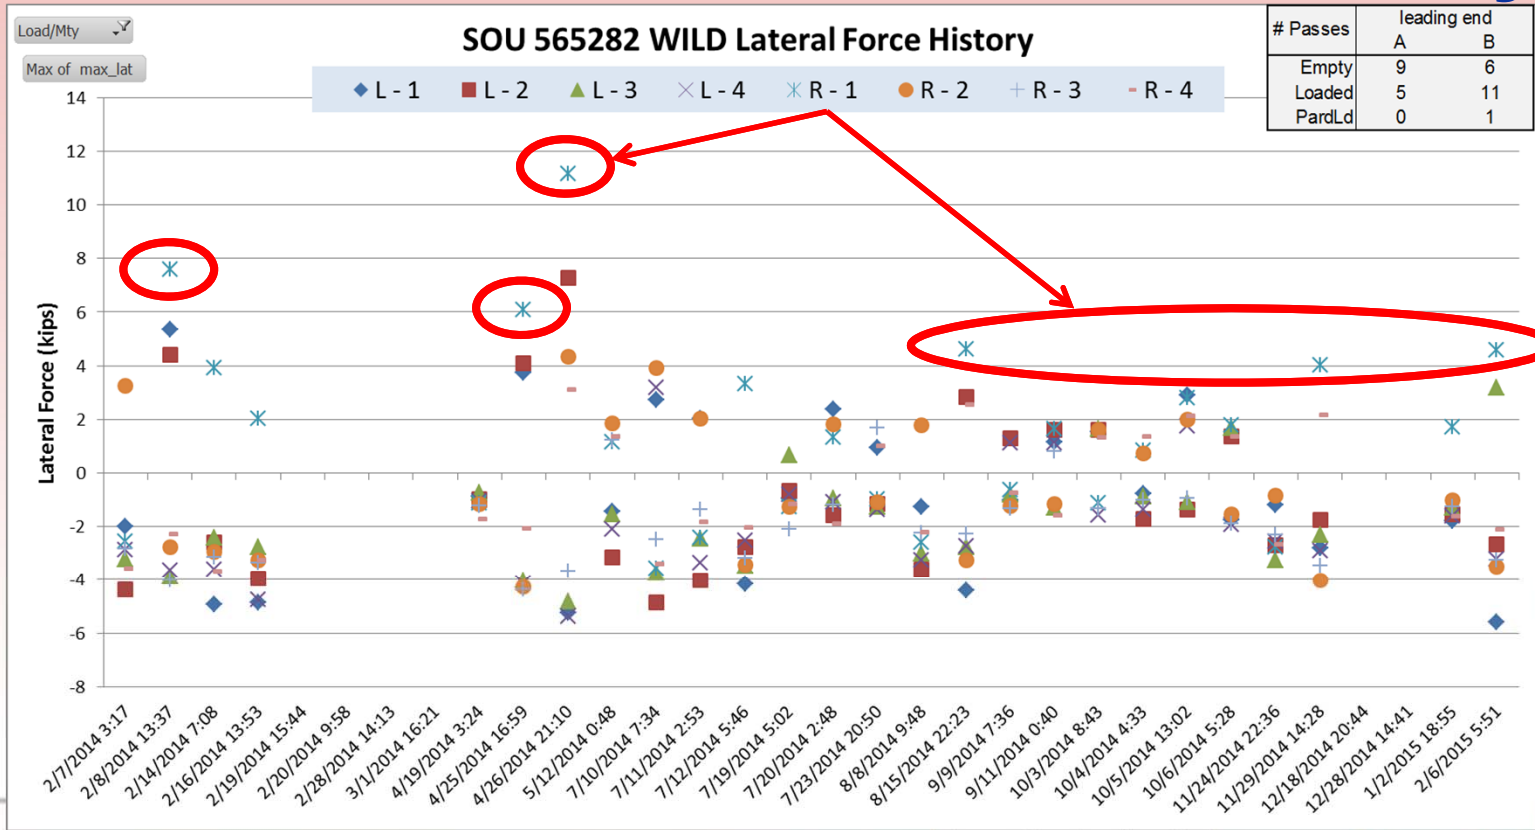
Grove – WILD Max Lateral History

- “Lead truck of 69th head car, loaded box SOU 565828, picked normal switch point account B-end centerbowl rim contact created lateral forces sufficient to deflect stock rails and gap switch point.”
- **FRA Cause Code: E4BC** Truck bolster stiff (failure to slew)

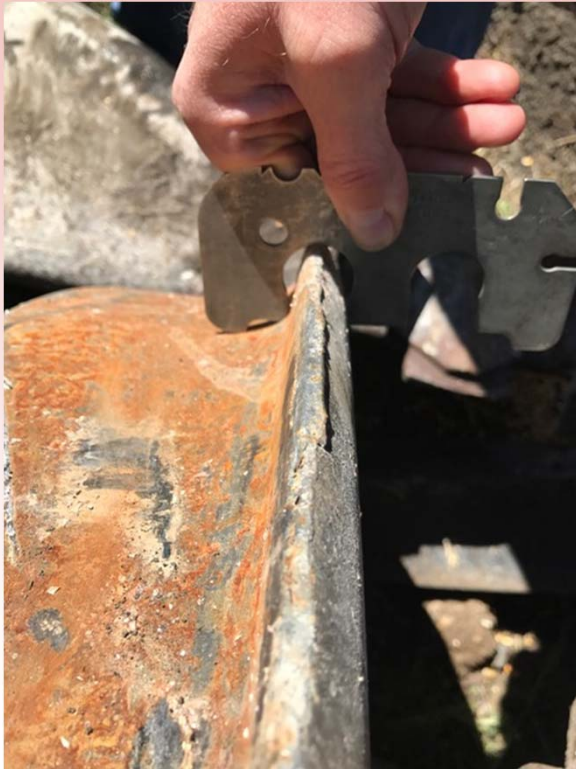
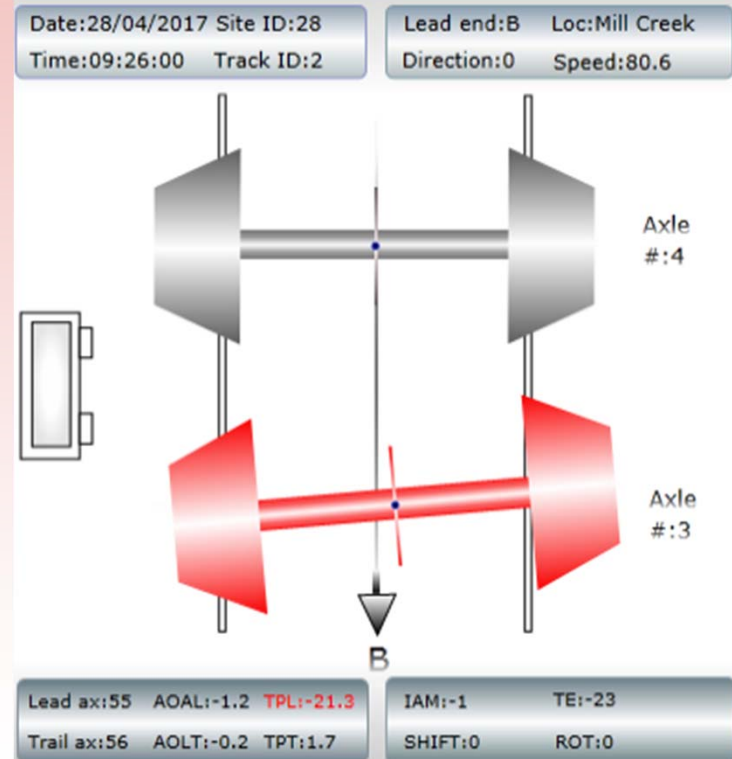
Further Examples – thin flange

- Tbogi identified a thin flange on 5th of 5 cars to derail (per train list)
- POD: We knew one low rail wheel dropped in, then high rail wheel climbed out, and the thin flange wheelset appeared to be the first derailed.
- Tbogi and observations made sense when we realized train was pulled in reverse down branchline.
- Cause analysis underway: contributions from thin flange, wide gage, and buff (pusher) forces

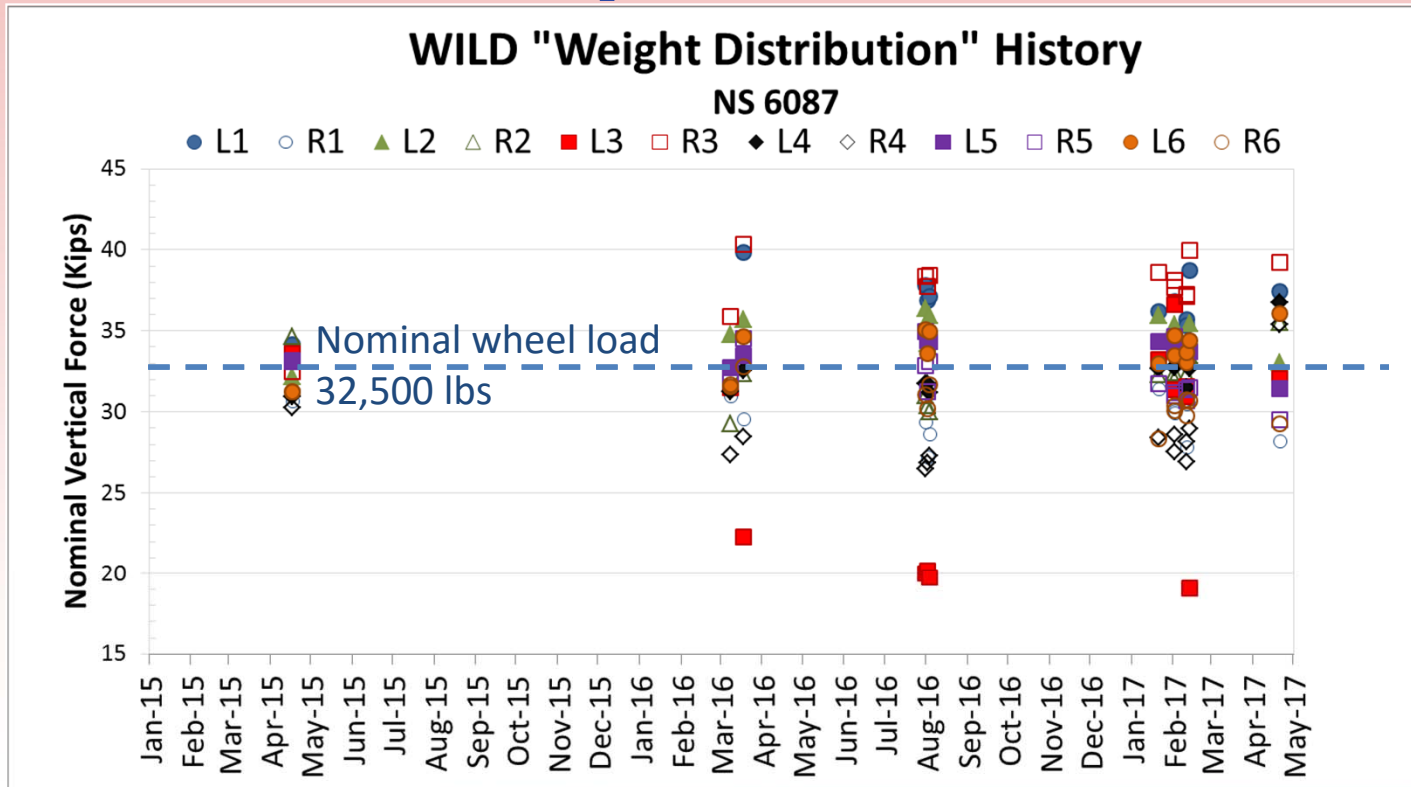
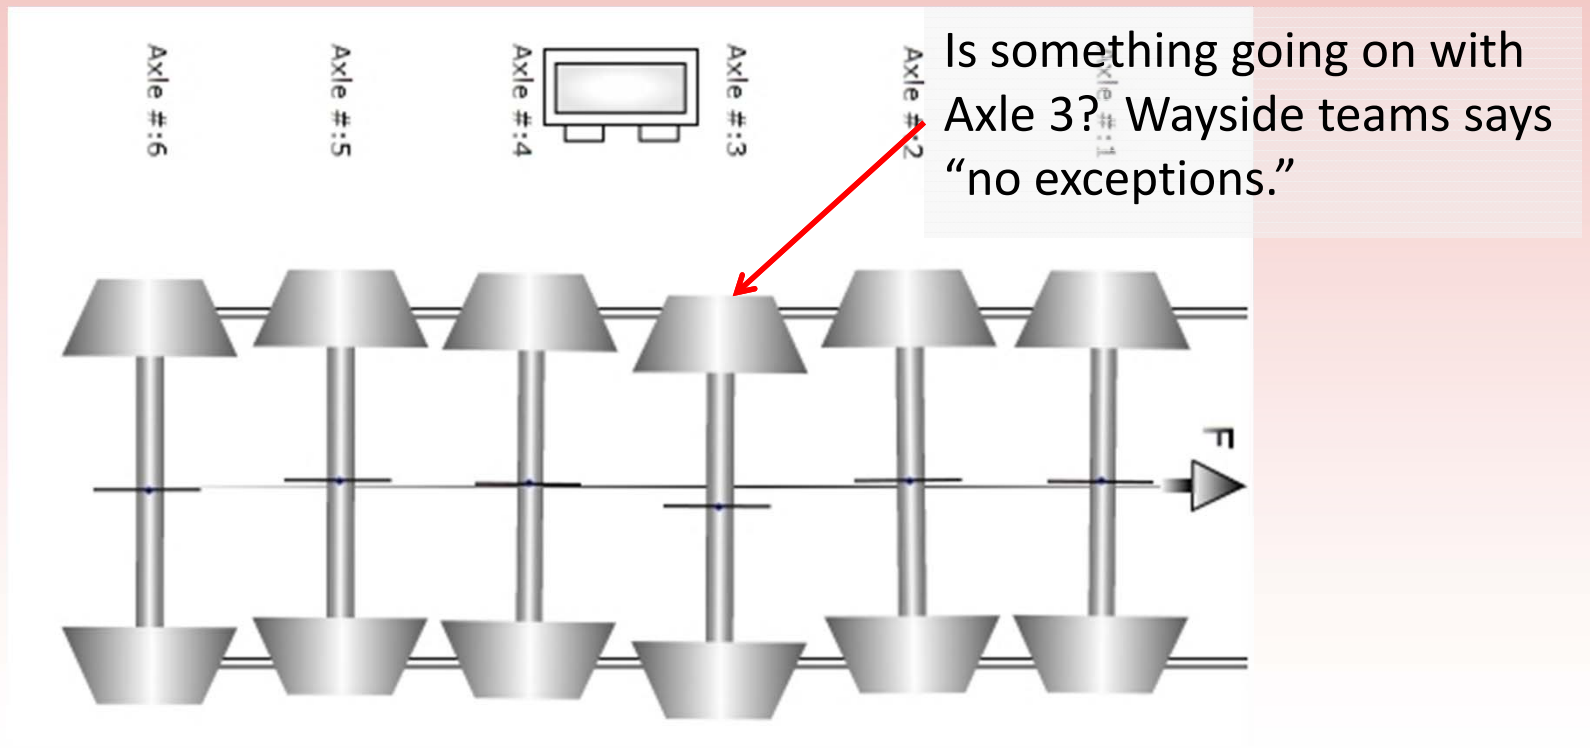
Further Examples – wheel climb

- SD40-2 Lead wheel, trail truck (L3, long hood leading) climbed high rail in 20-21 degree curves, industry track, low speed
- Two derailments in one day, same conditions
- #3 wheelset/combo recently renewed
- Truck inspected in Chattanooga after derailment – “no exceptions”
- Unit is on the way to Juniata for truck teardown
- Root cause remains under investigation
