Case Study: Investigating a Rail Rollover Derailment

Brad Kerchof
Director Research & Tests
Norfolk Southern Railway

PRINCIPLES COURSE • MAY 1, 2018

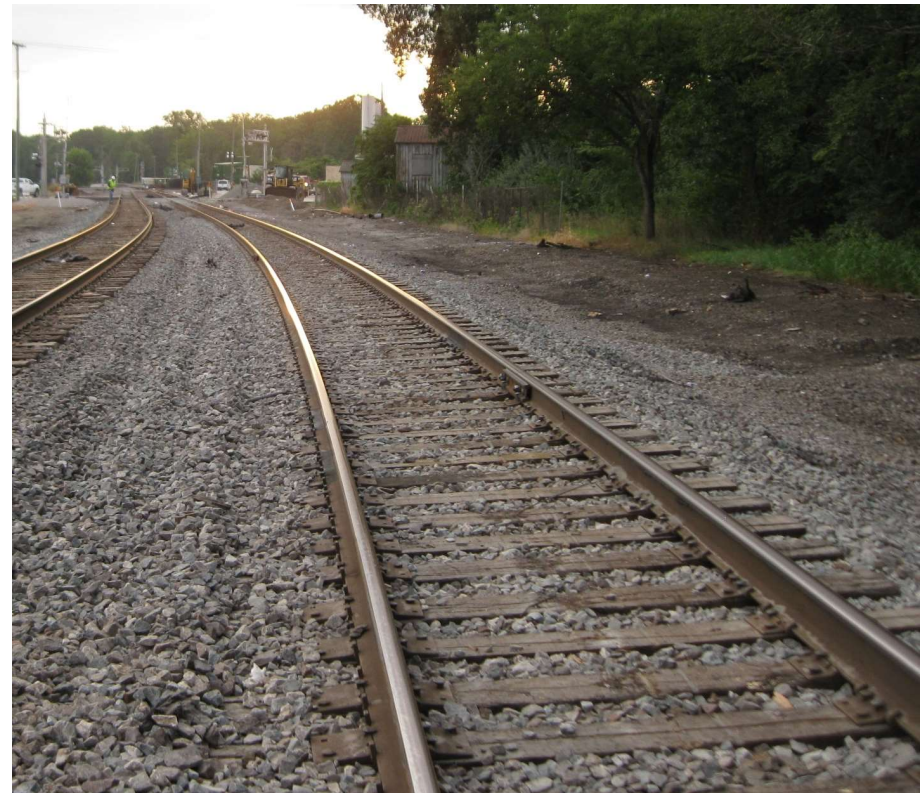
- CP NE, Ft Wayne, IN
- August 18, 2017
- Train 20A
 - 2 locomotives
 - 36 loads (88 double-stack platforms)
 - 5921 tons / 5894 feet
 - train was moving at 16 mph in notch 3
- 3.7° curve, 3" elevation
- Looking in direction of train movement at the POD

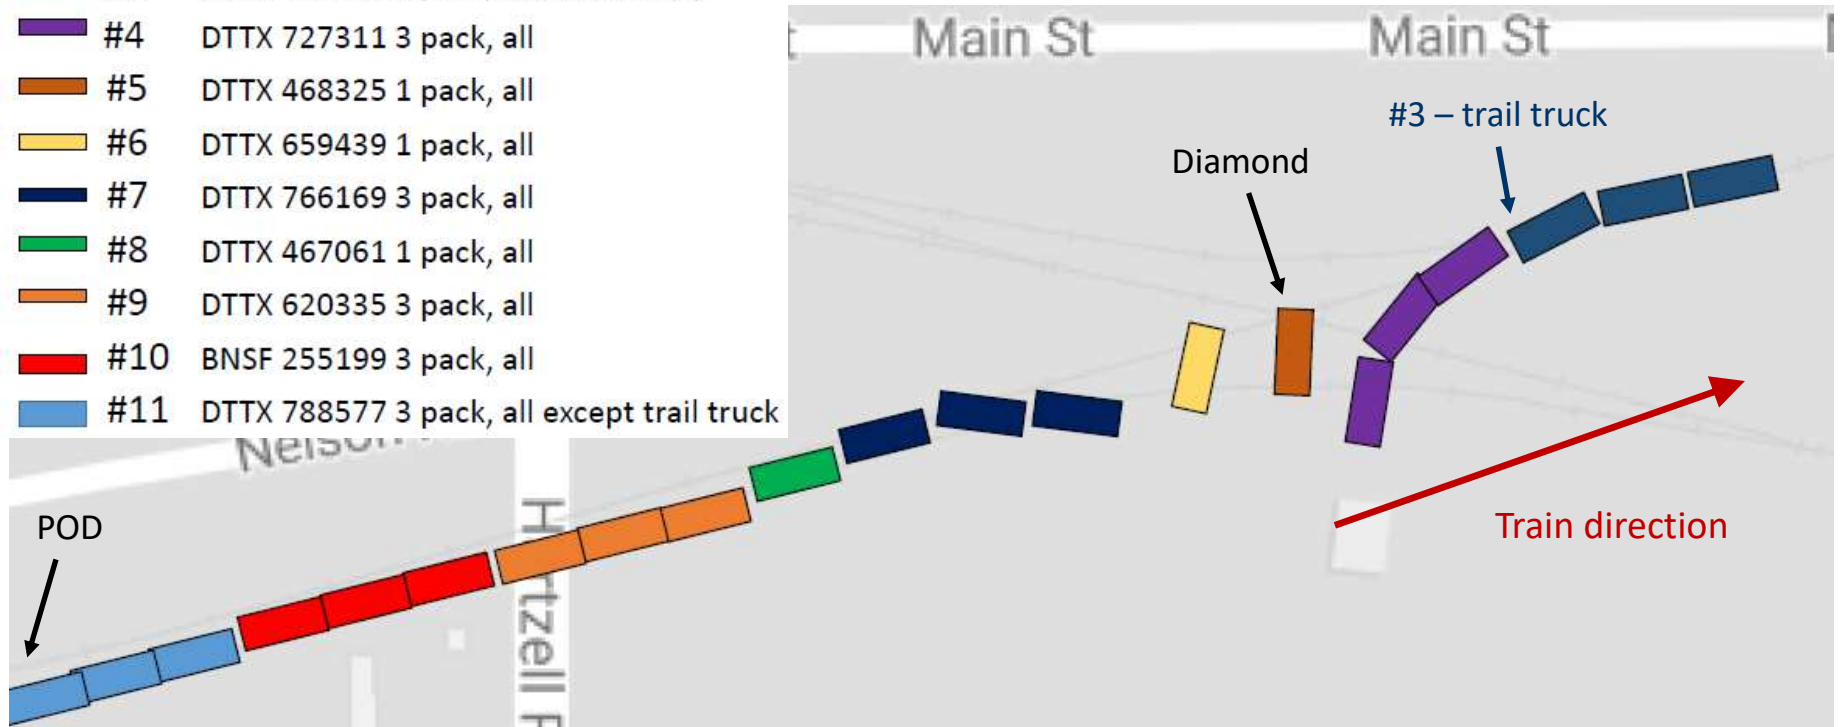
<u>Position</u>	<u>Description</u>
#3	DTTX 787816 3 pack, trail truck only
#4	DTTX 727311 3 pack, all
#5	DTTX 468325 1 pack, all
#6	DTTX 659439 1 pack, all
#7	DTTX 766169 3 pack, all
#8	DTTX 467061 1 pack, all
#9	DTTX 620335 3 pack, all
#10	BNSF 255199 3 pack, all
#11	DTTX 788577 3 pack, all except trail truck

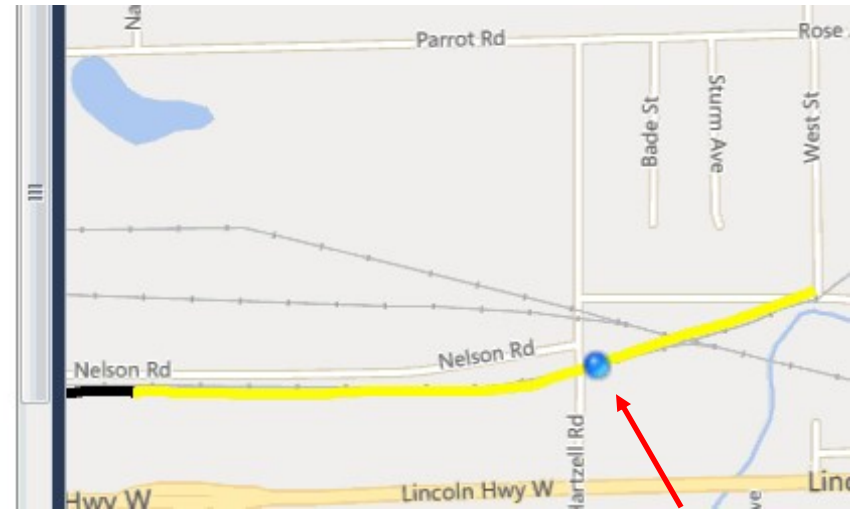
The cursor marks when the lead locomotive was just east of Hartzell Rd, speed was 16 mph and climbing gradually, and throttle was in notch 3.

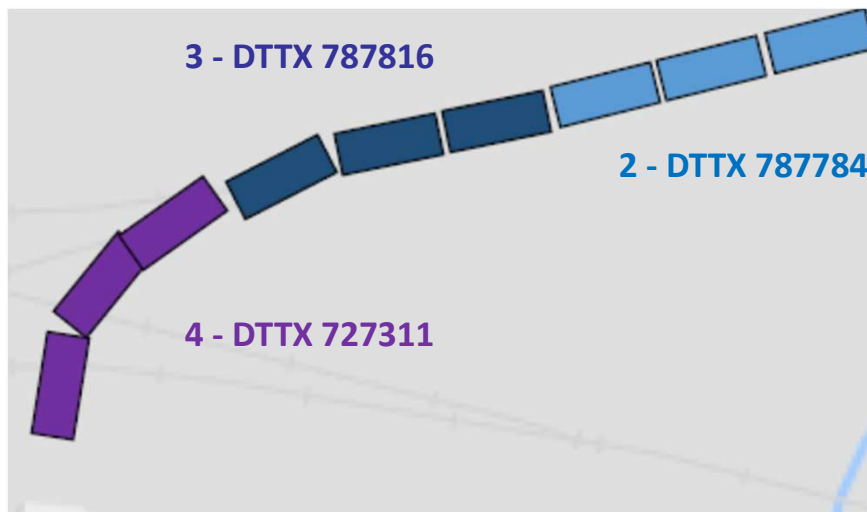
2nd head car, **DTTX 787784**, lead truck (the one thought to have derailed and then railed itself) inspected in car shop. No exceptions.

3rd head car **DTTX 787816**, trail truck inspected in car shop, wheels replaced due to minor derailment damage. No other exceptions.

4th head car **DTTX 727311**, all four trucks derailed, with severe damage to the wheels on the two intermediate (C and D) trucks. Car was not re-railed. A thorough inspection was not possible.

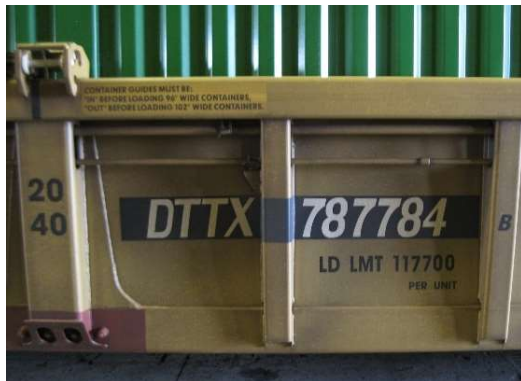
- Conclusion: This truck did not derail

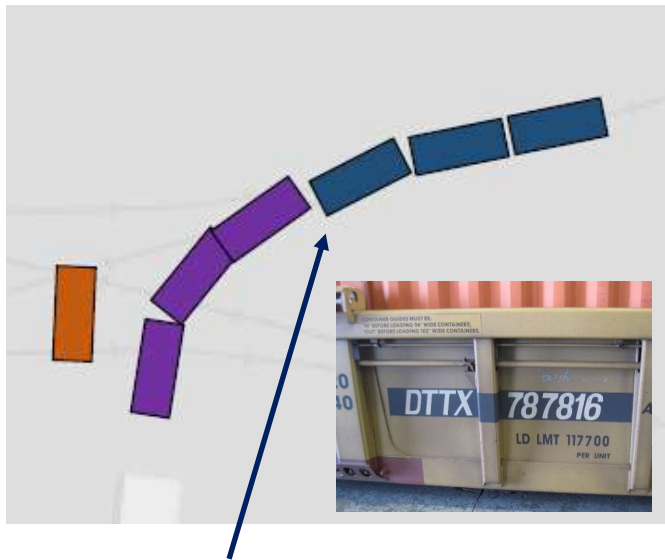
The first derailed wheels were under the trail truck of the 3rd car.

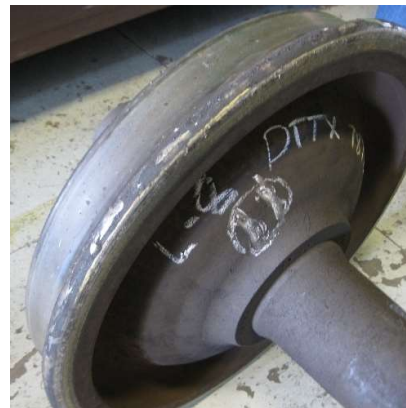
These wheels show some flange contact with the ground, but not enough to have been the first to derail (they would have run over 2 turnouts and a diamond).

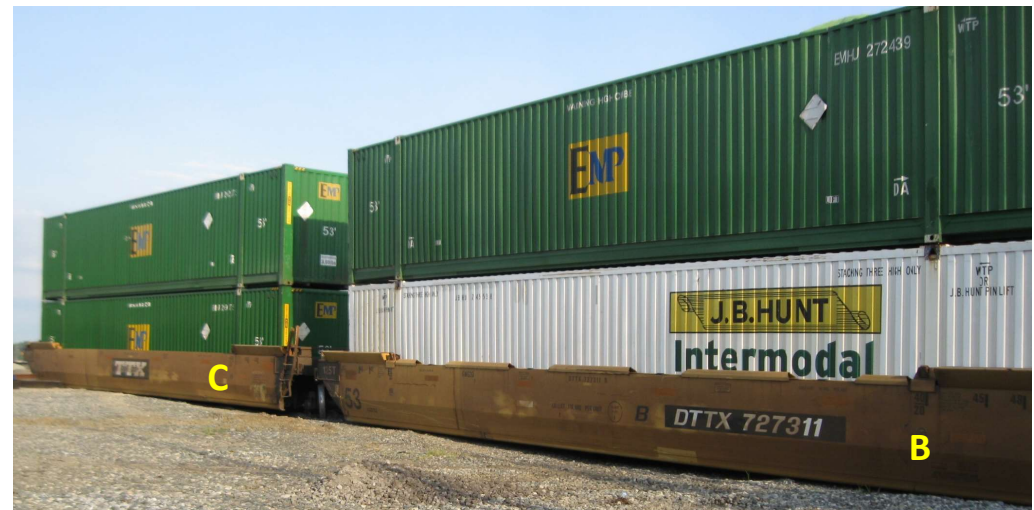
Wheels under all 4 trucks derailed

The B (lead) and C platforms shown. Between them is the C truck. The D truck and the A platform were separated by the derailment.

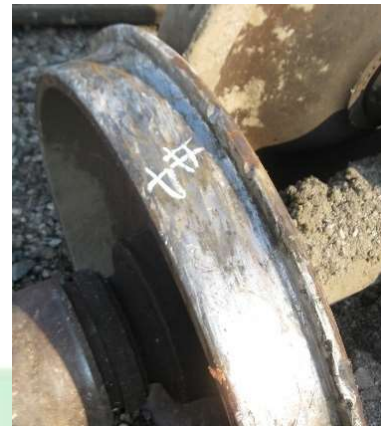
Bottom (left to right): L4, close-up of L4 flange, R4, and close-up of R4 tread (note asphalt deposit from Hartzell Rd crossing).

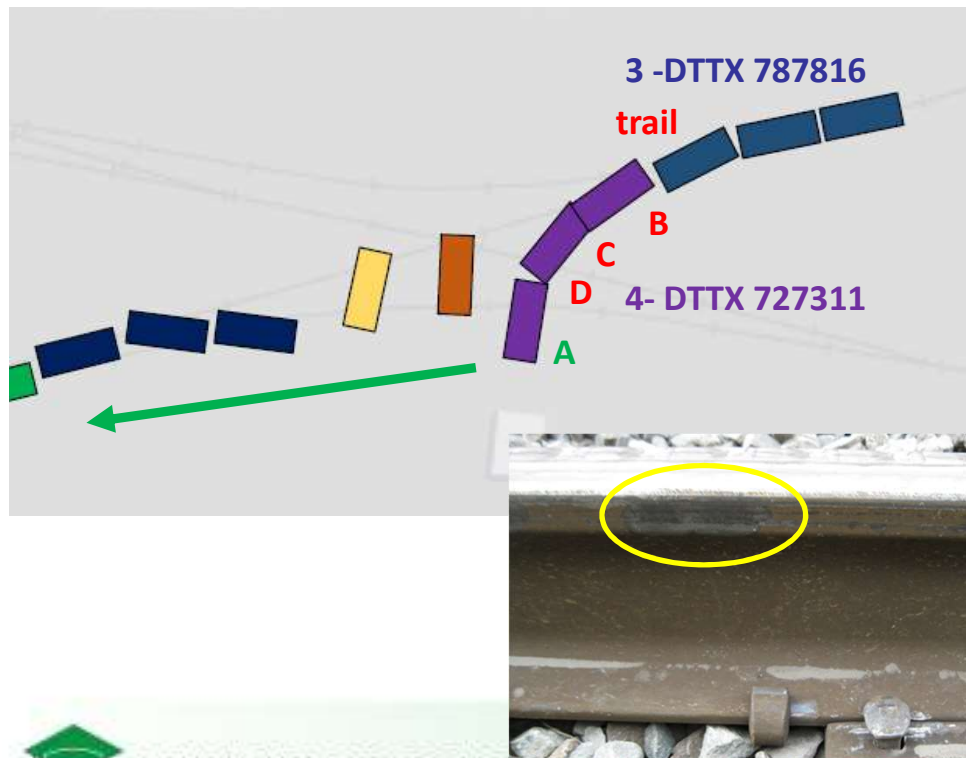
Based on the significant damage to wheelsets 4 and 6, and only slightly less damage to wheelsets 3 and 5, we concluded that:

1. The two intermediate trucks (**C** and **D**) under the 3rd car **DTTX 727311** were the first to derail, as a result of rolled rail.
2. These derailed trucks subsequently pulled off the lead (**B**) truck, which then pulled off the **trail** truck of the 2nd car (**DTTX 787816**).
3. All following trucks derailed due to the rolled rail.
4. The POD was identified where the 1st low-side wheel dropped in.

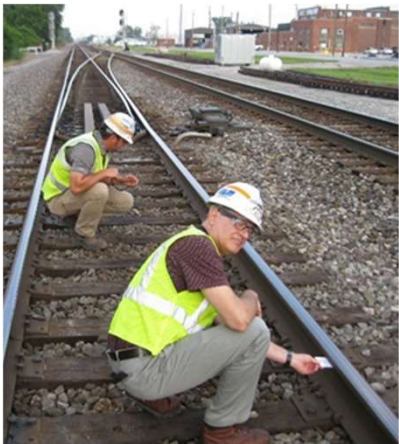
Entrance to curve, 350 ft. before POD

The low rail gage face showed evidence of wheel flange contact from the beginning of the curve to the POD.

In order for wheel flanges to contact this low rail gage face, the rail must be canted out!

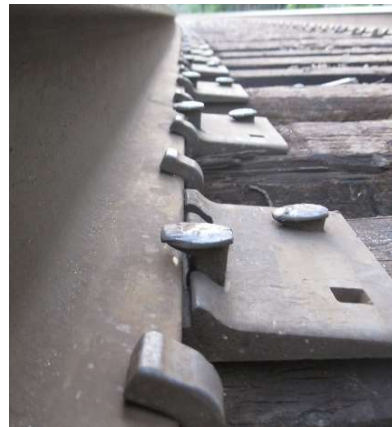
Station 14

The low rail showed evidence of dynamic cant from beginning of the curve to the POD.

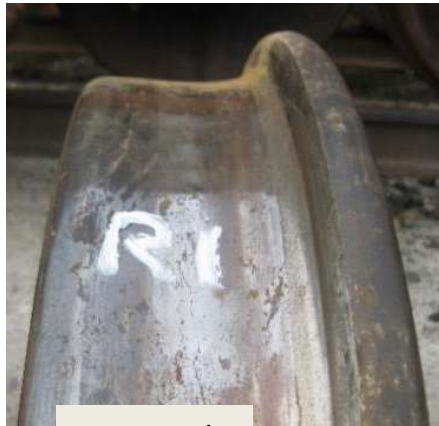
Low rail

Wheel profiles B truck

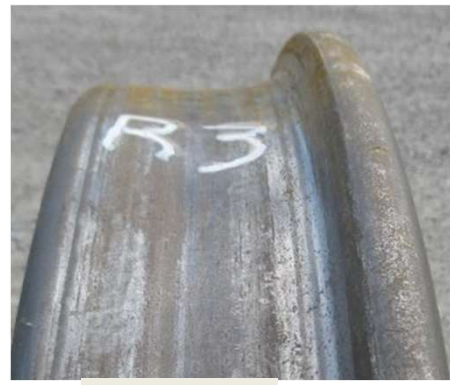
Low rail

Wheel profiles C truck

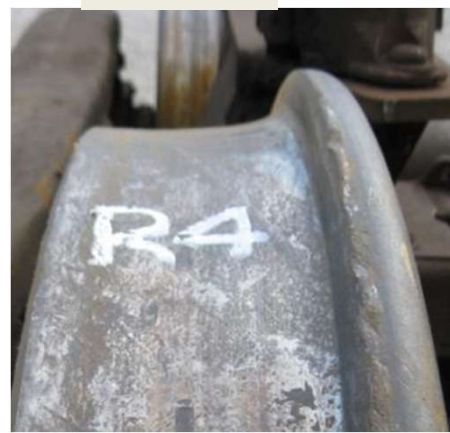
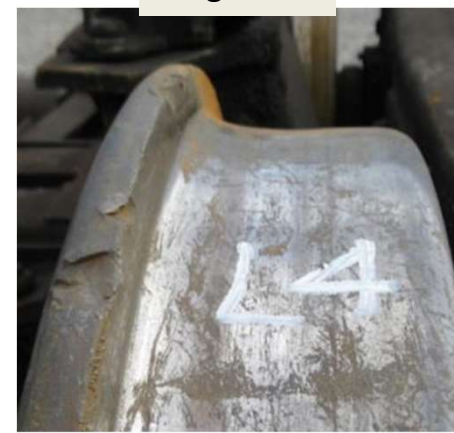
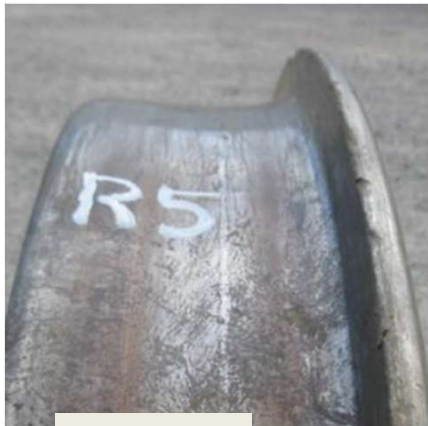
Wheel profiles **D** truck

Note asymmetric wear – each axle has a wheel with a worn flange and hollow tread, and a wheel with a full flange and normal tread.

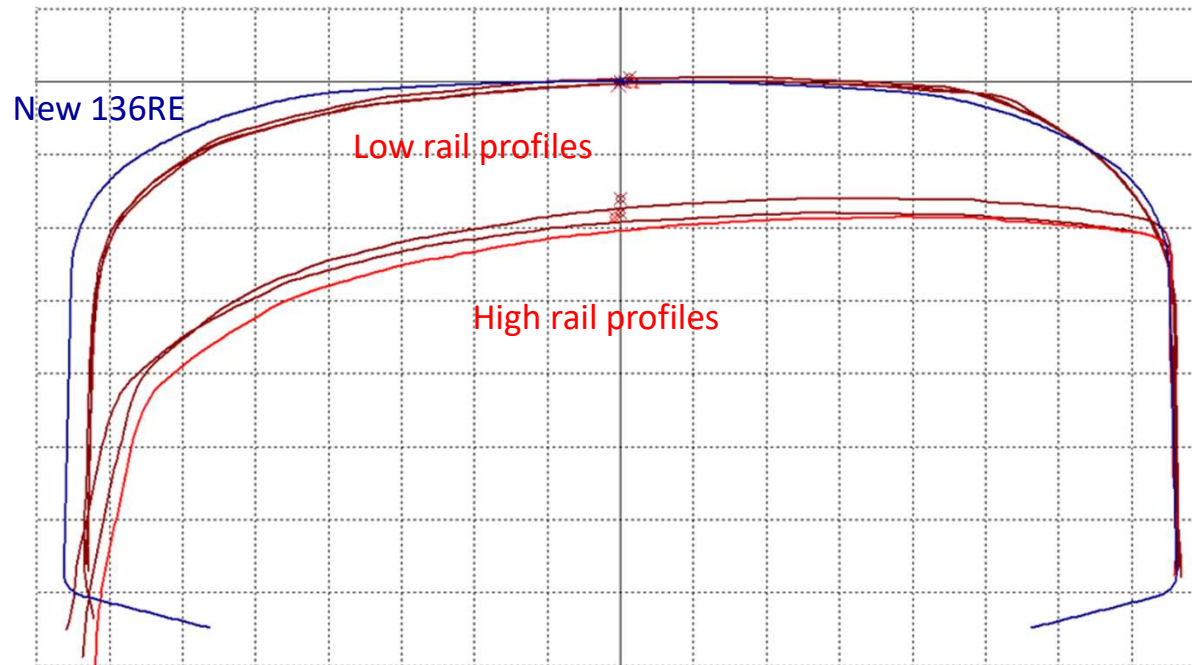
Rail profiles

High and low rail profiles from 3 locations in the full body.

The blue line is new 136RE.

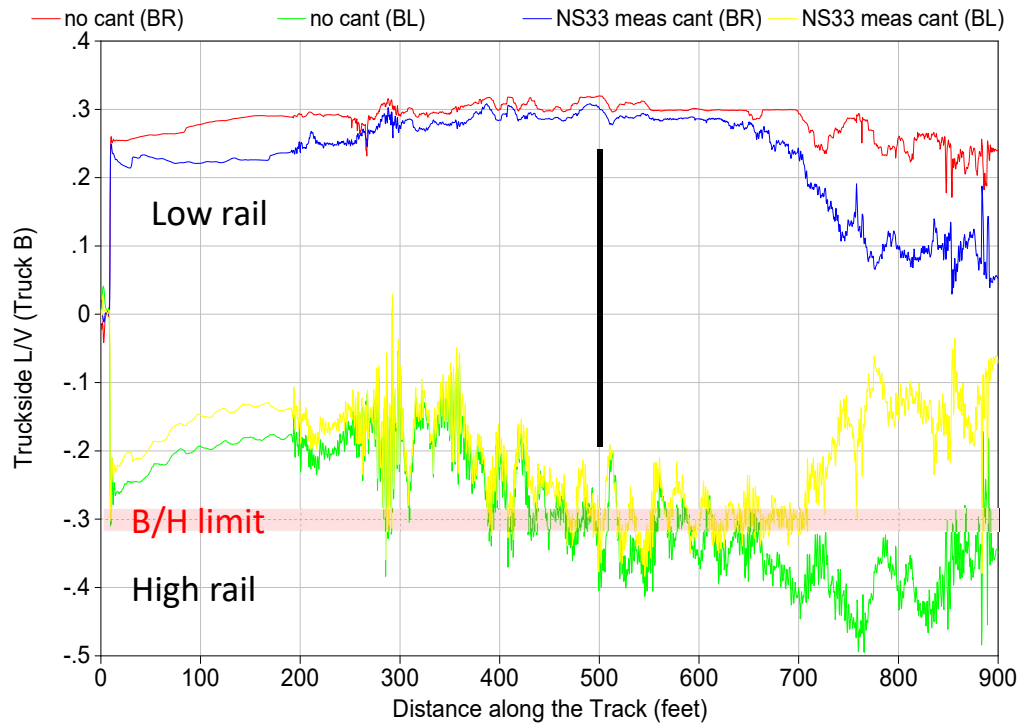
VAMPIRE truckside L/V ratios for B truck

Truckside L/V ratios are shown as a function of cant: blue & yellow = cant from April 2017 geometry car test (0.5° high rail, 1.0° low rail).

POD located at 500 feet.

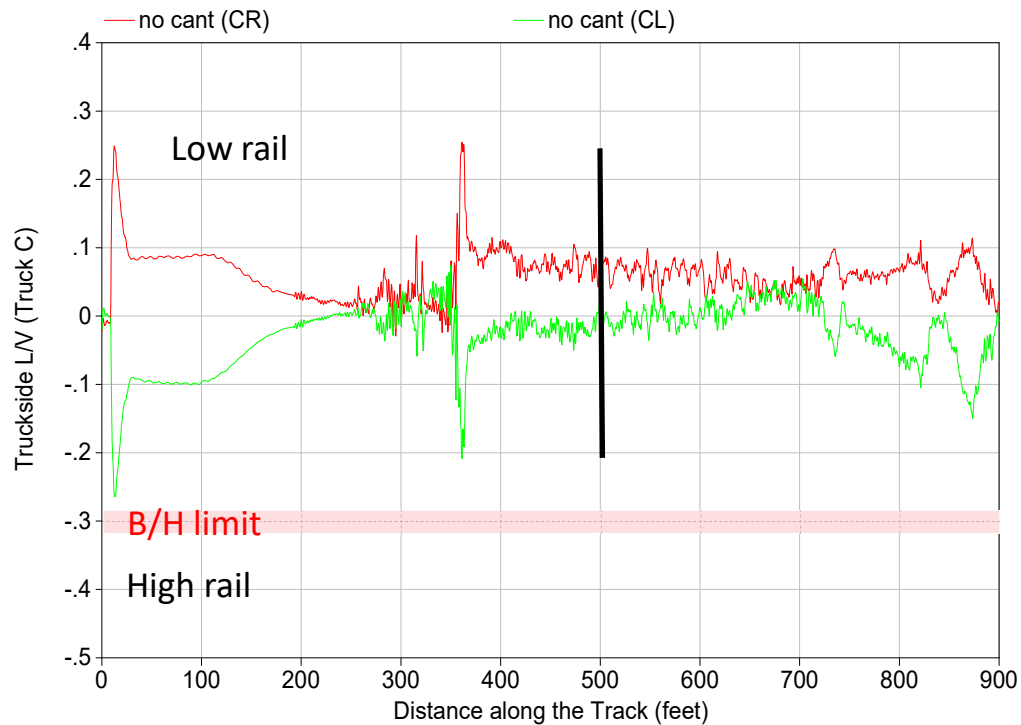
VAMPIRE truckside L/V ratios for C truck

Truckside L/V ratios are shown as a function of cant: red & green = no cant.

POD located at 500 feet
