Corrective Grinding of Adverse High Rail Profiles

Brad Kerchof

*Director Research & Tests (retired)
Norfolk Southern Railway*

HEAVY HAUL SEMINAR • OCTOBER 20 - 21, 2021

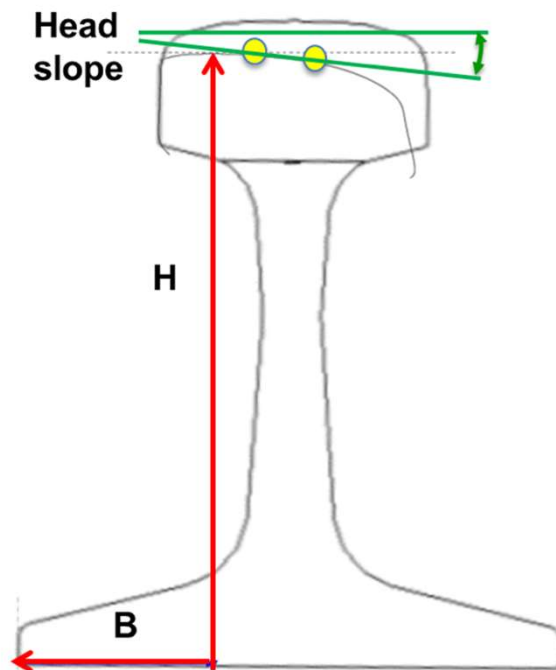
How do we measure an adverse high rail profile?

- B/H is a ratio that includes
 - H, the height of the rail at its highest point
 - B, the horizontal distance between the high point and the field edge of the base
 - ❑ New 136# rail: $3'' / 7\text{-}5/16'' = 0.41$
 - ❑ As high point moves toward field side -> B/H gets smaller
 - ❑ Threshold for concern: < 0.35
- Head slope is the angle between horizontal and a line defined by two points one-half inch on either side of rail centerline
 - ❑ Steeper slope -> more likely that wheels will run on the field side
 - ❑ Threshold for concern: $> 5^\circ$

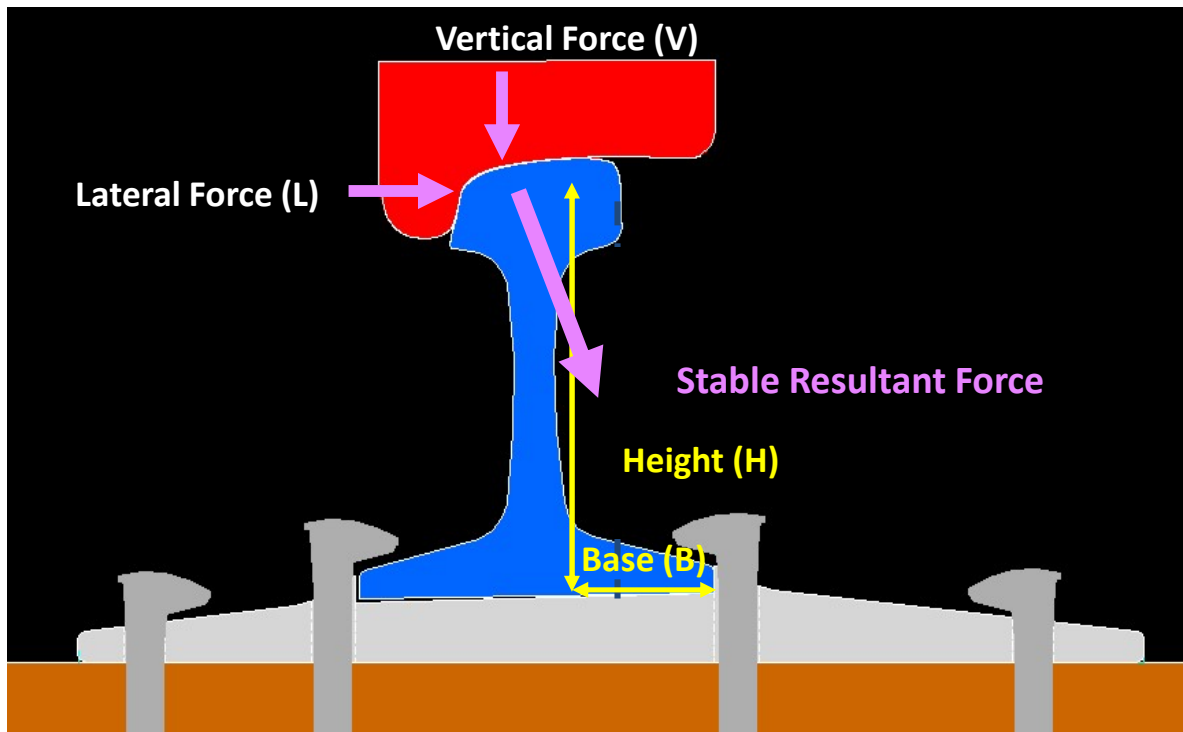
Wheel/rail force diagram, stable condition

Lateral & vertical forces
produce a resultant directed
inside the rail base

This is a stable condition –
the rail will not tend to roll

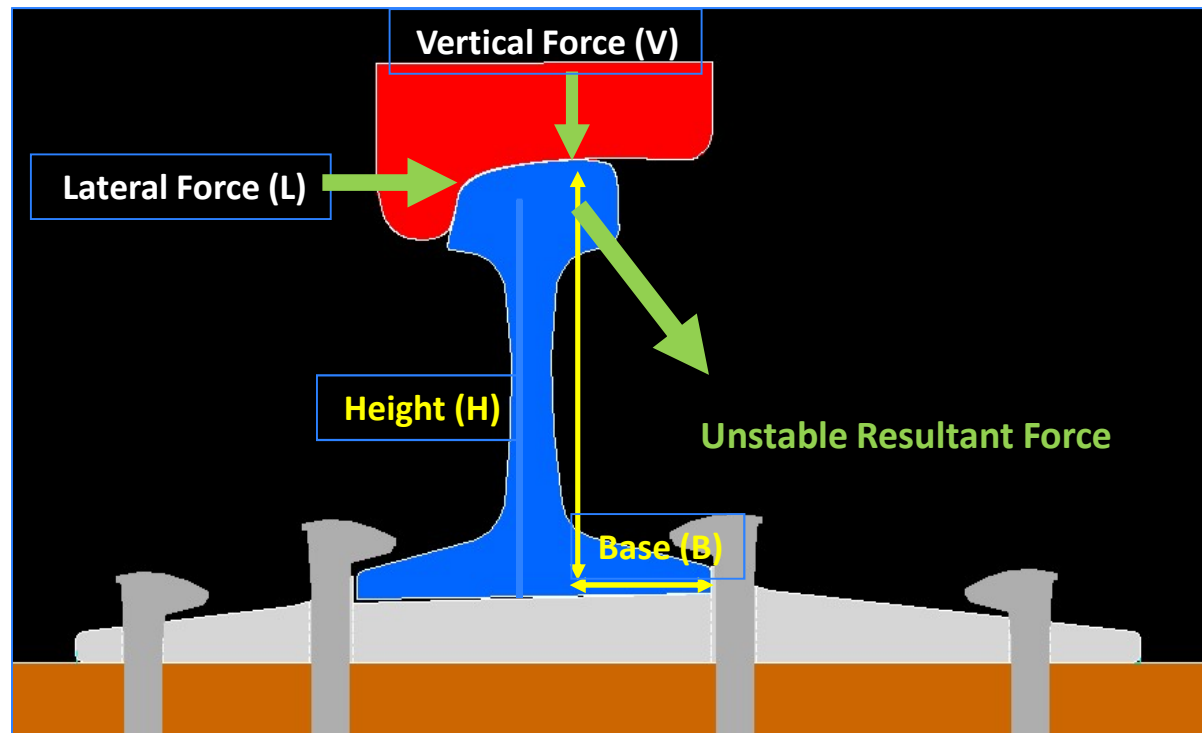
Wheel/rail force diagram, unstable condition

Vertical force has shifted
toward the field side

Lateral & vertical forces
produce a resultant directed
outside the rail base

This is an unstable condition -
an unrestrained rail will tend
to roll outward

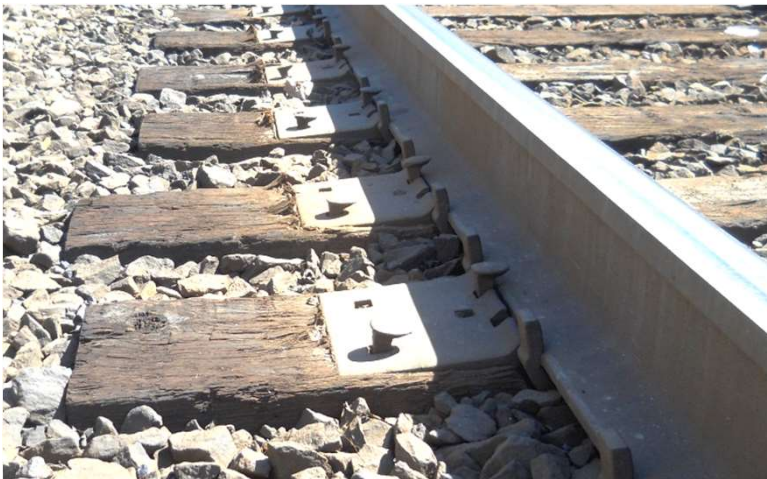
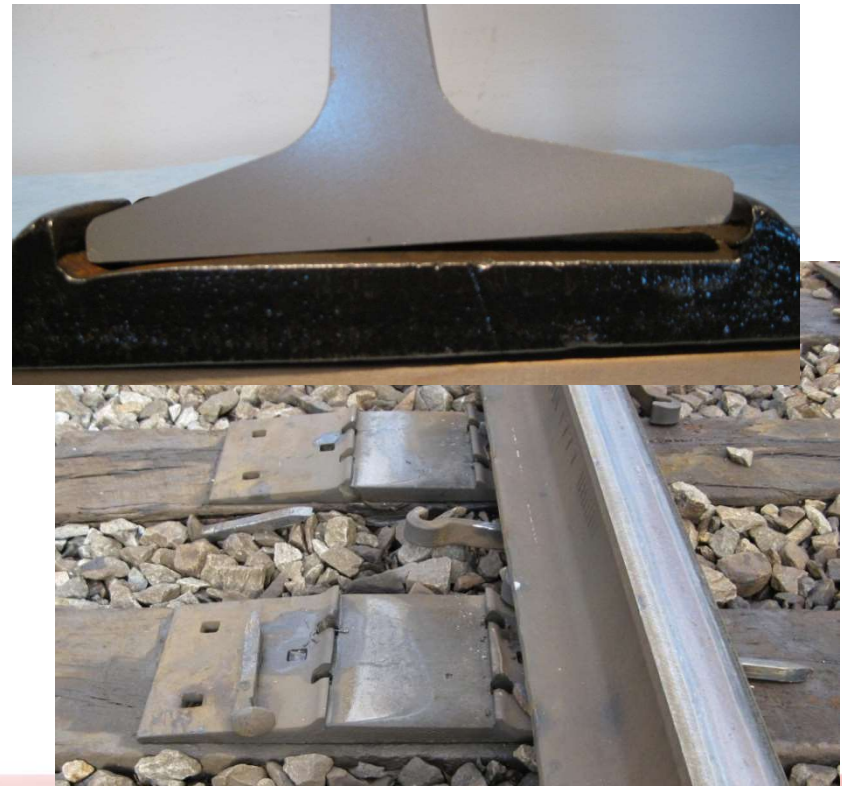
Primary reason: Grinding canted rail

Canted rail (on wood ties) is caused by plate-cut ties or worn tie plate rail seats

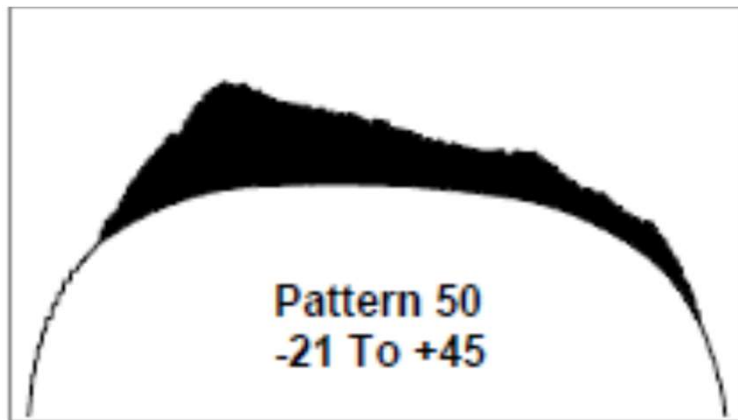
Loram's shadow diagrams

- Shows the relative amount of metal removed across the rail head of a new rail.
- Gage side is always on the right
- The numbers on the bottom line (-21 to +45) indicate the range of grinding stone angles
- This newly-developed pattern 50 emphasizes metal removal from the field side

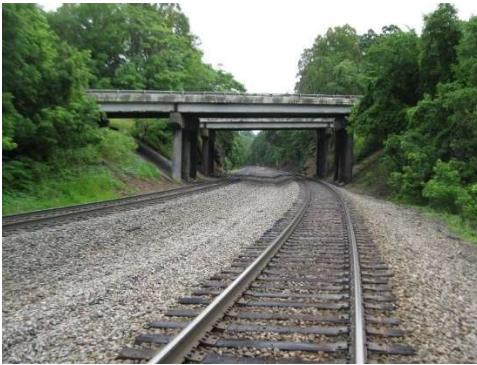
Phase 1 test results - single pass

Speed 6 mph

Pre-grind: Primary contact band is on the field side
Side wear 6/16", cant 1.5°, B/H 0.34, head slope 8°

Post grind: Wheel contact shifted toward gage side

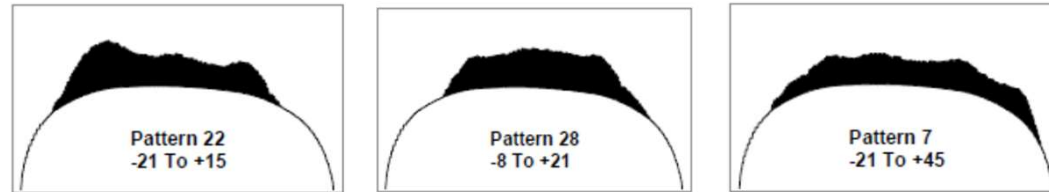
Phase 1 test results - 3 passes

Speed 13 mph for all 3 passes

Pre-grind: Primary contact appears to be on gage side (red arrow). There is some field-side wheel contact (yellow arrow), though still-visible grinding marks suggest wheel frequency is low.

Side wear 6/16", cant 1°, B/H 0.35, head slope 6°.

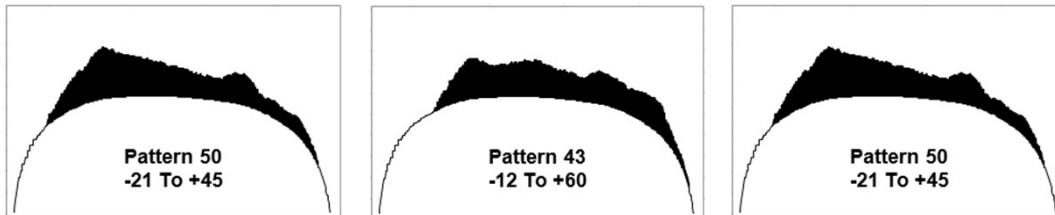
Phase 2 test results - 3 passes

Speed 10 mph for all 3 passes

Pre-grind: Primary wheel contact is at the center, though there is significant wheel contact over most of the head.

Side wear 7/16", cant 0°, B/H 0.35, head slope 8°.

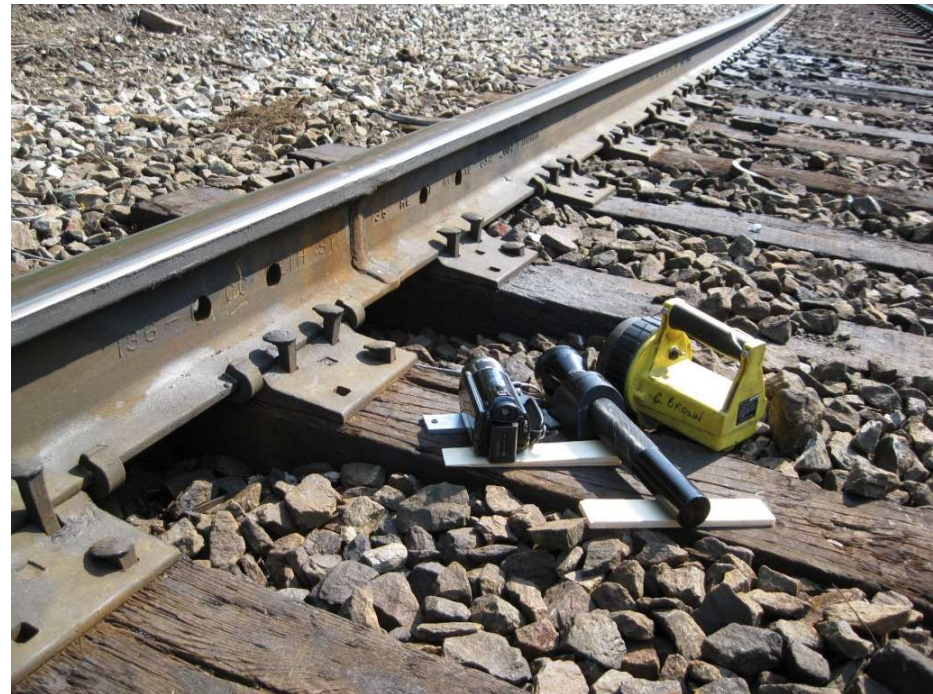
Camera set-up on low rail of this same 8° curve

Low rail still has conventional tie plates & cut spikes
