Forensic Analysis of RCF defects

Dominick Pagano Technical Adviser, Plasser American

HEAVY HAUL SEMINAR • JUNE 8 - 9

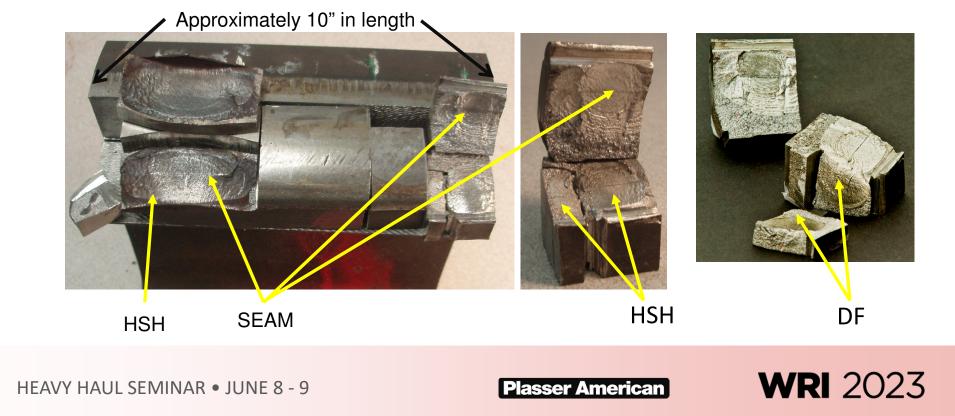
In 2007 we had introduced an enhanced detection method for TDs located in the gage corner masked by rail geometry and Horizontal head defects in the gage corner, these were initiated by a seam located in plastic zone generated by excessive loads on post grinding facets.

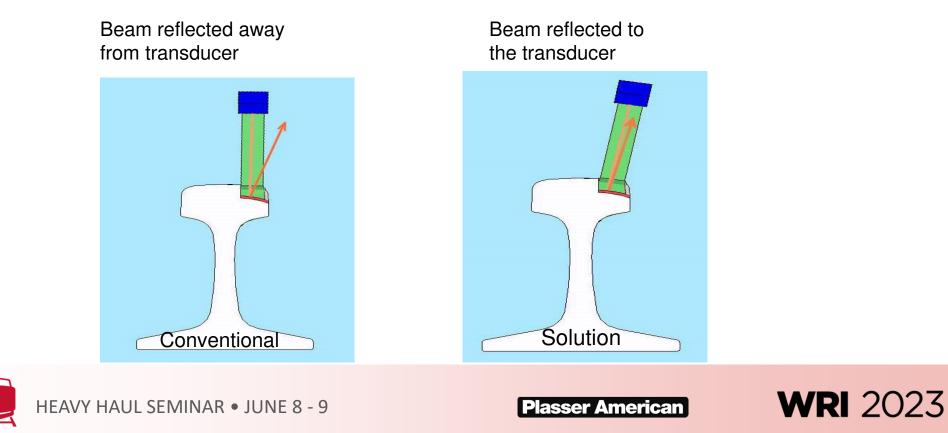
• This technology significantly increased the number of detected DFs, it did not eliminate the DF service failures.
