# Studs, Squats, and similar damage mechanisms

Richard Stock, Mark Reimer and Eric Magel

# Seattle Sound Transit

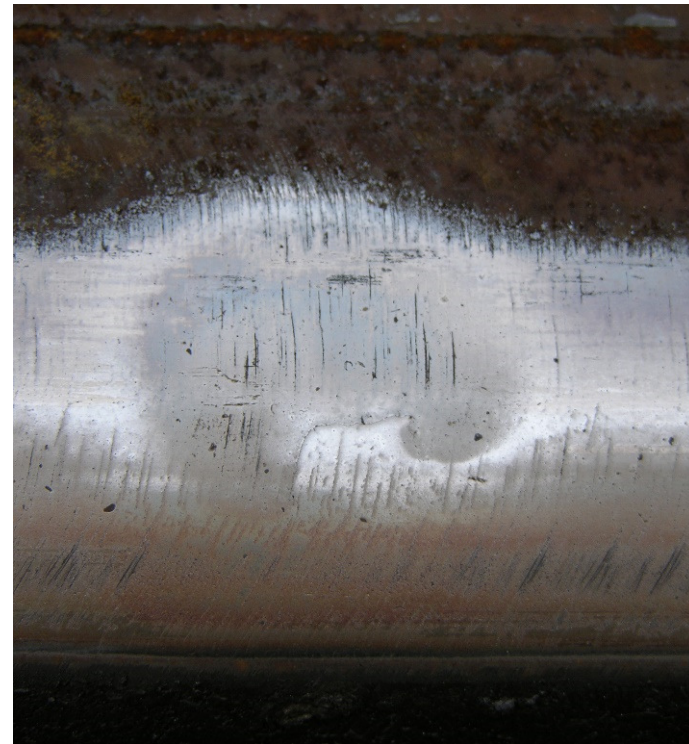
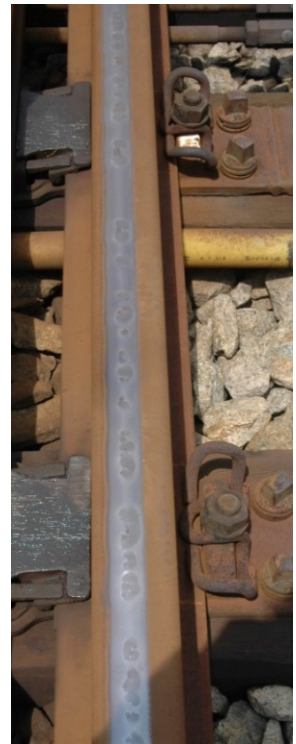
- Mid 1990s reports of increased Squat appearance
- Superficial similarity to Squats
- Massed appearance

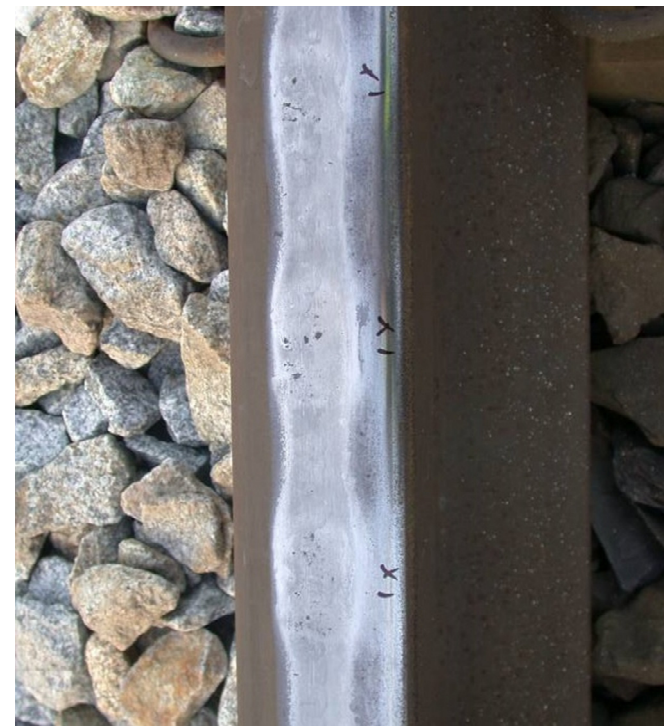
- In the late 1990s, early 2000s a lot of research activity focused (again) on Squats
- First Question asked:
  - What has changed?
- Quick answer found:
  - Heat Treated Rails (introduced around the same time)

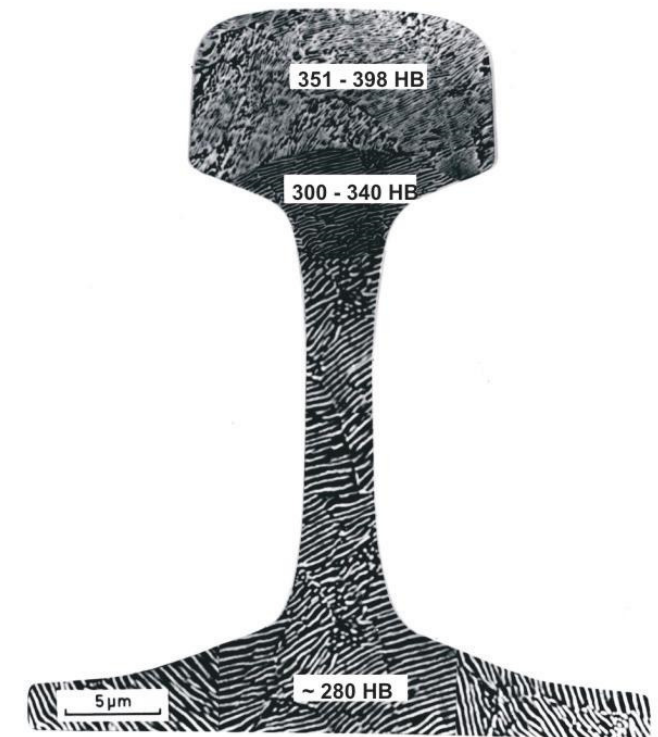
- Premium (HT) rails:
  - increased hardness and strength, similar toughness
  - Increased wear and RCF resistance
- Squats found on premium (increased likelihood) and on standard grade rails
- Conclusion: Studs in areas with low rail wear

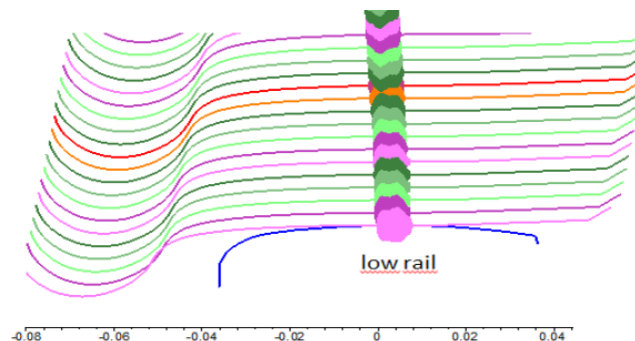
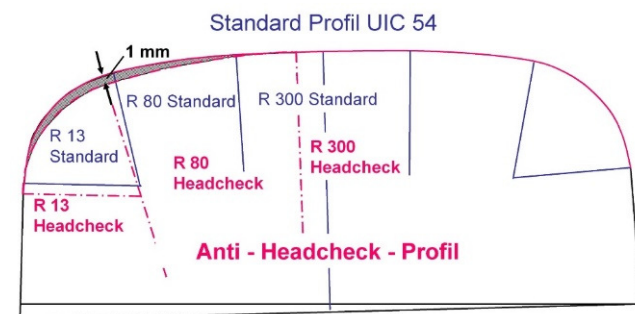
- Anti-Head Check profiles introduced in 1990s
  - Gauge corner undercutting
  - Concentrating contact on TOR
- Conclusion: concentrated contact conditions favor formation of studs
- Especially of concern when combined with low wear situations

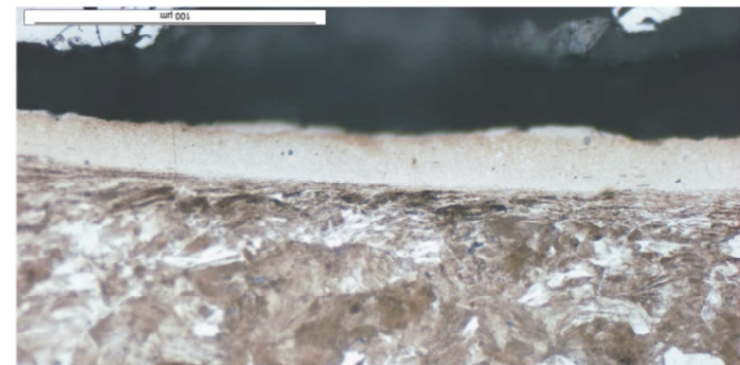
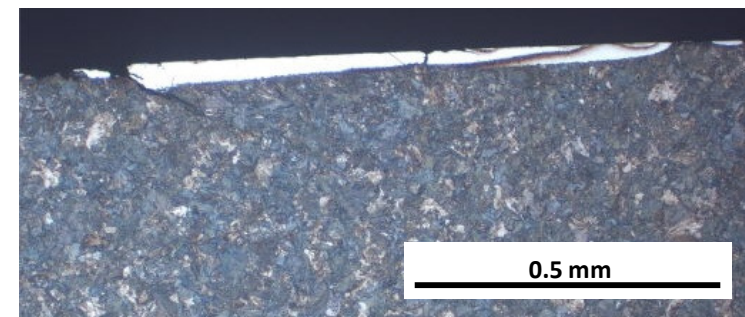
- Thin, hard layer on rail surface
  - Cause: thermal transformation
- WELs always present at Studs
  - contributing factor
- WELs found everywhere in track (not only at Stud areas)
  - Usually, these layers wear away

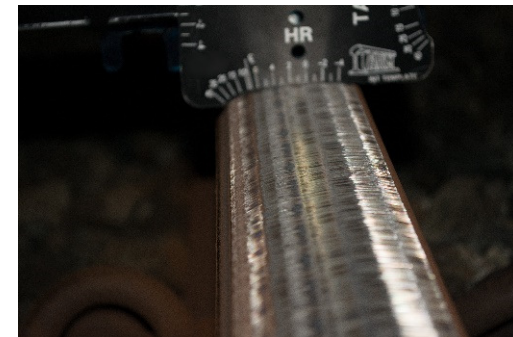
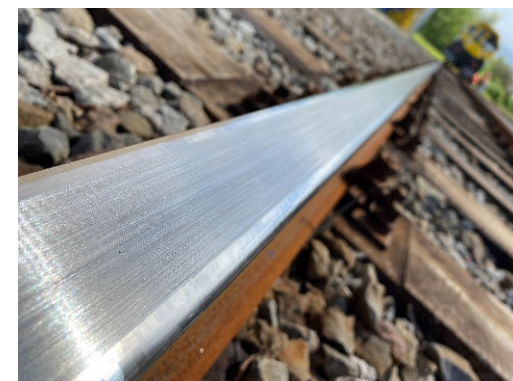
- WELs can be caused by rail grinding
  - Dependent on grinding parameters
- Rail grinding creates facets and grinding marks
  - Both can act as stress risers
- Milling does not result in WEL
  - However: polishing process can result in WEL
- Newest research results indicated that WEL after rail maintenance has minor impact on Stud formation
