# *Origins and Dynamics of Wide Gage Derailments*

**Gary Wolf**

**Wolf Railway Consulting**

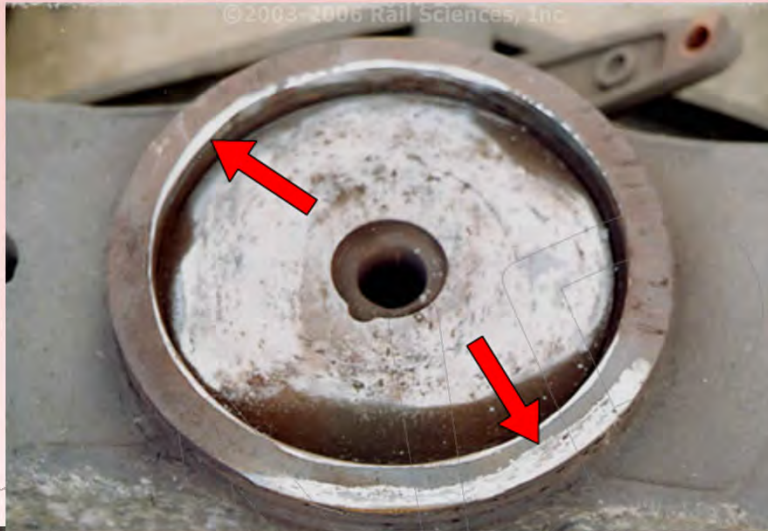
**Centerplate Weld Repair**

- ✓ Improper centerplate repair
- ✓ Lack of bowl lubrication
- ✓ Insufficient side bearing clearance
- ✓ Fouling between bowl and rim

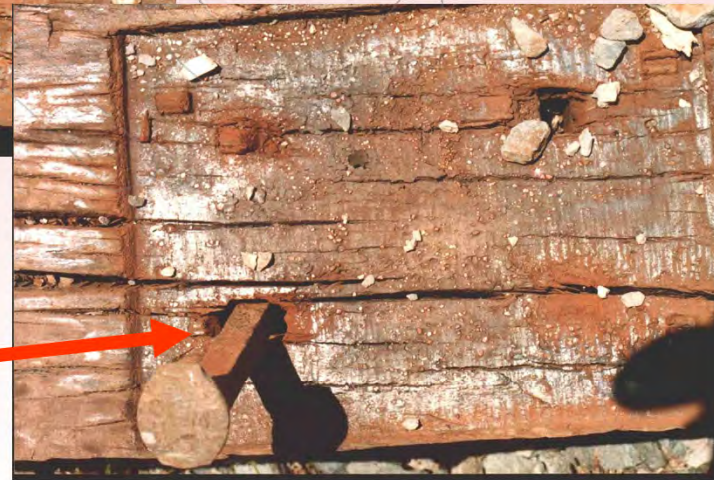
**Elongated Field side  
Spike hole and showing  
Loose spike in hole**

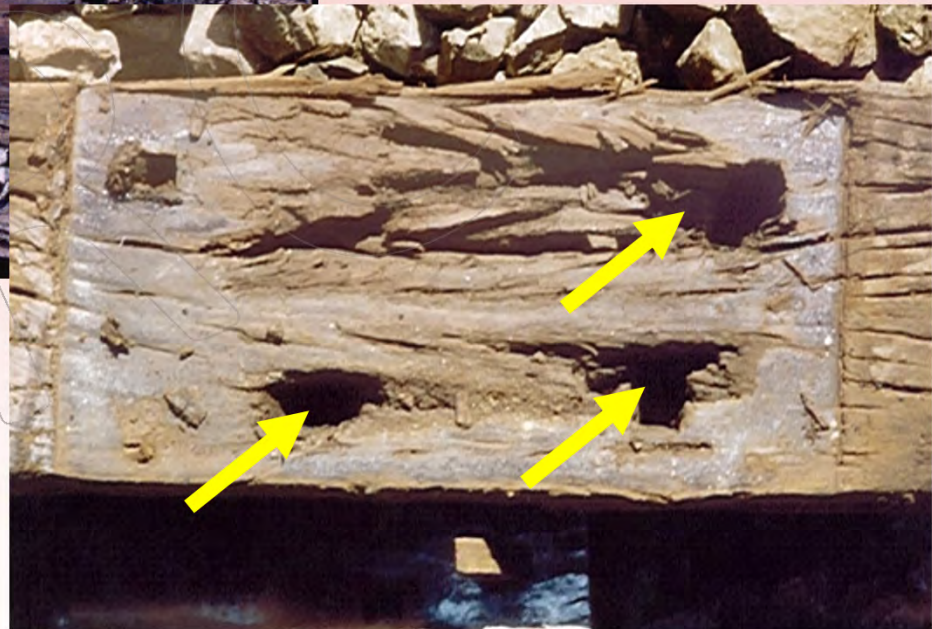
**Spike Kill**

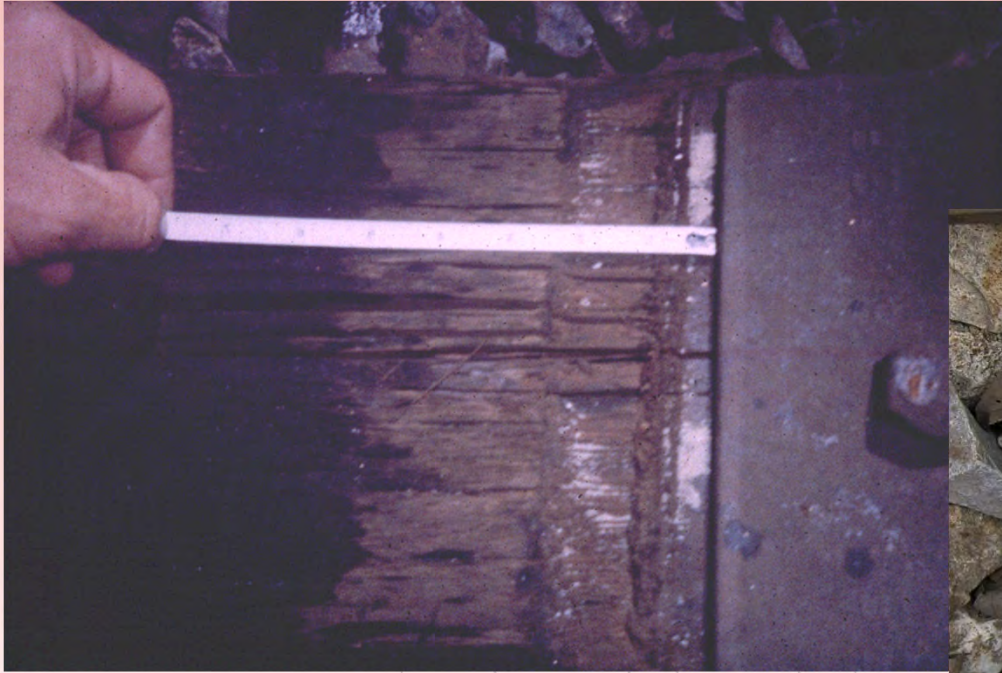
**No more than 1/2" lateral movement per FRA**

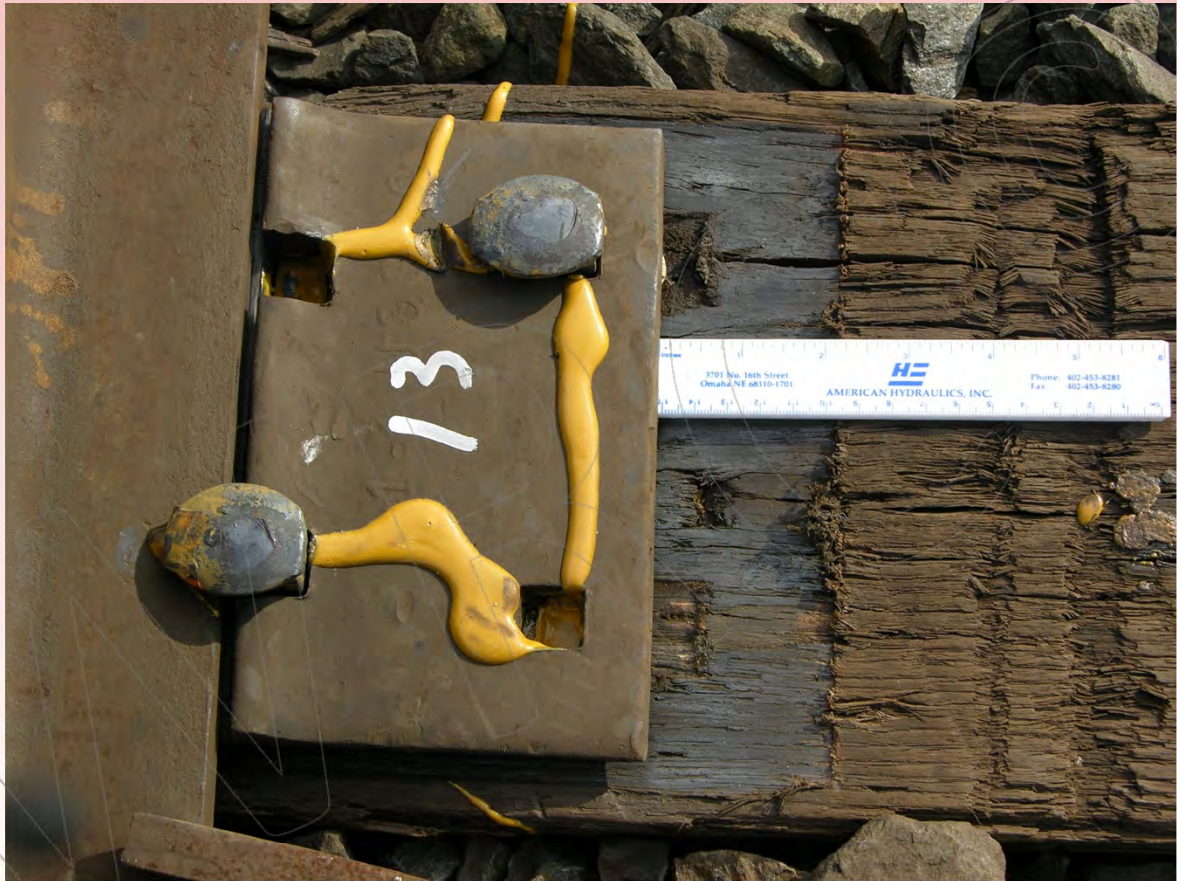
**Closeup showing amount of dynamic plate movement**

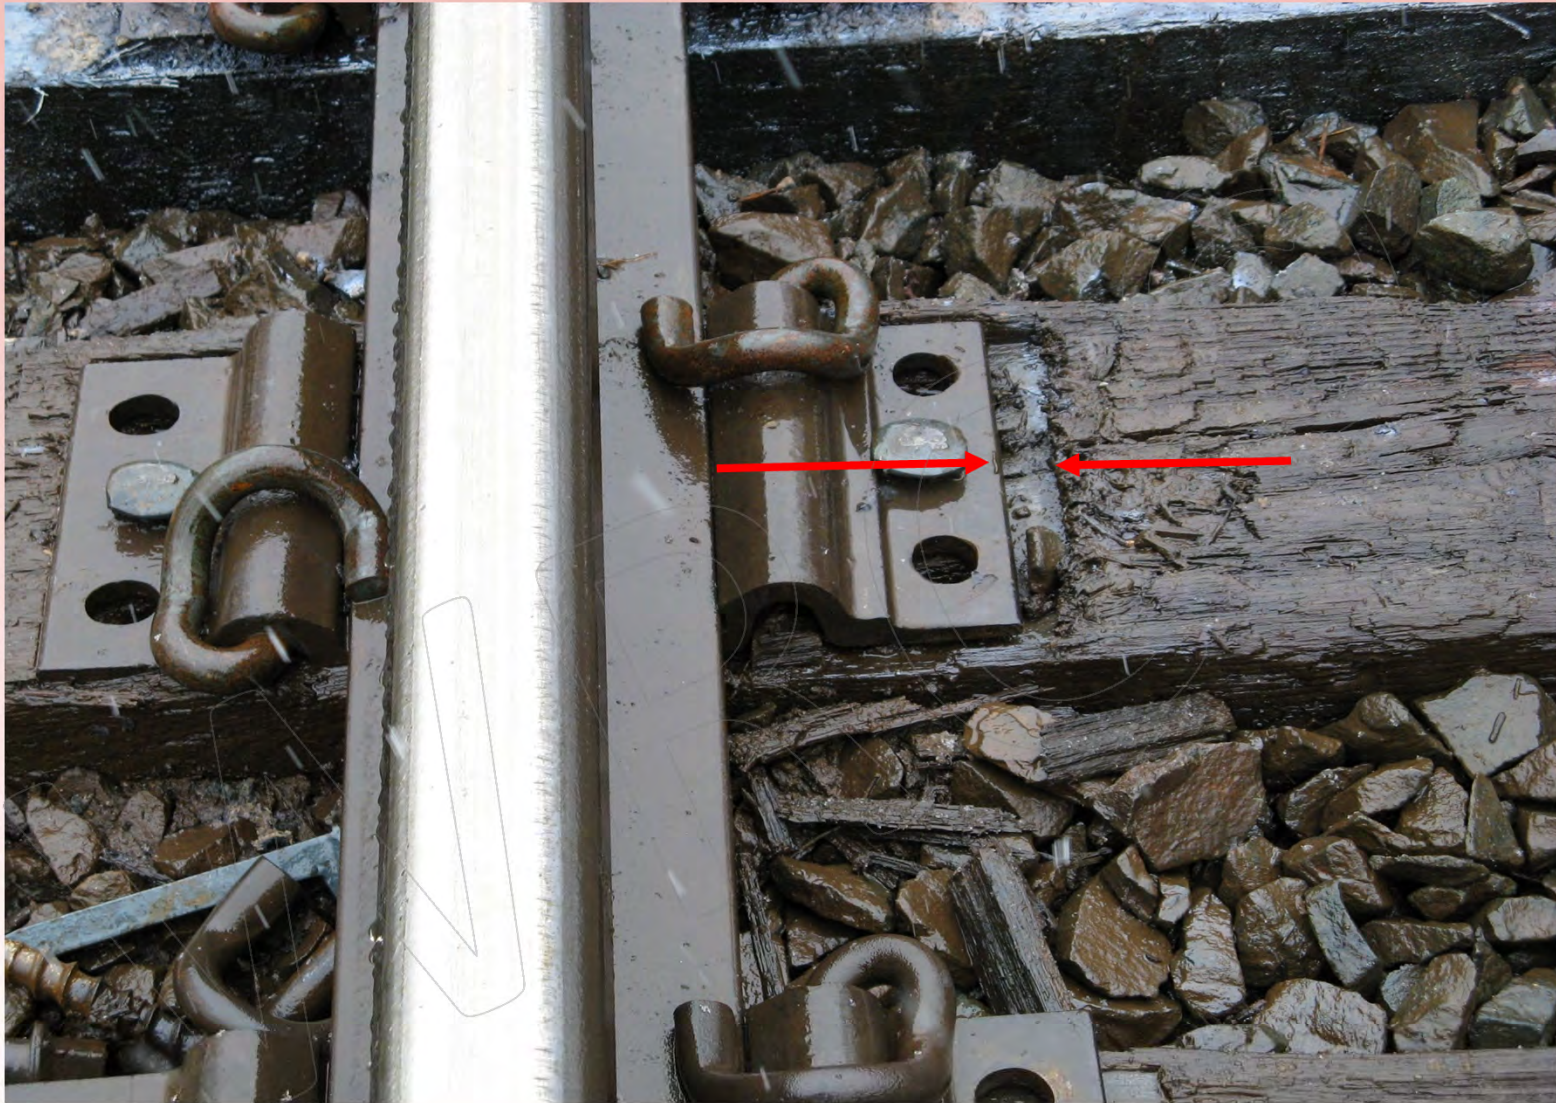
Note wear in shoulders of tie plate allowing additional rail movement under dynamic load.

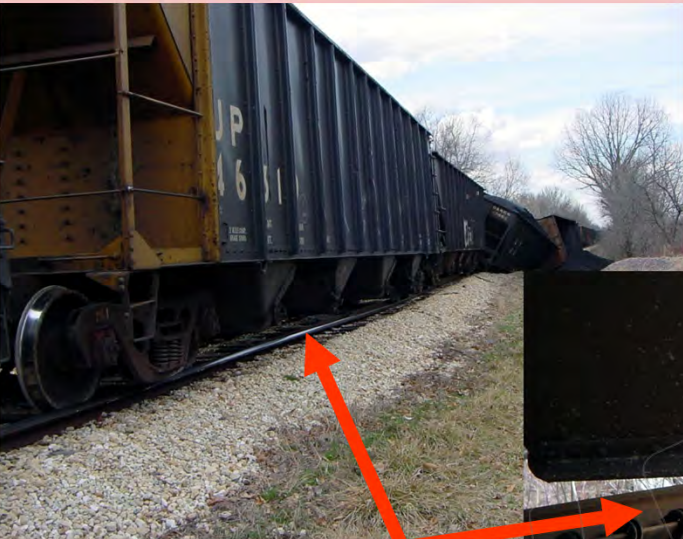
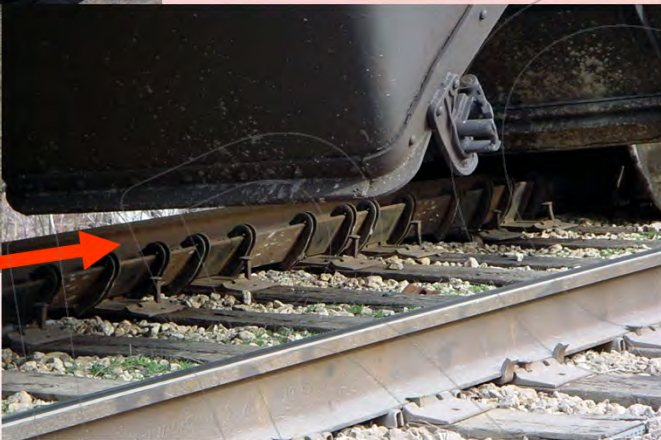
One or both rails  
rolled  
outward under train

Evidence of raised  
spikes leading into  
POD
