A Derailment Investigation and Broken Spikes

*Brad Kerchof
Research & Tests*

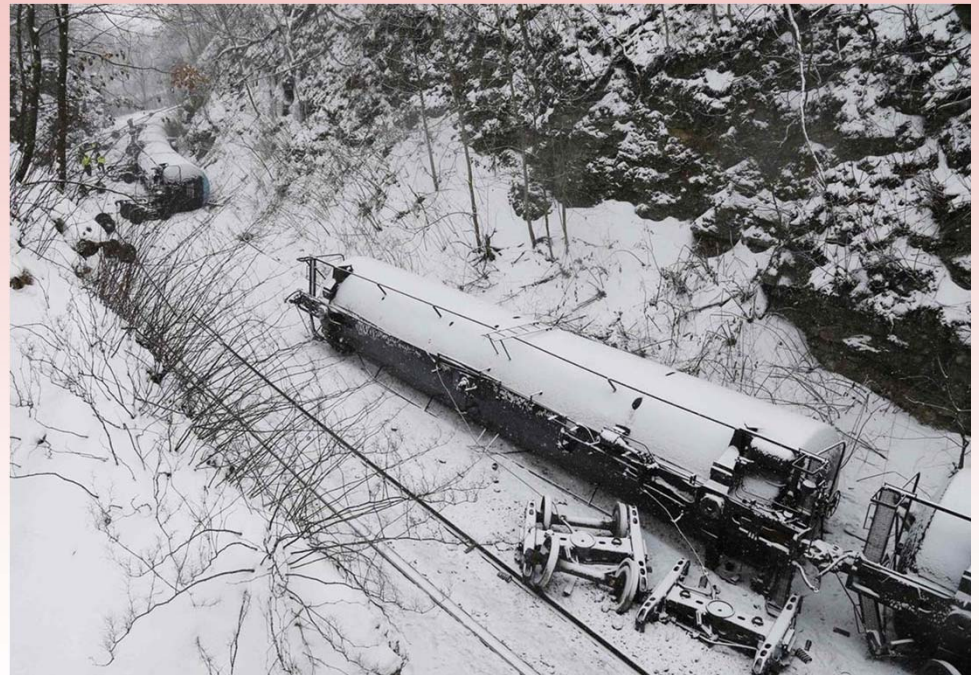
Google Earth image of the derailment site

- Vandergrift, PA, January 2014
- 8.3° curve, river grade (0.3% descending to 0%)
- Timetable speed 30 mph, direction of travel top to bottom on map
- former steel plant located on the outside of the curve
- length of track damage indicated by red line

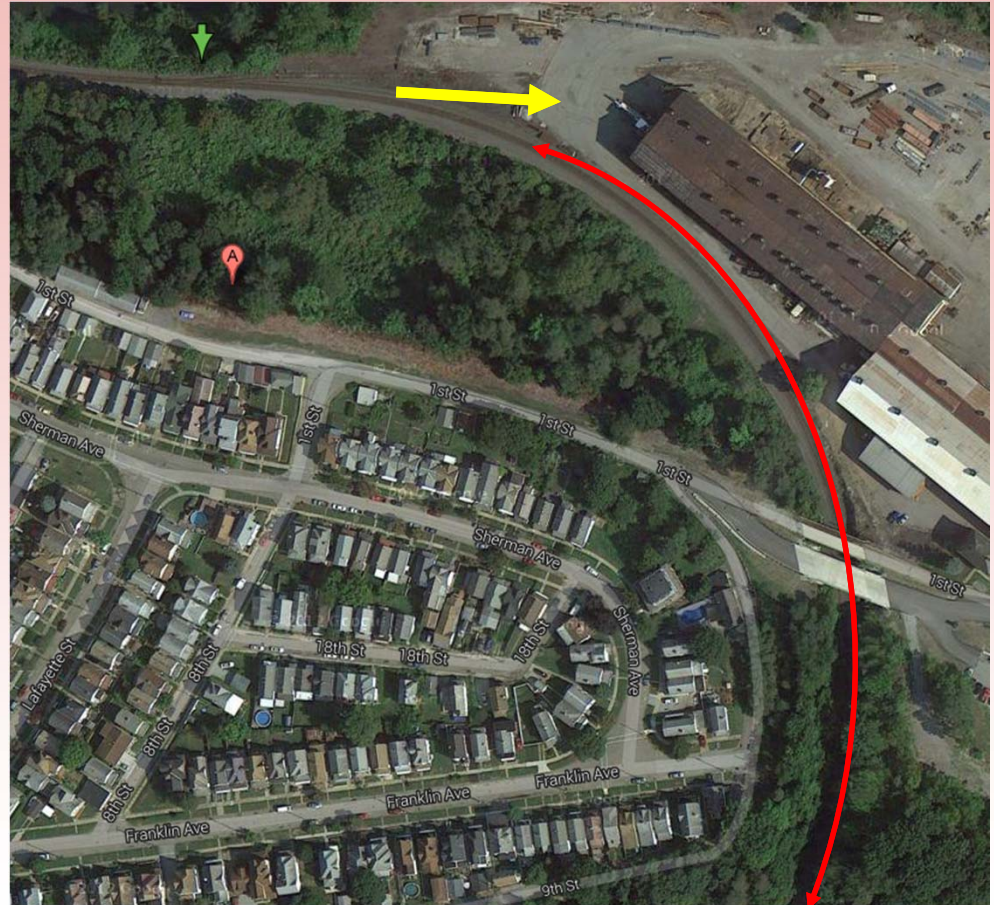
Looking in the direction of train travel

- looking east at the entrance spiral to the 8.3° curve and at the former steel plant
- signal cut section with insulated joints is at the point of spiral to curve (red arrow)
- track damage began at the insulated joints

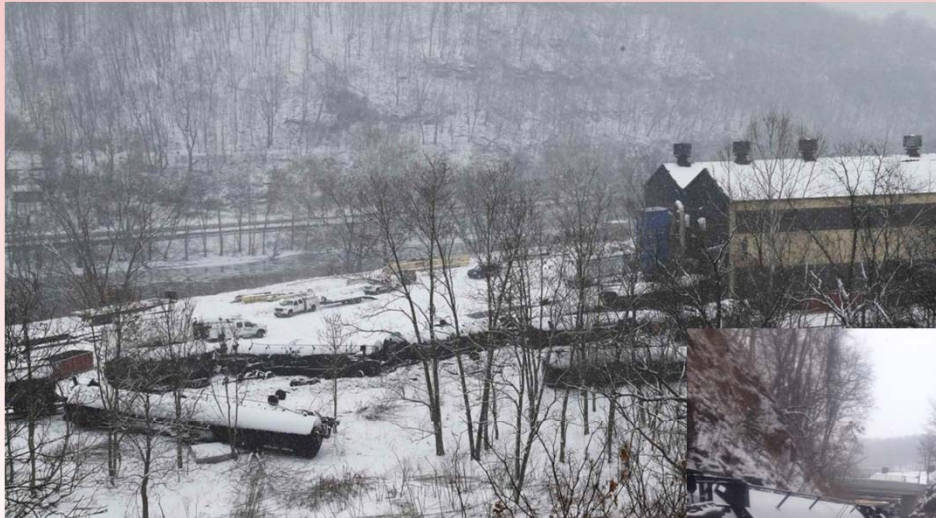
14G, a mixed merchandise train with a cut of 67 loaded crude oil tank cars

21 of those tank cars derailed,
positions in train 67 - 87

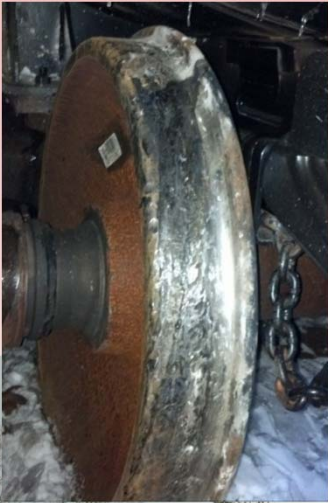
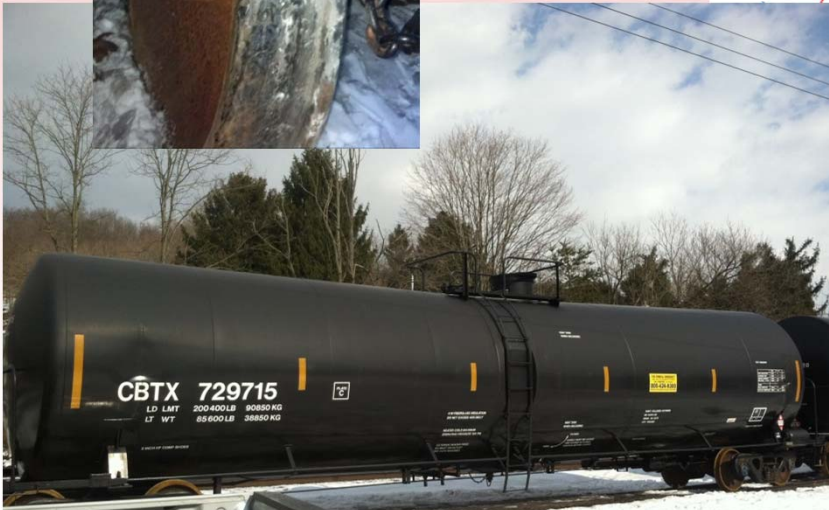
The first car to derail was the 67th head car

Does this video also suggest a POD and a derailment explanation?

Yes to both questions:

- POD - likely at the beginning of the track damage
- Explanation - this is likely a wheel climb or wheel drop-in derailment

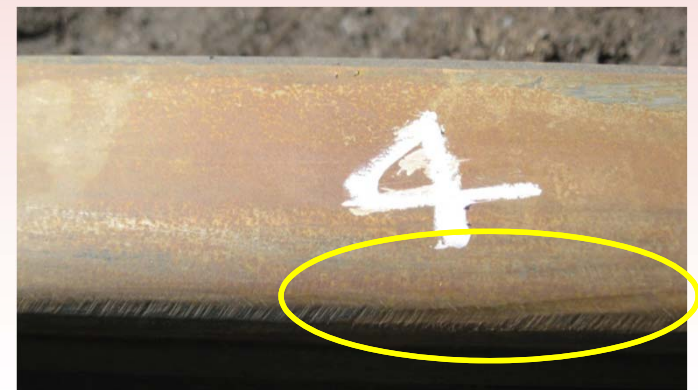
The low rail / gage corner showed four wheel rim drop-in marks, located 3 to 6 feet before the insulated joint.

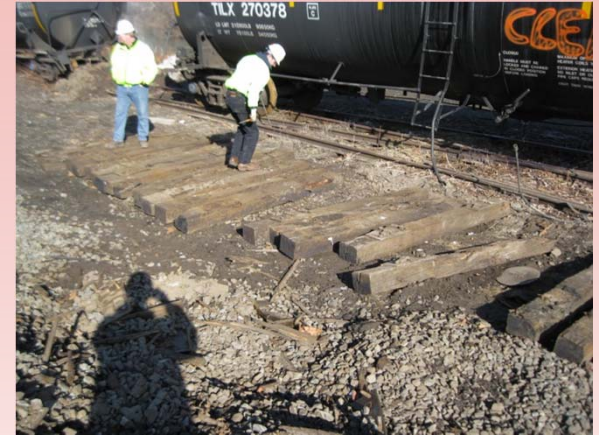
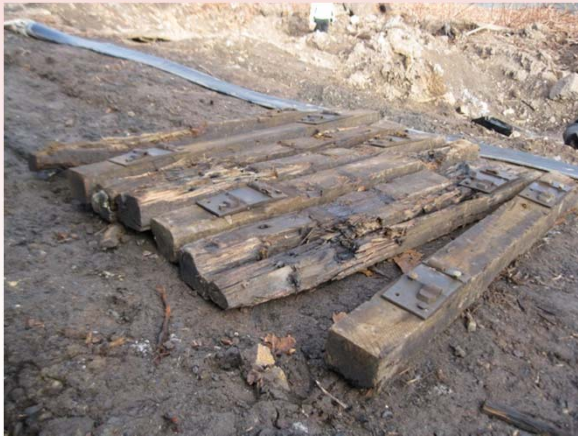
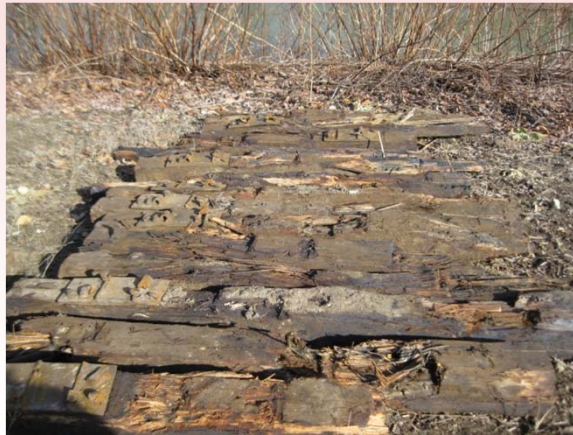
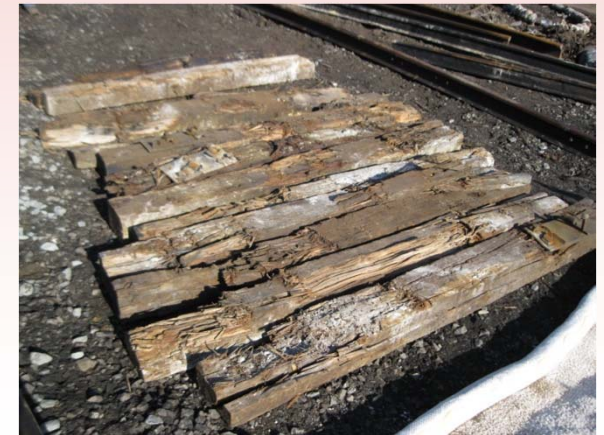
Ties that were close to the POD had been gathered into 4 groups

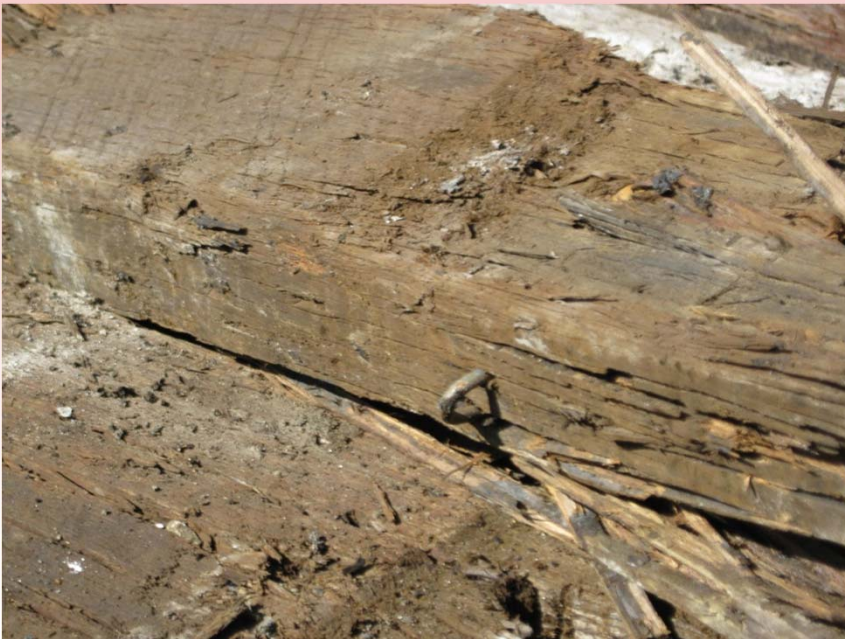
We looked for a staple that once held a track wire.

We found one.

This indicated we had the correct group of ties.

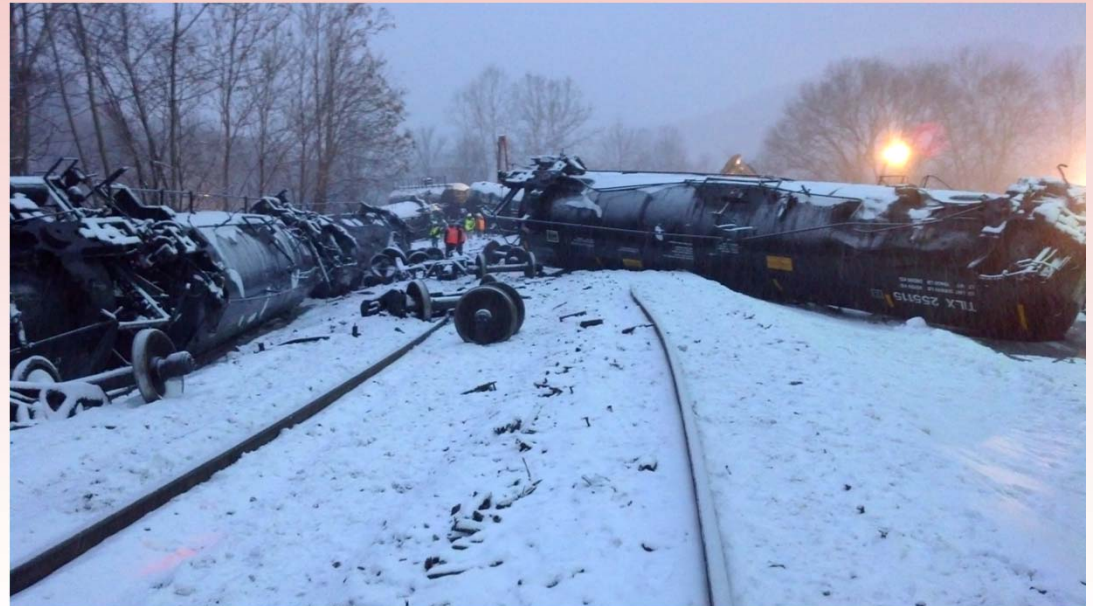
Official cause determined

“High-side wheels of 67th head car, loaded tank CBTX 729715, ruptured gage by shoving the high rail out in a 8.3° RH curve account broken spikes under high rail IJ, and allowing low-side wheels to drop inside the low rail.”

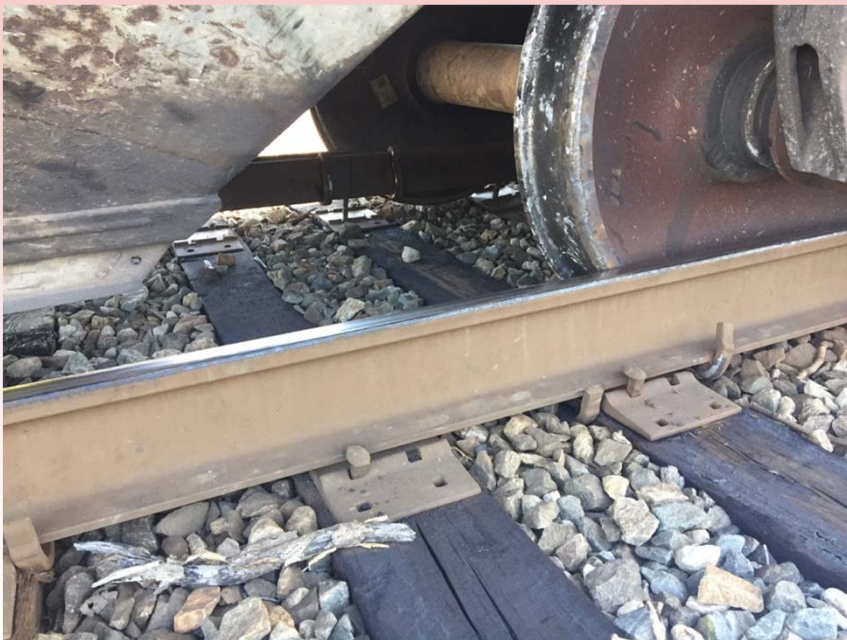
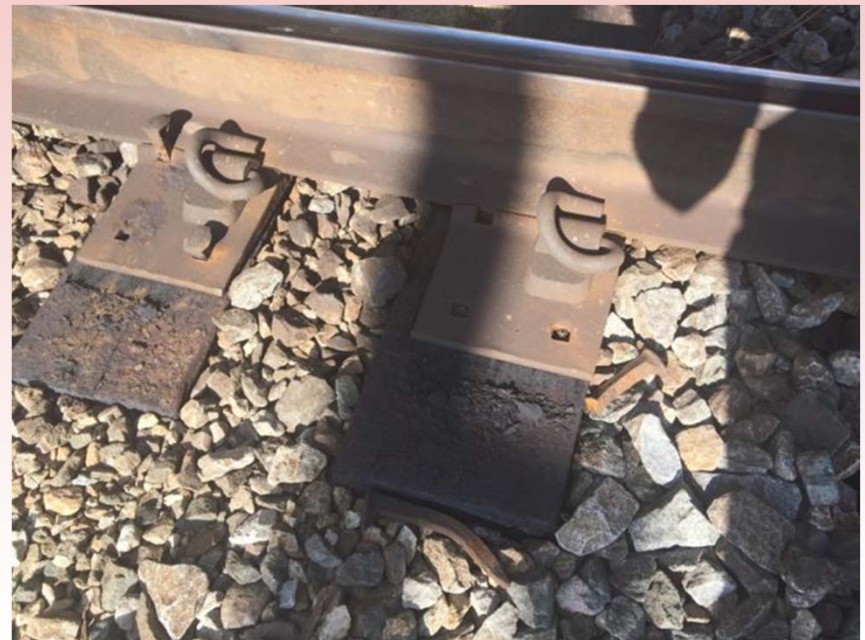
How do we find broken spikes?
We investigate a derailment caused by ruptured gage

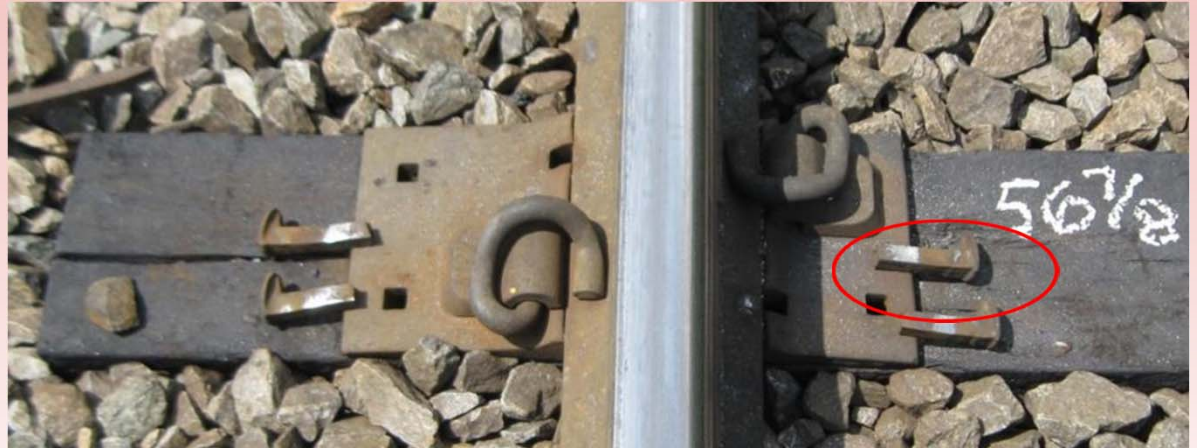
Let's look at a broken spike

- High rail of a 10° curve
- Descending 1.2% grade (loaded unit trains use air brakes, all other trains use dynamic)
- Tie condition was exceptional – most had been installed within the past 2 years.

- Yellow arrows - note deep groove on uphill side of shaft, caused by longitudinal (downhill) force applied by the tie plate.
- Red - fatigue fracture originated in uphill back corner.

- The fatigue fracture originated in the corner marked with the red arrow, and propagated along a pattern indicated by the blue lines.
- The primary load was due to lateral forces, however, significant longitudinal force is also indicated.

Adding anchors to the high rail has reduced the frequency of broken spikes significantly.

Installing "bridge" Victor plates every third tie has eliminated broken spikes... so far. The plates have round holes for 15/16" Evergrip screws.

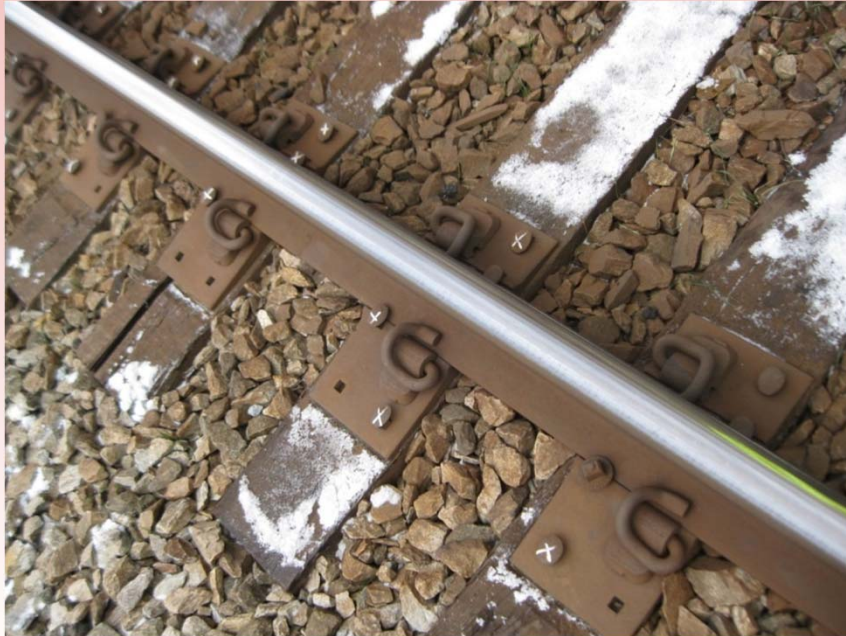
5 consecutive ties have 13 broken spikes in 20 spike positions, yet no tie plate movement!
